State of California The Resources Agency
DEPARTMENT OF PARKS AND RECREATION
PRIMARY RECORD

Page 1 of 16 *Resource Name or #: (Assigned by recorder) 815 W. San Carlos St.San Jose

c. Address 815 W. San Carlos St **City** San Jose **Zip** 95126

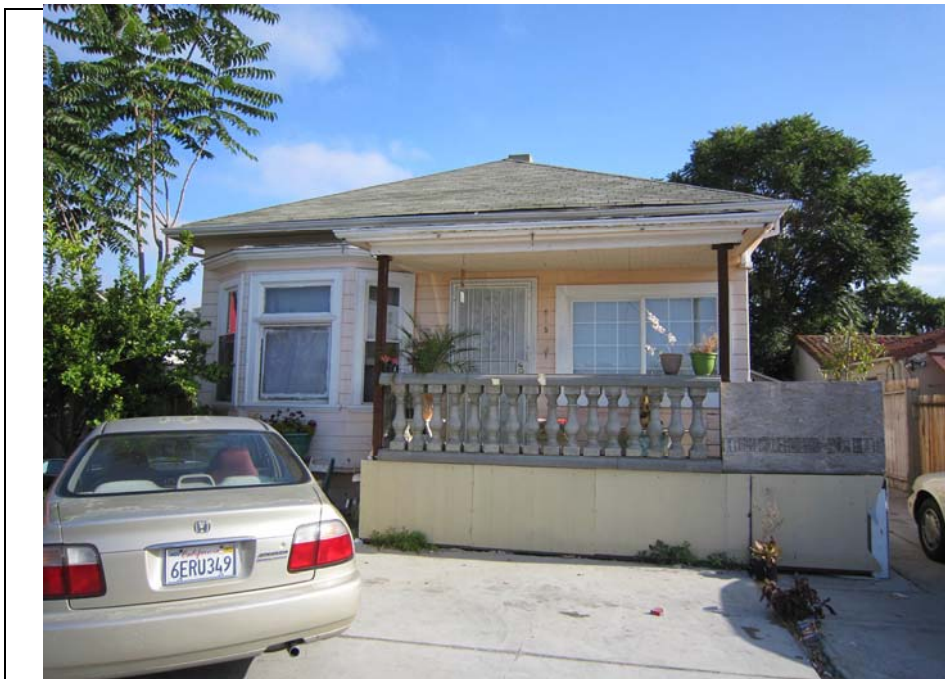
P5b. Description of Photo: (view, date, accession #) Front Façade, 6/2015

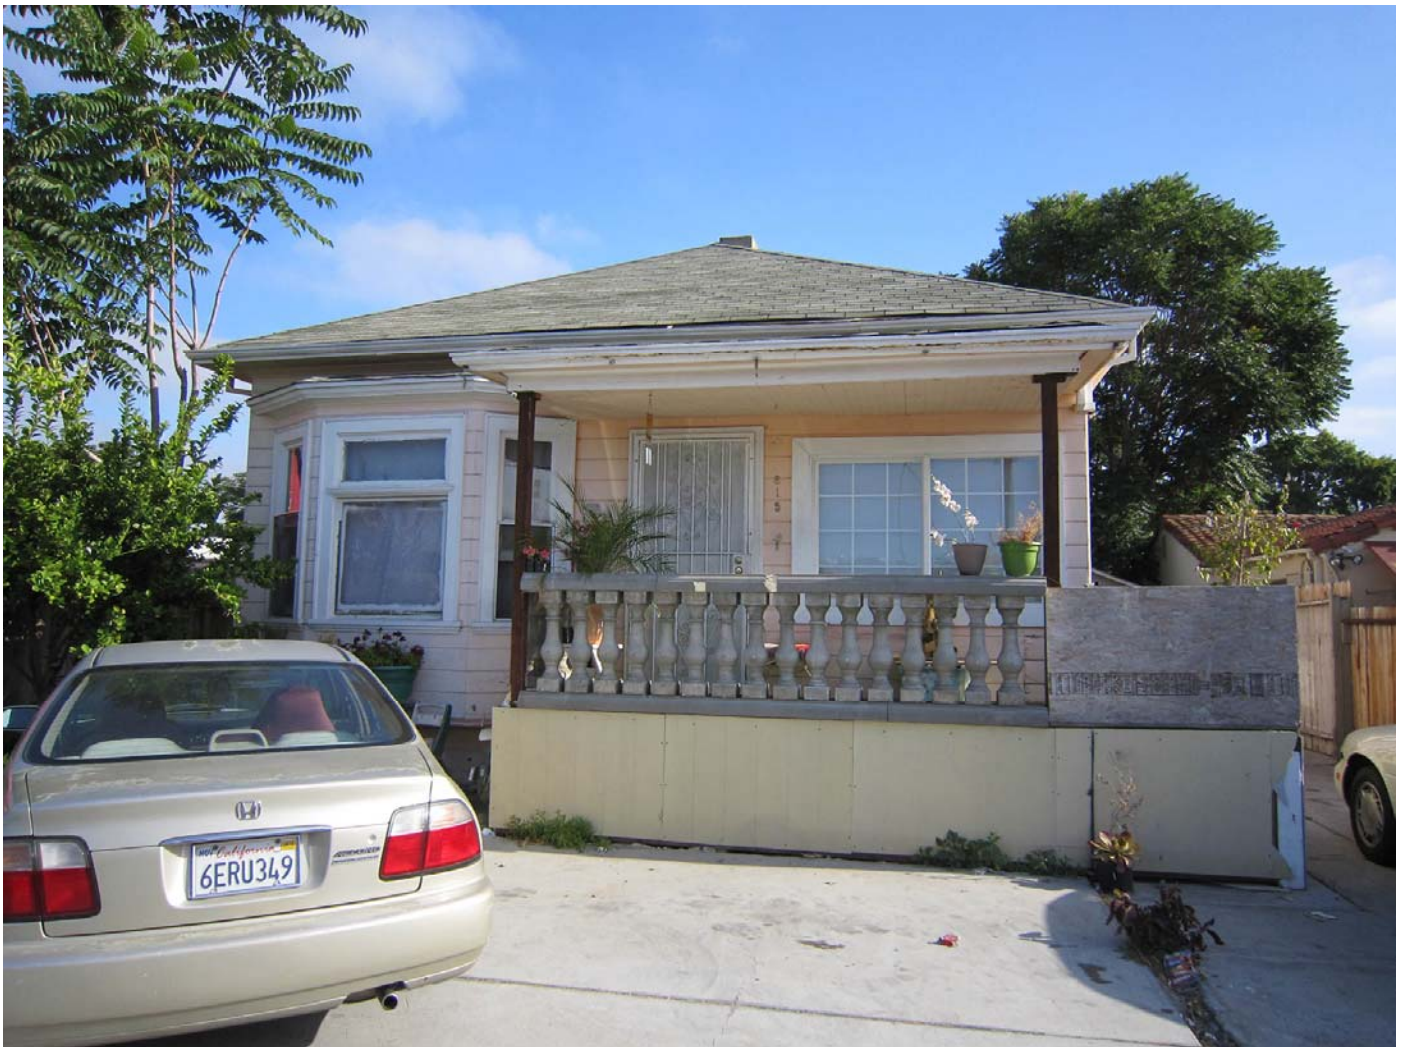
Photograph 1 815 W. San Carlos Street, San Jose
View: Front façade showing the recent porch construction and replacement windows as well as the body of the building.
Date: June 15, 2015

The house a small single-story balloon framed wooden structure built upon a rectangular floor plan with a composite shingled hipped roof that is crowned by a centered rectangular-shaped chimney. The walls are wide horizontal shiplap. Fenestration is minimal and consists of primarily tall rectangular windows. The only major exterior detail is located on the front façade and includes a projecting angled three sided bay window exhibiting a centered rectangular window with transom window above and flanked by two tall one over one windows on the side sections of the bay. The centered window exhibits an over-scaled wooden member separating the transom from the main portion of the light. This projecting bay is cantilevered off the side of the building and is topped by a small hipped roof also of composite shingles. A second front-projecting hipped roof covers an entry porch which is supported by two tall square posts that do not seem original to the house. The dominant design feature of this porch is the row of over-sized classical balusters which are another more recent incongruous addition not in harmony with the original much simpler design. The entry door is a plain rectangular shape although modernized and the large multi-paned rectangular double window under the porch is a more recent alteration to the structure. The architectural style is Colonial Revival Cottage which was very popular during the last decade of the 19th century and the first two decades of the 20th century. This post Victorian style is characterized by simple forms, plain walls and little ornament, Where the ornament appears, it is very basic such as the wooden moldings around the windows and doors. The small house contains a much altered front entry porch which is raised above the ground and reached by a wooden stair that wraps around the residence to the east along the concrete driveway. The stair and the porch's base are all recent construction.

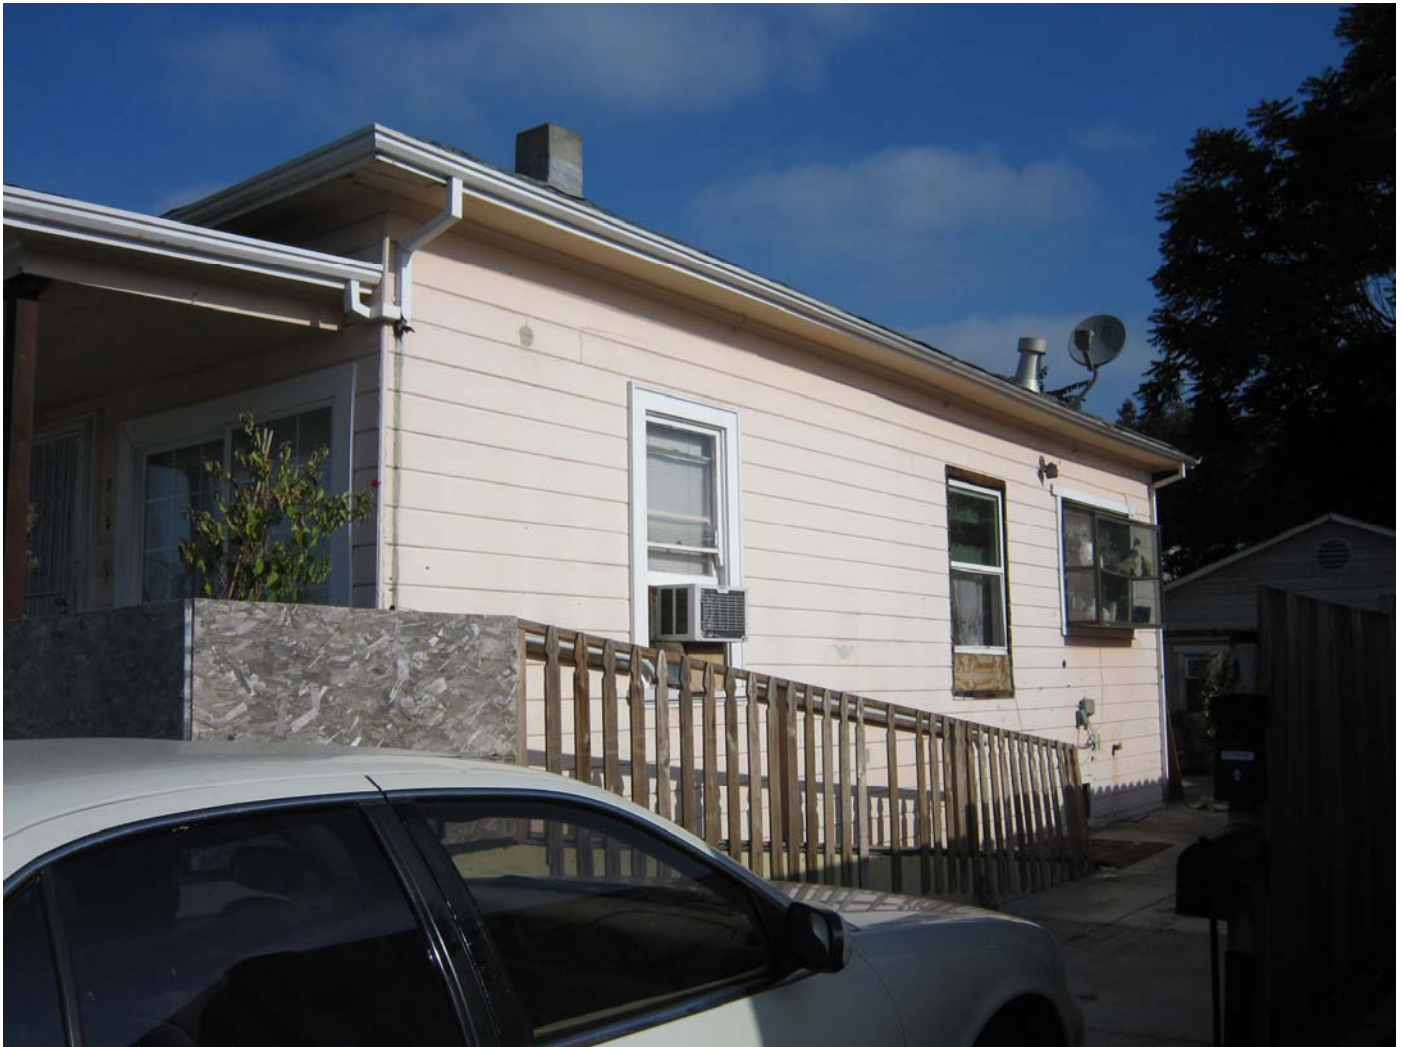
Photograph 2 815 W. San Carlos Street, San Jose
View: East façade showing the ramp construction and replacement windows as well as the body of the building.
Date: June 15, 2015

The east facade is a very plain wooden wall with three windows breaking up the space. The

first on the south east corner is a tall double-hung window while the second window is a larger opening that has been altered with the new addition of a projecting glass “display” window. The third window is a larger rectangular opening at the northeast corner of the house. The west elevation is the most simple with only a single tall wooden double-hung window breaking up the space of flat wooden exterior wall. The rear elevation exhibits a centered back door covered by a shed-roof projecting from the house. This facade also contains two tall narrow double-hung windows flanking the back entry.

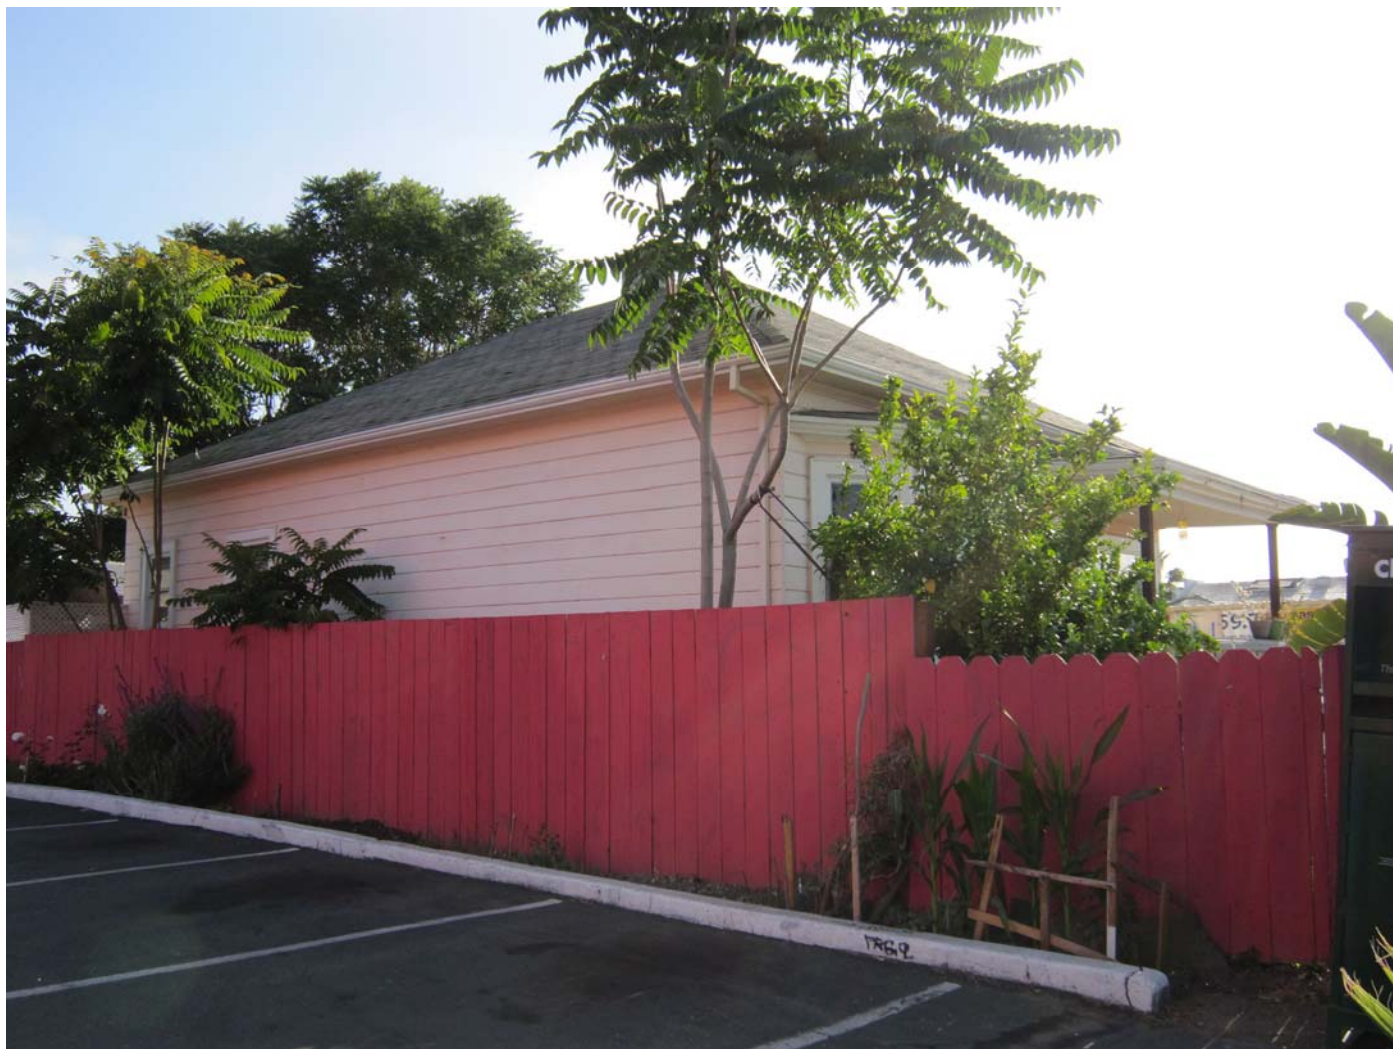
Photograph 3 815 W. San Carlos Street, San Jose
View: West façade, the only window is in the infill rear porch area.
Date: June 15, 2015

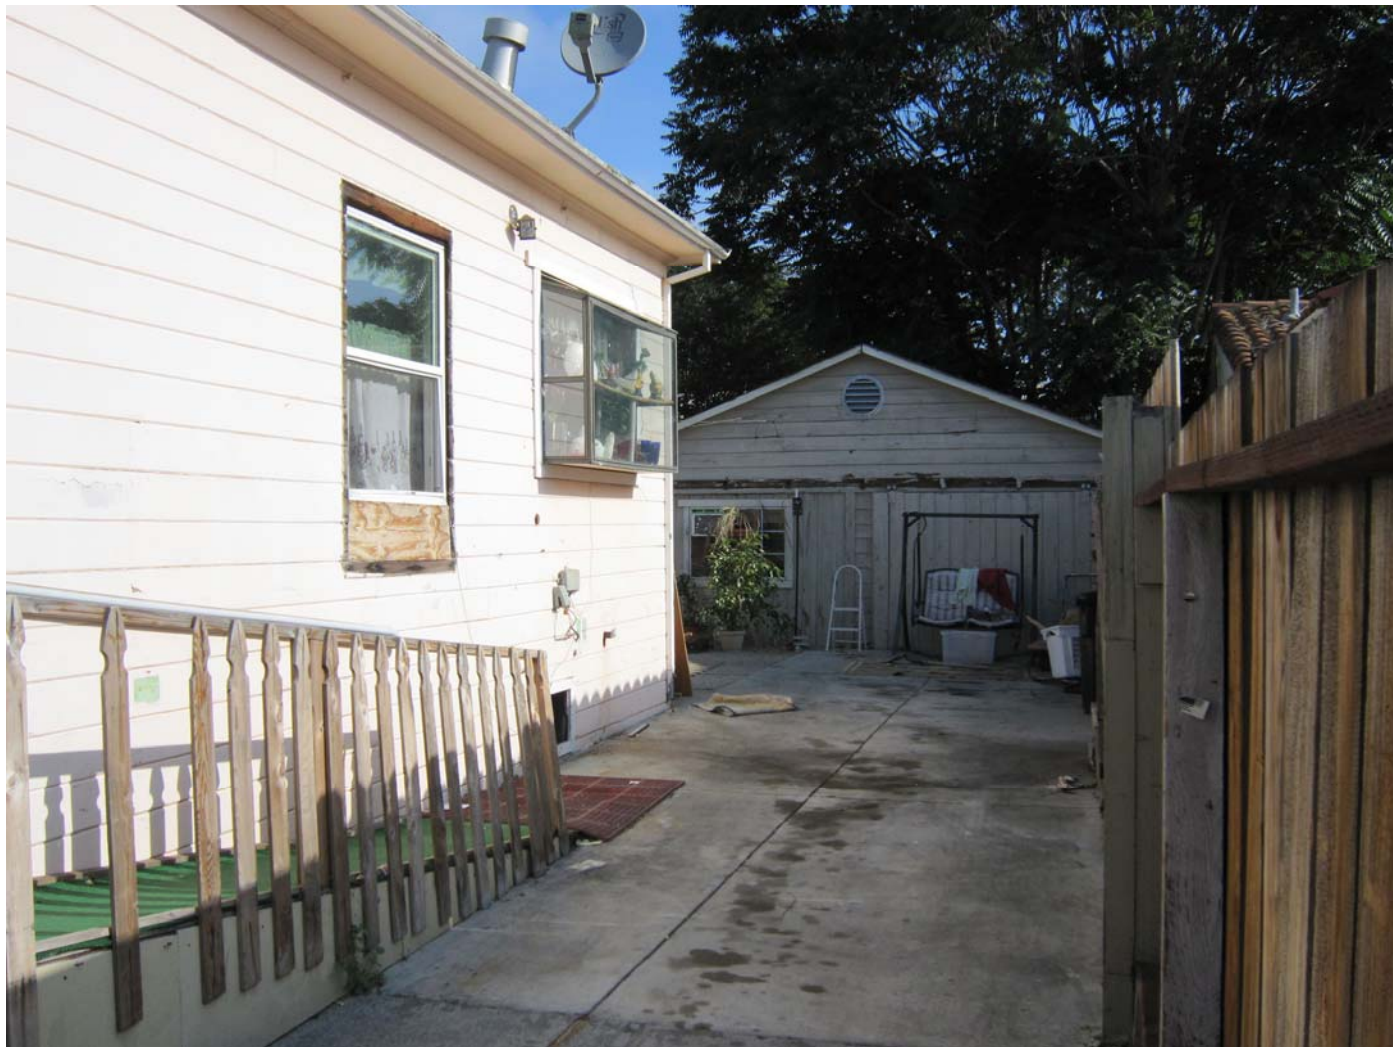
Photograph 4 815 W. San Carlos Street, San Jose
View: East façade and garage remodeled for a residential apartment
Date: June 15, 2015

The garage is another small rectangular wooden single-story building which is built on a simple rectangular floor plan and exhibits a very low gabled roof. It contains both a garage space with large garage door and an adjacent space for a room with small rectangular window. It is sheathed in like wooden horizontal tongue and groove boards and contains a round vent shape under the gable. The roof here is again sheathed in composite shingles. The garage hugs the northwest corner of the small lot.
