# City of San José Stormwater Management *Annual Report 2014-2015*

# ***City of San José Stormwater Management Annual Report 2014-2015***

September 2015

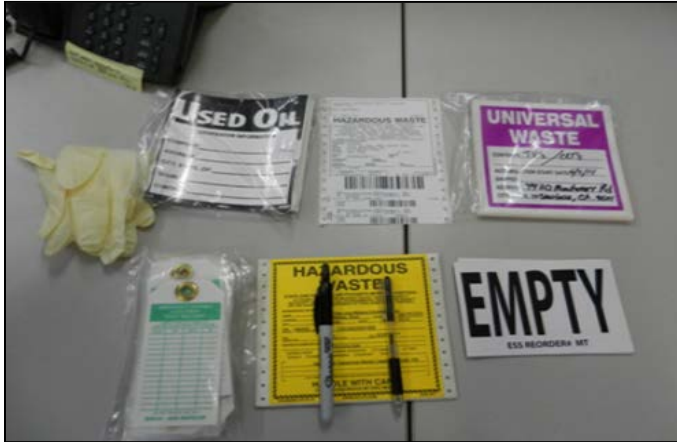
*Inspection kit used during daily yard stormwater inspection allows for safe and immediate response to common issues*

| Corporation Yard Name | Inspection Date<br>(1x/year required) | Inspection Findings/Results | Follow-up Actions |
|---|---|---|---|
| South Service Yard<br>4420 Monterey Road<br>San José, CA 95111 | September 24, 2014 | This yard was exceptionally clean. Staff conducting the daily yard inspections had compiled an inspection kit including gloves; sharpies and pens; and stickers for labeling empty cans, universal waste, used oil, and hazardous waste. This allowed Staff to immediately address many of the common issues that arise during daily yard inspections, such as safely disposing of waste and trash, updating illegible stickers, and labeling containers with appropriate identification. There was a small spill at the fuel pump, and some cardboard and 5-gallon buckets were left outside of the over packs in the hazardous materials storage area. There were also two over packs that needed identification. | The unlabeled over packs were emptied during a scheduled pick-up and were then labeled as "EMPTY." Absorbent was used on the fuel spill and then removed and placed in the drum for used absorbent. The cardboard and the 5-gallon buckets were placed in proper over packs and scheduled for a hazardous materials pick-up a week later. |

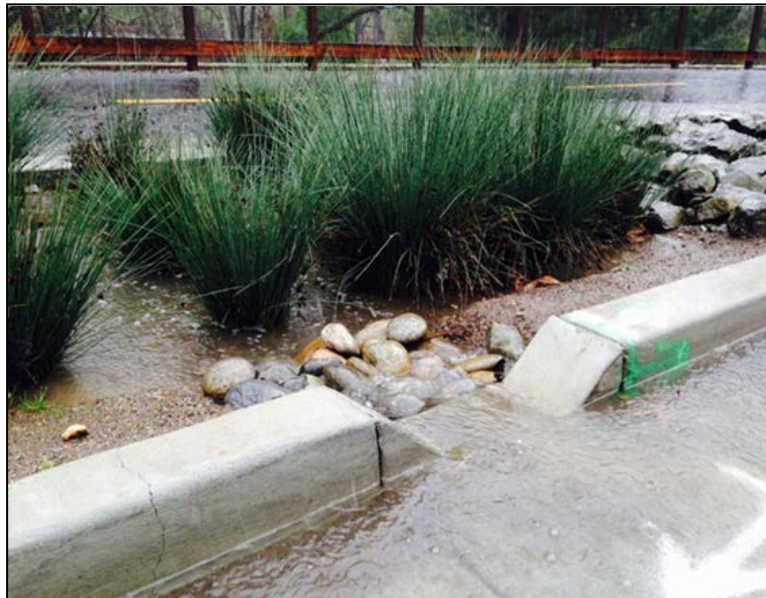
*New and Redevelopment – stormwater runoff draining into bioretention cell through curb cut*

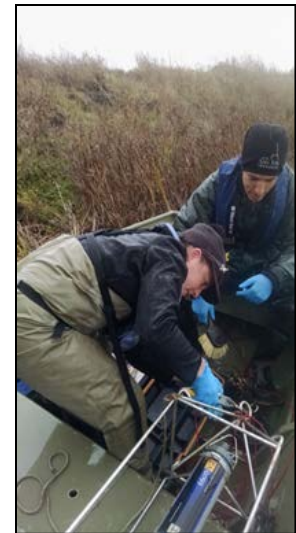
*ESD staff maintaining the sonde deployed at Alviso Slough*

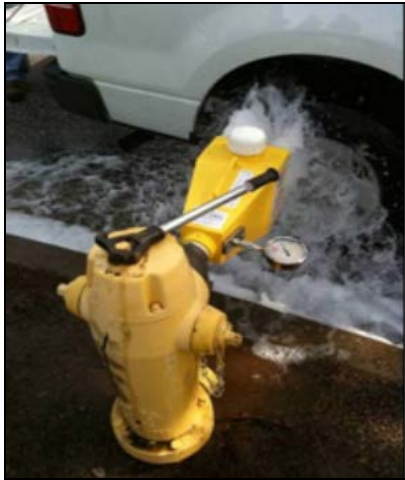
*Potable water discharge BMP*
