COYOTE CREEK TRESTLE, SAN JOSE, CALIFORNIA  
SECRETARY OF THE INTERIOR'S STANDARDS  
COMPLIANCE REVIEW

July 21, 2023

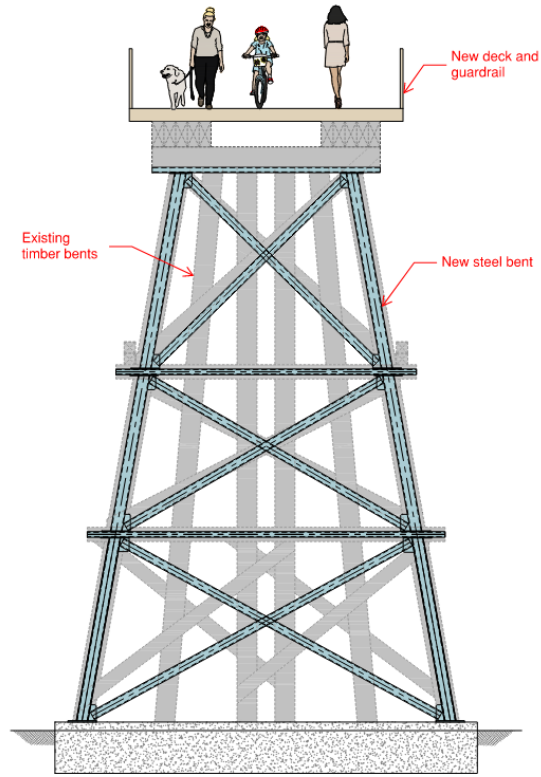
Alternative 1 - Life Safety Retrofit

Figure 2. Alternative 1. Retrofit Existing Bridge. Drawings provided by GHD Inc. Dated April 2023.

Alternative 1: The proposed project to retrofit the existing bridge will change the historic use as a freight train trestle to a pedestrian and bicycle bridge. Two types of retrofitting are proposed to address two structural issues. The first is a collapse prevention retrofit, which requires the replacement of existing bolts and diagonal braces where deteriorated on the existing bridge. This retrofit additionally requires new steel plates to reinforce the connections between the timber members. The second retrofit addresses the lack of lateral capacity to safely carry loads across the bridge. This deficiency is to be addressed with the installation of new steel bents between every two existing timber bents. The existing railroad ties and catwalk will be removed, and replaced with a new concrete deck and guardrails.

Over time, the bolts, diagonal braces, and connections between the timber members of the bridge have significantly deteriorated, leaving the structure vulnerable and at risk of collapse during a significant seismic event. To prevent this, the minor retrofit would replace the existing bolts and diagonal braces and add new steel plates to reinforce the connections between the timber members. These measures would not only improve the capacity and durability of the structure but also provide greater protection against future deterioration and potential collapse. However, it should be noted that this level of retrofitting alone would not be sufficient to allow for safe pedestrian use of the bridge, and additional measures would be needed.

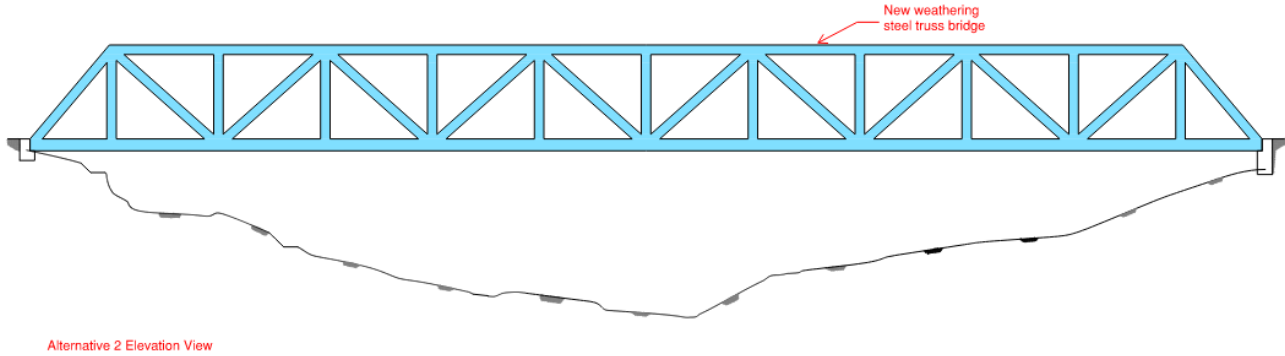
Figure 4. Alternative 2. Elevation of the new steel truss bridge. Drawings provided by GHD Inc. Dated April 2023.

Alternative 2 proposes to demolish the Coyote Creek Trestle entirely. A new single-span 250-foot weathering steel truss bridge would be reconstructed following either the same alignment or a similar alignment. The bridge would be composed of two Pratt trusses connected by transverse floor beams supporting a concrete deck.

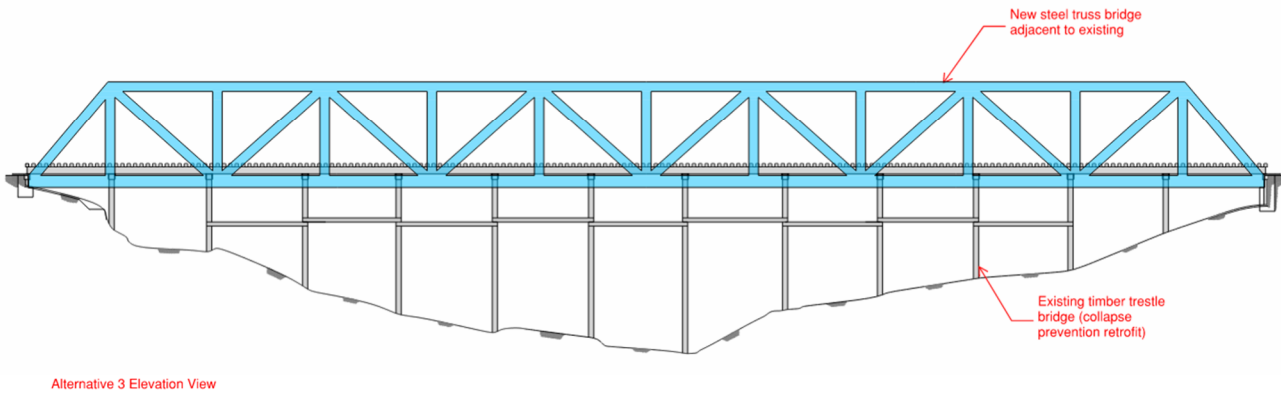
Figure 5. Alternative 3. Elevation of the new steel truss bridge and existing trestle with retrofit. Drawings provided by GHD Inc. Dated April 2023.

Alternative 3 includes new construction and a retrofit. Coyote Creek Trestle would receive a minor retrofit, and a 250-foot span weathering steel truss bridge would be constructed. The retrofit involves strengthening the existing timber elements and adding new steel plates and bolts for more support. The retrofit would only improve the structural integrity of the existing bridge, and would not allow for any type of traffic use. Open to pedestrians and bicyclists, the new bridge would be 250 feet in length and be constructed approximately 50 to 100 feet east of the existing bridge.

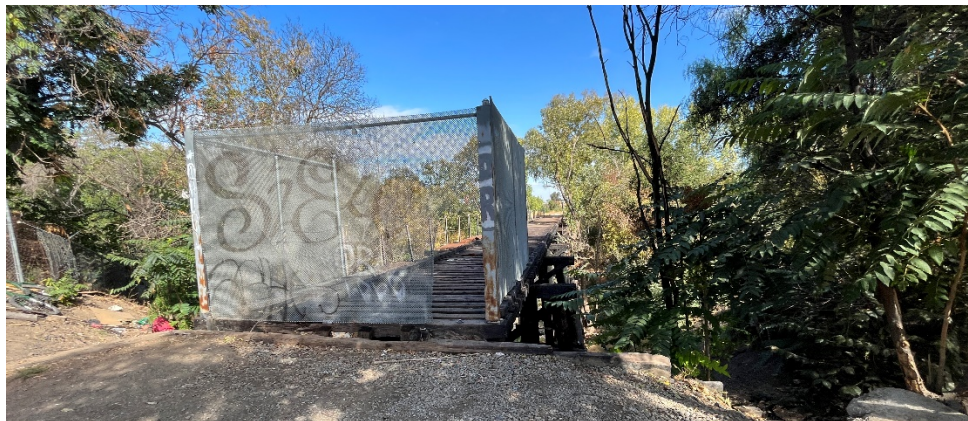
Figure 6. South entrance of Coyote Creek Trestle (September 2022).

A metal fence with an opening cut out occupies the south entrance. A metal grate supported by steel beams sits to the side. On the north entrance, a metal fence sits only to the side. The Trestle is raised above Coyote Creek and the Coyote Creek trail, which is paved in this area.

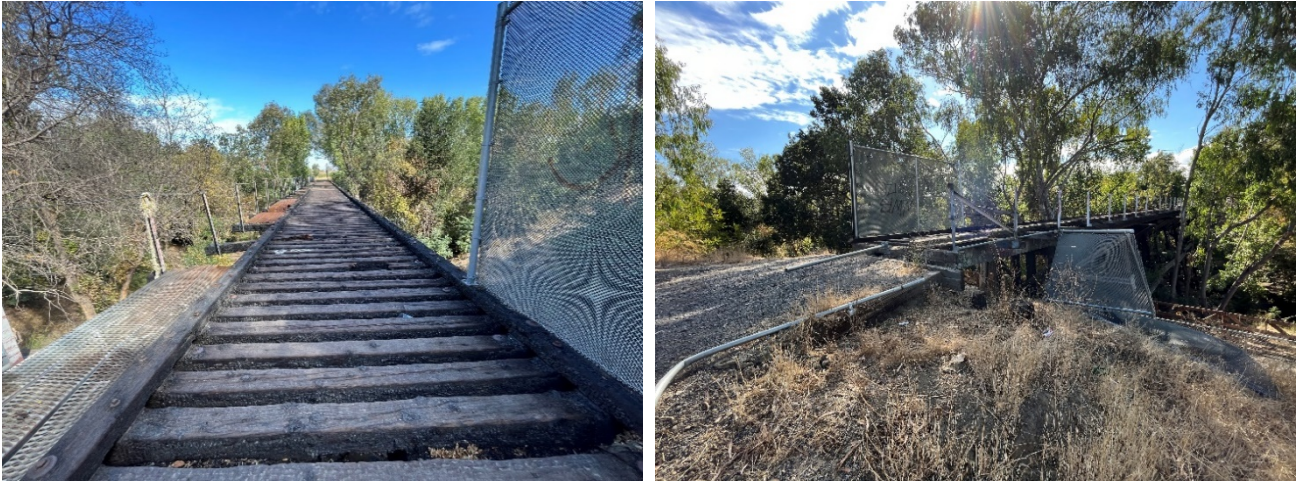
Figure 7. The south entrance of the Trestle (left) and the north entrance of the Trestle (right) (September 2022).

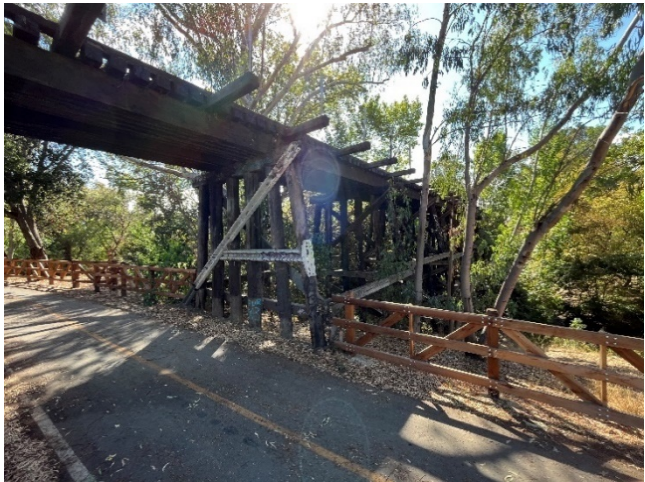
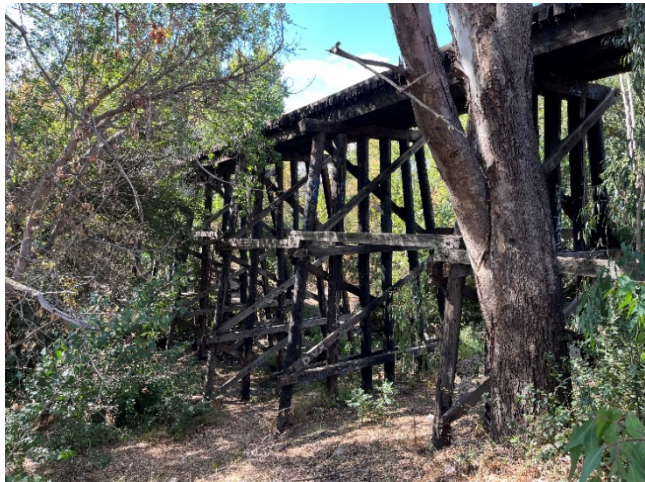
Figures 8 and 9. View of the Trestle from the Coyote Creek Trail (left) and view of the Trestle off-trail (right) (September 2022).

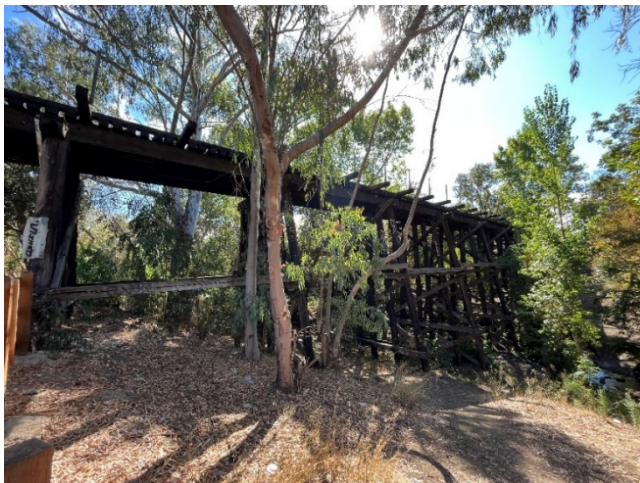
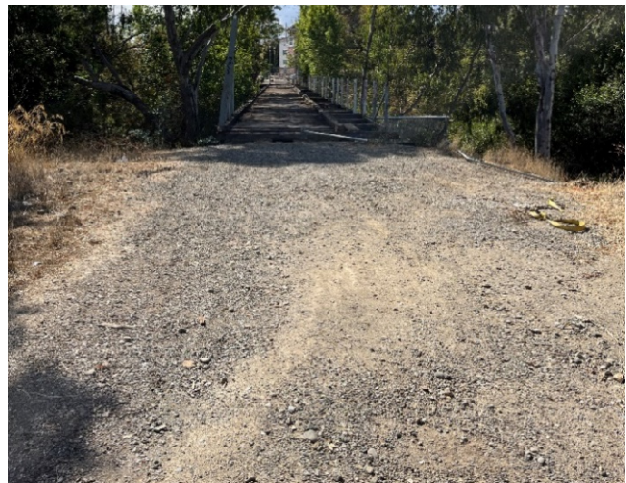
Figure 10. A view of the Trestle from below with Coyote Creek on the bottom right (left) and a view of the footpath leading to the south end of the Trestle (right) (September 2022).

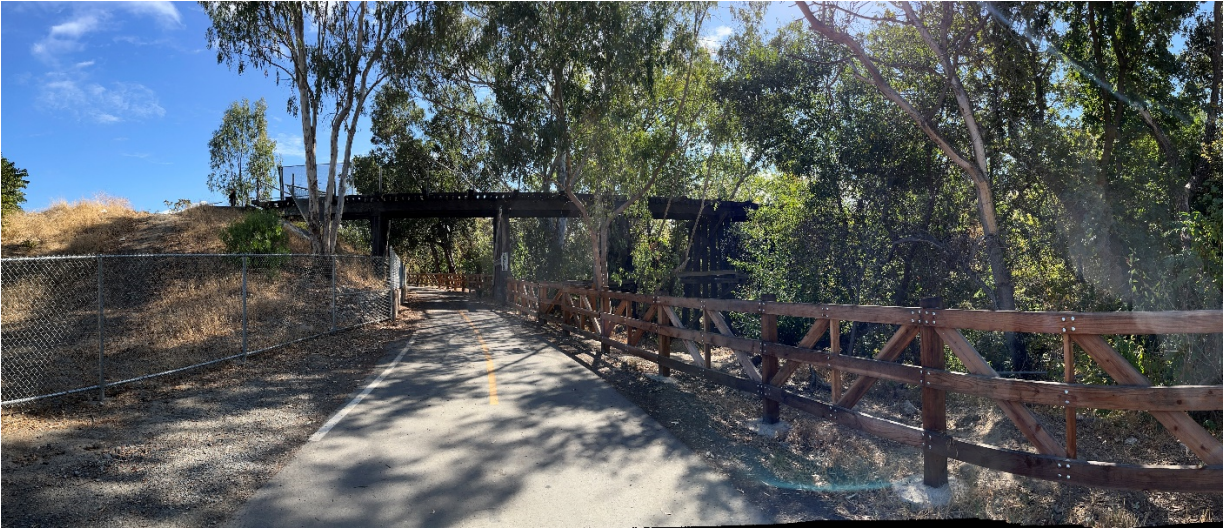
Figure 11. Looking east, a view of the Trestle from the Coyote Creek Trail with Coyote Creek on the bottom right (September 2022).

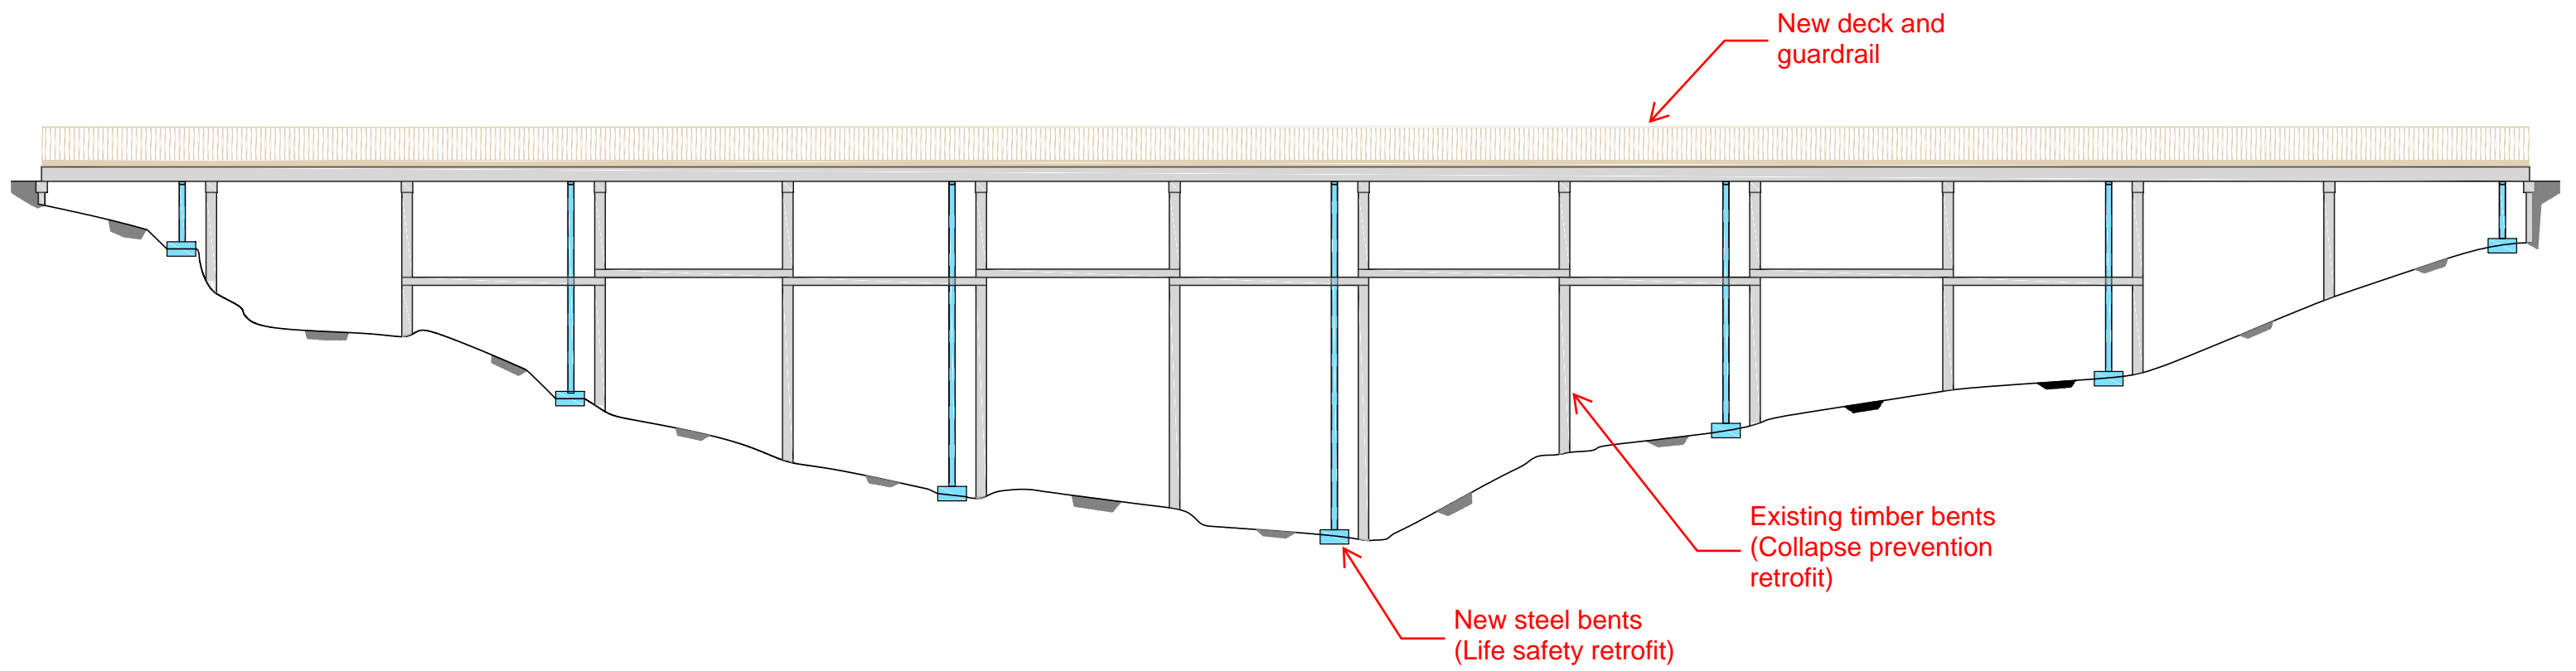
Alternative 1 Elevation View

The Structural Evaluation report revealed that the existing trestle bridge lacks sufficient lateral capacity. To address this issue, a major retrofit is needed, which involves the installation of new steel bents between every two timber bents. These supplementary structures would provide lateral support that are deficient in the existing timber bents.

New framing members would also be required in the superstructure to allow loads to transfer into the new bents. Finally, the existing railroad ties and catwalk will be replaced with a new deck and guardrails.

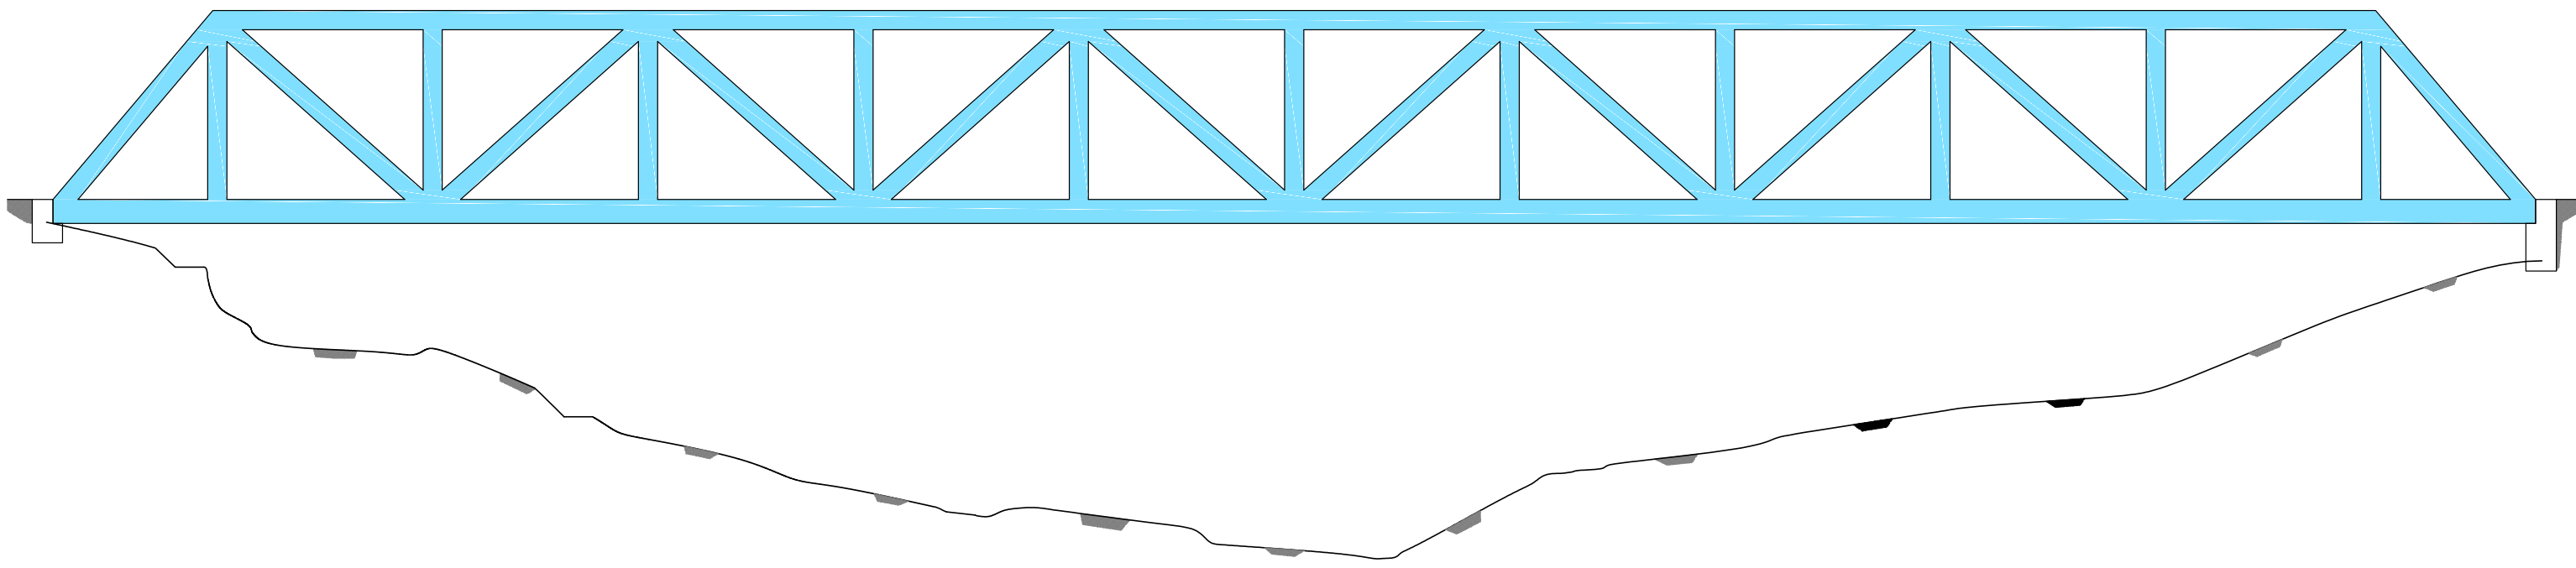
Alternative 2 Elevation View

This type of bridge is constructed with weathering steel, which is a specially designed alloy that forms an exterior rust barrier, creating a low-maintenance surface that does not require painting or cleaning. Weathering steel truss bridges are ideal for locations that require low-maintenance structures that can withstand harsh environmental conditions.

The construction process involves lifting the bridge into place using mobile cranes and bearing it on cast-in-place concrete abutments at each end.
