Initial Study and Addendum
to the Final Program Environmental Impact Report
for the North San José Development Policies Update
(SCH# 2004102067)

SONY PROJECT

File No. 06-038 & PD07-006

May 2007

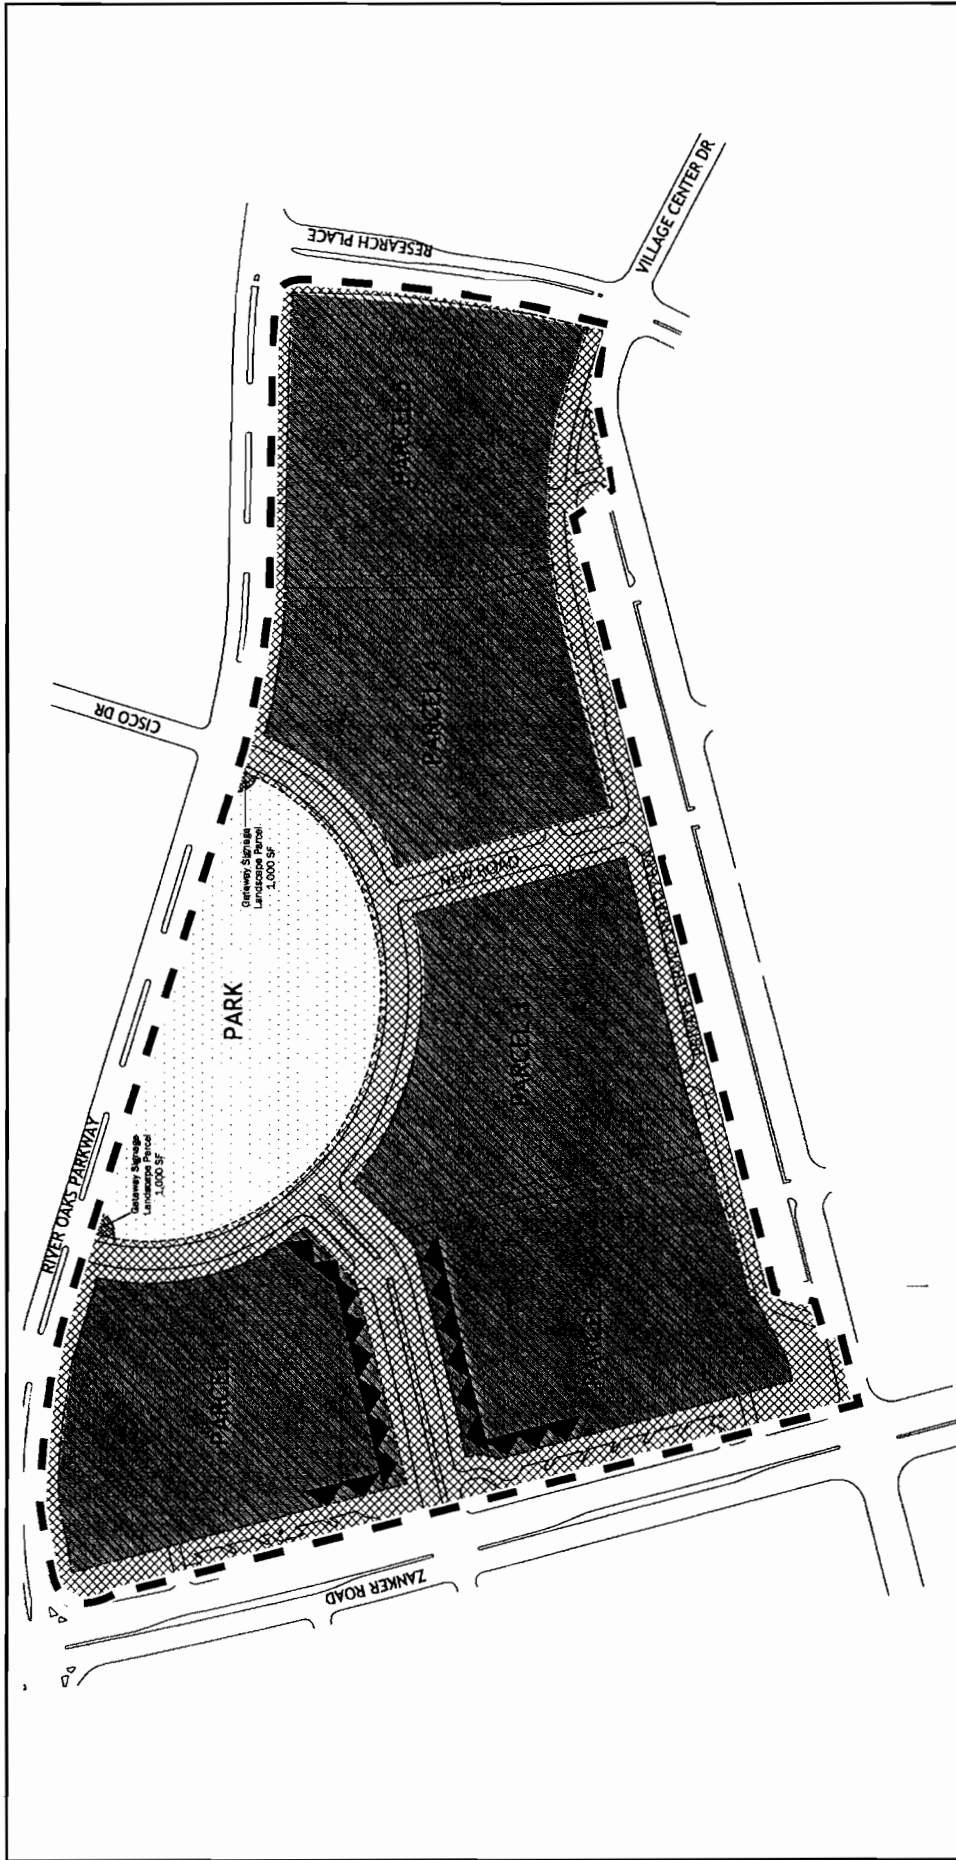
FIGURE 3.0-3

Residential/Mixed Use	Area (acres)		Density (du/acre)		Program (units)		Commercial Uses (square feet)		Leasing Center (square feet)	
	Min.	Max.	Min.	Max.	Min.	Max.	Min.	Max.	Min.	Max.
Parcel 1	5.05	78	55	78	278	395	7,500	7,500	0	0
Parcel 2	4.82	78	55	78	265	376	7,500	7,500	0	0
Parcel 3	5.16	77	55	77	284	397	0	0	15,000	15,000
Parcel 4	4.58	78	55	78	252	357	0	0	0	0
Parcel 5	4.79	78	55	78	263	375	0	0	0	0
Signage/Gateway Parcels	0.05									
Park	5.00									
Public ROW	9.25									
TOTAL	38.70				1,342	1,900	15,000	15,000	15,000	15,000

PROPOSED LAND USE PLAN

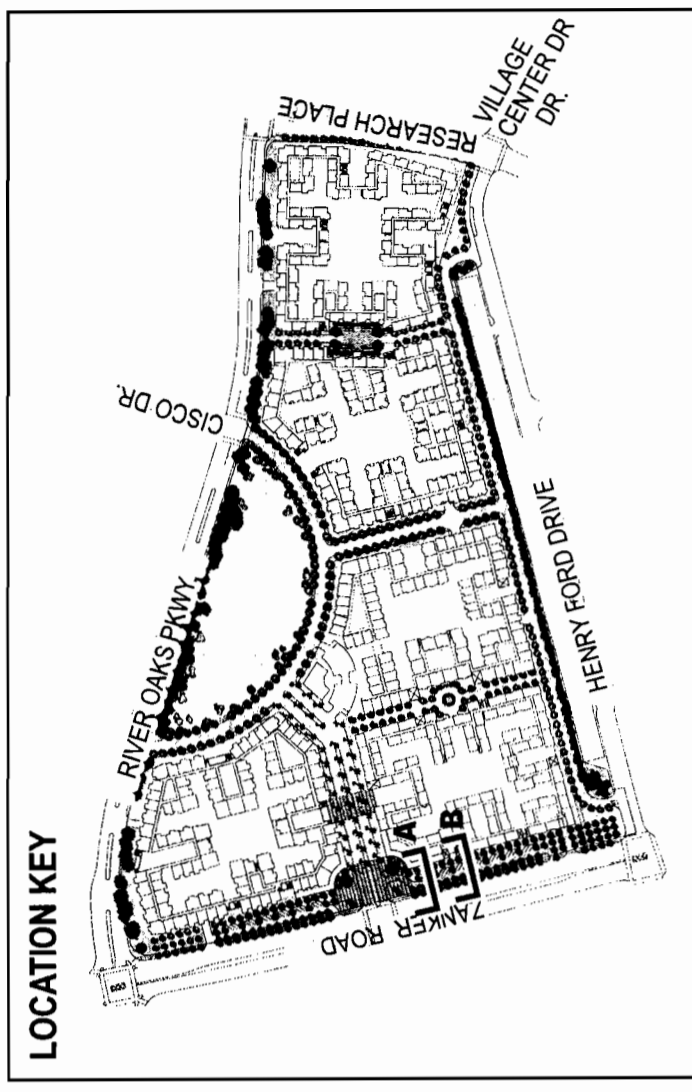
FIGURE 3.0-4

A FRONTAGE ROAD -- RETAIL

B FRONTAGE ROAD -- RESIDENTIAL

CONCEPTUAL CROSS-SECTION

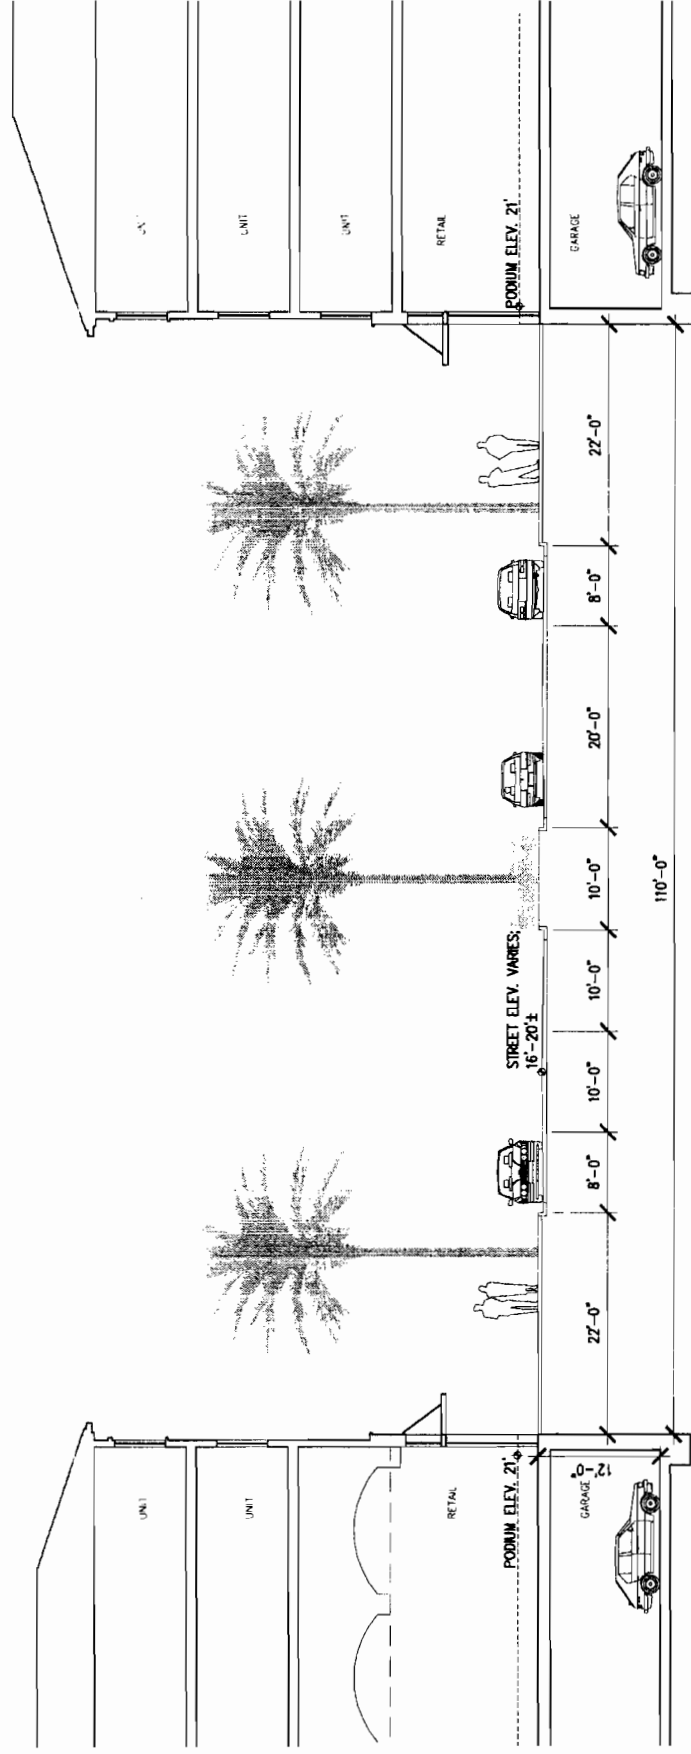
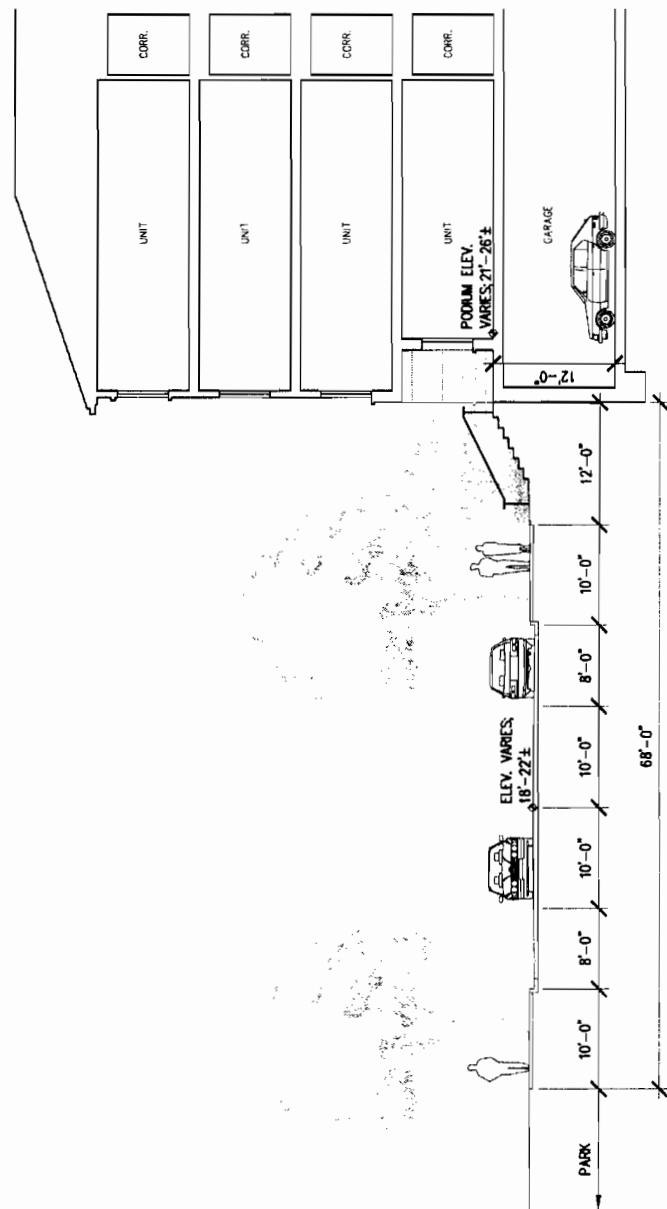
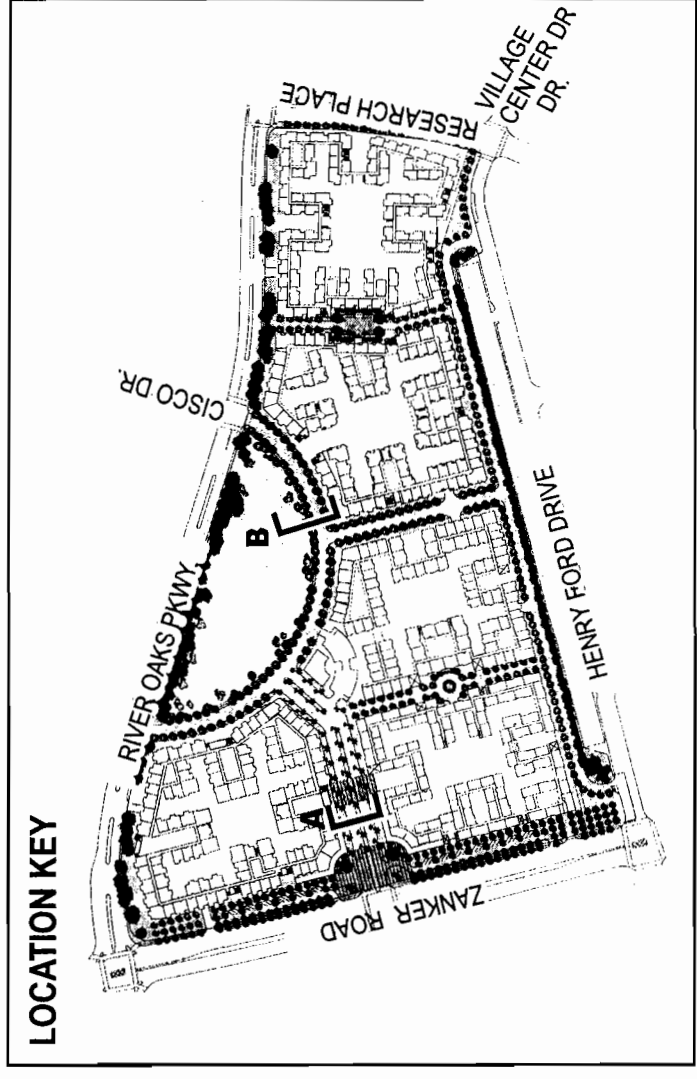
FIGURE 3.0-5

A ENTRY ROAD

B CISCO DRIVE

CONCEPTUAL CROSS-SECTION

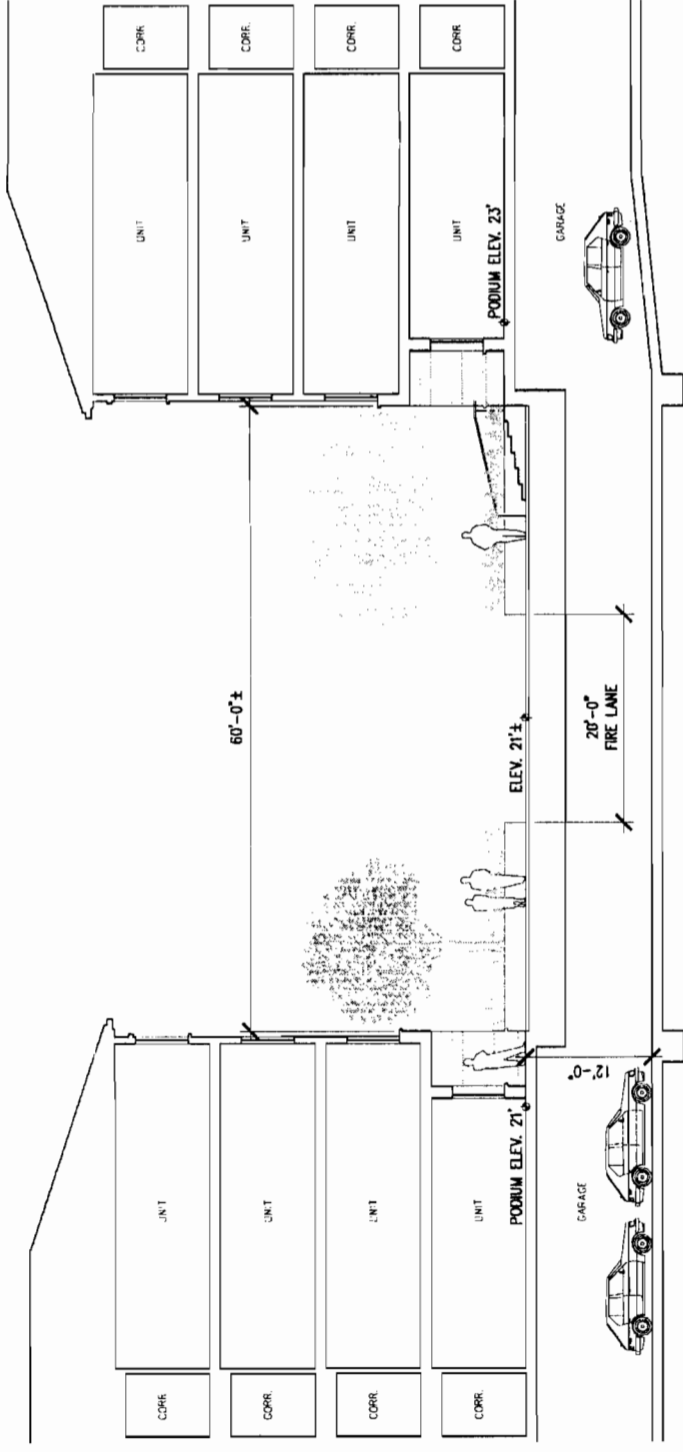
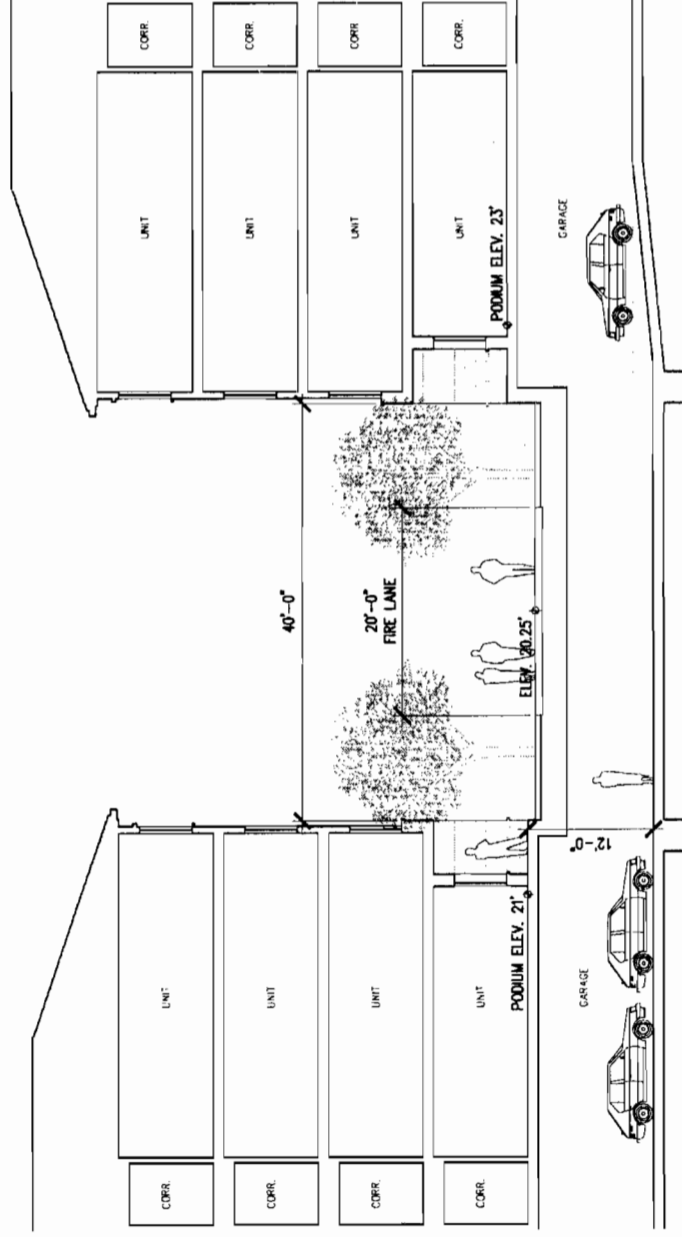
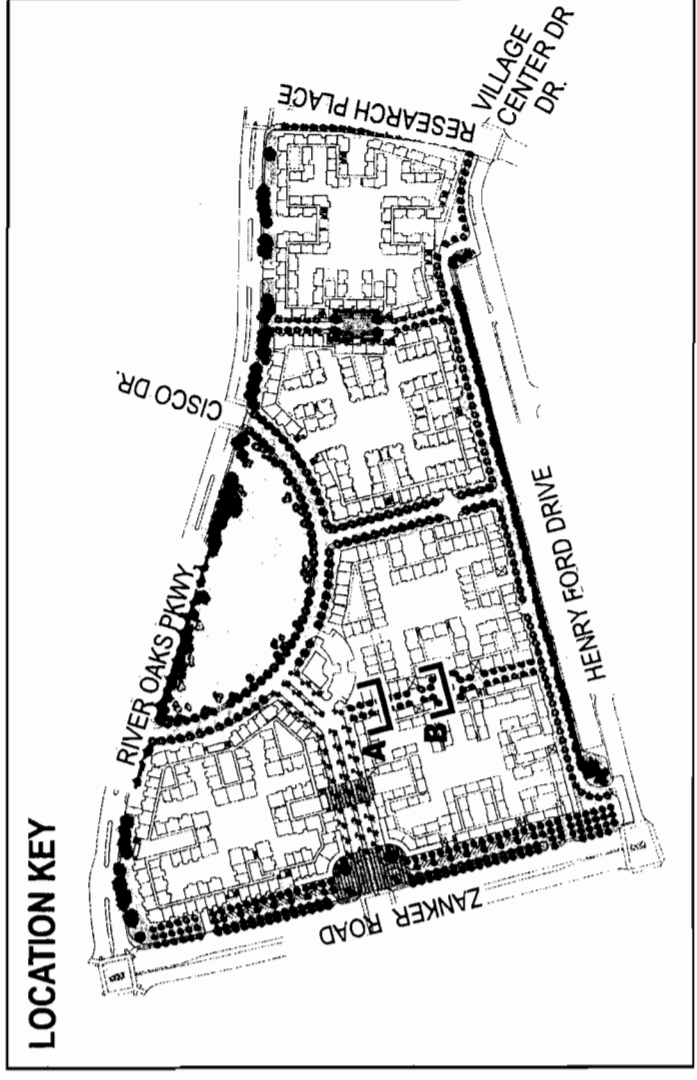
FIGURE 3.0-6

A PASEO

B PASEO

CONCEPTUAL CROSS-SECTION

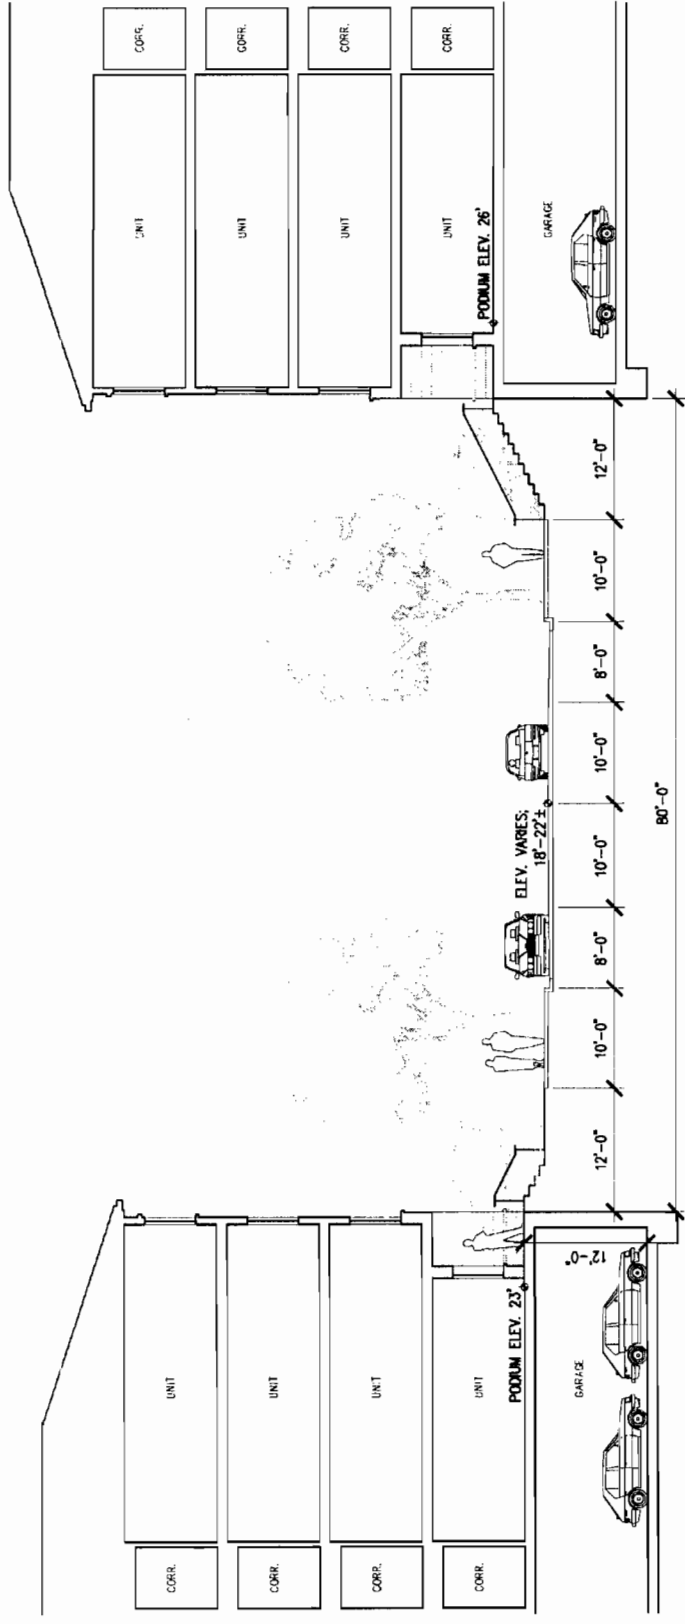
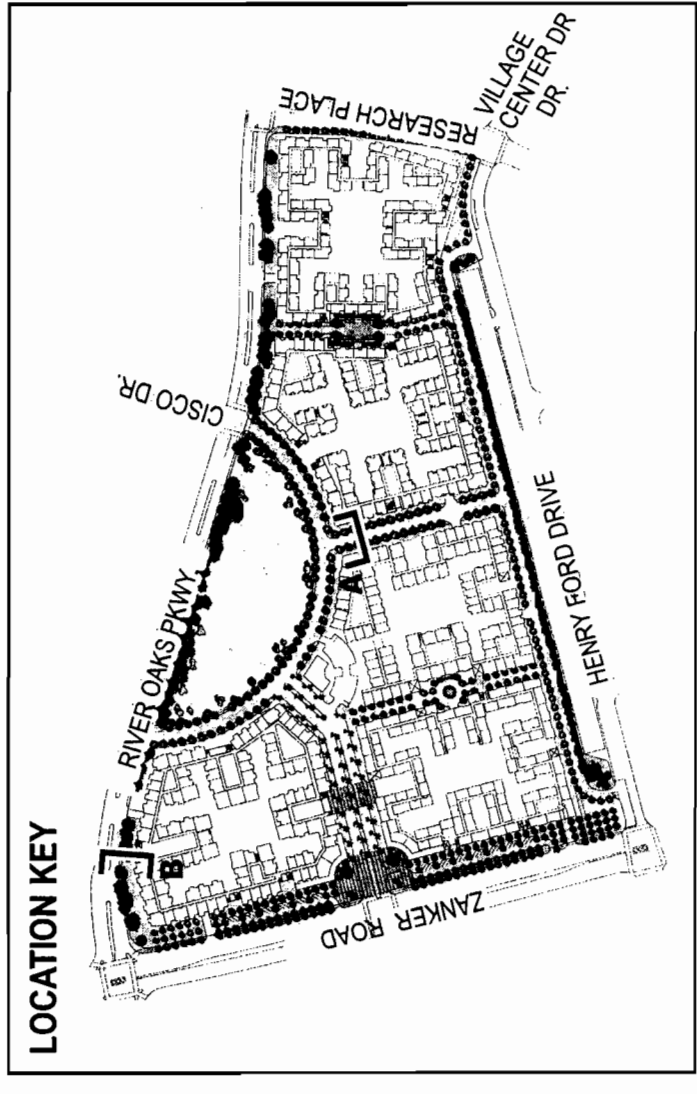
FIGURE 3.0-7

A NEW STREET

B RIVER OAKS PARKWAY

CONCEPTUAL CROSS-SECTION

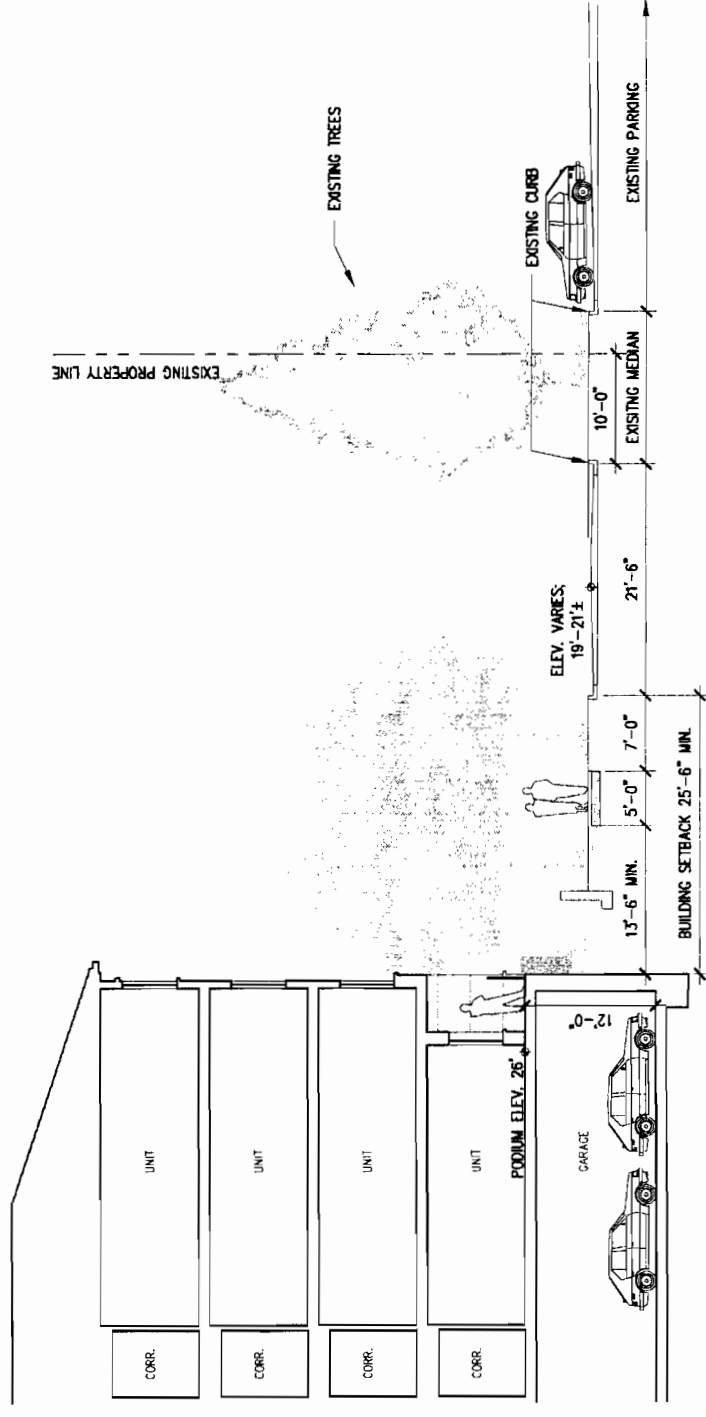
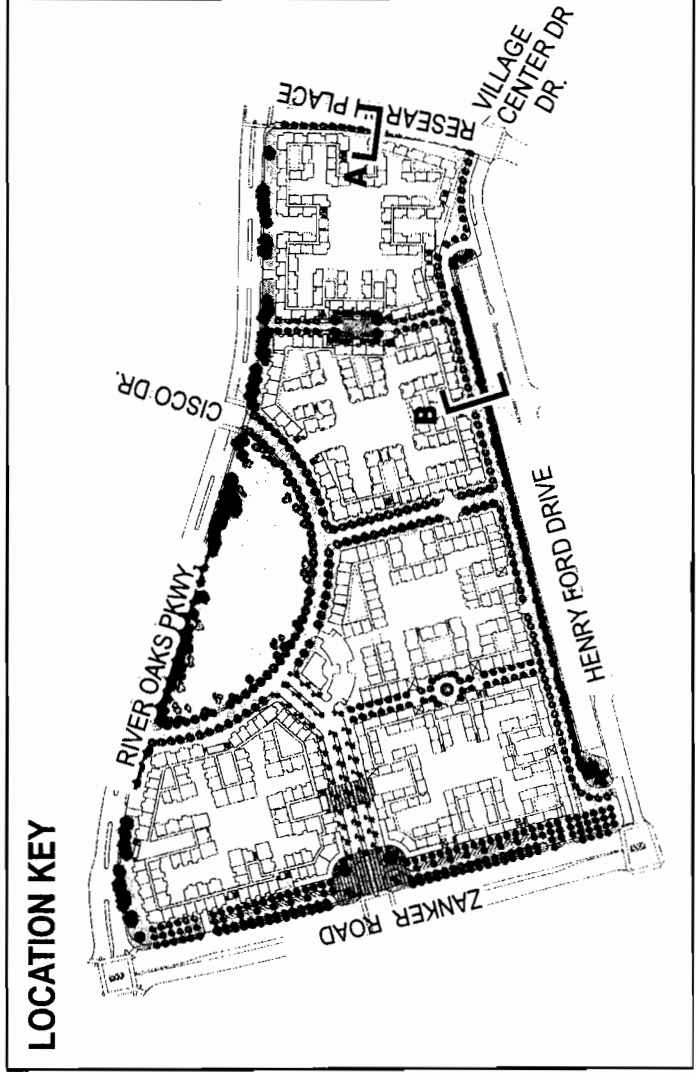
FIGURE 3.0-8

A RESEARCH PLACE

B PRIVATE SERVICE ROAD

CONCEPTUAL CROSS-SECTION

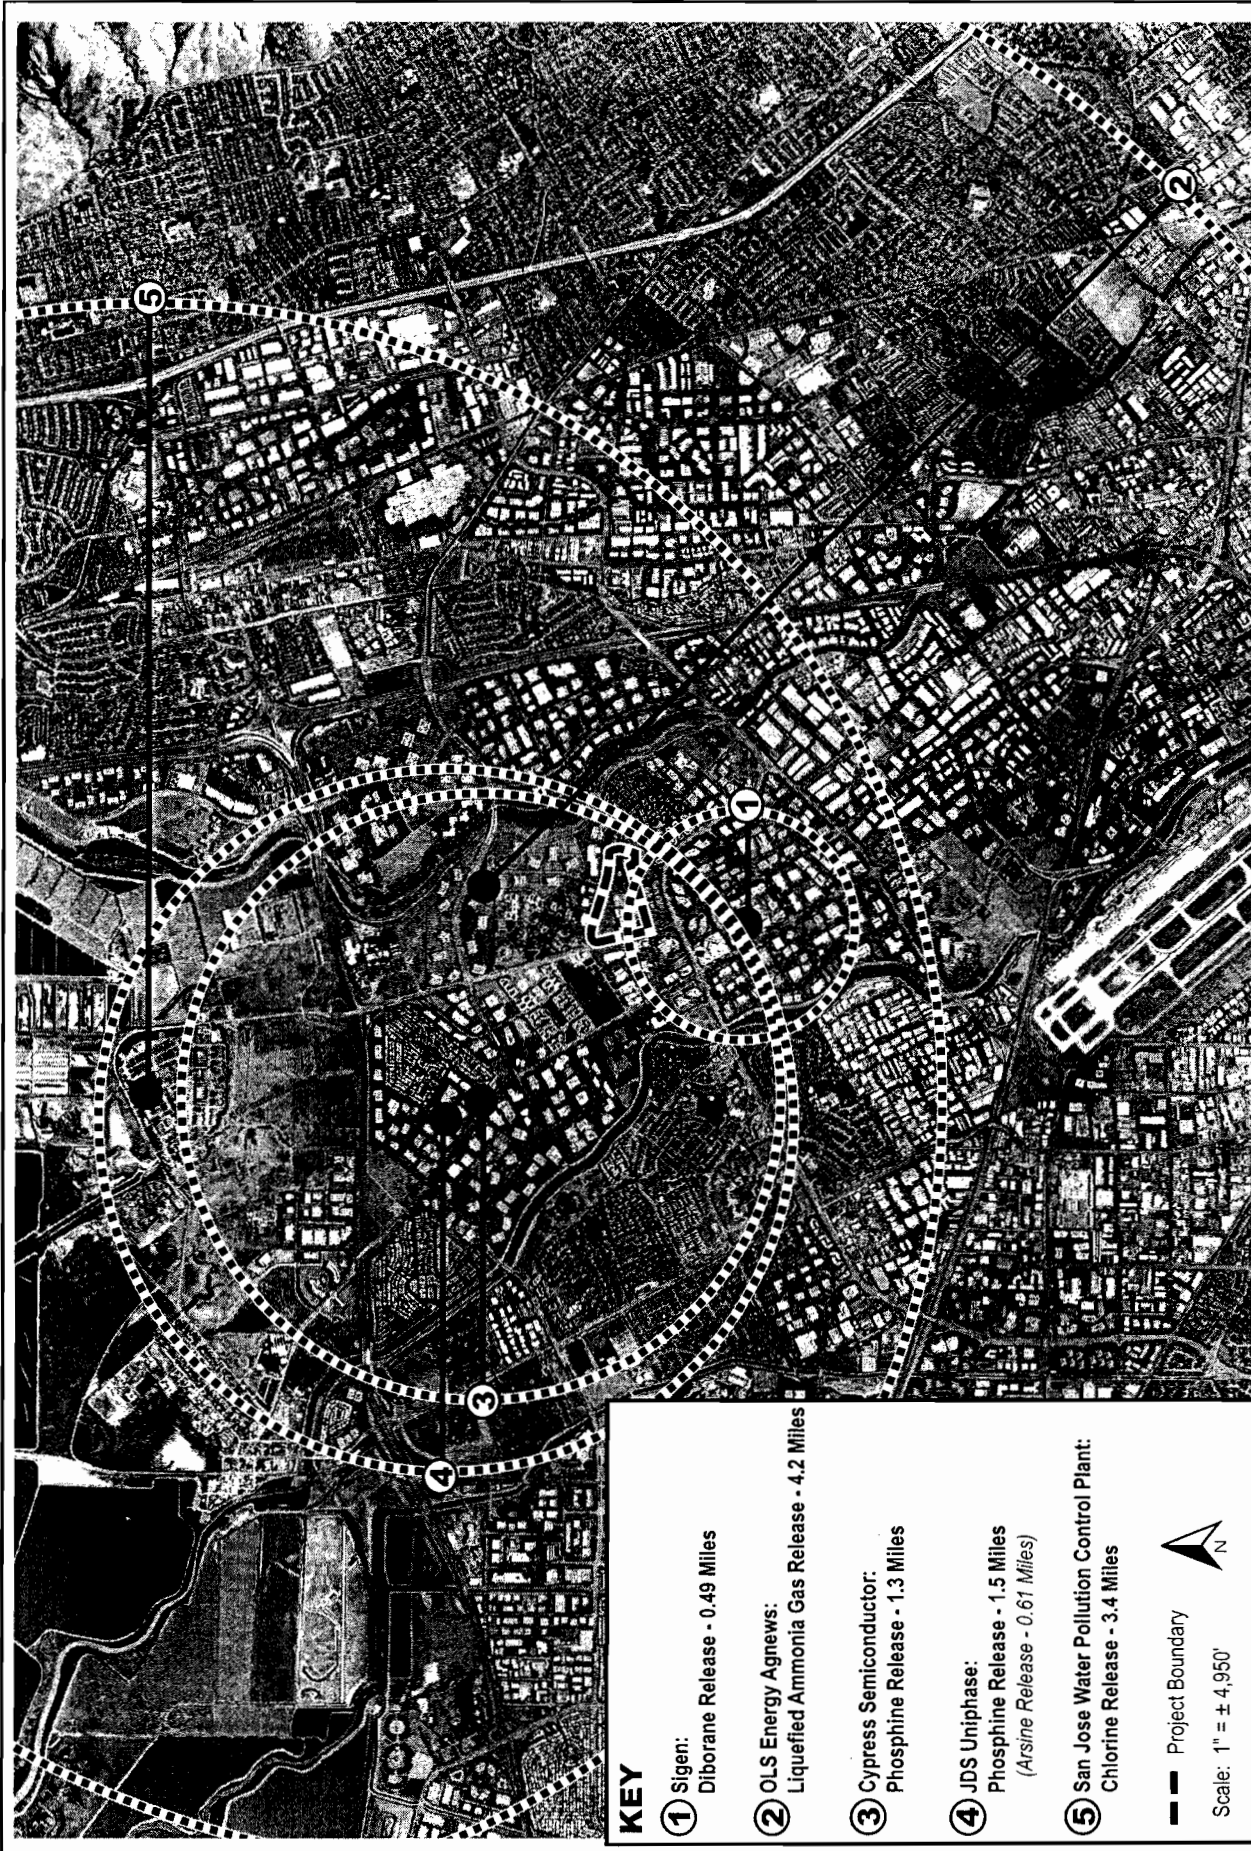
FIGURE 4.0-2

WORST-CASE ACCIDENTAL RELEASE SCENARIO IMPACT AREAS

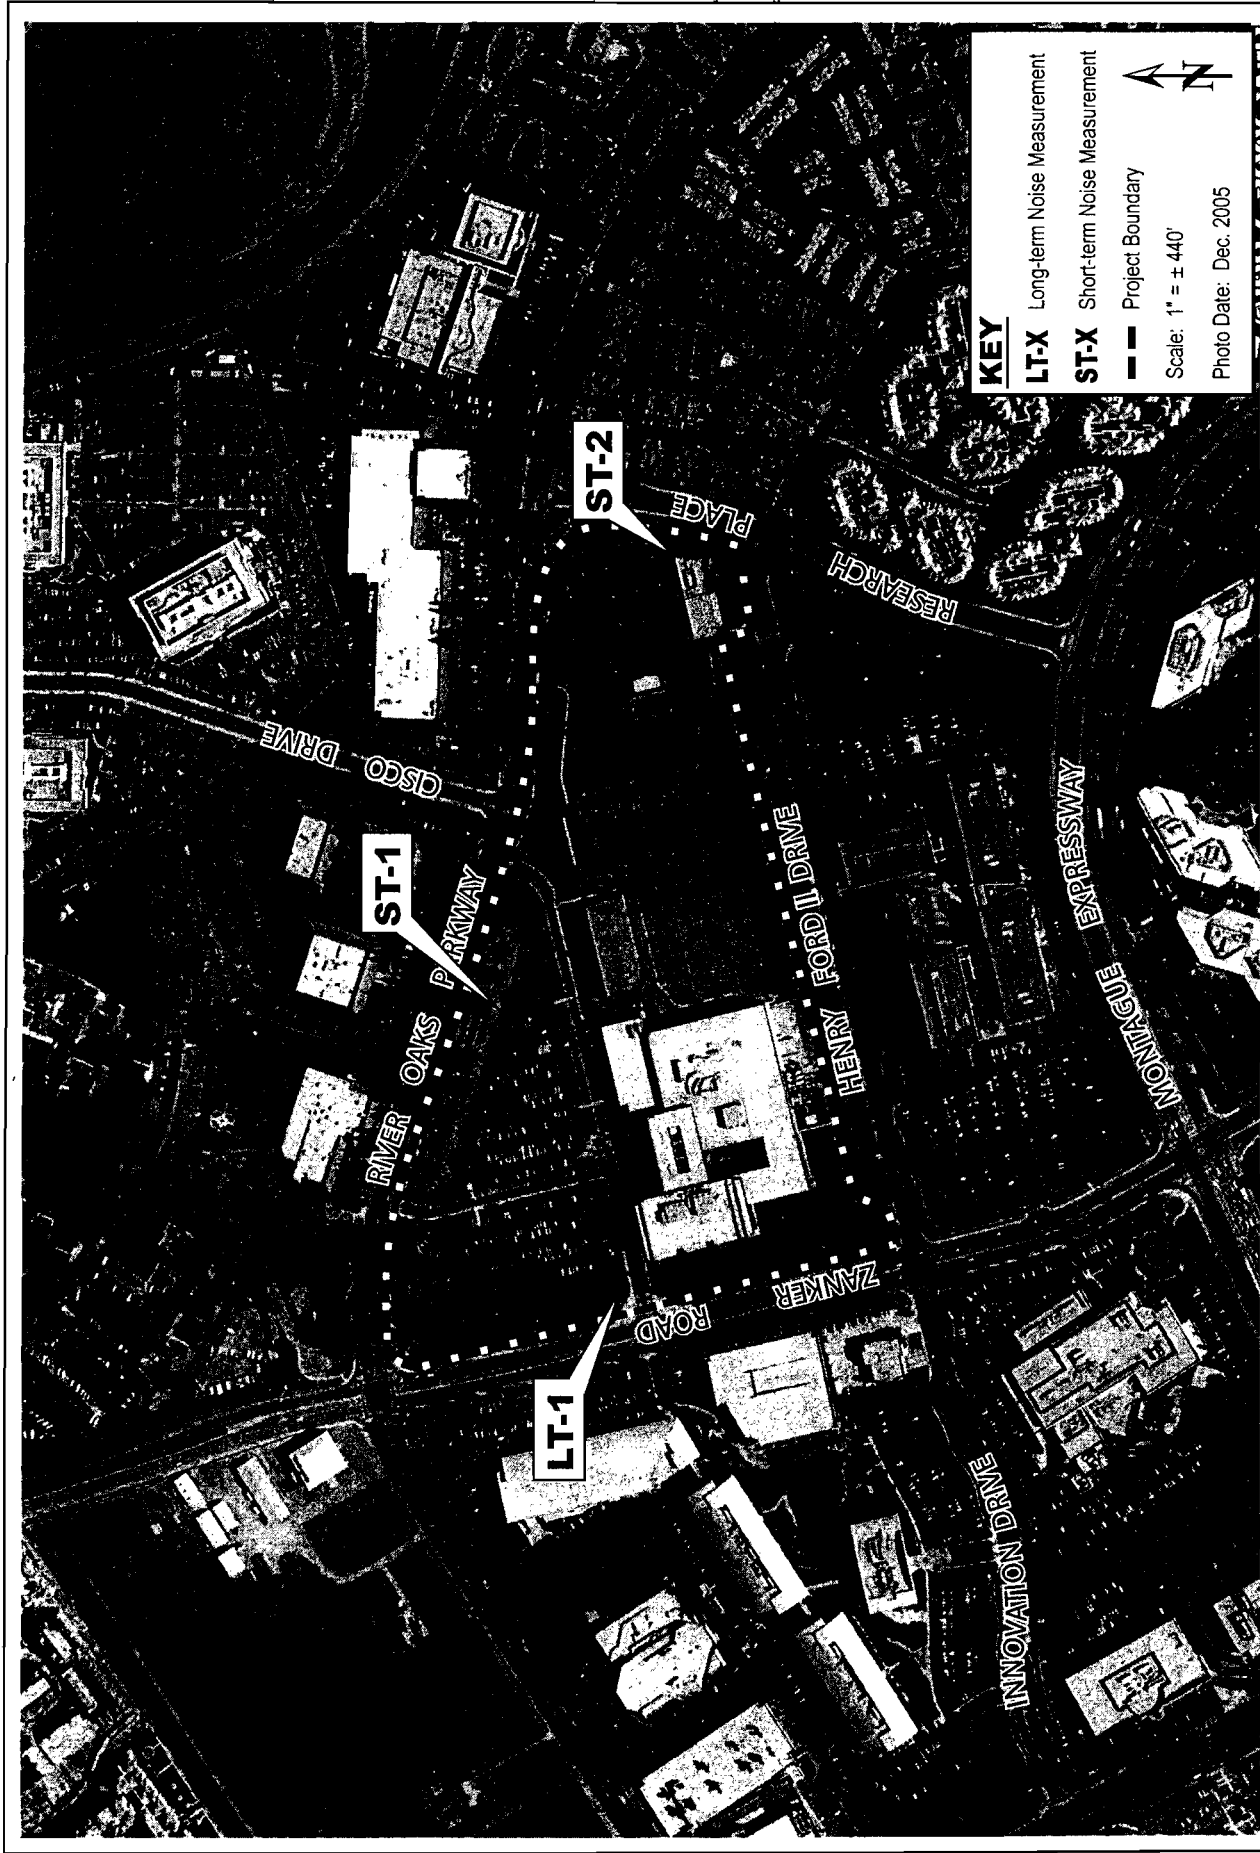
FIGURE 4.0-3

NOISE MEASUREMENT LOCATIONS

Ambient noise levels at the project site were measured in September 2006. Noise measurements were taken from three locations on the site: one long-term noise measurement was taken on the western project boundary, one short-term noise measurement was taken on the northern project boundary, and another short-term noise measurement was taken on the eastern boundary of the project site. The locations of these measurements are shown on Figure 4.0-3.

The L_{dn} noise level at the project site, estimated based on the relationship between the long-term and short-term noise data, ranged from 65 to 70 dBA.

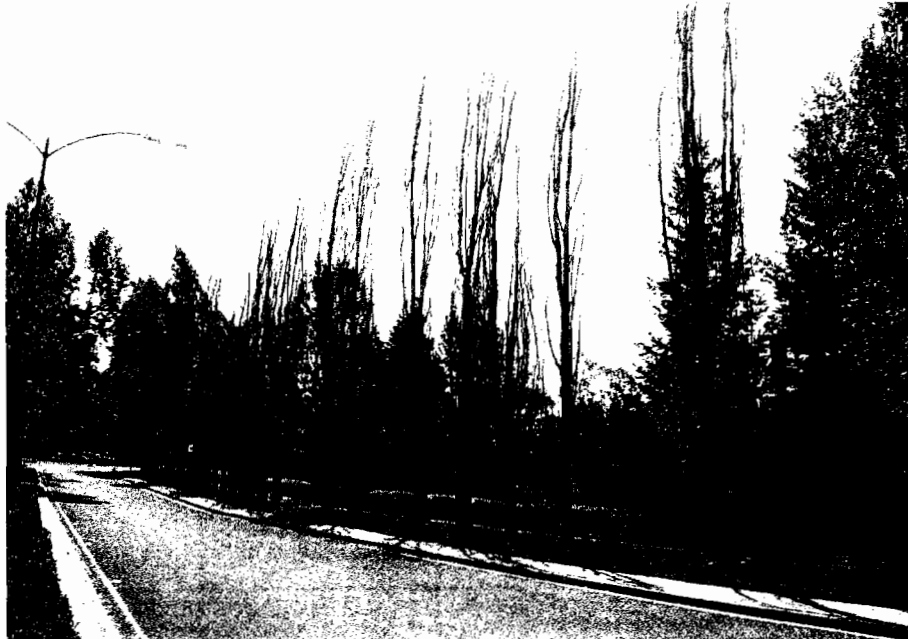
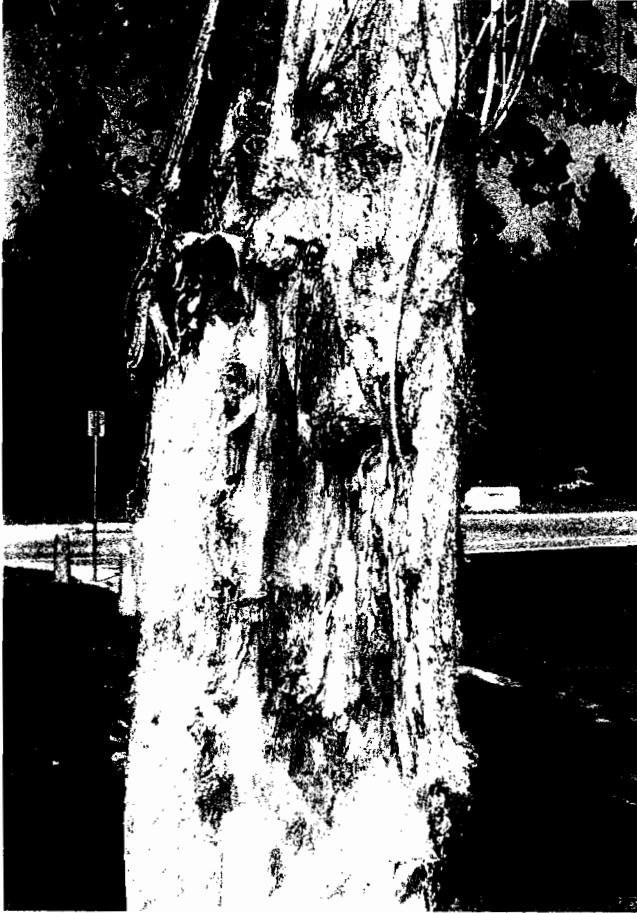
Trees # 128 Lombardy poplar – bark damage

Trees # 142 Lombardy poplar - oak root fungus mushrooms

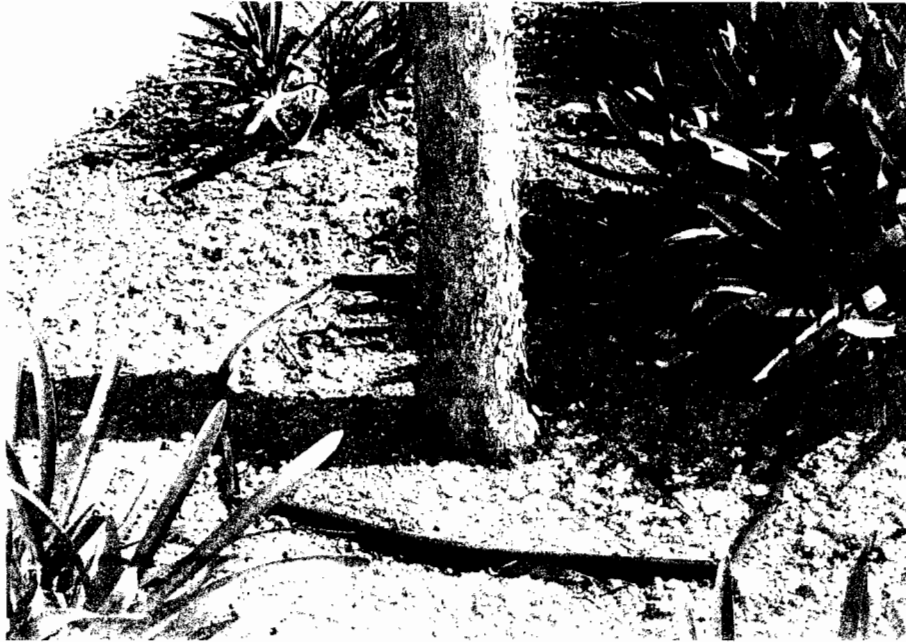
Tree # 594 – Example of root barrier used

Trees # 594, 595 Yarwood sycamore. Most of the Yarwood sycamores are in fair to poor condition due to the use of root barriers at this site.

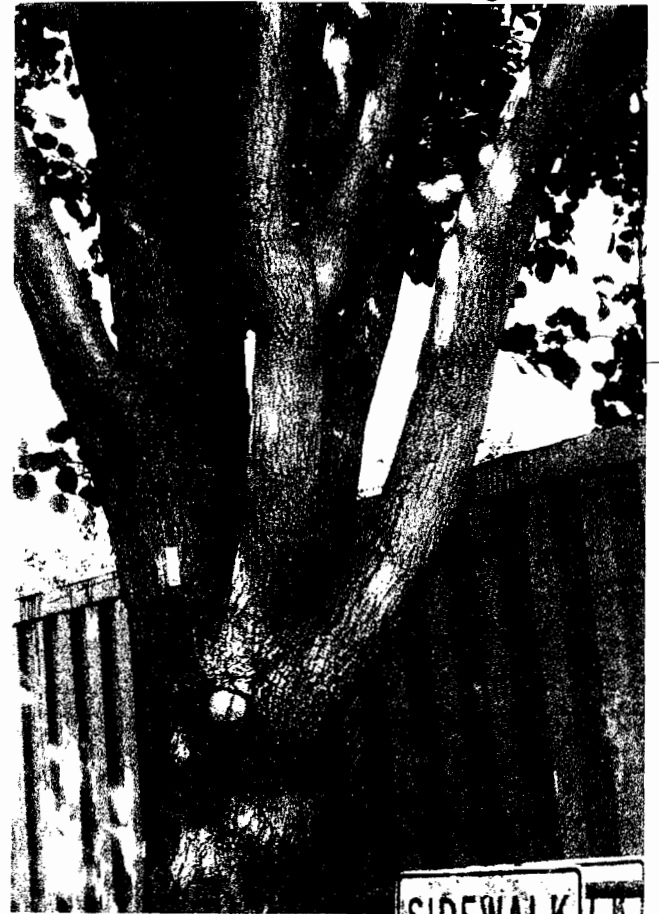
Tree # 770 Callery pear with Fire blight (*Erwinia*)

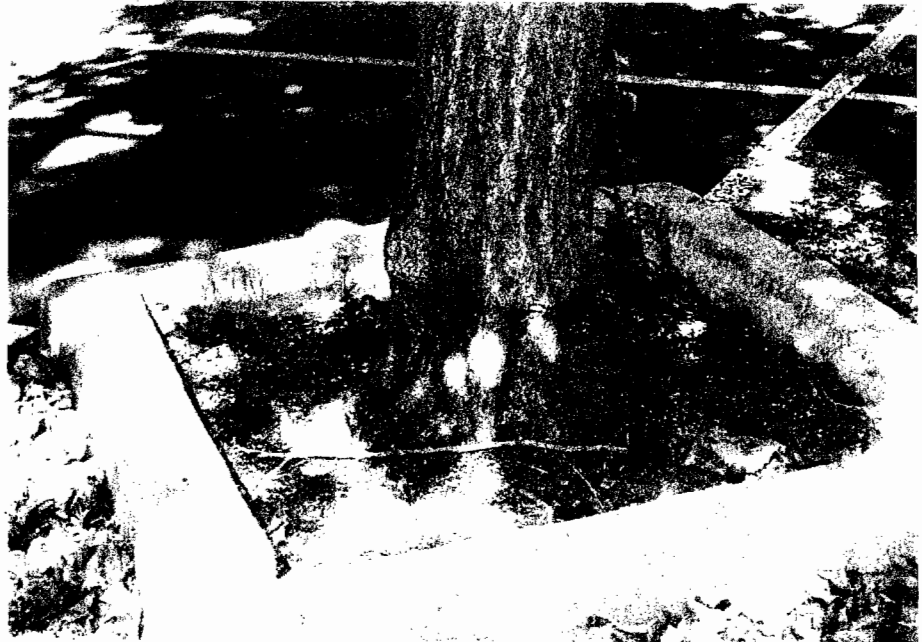
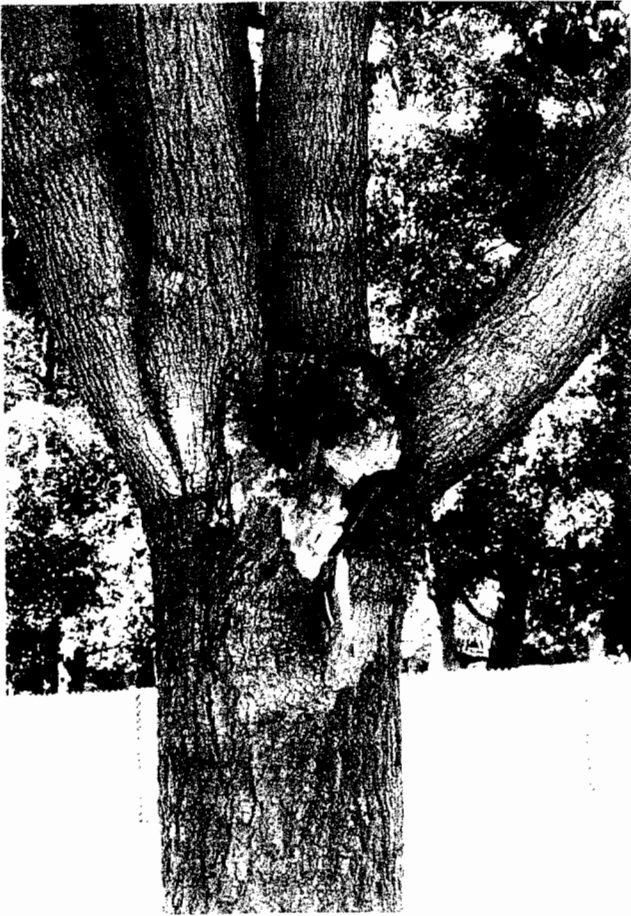
Trees # 773 Callery pear – poor graft as seedling

Trees # 775 Callery pear – broken limb as a result of attachment at an acute angle- virtually every Callery pear on site has this problem of varying degree

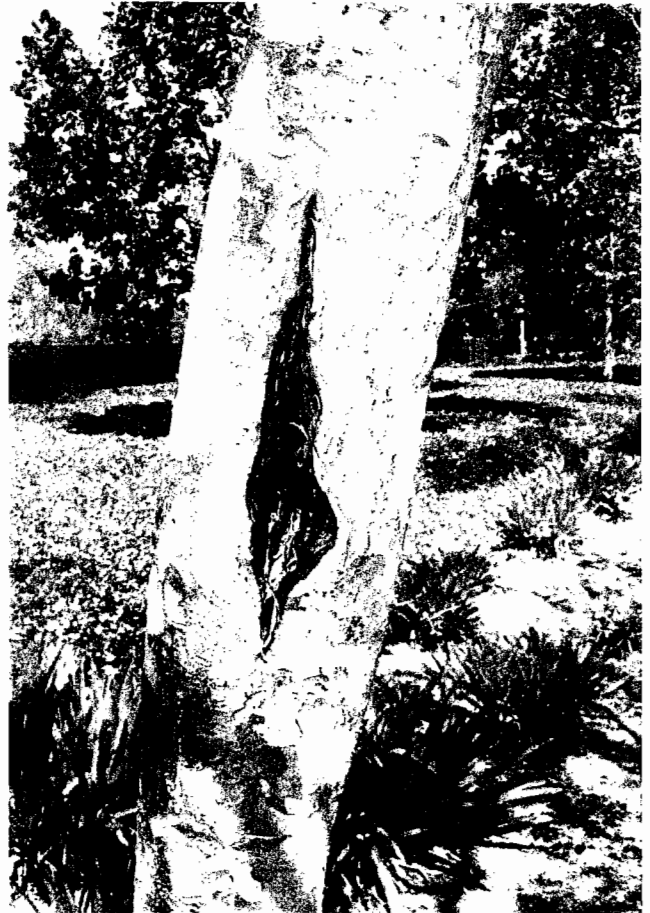
Tree # 870 Example of elm anthracnose disease, in which many
of the Chinese elms at this site are infected.
