PHASE I ENVIRONMENTAL SITE ASSESSMENT UPDATE

**Julian Street
715-835 W. Julian Street & 303,
307, and 311 Stockton Ave.
San Jose, California**

February 17, 2017

TRC Project No: 247457

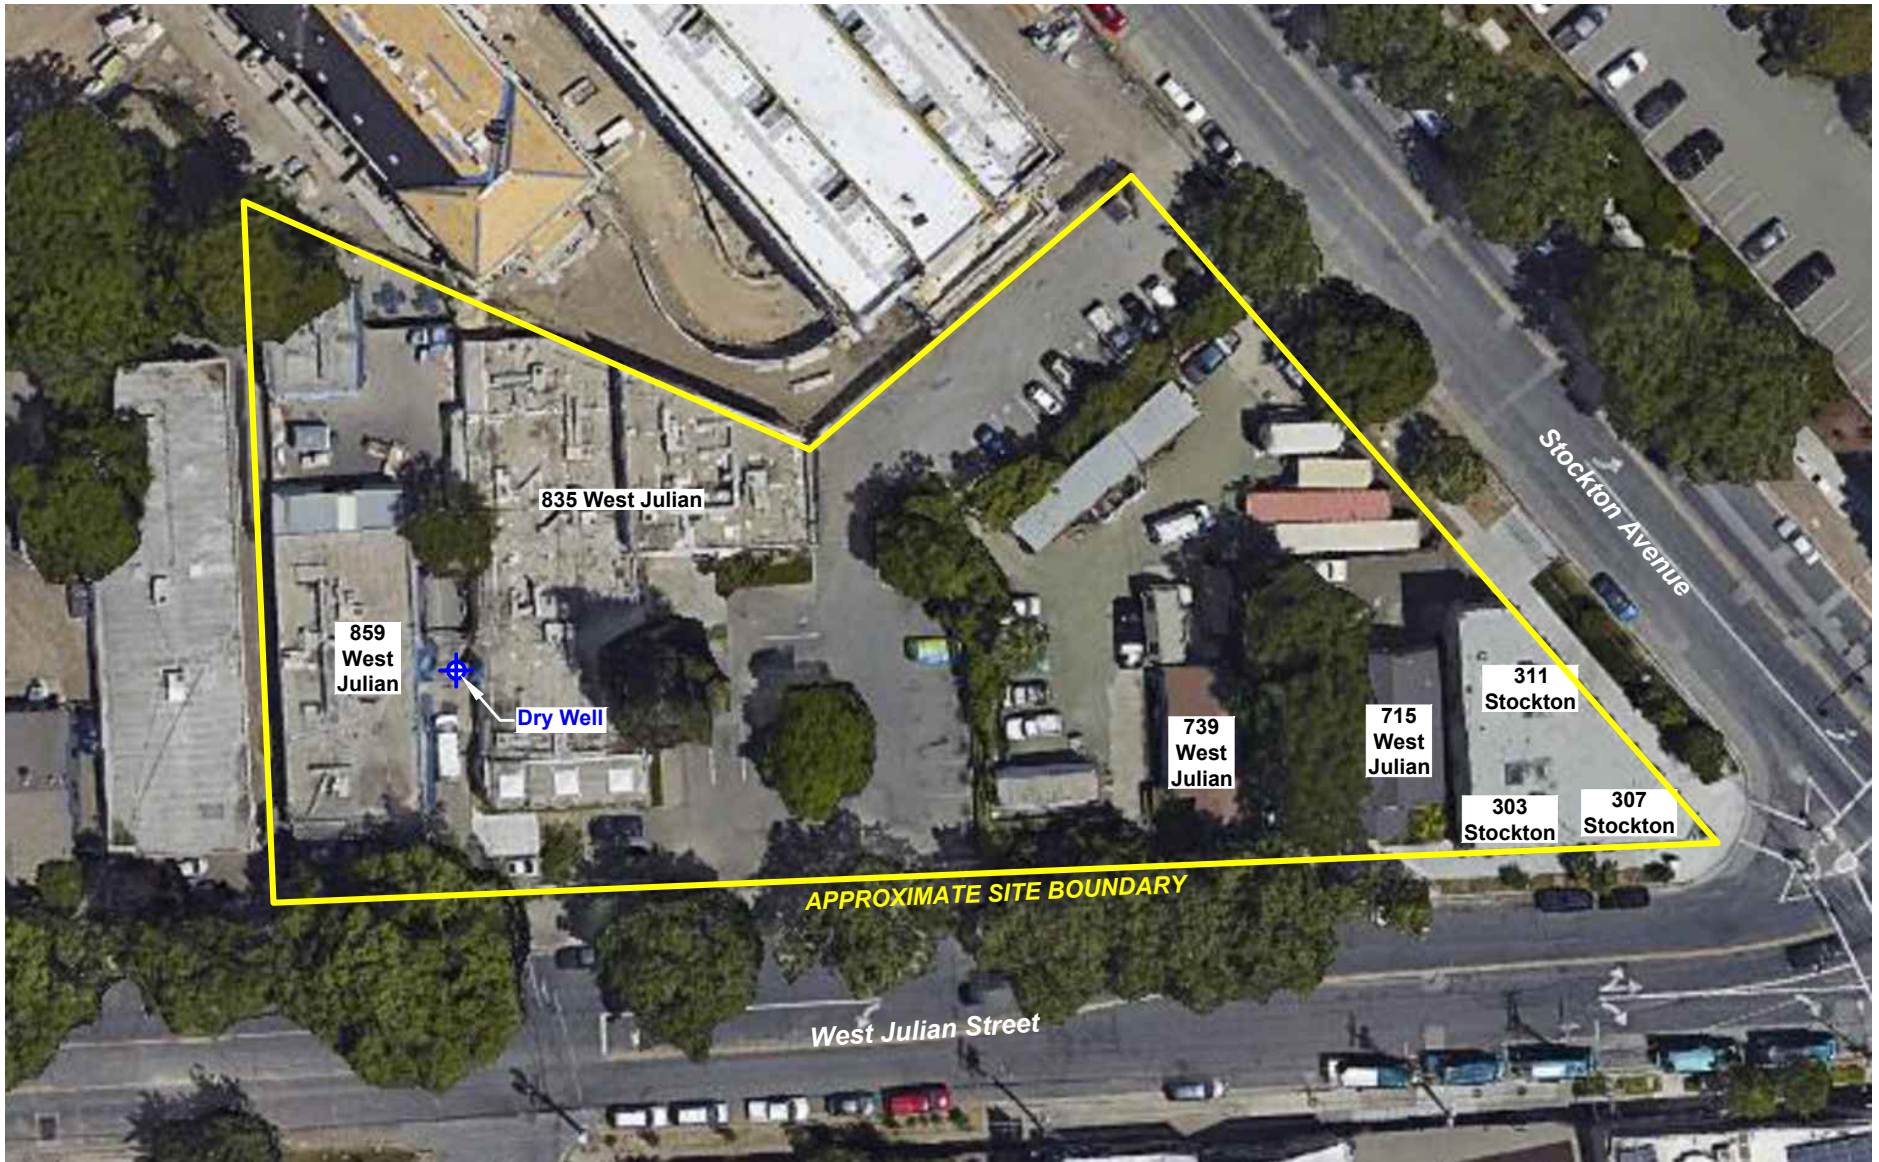
SITE PLAN		
Cypress Group 715-835 West Julian Street San Jose, California

Wells (including dry wells, irrigation wells, injection wells, abandoned wells, or other wells)	Yes	One dry well was observed in a paved access area between the commercial buildings along 835 and 859 W. Julian St. (refer to Figure 2). The dry well was covered with a steel grate, which could not be removed by hand, however, the dry well was visually observed. A previous Phase I for the Site indicated that the well was used for excess stormwater runoff during rain events.
Septic systems or cesspools	No	
Storm drains	Yes	Several storm drains were observed in the exterior paved areas around the commercial buildings along 835 and 859 West Julian Street.

- A dry well was located in the paved access area between 835 and 859 W. Julian St. There was no water in the well at the time of observation, however, leaves and gravel debris were observed in the interior of the dry well. No apparent staining was noted, and no odors were noticed coming from the well. A previous Phase I ESA completed by Converse Consultants in 2005 stated that the well was used to hold stormwater runoff during rain events, which then was then allowed to percolate into the subsurface. This could potentially allow a pathway for hazardous materials to enter the subsurface if a release were to occur on-Site.

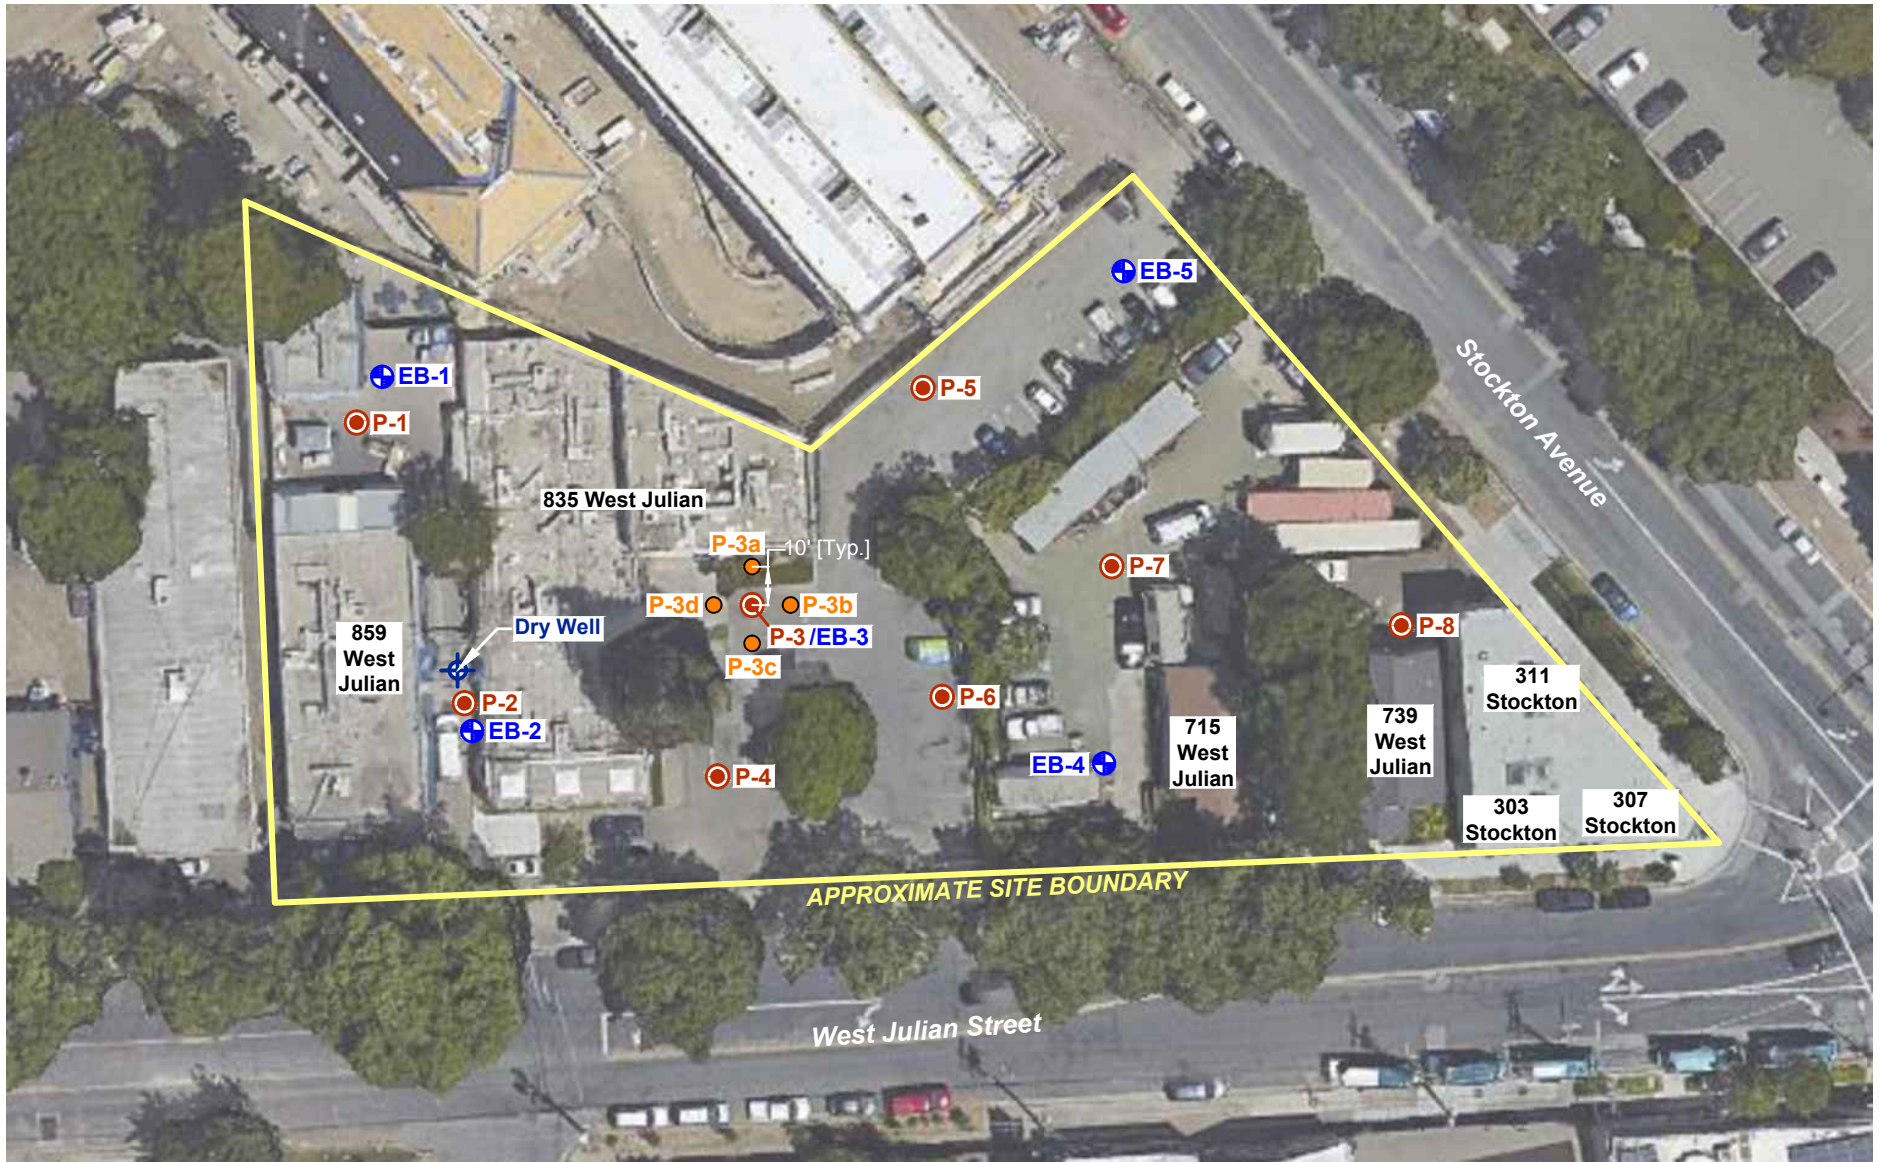
SITE PLAN

To evaluate lead and cobalt impacts to soil in the vicinity of Boring EB-3, TRC completed 5 shallow probes P3, and P3-a through P3-d (*Figure 2*). For the purposes of this additional investigation, these probes were completed to a depth of approximately 3.5 to 4.0 feet). Soil encountered in those probes generally comprised shallow fill to 2 feet bgs over native soil to the maximum depth explored. Shallow fill consisted of sand with silt and gravel, and silty sand with brick fragments and nails observed. The underlying native soil consisted of clayey silt and silty sand. No groundwater was encountered.

Stepout boring 10' from P-3

For shallow soil in the vicinity of EB-3, results of chemical analyses identified the presence of elevated cobalt and lead concentrations at P-3 and step-out Sample P3c-1.0'. The vertical and lateral extent of those metals are not fully defined at this time. For the EB-3 investigation area, TRC recommends the following:

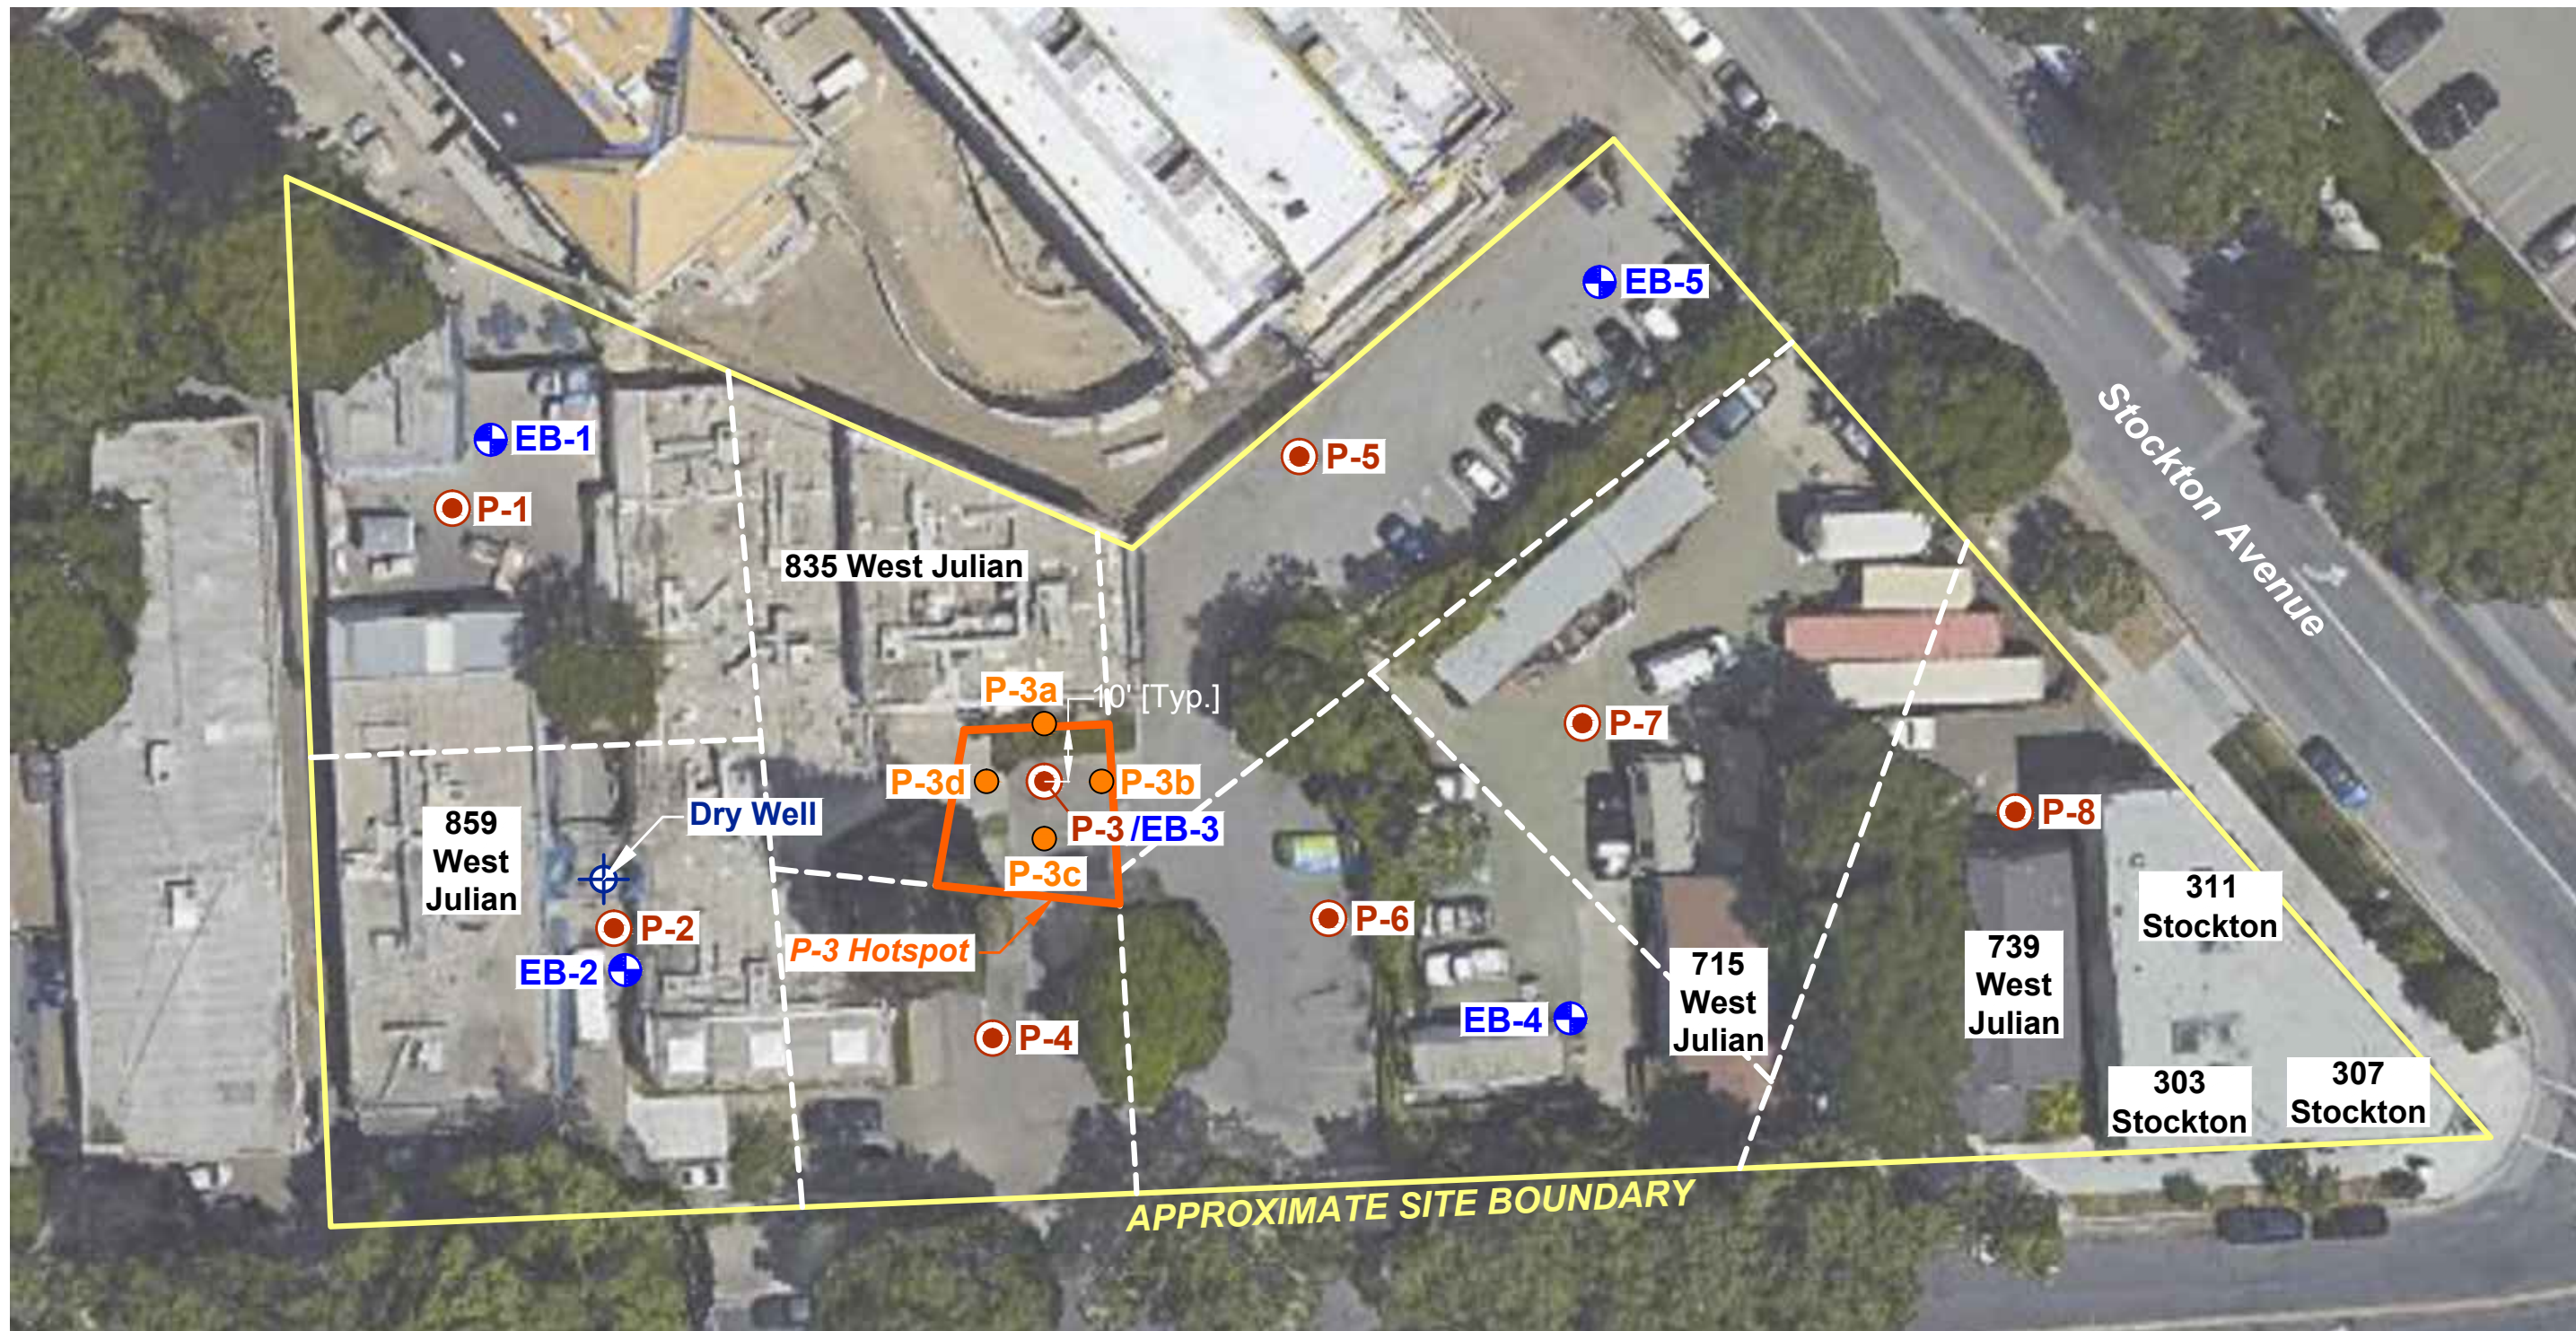
SITE PLAN
 Cypress Group
 715-835 West Julian Street
 San Jose, California

- ⊕ Environmental boring, November 2014
- ⊙ Probe
- Stepout boring 10' from P-3

Probe ID	Approximate Area in Square Feet
P-1	332
P-2	515
P-3	3,778
P-3 Hotspot	832
P-4	3,232
P-5	5,157
P-6	1,117
P-7	1,133
P-8	7,025
