Phase I Environmental Site Assessment & Supplemental Subsurface Investigation

**PHASE I
ENVIRONMENTAL SITE ASSESSMENT
750 WEST SAN CARLOS STREET
SAN JOSE, CALIFORNIA**

SEPTEMBER 1, 2017

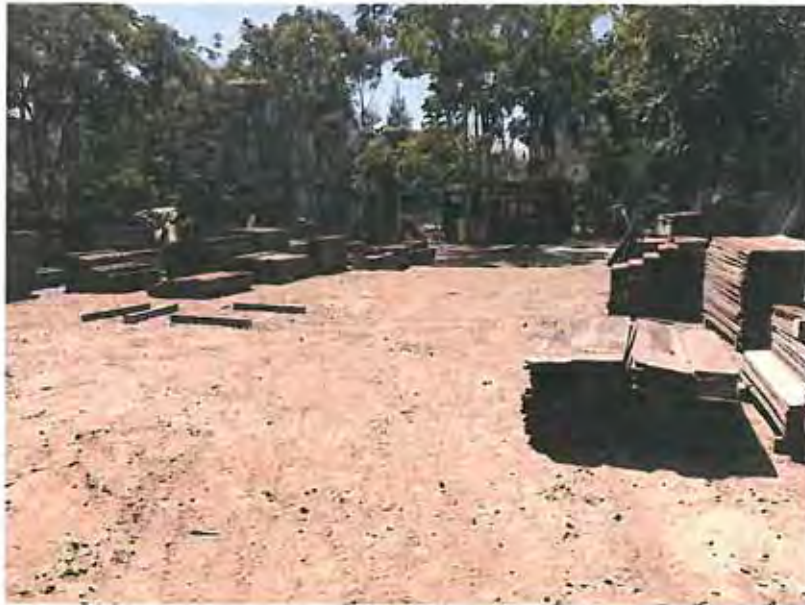
Photo 1.
View of the southern portion of the subject property, looking southeast.
Photograph taken August 16, 2017.

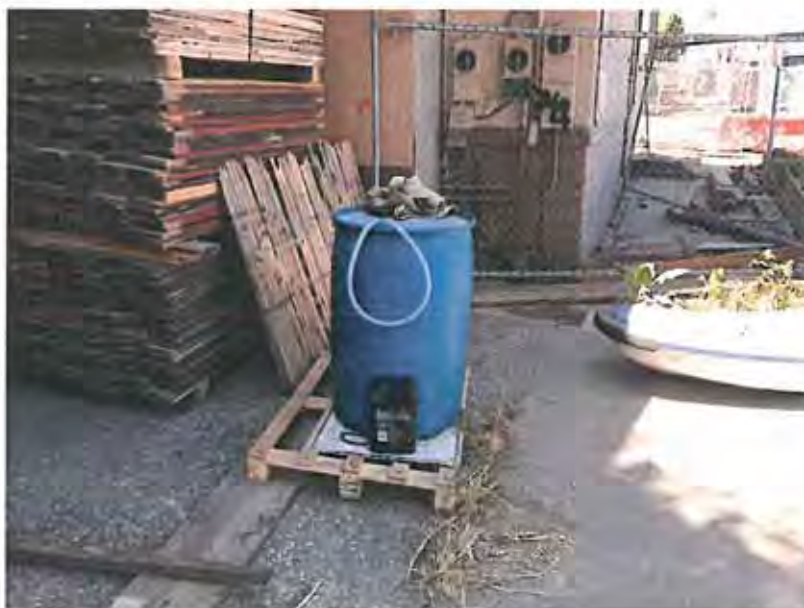
A partially full 55-gallon drum (containing what appeared to be water), an empty 55-gallon drum, and an empty gasoline container were present in the driveway area west of the subject property building (Plate 4, Photo 1). A partially full 55-gallon drum and a small-quantity (i.e. less than 5-gallon) container of what appeared to be automatic transmission fluid (ATF) were present on the northern side of the subject property (Plate 5, Photo 1). No staining or indications of a release were observed in the vicinity of the ATF. A compressed acetylene tank was observed in the northwestern corner of the subject property. The driveway and yard areas, located on the western and southern portions of the site, respectively, contained primarily salvaged wood, tools, and miscellaneous trash and debris (Plate 5, Photo 1 and

Photo 2.
View of drum located on the northern portion of the subject property.
Photograph taken August 16, 2017.

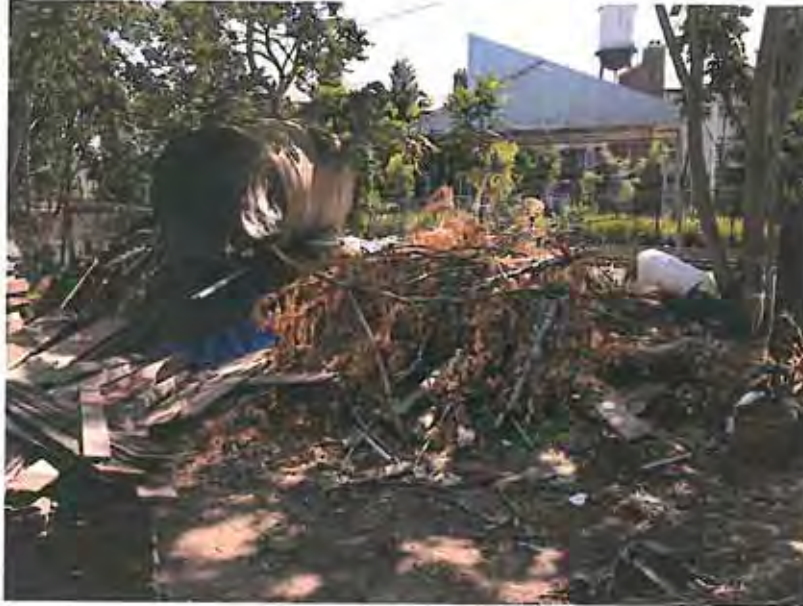
Plate 6, Photo 1). A large dumpster, containing primarily trash and wood debris, and a portable restroom were also observed on the southern portion of the subject property.

Photo 1.
View of miscellaneous trash and debris observed on the southern portion of the subject property. Photograph taken December 12, 2016.

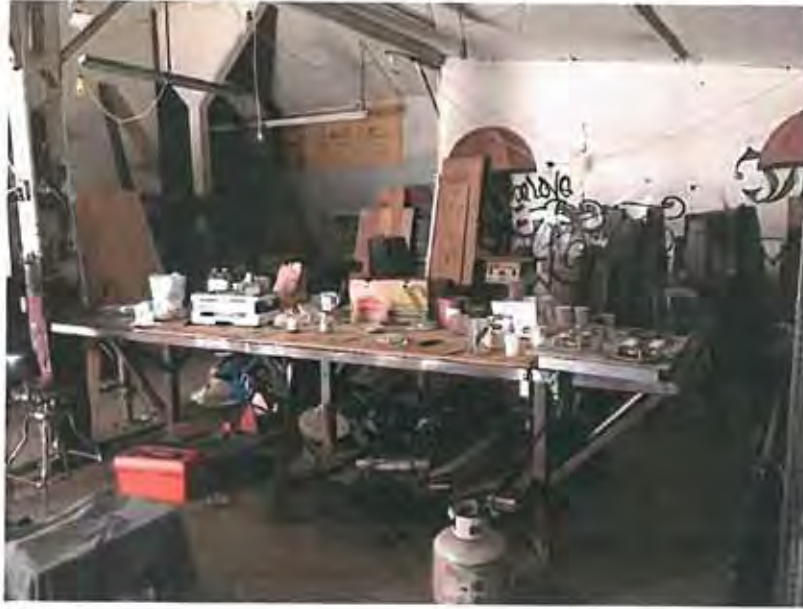
Photo 1.
View of southern portion of the subject property building, looking northeast.
Photograph taken August 16, 2017.

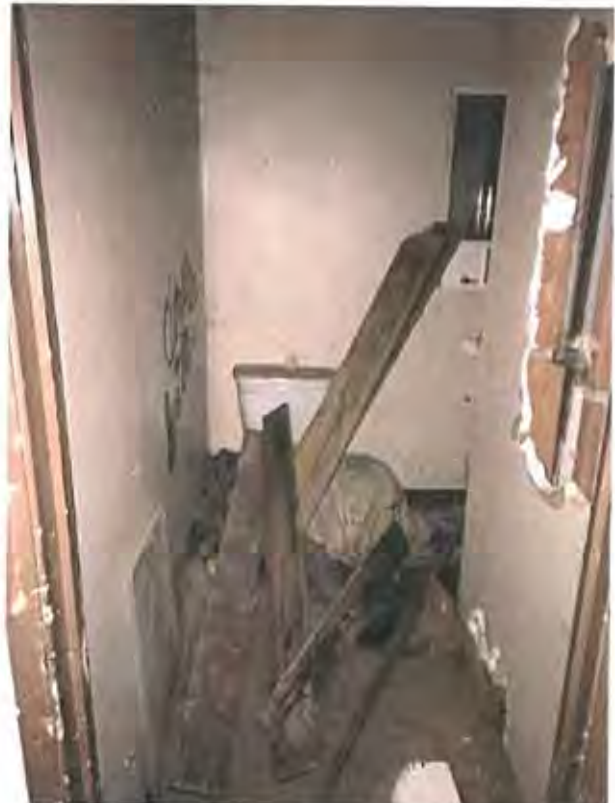
Photo 2.
View of miscellaneous trash and debris observed in the
northern portion of the subject property building.
Photograph taken August 16, 2017.

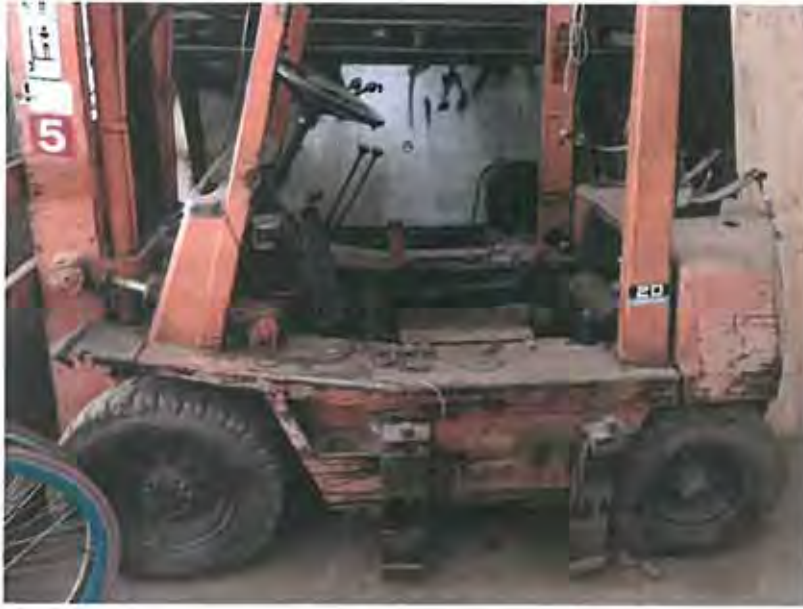
Photo 1.
View of typical forklift observed in the northern portion of the subject property building. Photograph taken August 16, 2017.

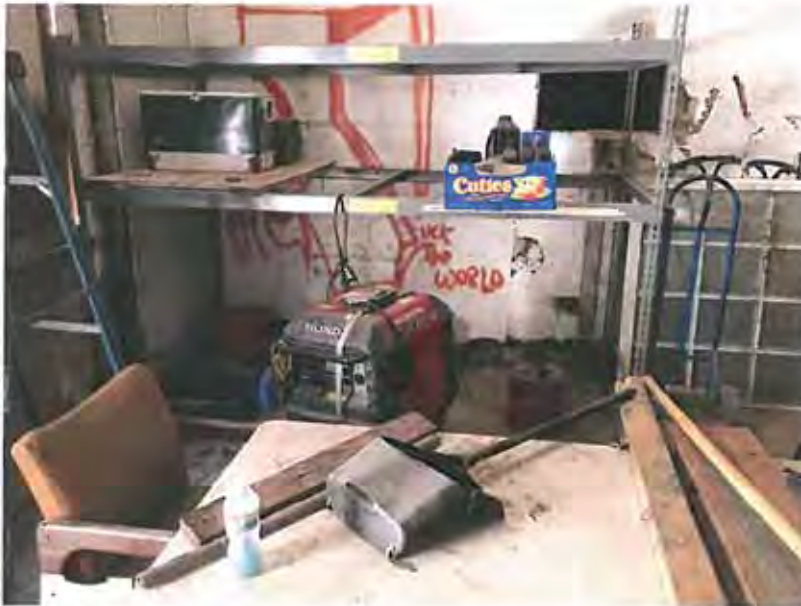
The southern portion of the subject property contained one gasoline-powered generator, five lead-acid automobile batteries, a 5-gallon bucket of tractor hydraulic fluid, several small-quantity (i.e., 5 gallons or less) containers of standard automobile maintenance fluids (i.e., motor oil, coolant, ATF, etc.) and paints (Plate 8, Photo 2). Two containers (an open plastic reservoir and an open 5-gallon bucket) containing what appeared to be used motor oil were observed in the same area. Numerous compressed gas (i.e., acetylene, propane, etc.) containers were observed in the subject property building (Plate 9, Photo 1). Two 5-gallon buckets of tractor hydraulic fluid and several small-quantity (i.e., 5 gallons or less) containers of standard automobile maintenance fluids (i.e., motor oil, coolant, ATF, etc.) were observed in the southwestern corner of the subject property building (Plate 9, Photo 2). Numerous containers of compressed propane gas (i.e., for use with stoves) were observed in the southern portion of the subject property building. Some *de minimis* staining was observed on the concrete floor in the vicinity of the batteries, tractor hydraulic fluid, standard automobile maintenance fluids, and used motor oil.

A gasoline-powered generator was observed in the southwestern portion of the subject property building. No staining or indications of a release were observed in the vicinity of the generator.

Photo 2.
View of gasoline-powered generator and various containers of gasoline, paint, automobile motor oil, and tractor hydraulic fluid located in the southern portion of the subject property building. Photograph taken August 16, 2017.

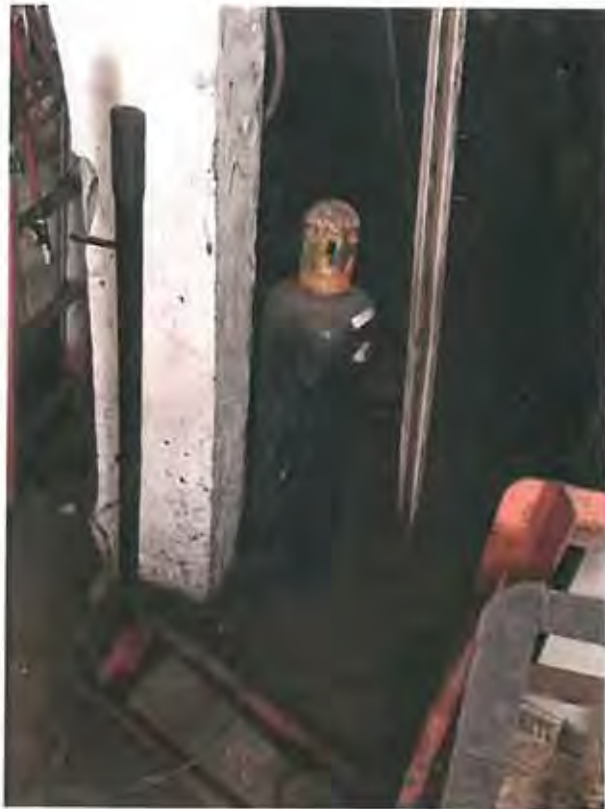
Photo 1.
View of typical compressed acetylene gas container observed in the southern portion of the subject property building. Photograph taken August 16, 2017.

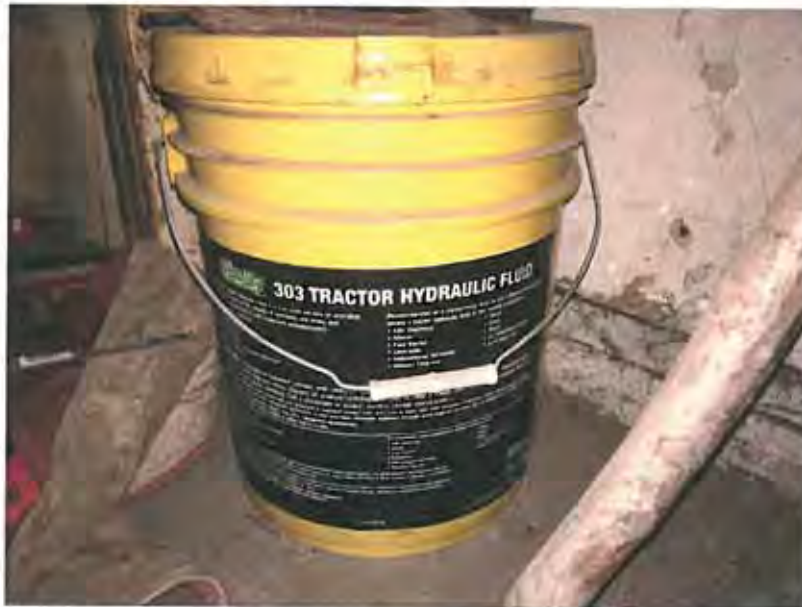
No hydraulic equipment was observed at the subject property. As discussed in Section 6.0, three 5-gallon buckets of tractor hydraulic fluid were observed in the southern portion of the subject property building.

Photo 2.
View of partially-full 5-gallon container of tractor hydraulic fluid located in the southern portion of the subject property building. Photograph taken August 16, 2017.
