Integrated Final
Environmental Impact Report/
Environmental Assessment

KING AND DOBBIN TRANSIT
VILLAGE AND US 101 -
OAKLAND/MABURY
TRANSPORTATION
DEVELOPMENT POLICY (PDC07-
015, NR07-002 and PP07-172)

HISTORIC PROPERTY SURVEY REPORT/FINDING OF EFFECT
(No Historic Properties Affected)

KING AND DOBBIN TRANSIT VILLAGE PLANNED DEVELOPMENT ZONING
CITY OF SAN JOSE, SANTA CLARA COUNTY, CALIFORNIA

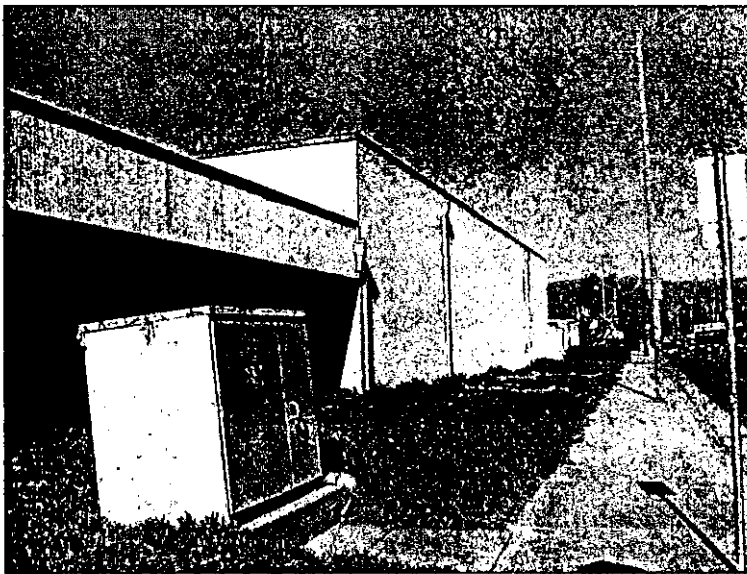
Photograph: APE# 4
Address: 670 N. King Road
APN: 254-04-088

Age: 27 yrs. Constructed in 1980.

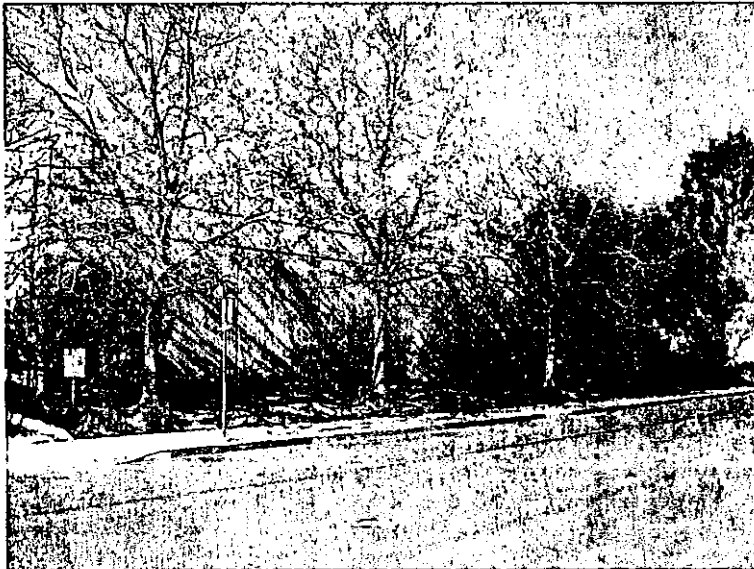
Photograph: APE# 6
Address: 1855 Dobbin Drive
APN: 254-04-082
View: Front façade, of the vacant industrial warehouse building.
Age: 29 yrs. Constructed in 1978.
Camera pointing: NW
Date of Photograph: 2/3/07

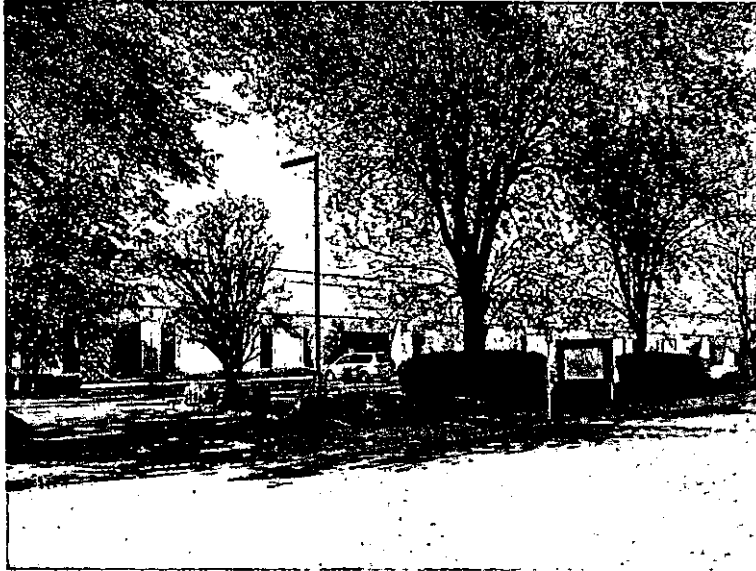
Photograph: APE# 7
Address: 1895 Dobbin
Drive
APN: 254-55-010
View: Front façade, of the
vacant industrial warehouse
building.
Age: 23 yrs. Constructed in
1984.
Camera pointing: NW
Date of Photograph: 2/3/07

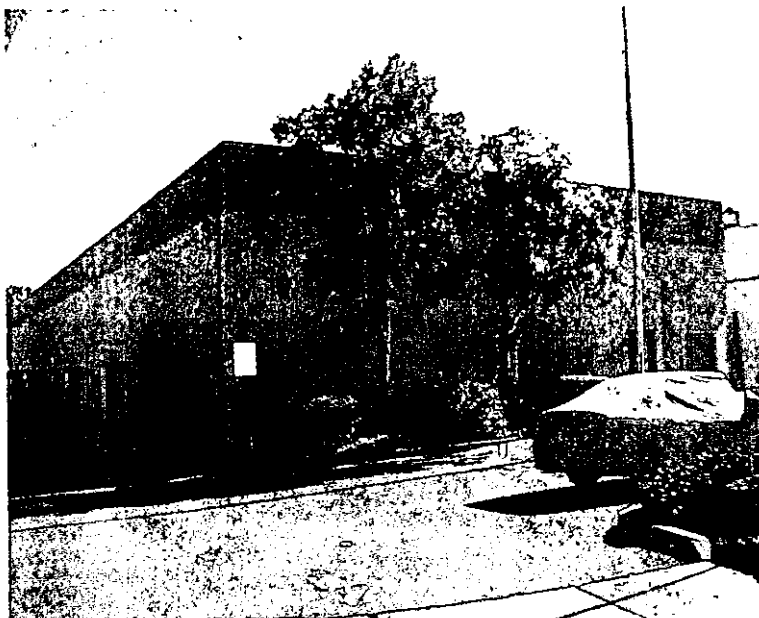
Photograph: APE# 9
Address: 1900 Dobbin Drive
APN: 254-55-007
View: Front façade, of the warehouse building.
Age: 26 yrs. Constructed in 1981.
Camera pointing: NE
Date of Photograph: 2/3/07

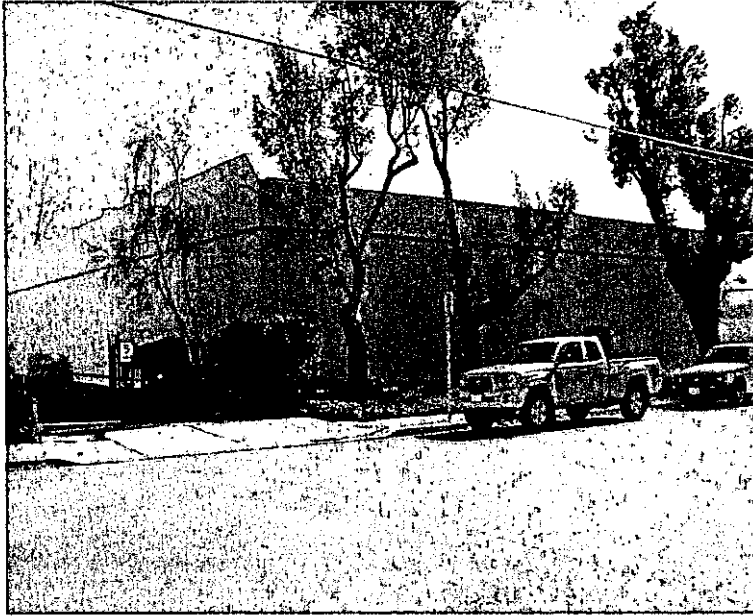
Photograph: APE # 10
Address: 1890 Dobbin Drive
APN: 254-55-003
View: Front Façade, concrete
industrial warehouse building.
Age: 27 yrs. Constructed in
1980.
Camera pointing: NE
Date of Photograph: 2/3/07

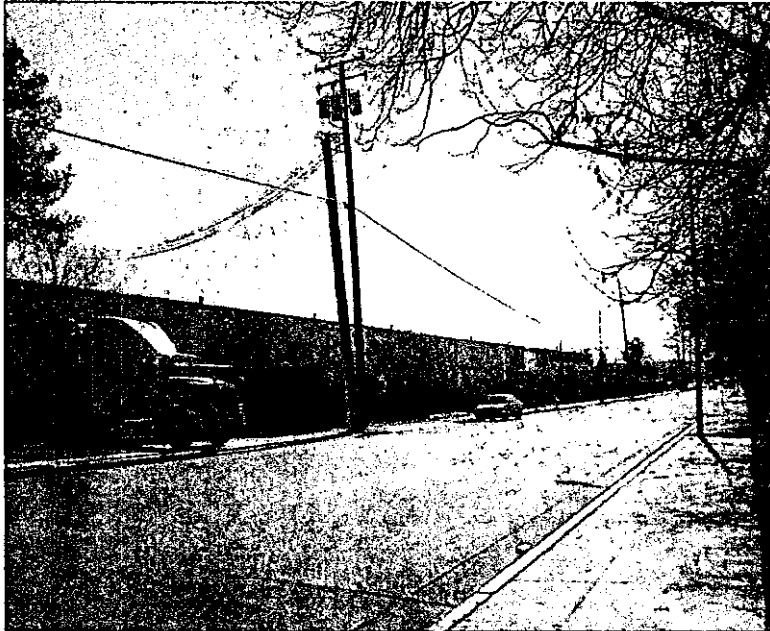
Photograph: APE# 13
Address: 1860 Dobbin Drive
APN: 254-55-012
View: Front façade, of the
concrete warehouse building.
Age: 35 yrs. Constructed in
1972.
Camera pointing: S E
Date of Photograph: 2/3/07

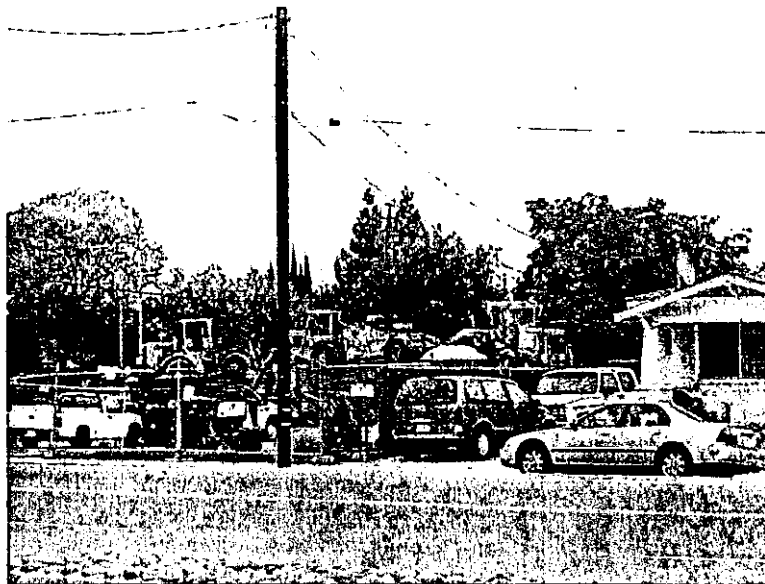
Address: 778 N. King Rd
APN: 254-04-092
Age: 0 yrs
Eligible NR: No
Integrity: NA
NR Criteria: NA
Photograph: APE# 19
View: lot under
construction
Date: 7/20/07
Camera Facing: East

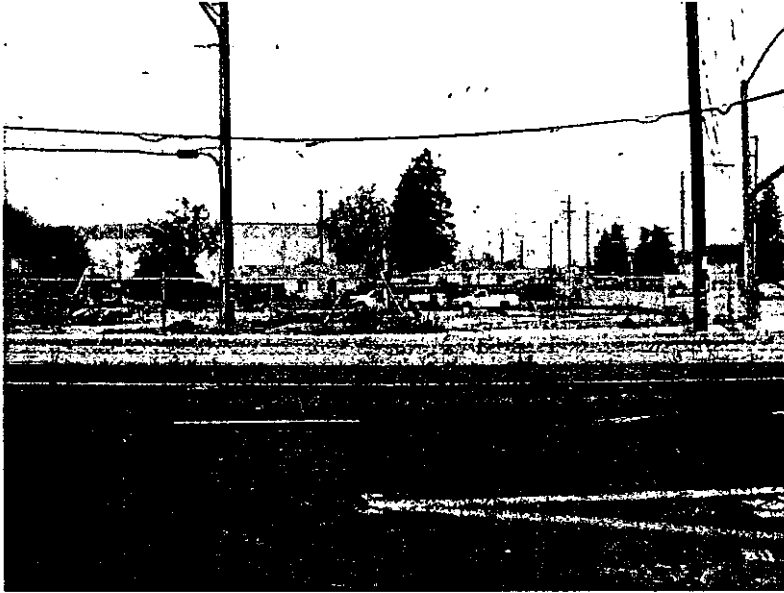
Address: 780 N. King Rd
APN: 154-04-093
Age: 0 yrs
Eligible NR: no
Integrity: NA
NR Criteria: NA
Photograph: APE# 20
View: Parcel under
construction
Date: 7/20/07
Camera Facing:: South

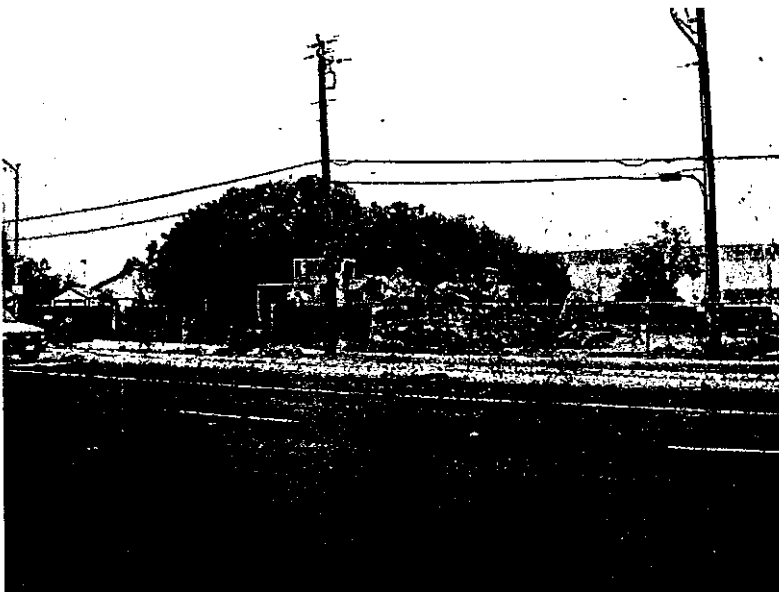
Address: 12280 Mabury Rd.
APN: 254-04-94,95
Age: NA
Eligible NR: no
MR Criteria: NA
Integrity: No -
Photograph: APE # 21
View: vacant lot under
construction
Date: 7/20/07
Camera Facing: SE

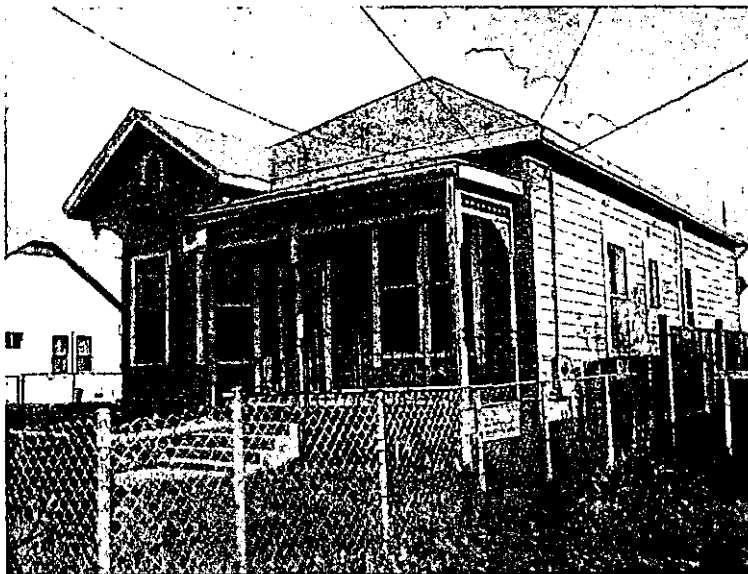
Address: 12320 Mabury Rd.
APN: 254-04-96
Age: 107
Eligible NR: Yes
NR Criteria: C
Integrity: yes
Photograph: APE# 23
View: Front and west
facades
Date: 3/1/07
Camera Facing: SE

The property at 12320 Mabury is .25 acre and includes a single story Queen Anne Cottage c. 1896, of the Spindle-work subtype with a hipped roof and a front pitched-roof gable. The front façade is divided between a slanted bay gable and the front porch. The porch is covered by a slightly hipped porch roof supported by turned posts at the corners and pilasters, against the wall. Spindle work lines the edge of the porch roof, below the gutters, with carved brackets in the corners. The balustrade has been removed and replaced with a vertical metal fence. The original wood steps have been replaced with formed concrete.

The house at 12320 Mabury Road appears eligible for listing in the National Register under criteria C - as an example of the Spindle-work style of Queen Anne Cottage architecture, a popular style in the late 1800's in the Santa Clara Valley, of which few constructed in rural settings remain. The building retains integrity except for alterations to the rear and missing porch balustrade and wood steps. The parcel was included as part of a 1926, Mayflower Park subdivision which created a row of residential parcels, diminishing the rural setting.

The house is typical of the Queen Anne Cottage, Spindle sub-category, exhibiting the classical elements of the style, hipped roof with front facing gable that together with the front porch are highly ornamented with spindle work, carved brackets and turned wood posts. It appears to be original with the exception of a metal fence that replaced the porch balusters. The style was popular during the during the last two decades of the nineteenth century, and was the style selected for many farm houses of that period, although few remain. However, within Santa Clara County the style is most commonly found in the urban areas. The building retains all aspects of integrity except for the setting in a mid-century subdivision rather than the fruit ranch. Alterations to the rear and east facades slightly diminish the integrity, but do not affect the front façade or overall understanding of the style and period. The building exhibits the distinctive characteristics of a type and period and appears eligible for listing in the National Register of Historic Places, as a Rural example of the architectural style Queen Anne Cottage with Spindle work c. 1896.

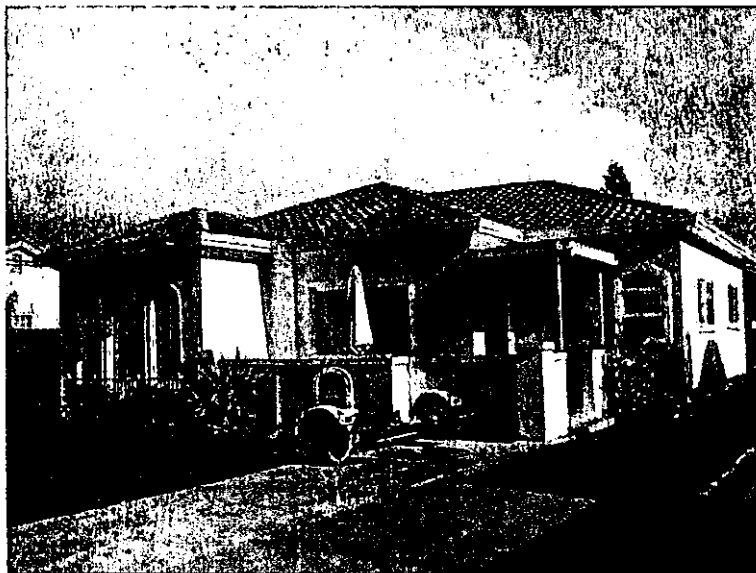
Address: 12340 Mabury Rd
APN: 254-04-013
Age: 77
Eligible NR: No
Nr Criteria: NA
Integrity: Yes
Photograph: APE# 25
View: Front Facade
Date: 3/1/07
Camera Facing: SE

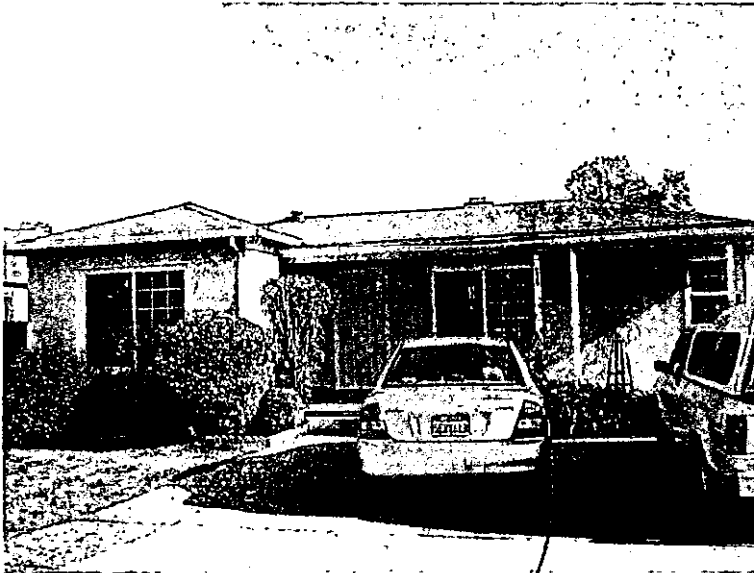
Address: 12370 Mabury Rd.
APN: 254-04-016
Age: 59
Eligible NR: no
Nr Criteria: NA
Integrity: yes
Photograph: APE# 28
View: front facade
Date: 3/1/07
Camera Facing: SE

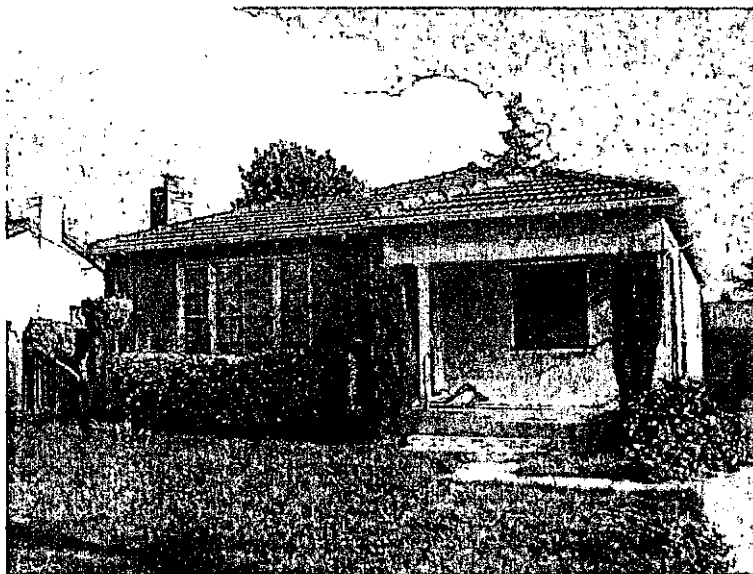
Address: 12400 Mabury Rd
APN: 254-04-043
Age: 66
Eligible NR: No
NR Criteria: NA
Integrity: no, stucco over
wood, tile roof added
Photograph: APE# 31
View: front facade
Date: 3/1/07
Camera Facing: SE

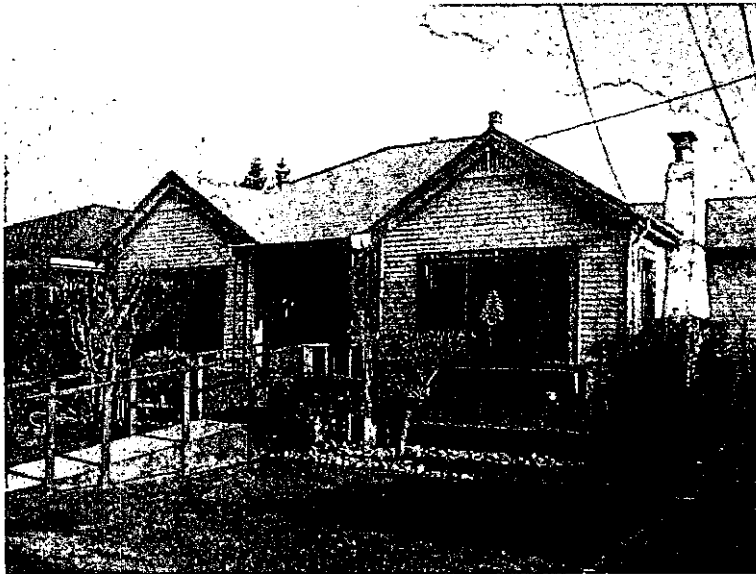
Address: 12420 Mabury Rd
APN: 254-04-020
Age: 75 yrs.
Eligible NR: no
NR Criteria: NA
Integrity: no – moved to the
site, c. 1935 gable added to
front facade
Photograph: APE# 33
View: front facade
Date: 3/1/07
Camera Facing: SE

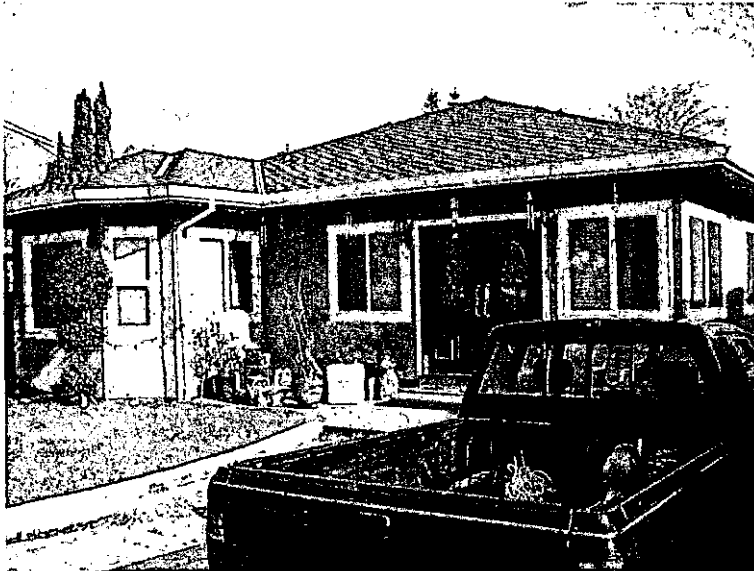
Address: 12430 Mabury Rd.
APN: 254-04-021
Age: 63
Eligible NR: No
NR Criteria: NA
Integrity: No, altered facades
remodeled 1999
Photograph: APE# 34
View: Front Facade
Date: 3/1/07
Camera Facing:

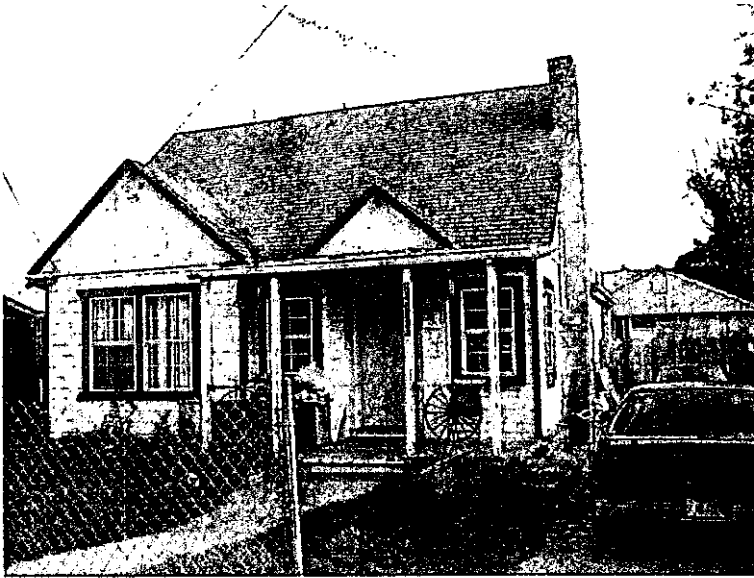
Address: 12490 Mabury Rd
APN: 254-04-027
Age: 75 yrs.
Eligible NR: No
Nr Criteria: NA
Integrity: No, resized
windows, wall cladding,
artificial siding and stucco
Photograph: APE# 40
View: front facade
Date: 3/1/07
Camera Facing:

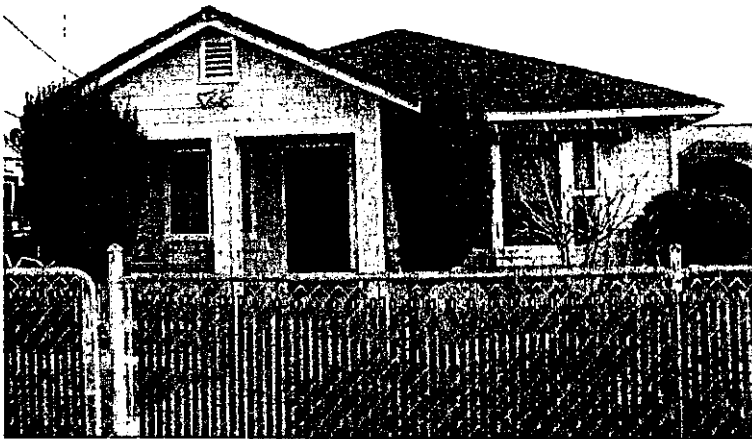
Address: 12510 Mabury Rd.
APN: 254-04-029
Age: 91 yrs,
Eligible NR: No moved to
the site, remodeled facade
NR Criteria: NA
Integrity: no, altered
windows, addition in rear,
moved to site
Photograph: APE# 42
View: Front facade
Date: 3/1/07
Camera Facing: SE

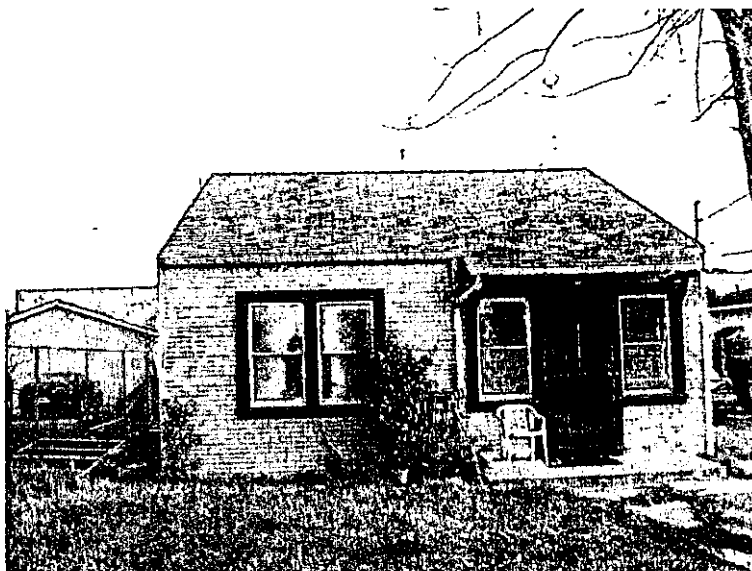
Address: 12520 Mabury Rd.
APN: 254-04-030
Age: 91 yrs.
Eligible NR: no moved to
the site; remodeled ancillary
building.
NR Criteria: NA
Integrity: no, additions and
alterations in rear, moved
Photograph: APE# 43
View: front facade
Date: 3/1/07
Camera Facing:

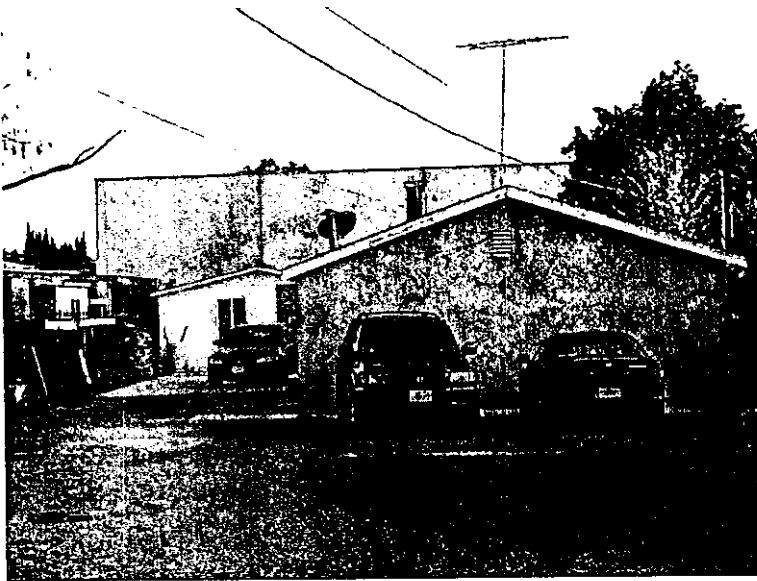
Address: 12530 Mabury Rd.
APN: 254-04-031
Age: 61 yrs
Eligible NR: no
NR Criteria: NA
Integrity: no, remodeled to
expand plan, resized
openings to replace
windows
Photograph: APE# 44
View: Front façade, end of
new wing and garage
Date: 3/1/07
Camera Facing:

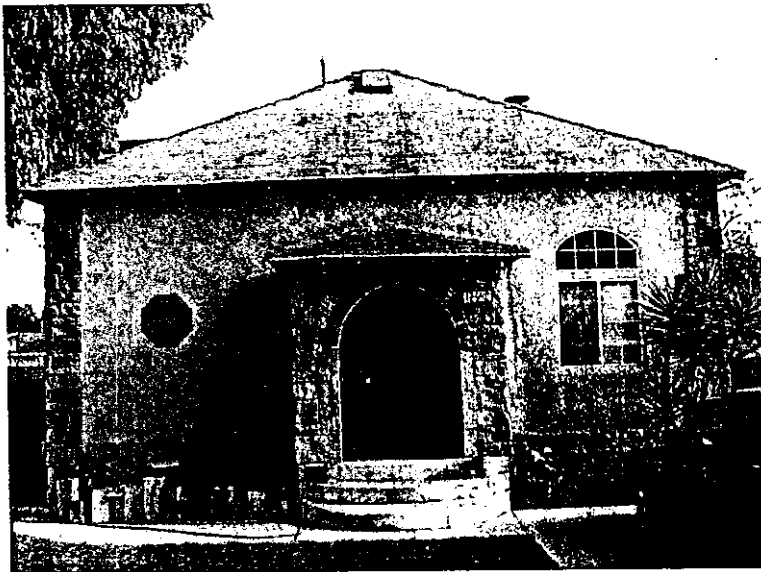
Address: 12540 Mabury Rd
APN: 254-04-032
Age: 106 yrs
Eligible NR: no
NR Criteria: NA
Integrity: no, moved to the
site and extensive
remodeling, added stucco
and stone elements,
windows altered
Photograph: APE# 45
View: front facade
Date: 3/1/07
Camera Facing:

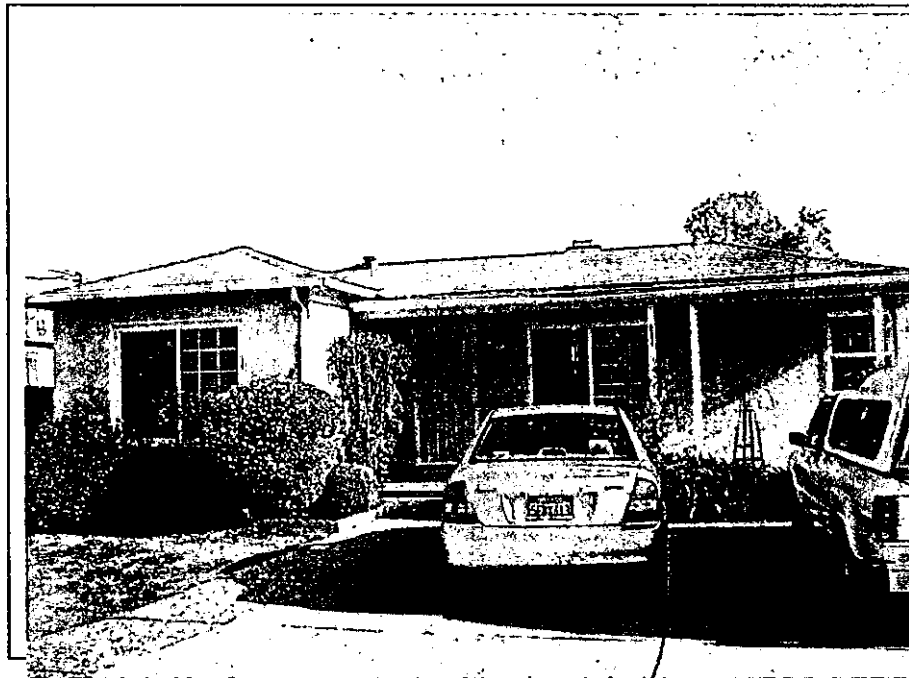
*P3a. **Description:** (Describe resource and its major elements. Include design, materials, condition, alterations, size, setting, and boundaries)
The single-story, house was constructed 1948, in an eclectic version of mid-century Ranch style architecture. The front façade is divided between a projecting bay with double wide window a recessed long porch that has the entry door in the corner and a second double window close to the door and another one at the corner of the wall. The concrete pad porch is raised two steps above grade and the front walkway is combined with a concrete parking pad that extends the width of the porch. The porch roof is support by two pairs of square posts. The projecting bay and the cross gable are covered by low hipped roof. The house is sheathed in textured stucco and has a composition shingle roof that extends over the porch. The sides and rear are relatively plain with standard windows and a back door. Landscaping is minimal, a lawn in front of the projecting gable with a low bushes along the front edge of the house and porch. A garage of similar style is behind the house. The property retains integrity. The property appears in good condition. The style is very modest example of the mid-century tract style Ranch House and is not significant in design or construction..

*P5b. **Description of Photo:** (view, date,
accession #) Front façade
Camera facing S 12/02/06
