**ERRATA to the
ARCO Gas Station Project
Initial Study/Mitigated Negative Declaration**

FILE NO. CP14-056

LOCATION OF PROPERTY Southeast corner of S. White Road and Mt. Vista Drive, at 3010 Mt. Vista Drive

Page 1 of 18 ***Resource Name or #:** (Assigned by recorder) 3110 Mt Vista Dr., San Jose CA

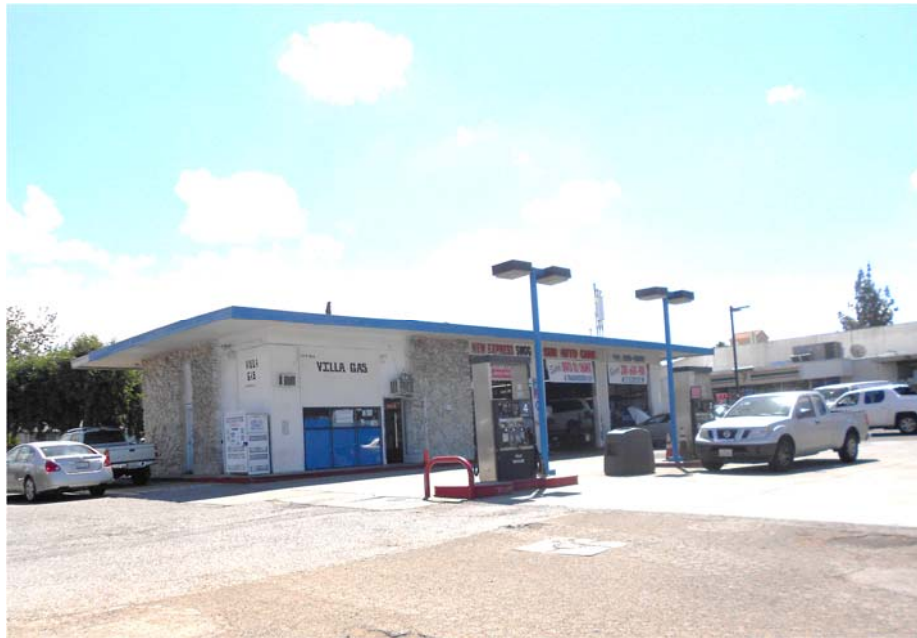
P5a. Photograph or Drawing (Photograph required for buildings, structures, and objects.)

P5b. Description of Photo: (view, date, accession #) Front Façade 2017

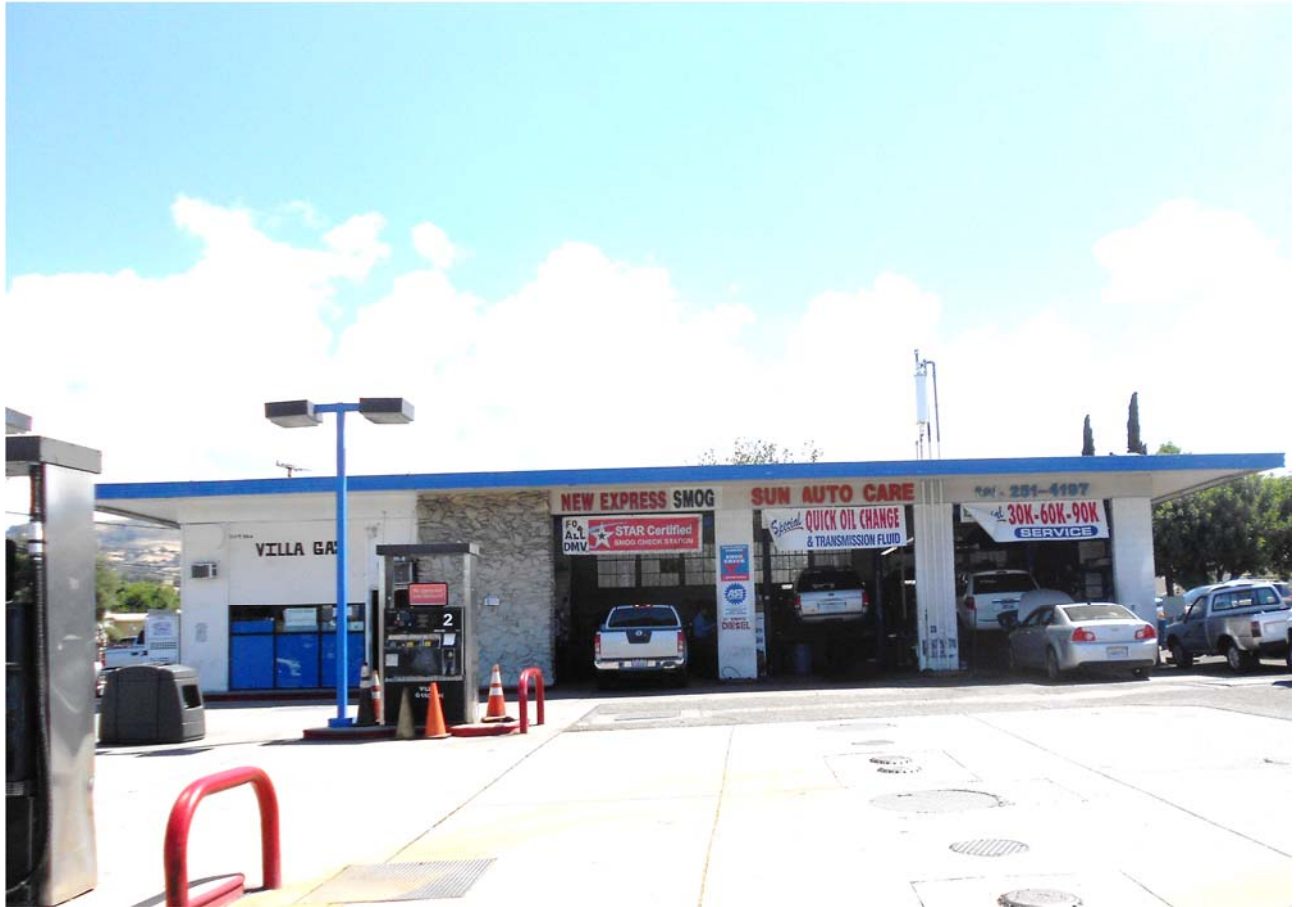
Photograph 1 3110 Mt. Vista Dr. San Jose

View: Front façade facing S. White Road (1414 S. White Road) showing the broad overhanging eave, three bay garage and office (on left)

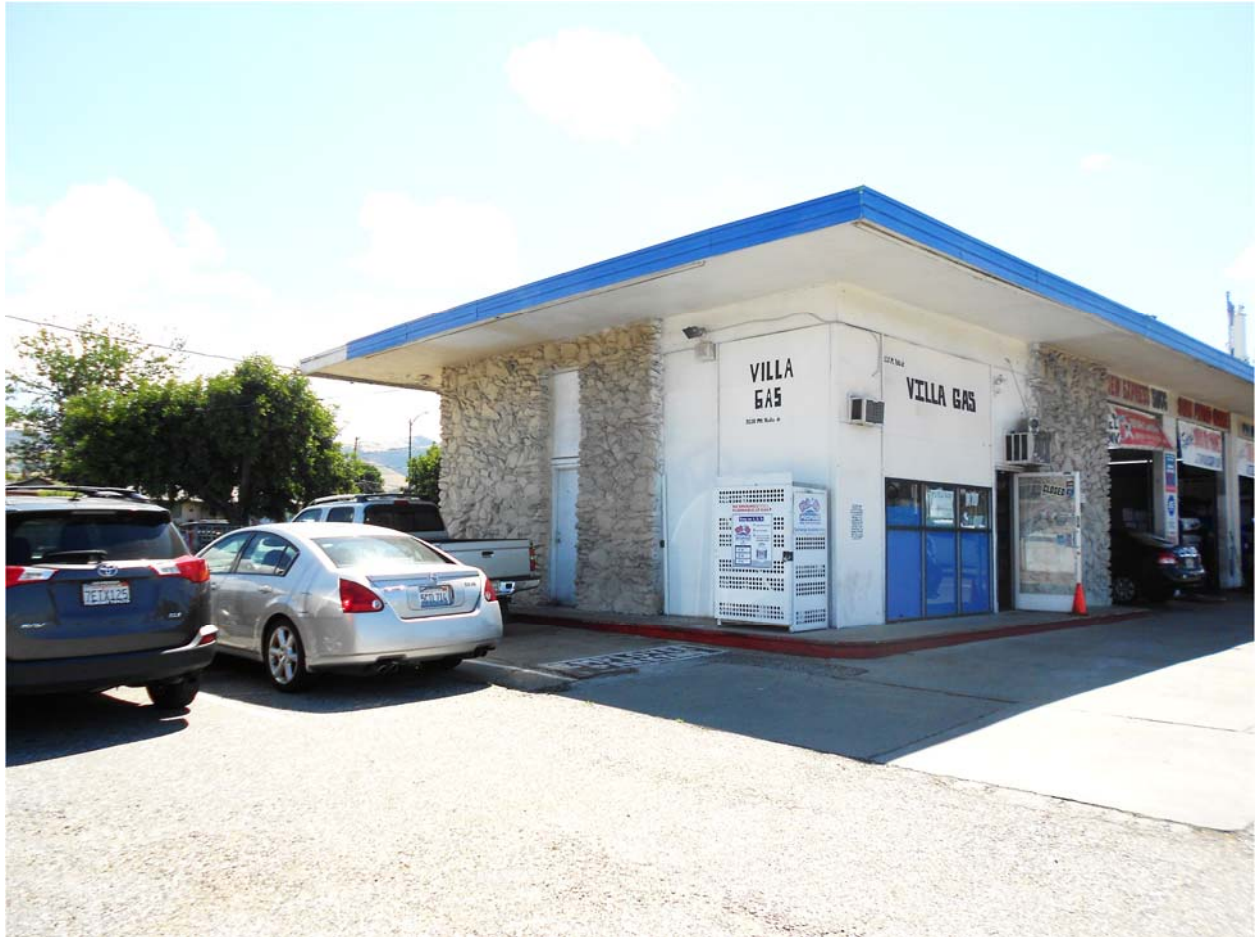
Photograph 2 3110 Mt. Vista Dr. San Jose
View: North and front façade facing S. White Road (1414 S. White Road)
showing the broad overhanging eave, and solid walls of the office
(right) and painted stucco-stone panels.
Date: June 8, 2017
Camera facing: Southeast

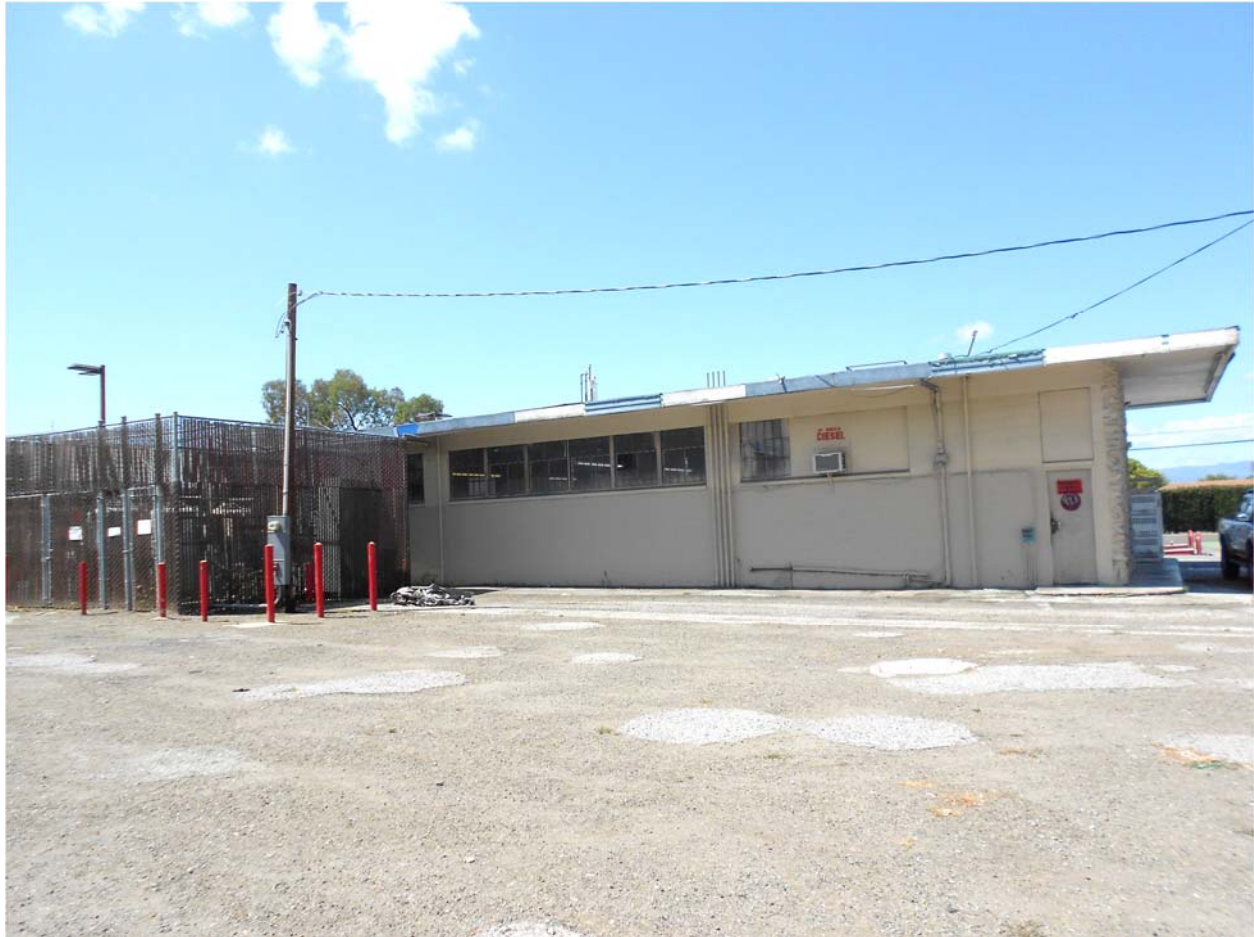
Photograph 3 3110 Mt. Vista Dr. San Jose

View: Ease (rear) façade showing industrial windows into the garage bays and the environmental extraction equipment enclosed in a chain link area.

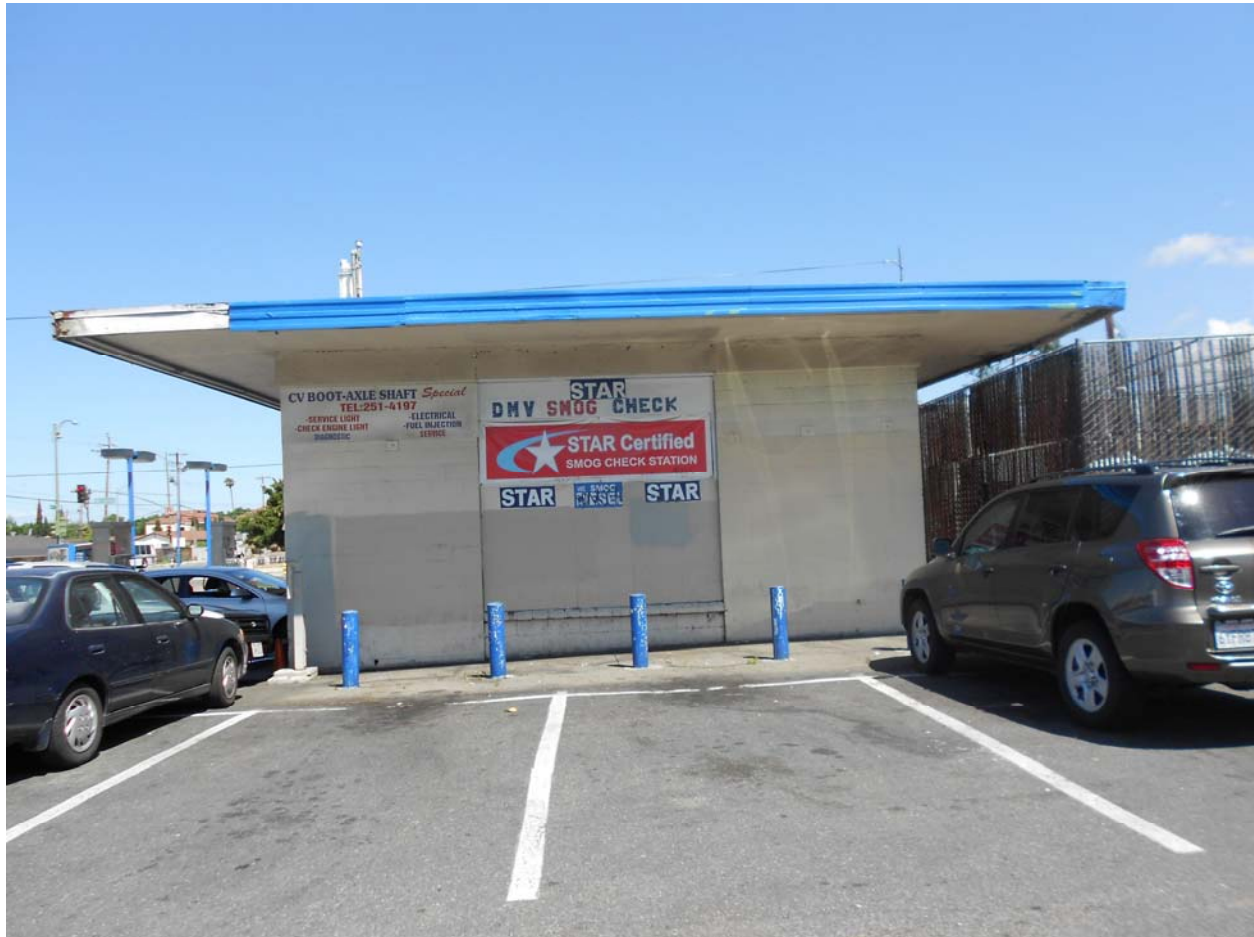
Photograph 4 3110 Mt. Vista Dr. San Jose
View: South end façade showing blanked in wall broad overhanging eaves.
Date: June 8, 2017
Camera facing: north

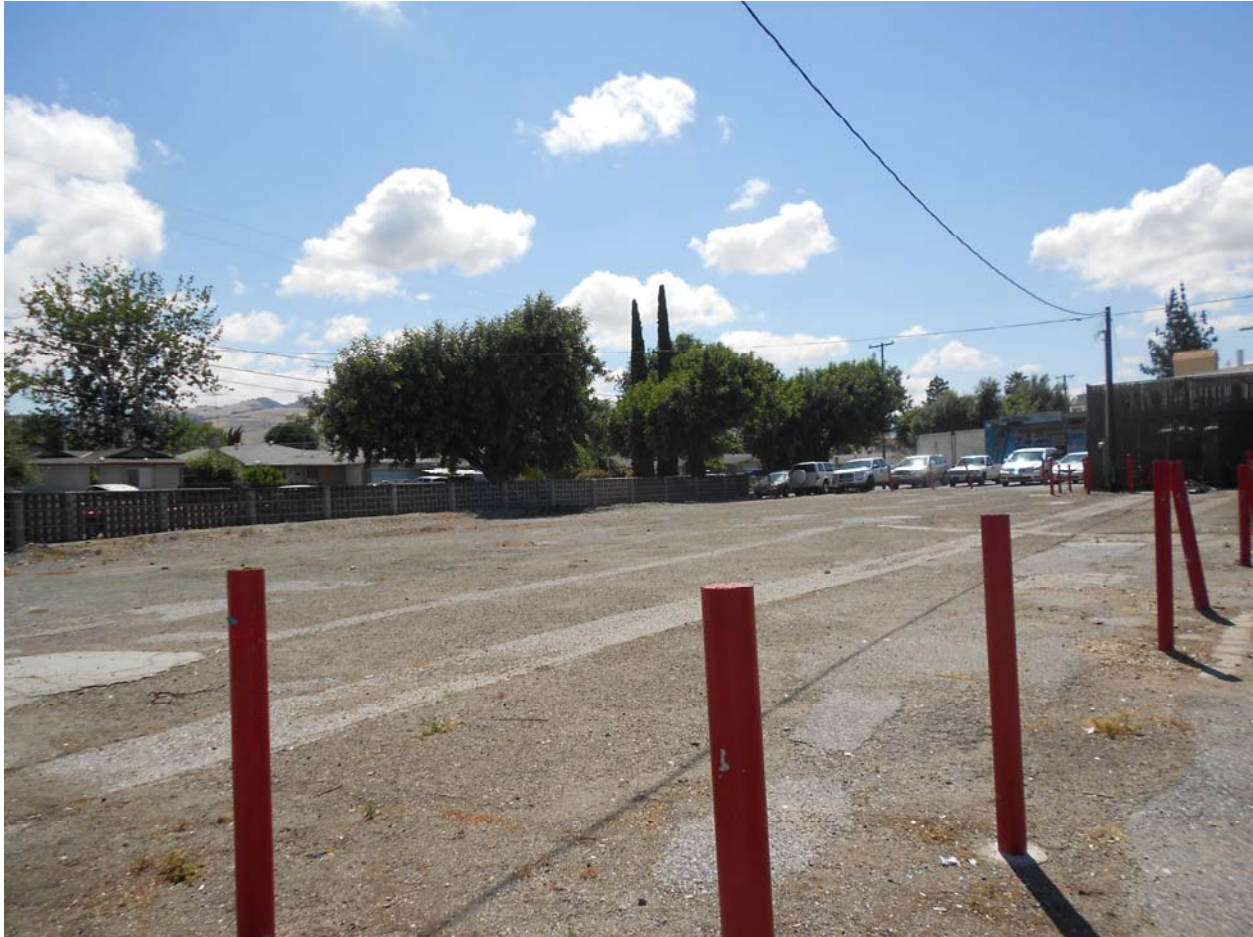
Photograph 5 3110 Mt. Vista Dr. San Jose
View: east vacant lot behind the gas station building.
Date: June 8, 2017
Camera facing: Southeast

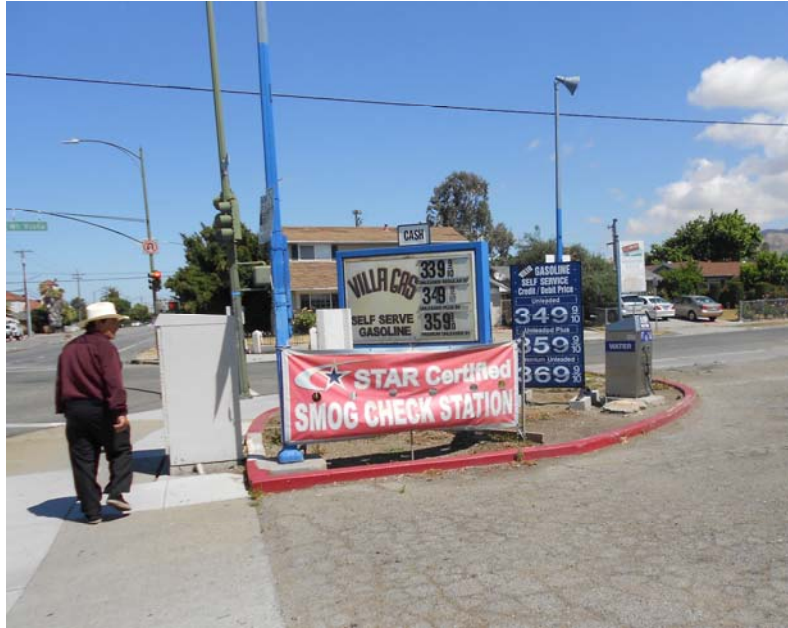
Photograph 6
3110 Mt. Vista
Dr. San Jose
View: Corner of
S. White Rd and
Mt. Vista Dr.
Sign and
landscape corner
of the station.
Date: June 8, 2017
Camera facing:
north

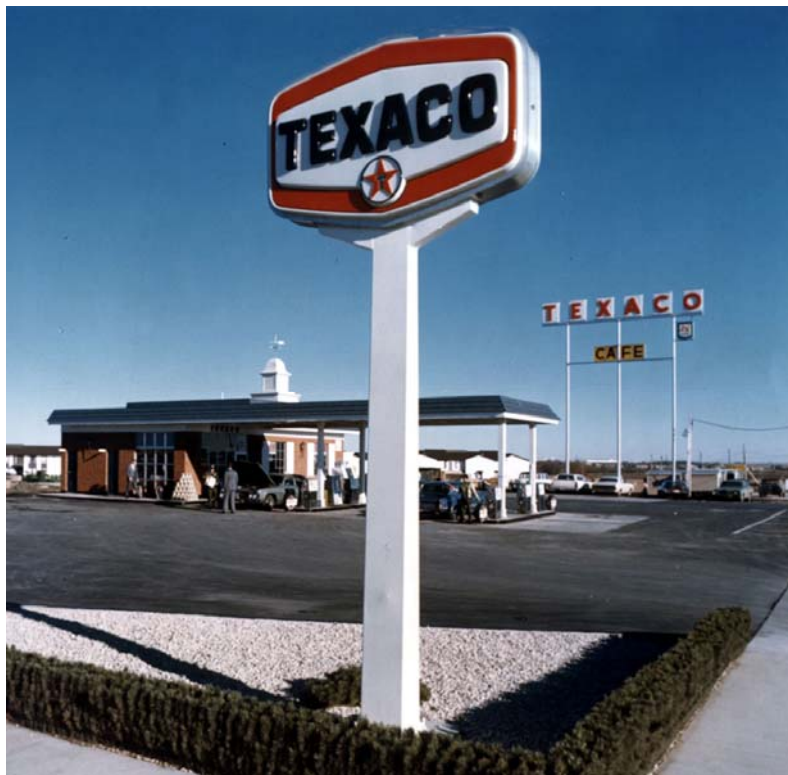
Historic image c.
1970s
View: Texaco Service
Station with similar
plan building and
front canopy

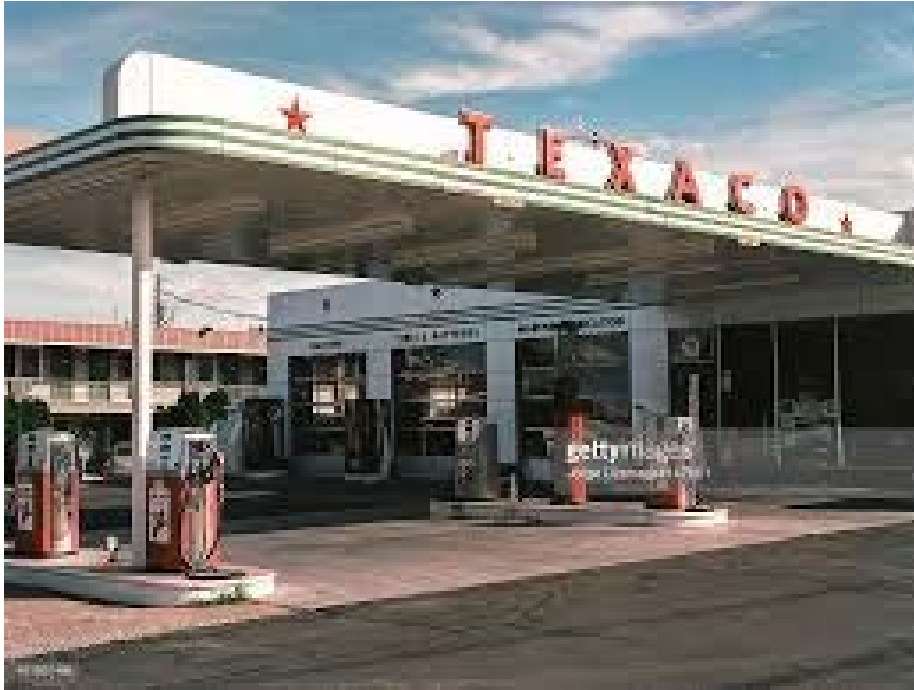
Historic image c.
1955-60
View: Texaco
Service Station
with similar plan
building
(reversed) and
earlier canopy
design

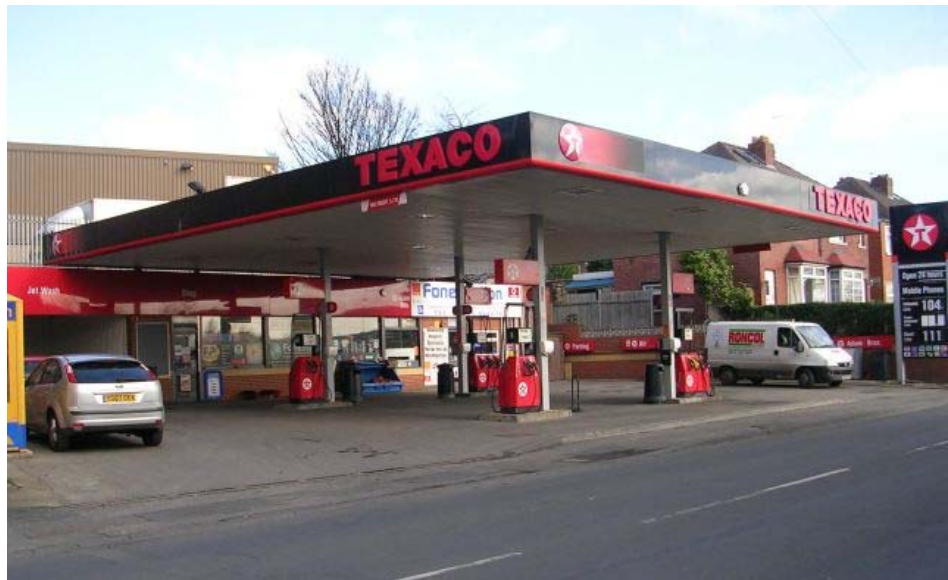
Texaco Station
c. 1990.

View: Modern
Texaco Corporate
canopy design
