Arco Gas Station Project (File No. CP14-056) Draft Initial Study

3010 Mt. Vista Drive, San Jose, California

Prepared for City of San José, Department of Planning, Building, and Code Enforcement

> > March 3, 2016

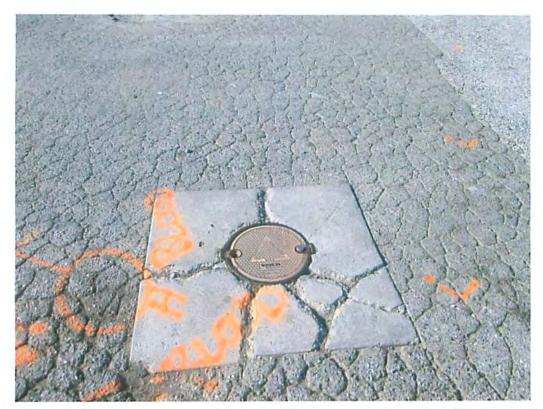
Photo 5: Looking at one of the existing groundwater monitoring wells

Soil and groundwater investigations, beginning in 1991, have indicated that the original USTs have leaked resulting in the contamination of the soil and groundwater. These contaminants include gasoline, diesel, benzene, gasoline, benzene, gasoline, methyl tertiary butyl ether (MTE), other fuel oxygenates, toluene, and xylene. As of October 28, 2015 this site has been an open remediation site, under the regulatory oversight by the Santa Clara County Department of Environmental Health.

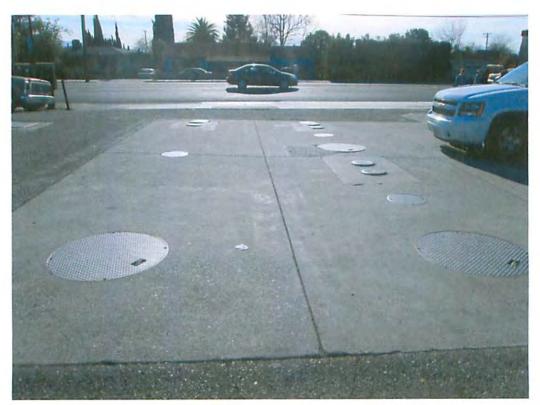
Photo 10: Looking at the underground storage tanks location on the property

The project site is currently occupied by a gas station that is approximately 55 years old. Given the age of the structures on-site, it is likely that they would contain hazardous building materials such as lead paint and asbestos. The site is also located within a predominately residential area, with single-family residences to the north, east, and west and a single story commercial strip mall to the southeast. According to the May 2015 Phase I Environmental Site Assessment (see Attachment 4), the site was used for agricultural purposes, between the 1920s and 1960s. The property has been occupied by a gas station since 1960 and contains several underground storage tanks (USTs) containing petroleum products. The original six USTs were removed in 1992 and replaced with the current underground tanks, one 8,000-gallon tank and two 6,000-gallon tanks that store gasoline.

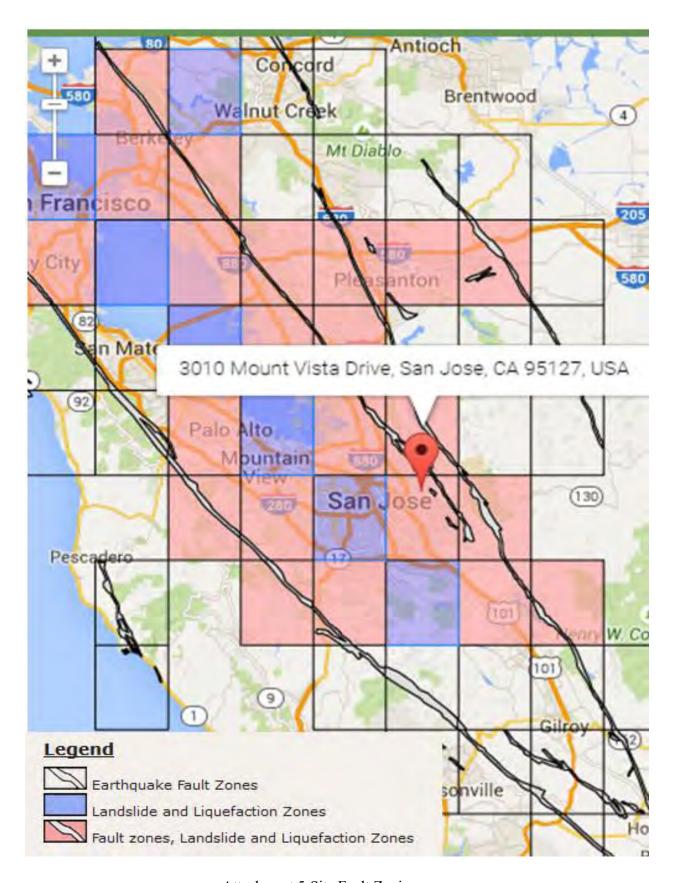
Attachment 5-Site Fault Zoning map

No Impacts. There is no known fault crossing the project boundary. The site is not located in a designated Alquist-Priolo Earthquake Fault Zone, which indicates areas that structures occupied by human cannot be constructed. The project will not have any surface fault rupture.

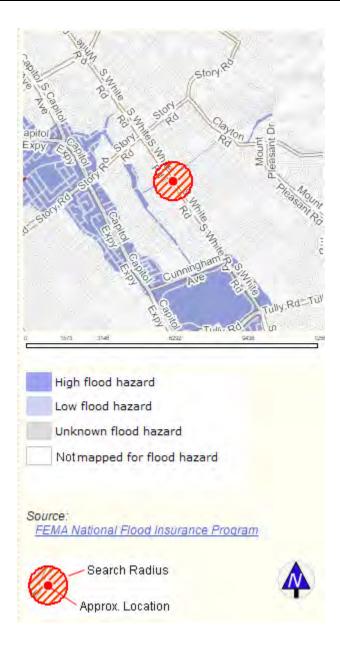
Attachment 6- Project Flood Insurance Rate Map (FIRM)
