Type of Services	Risk Management Plan
Location	DCP Alma 1402 Monterey Highway San Jose, California
Client	DOWNTOWN COLLEGE PREP FACILITIES 2, LLC
Client Address	1400 Parkmoor Avenue, Suite 206 San Jose, California 96126
Project Number	687-2-2
Date	March 17, 2016

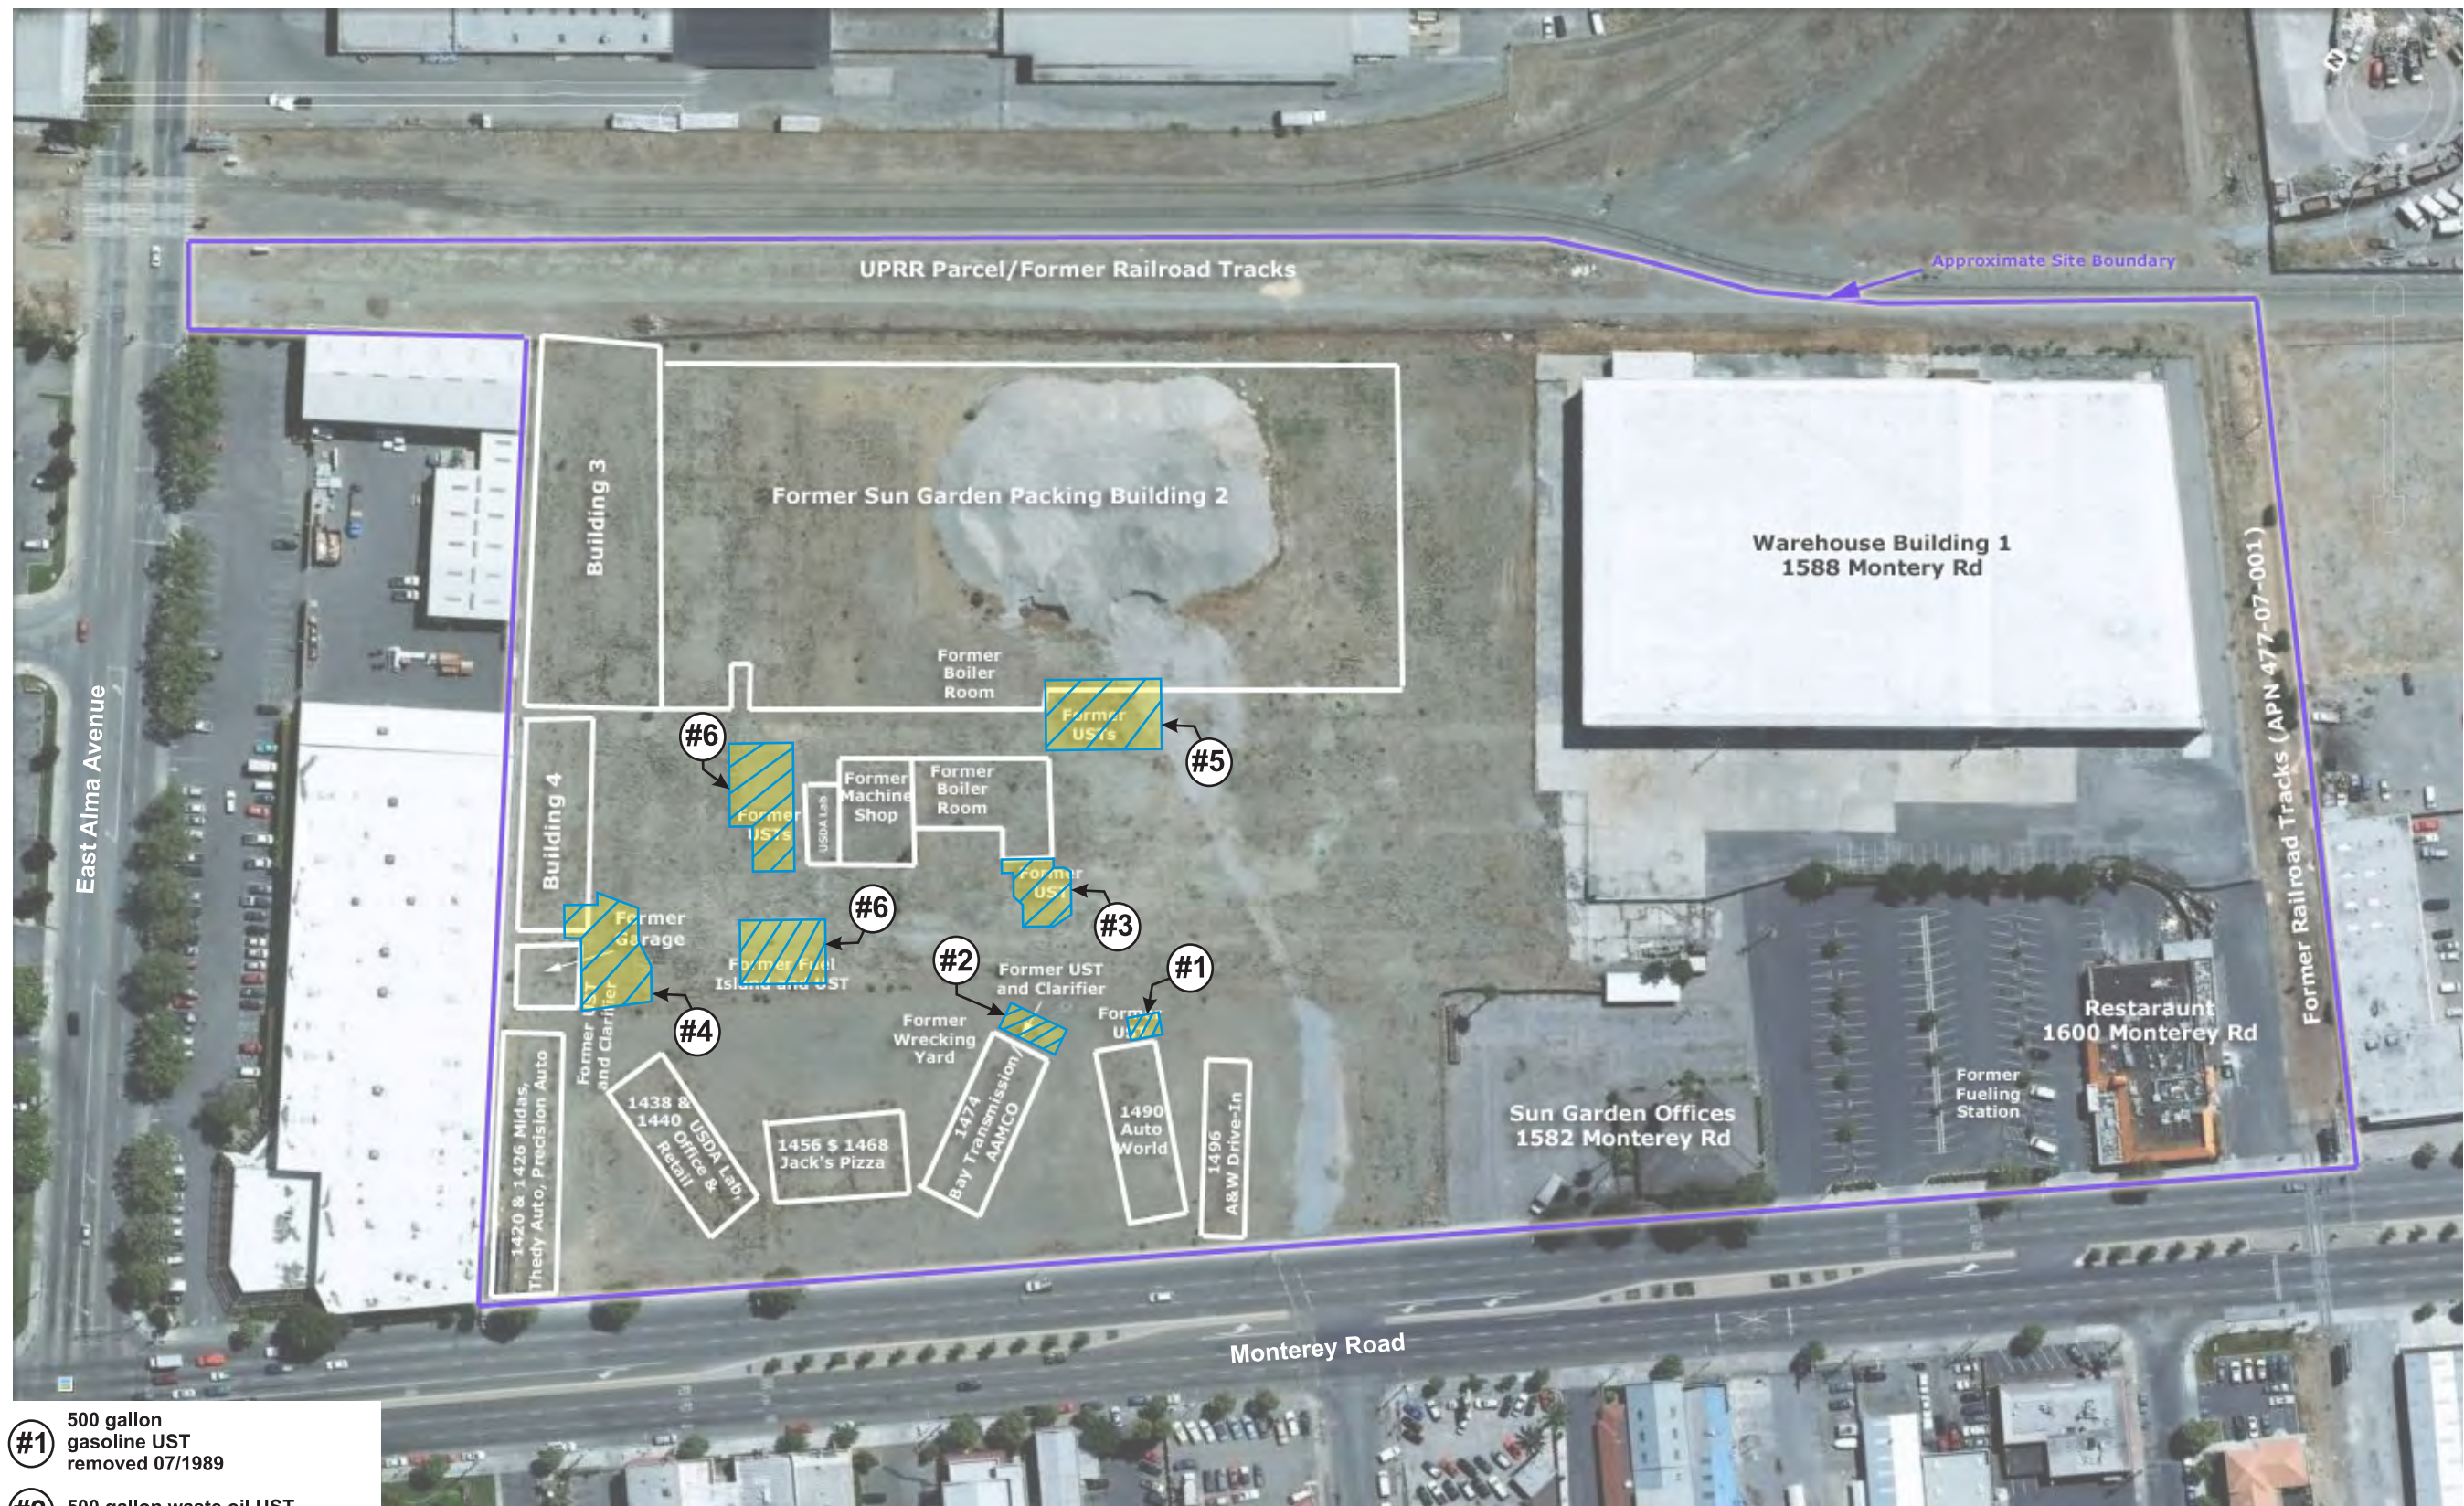
- #1 500 gallon gasoline UST removed 07/1989
- #2 500 gallon waste oil UST removed 07/1989
- #3 8000 gallon fuel oil UST removed 12/1997
- #4 300 gallon unknown fuel UST and OWS removed 12/1997
- #5 Two 5,000 gallon fuel oil USTs removed 07/2002
- #6 Five 1,200 gallon diesel and one 1,200 gallon gasoline USTs removed 01/1991
