**ALUM ROCK PARK  
HISTORIC RESOURCES REPORT**

**SAN JOSÉ, SANTA CLARA COUNTY, CALIFORNIA**

**ALUM ROCK PARK**  
**HISTORIC RESOURCES REPORT**  
SAN JOSÉ, SANTA CLARA COUNTY, CALIFORNIA

LSA Project #SJO0703

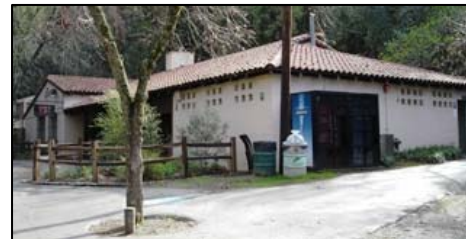
Figure 14: Youth Sciences Institute (LSA)

**Youth Science Institute.** The Youth Science Institute (YSI) is a Spanish Revival inspired building of concrete built in 1936 as a Lodge. In 1953 it became the Santa Clara Junior Museum. By 1958, the building became the YSI. The building is currently used as an education facility. The YSI is in good condition and is a contributor to the Alum Rock Park Historic District.

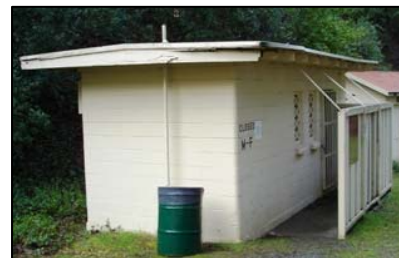
Figures 15 & 16: Restroom #1 (LSA)

*Restroom Building 1* is a rectangular building of cinder-block masonry construction that appears to have been built in the late 1950s or early 1960s. The architectural style is not unique and other examples can easily be found elsewhere, the decorative window treatments parallel the character-defining features of the Youth Science Institute and older restrooms. This restroom is in fair to good condition, but due to an apparent lack of sufficient age, it is not a contributor to the Alum Rock Park Historic District.

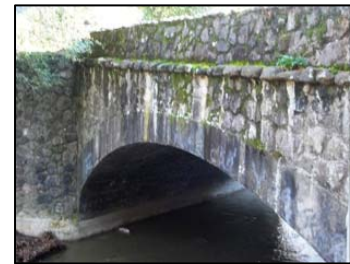
**Figure 24: Automobile Bridge #1 (LSA)**

*Automobile Bridge 1* is a two-lane, single span masonry rock and concrete arch bridge built in 1909 and conveys Penitencia Creek Road over Penitencia Creek. The architectural style is unique as an early example of *Park Rustic* style and the local stone quarried nearby and concrete used in its construction, and rough masonry styling influenced the Park’s later bridge design. This bridge is a contributor to the Alum Rock Historic District and also appears individually eligible for listing in the National Register, the California Register, and the City of San José’s HRI at the local level of significance as a City Landmark as an important example of early bridge design.

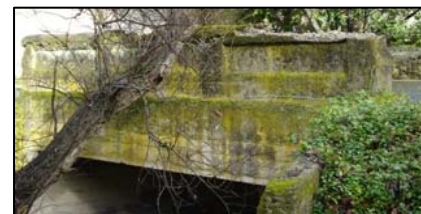
**Figure 25 Automobile Bridge #2 (LSA)**

*Automobile Bridge 2* is a two-lane flat concrete beam bridge built in 1911-1912 and carries Penitencia Creek Road over Penitencia Creek near its junction with Alum Rock Avenue. This bridge has diminished structural integrity due to extensive damage along the top railing. The bridge is not a contributor to the Alum Rock Historic District and does not appear eligible for listing in a historical register or inventory.

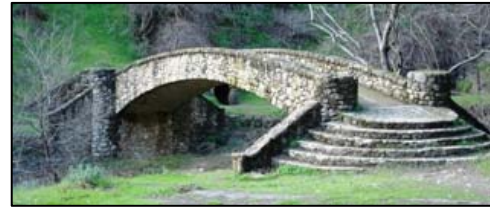
**Figure 30: Pedestrian Bridge #1 (LSA)**

*Pedestrian Bridge 1* is a distinctive concrete and masonry arch bridge that carries pedestrian traffic over Penitencia Creek to the mineral spring grottos on both sides of the creek. This bridge is in excellent condition and is a contributor to the Alum Rock Historic District and appears eligible for individual listing in the National Register, the California Register, and the City of San José's HRI at the local level of significance as an important example of early bridge design.

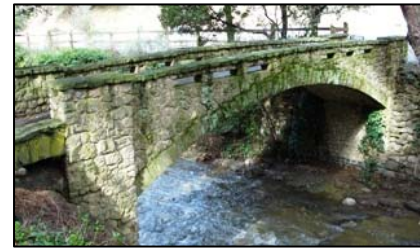
**Figure 32: Pedestrian Bridge #3 (LSA)**

*Pedestrian Bridge 3* is a distinctive concrete and masonry single-span arch bridge that carries pedestrian traffic from the parking lot over Penitencia Creek to the central Park area. This bridge features unique repeating triple narrow rectangular guard rail accents on both sides of the arch which is topped with parapet stones. This bridge is in very good condition and is a contributor to the Alum Rock Historic District and appears eligible for individual listing in the National Register, the California Register, and the City of San José's HRI at the local level of significance as an important example of early bridge design.

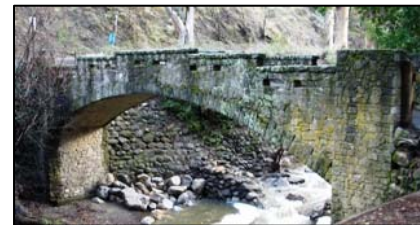
**Figure 33: Pedestrian Bridge #4 (LSA)**

*Pedestrian Bridge 4* is a distinctive concrete and masonry single-span arch bridge that carries pedestrian traffic from the parking lot over Penitencia Creek to the central Park area. This bridge features unique repeating double narrow rectangular guard rail accents on both sides of the staggered arch which is topped with parapet stones. This bridge is in very good condition and is a contributor to the Alum Rock Historic District and appears eligible for individual listing in the National Register, the California Register, and the City of San José's HRI at the local level of significance as an important example of early bridge design.

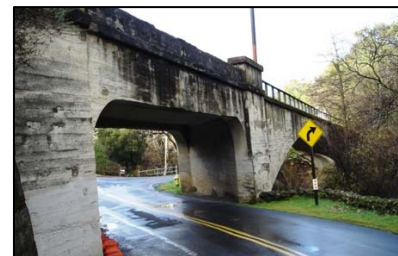
**Figure 34: Pedestrian Bridge #5 (LSA)**

*Pedestrian Bridge 5* is a reinforced concrete bridge built by the Southern Pacific Railroad in 1911-1912 to carry standard-gauge rail cars over Penitencia Creek and Alum Rock Avenue. This bridge is made of two unequal-length arches joined with a central pier. Alum Rock Avenue passes under the shorter, stout, flat arch, while Penitencia Creek flows underneath the longer, more graceful closed spandrel span. This bridge is the largest in the Park. The rails and related equipment were removed in the 1930s and the bridge and former railroad is currently used as a trail.

This bridge is in good condition and is a contributor to the Alum Rock Historic District and appears eligible for listing in the National Register, the California Register, and the City of San José’s HRI at the local level of significance as an important example of early bridge design.

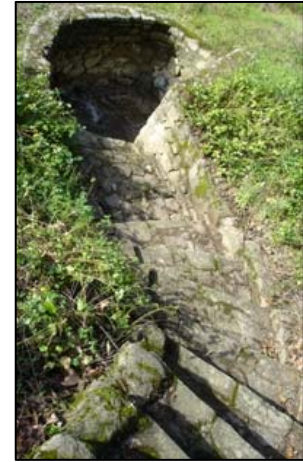
**Figure 35: Clamshell Reservoir (LSA)**

*Clamshell Reservoirs* are open-air masonry features containing sulphur springs and are located in the flat areas on both sides of Penitencia Creek. These reservoirs are in very good condition and are contributors to the Alum Rock Historic District.

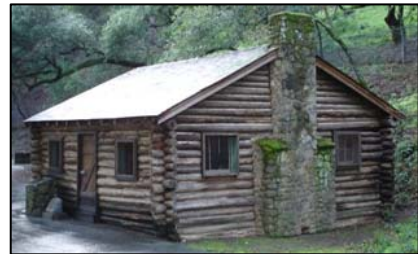
Figure 40: Log Cabin (LSA)

**Log Cabin.** Built in 1916 and dedicated by the Vendome Parlor of the Native Daughters of the Golden West to commemorate pioneers, this rectangular, one-story side-gabled log cabin is near a picnic area south of the former Natatorium. The cabin is listed on the City of San José Historic Resources Inventory as a certified City Landmark Structure. This building is a contributor to the Alum Rock Historic District.

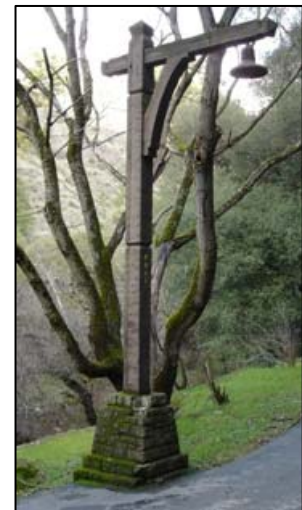
**Figure 45: Lampposts (LSA)**

**Lampposts.** Wooden lampposts within the Park were hand-hewn by Civilian Conservation Corps workers during the Great Depression. There are 26 remaining individual lamppost sites and are situated at locations along the main path throughout the central Park and Mineral Springs areas. Individually, these lampposts are in various stages of condition, but collectively they are contributors to the Alum Rock Historic District and appear eligible for listing in the National Register, the California Register, and the City of San José's HRI at the local level of significance as a City Landmark as an important example of unique woodwork design and craftsmanship from the Great Depression-era public works programs.

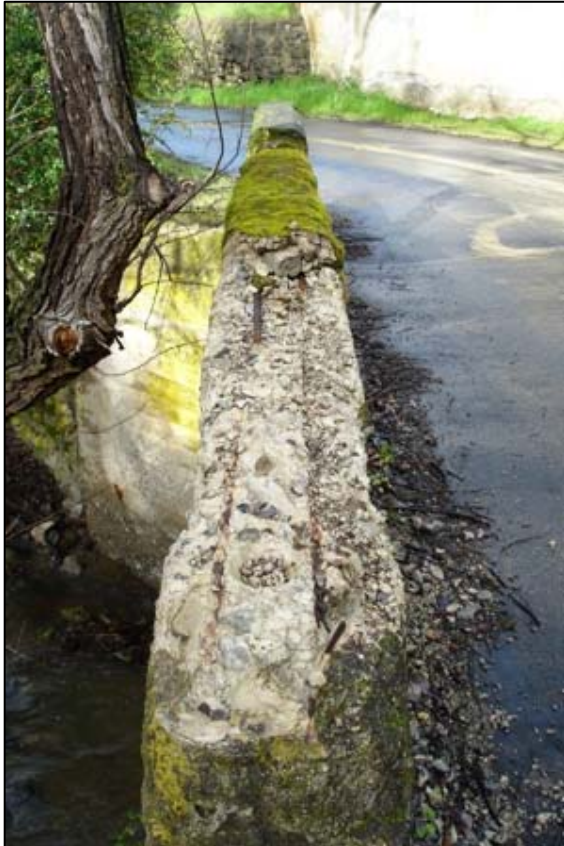
Northwest view of damaged railing.

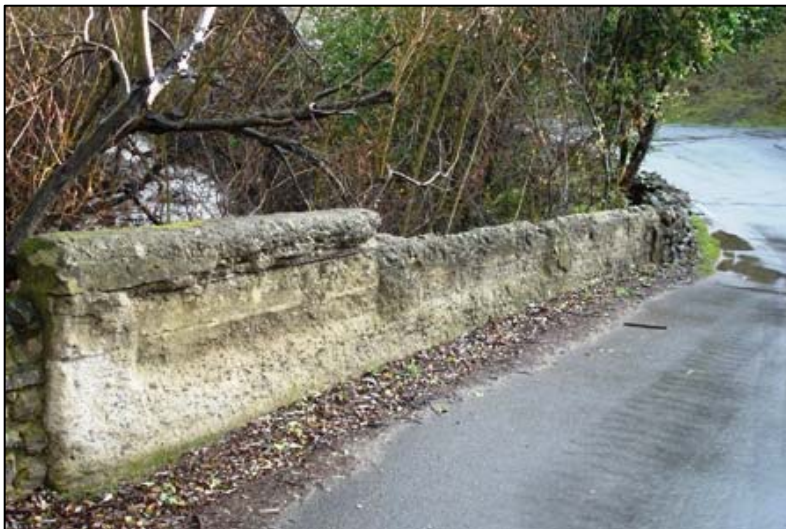
View of damaged railing. View west.

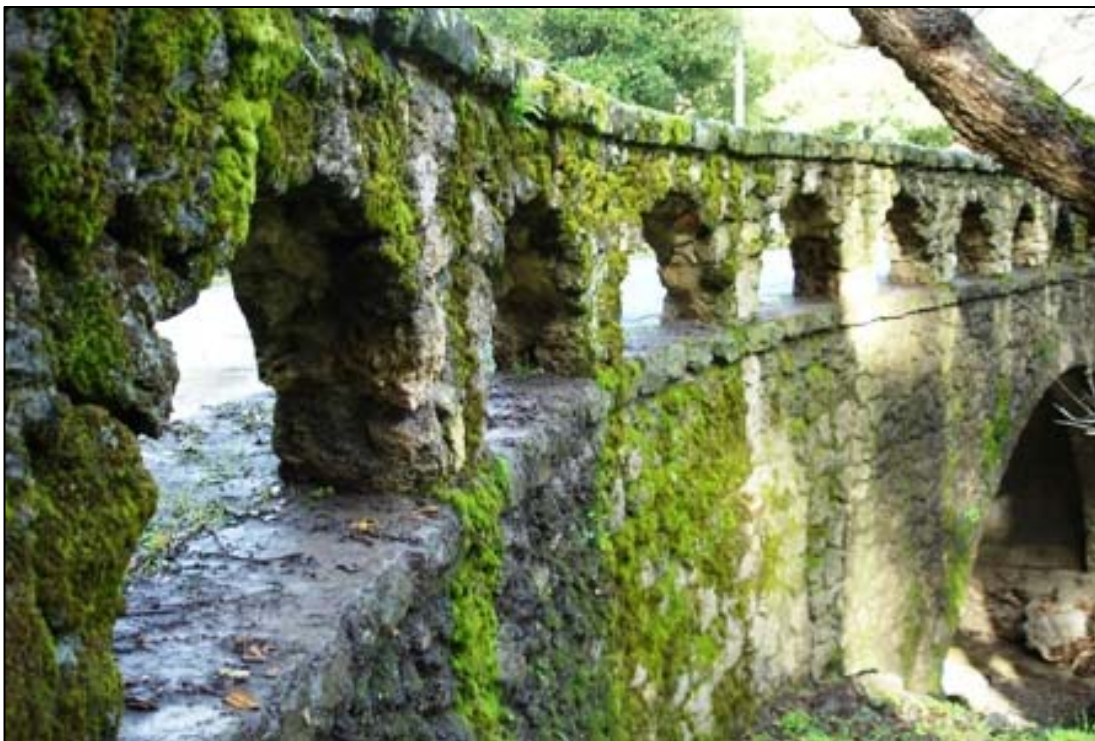
Detail view of Rustic stone masonry finish and arch design motif. View NW.

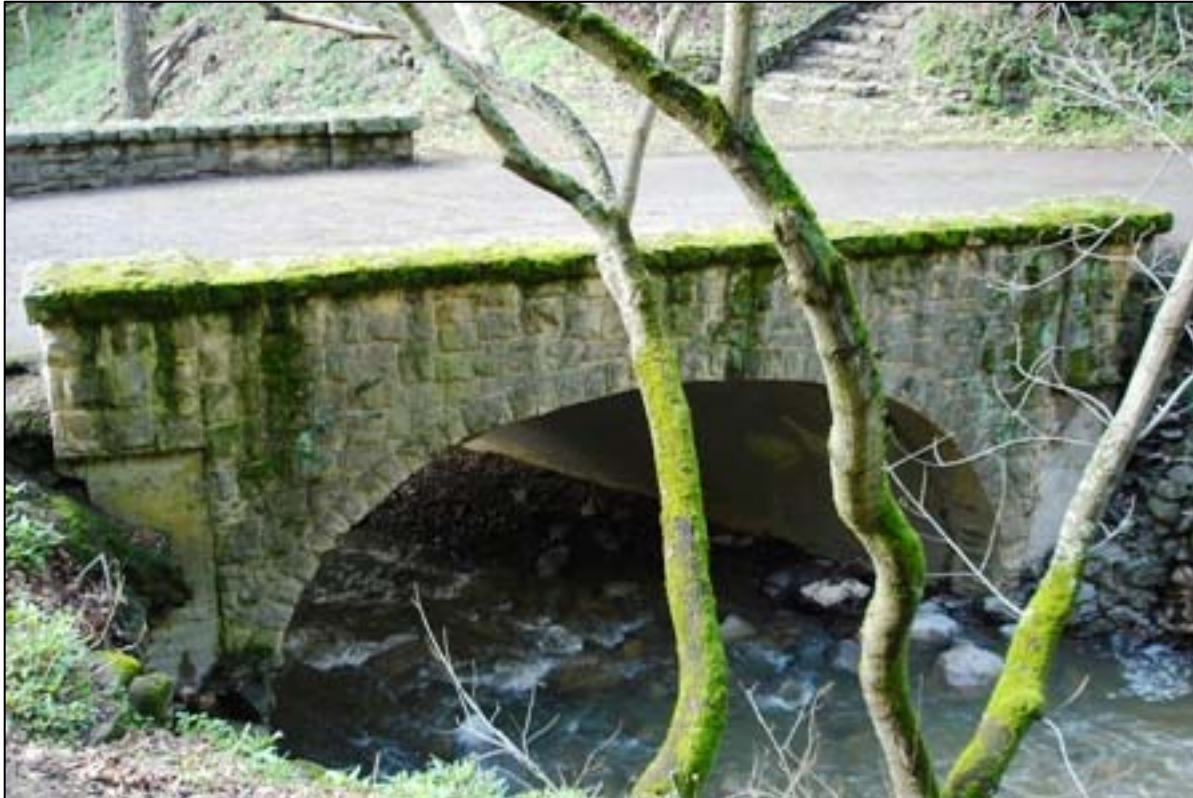
Automobile Bridge 6. View to the NE. Note piece of faux-ashlar finish missing from left abutment.

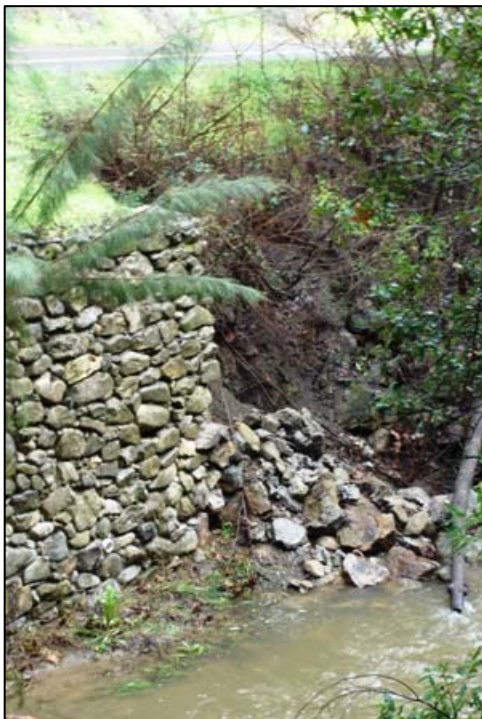
Failing masonry wall, north bank Penitencia Creek Alum Rock Falls Road in background. View Northeast.

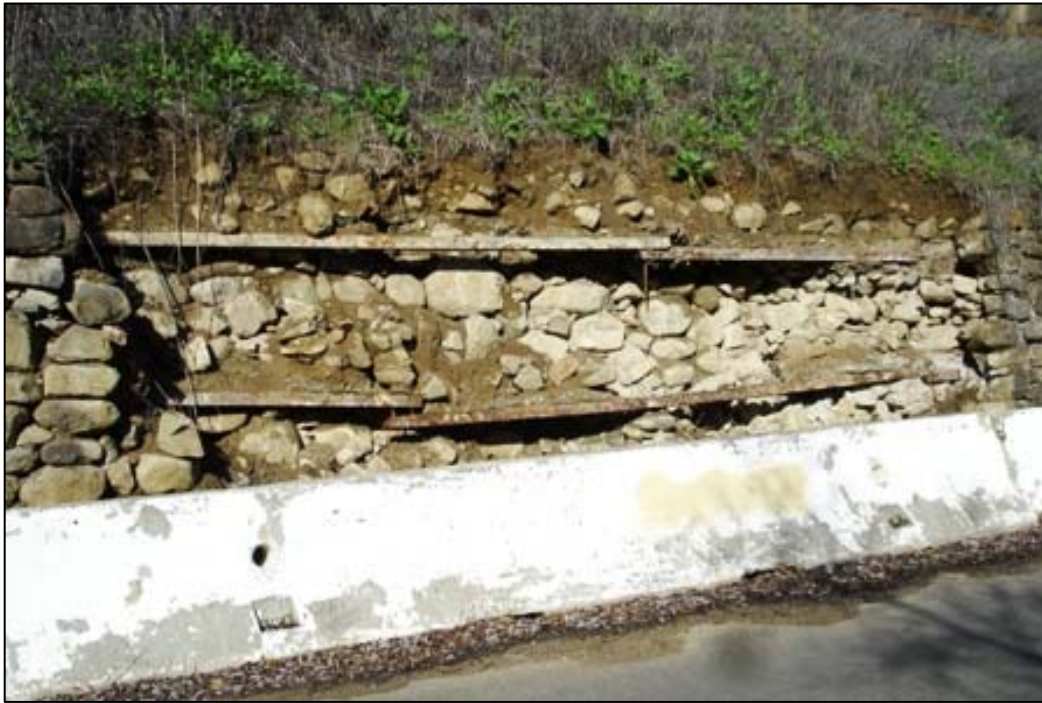
Damaged sections of masonry retaining wall along Penitencia Creek Road. View NE. Note use of former railroad rails as reinforcement.

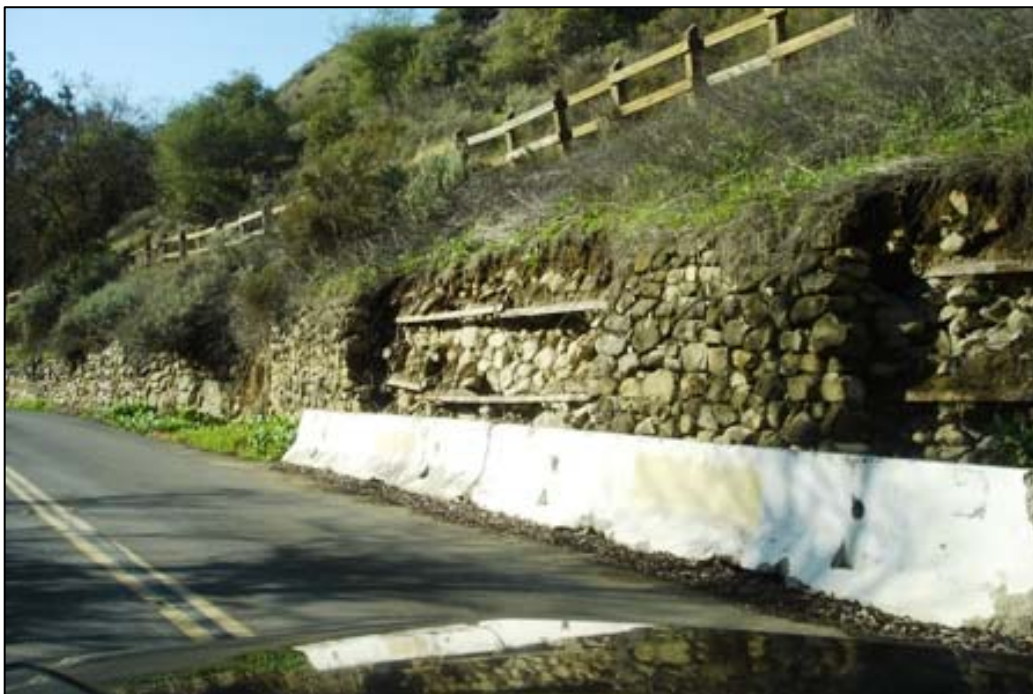
Damaged sections of masonry retaining wall along Penitencia Creek Road. View NW. Note use of former railroad rails as reinforcement.

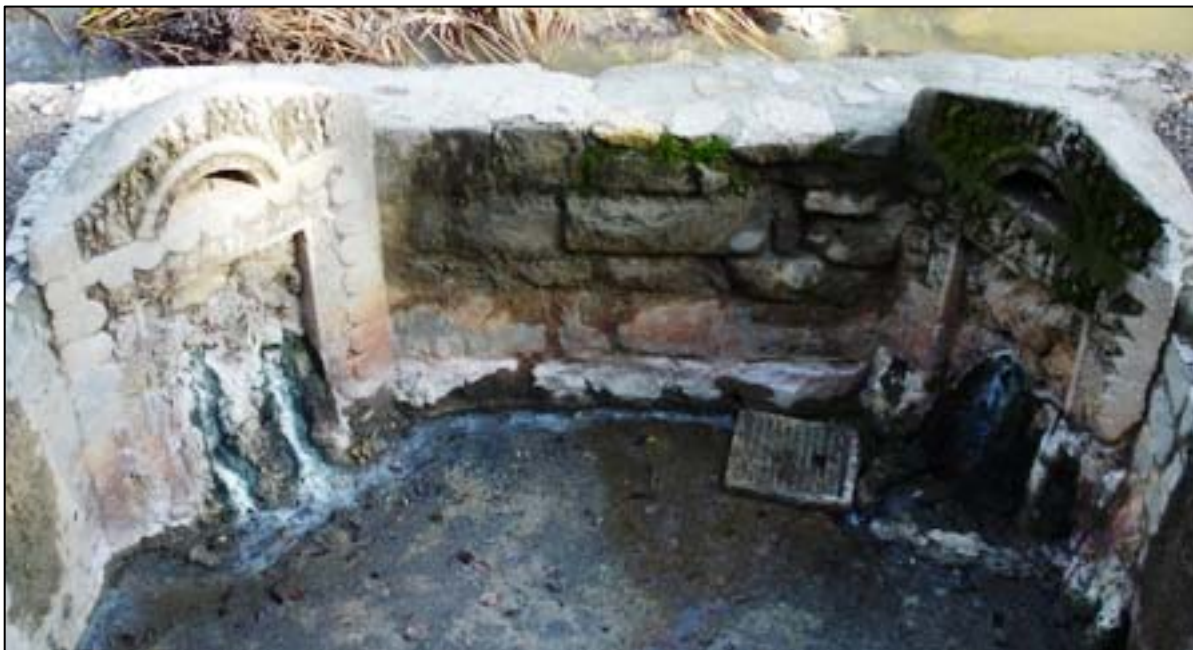
Clamshell reservoir.  
Decorative springboxes.  
View south.  
Penitencia Creek on other side of reservoir wall at top of image.

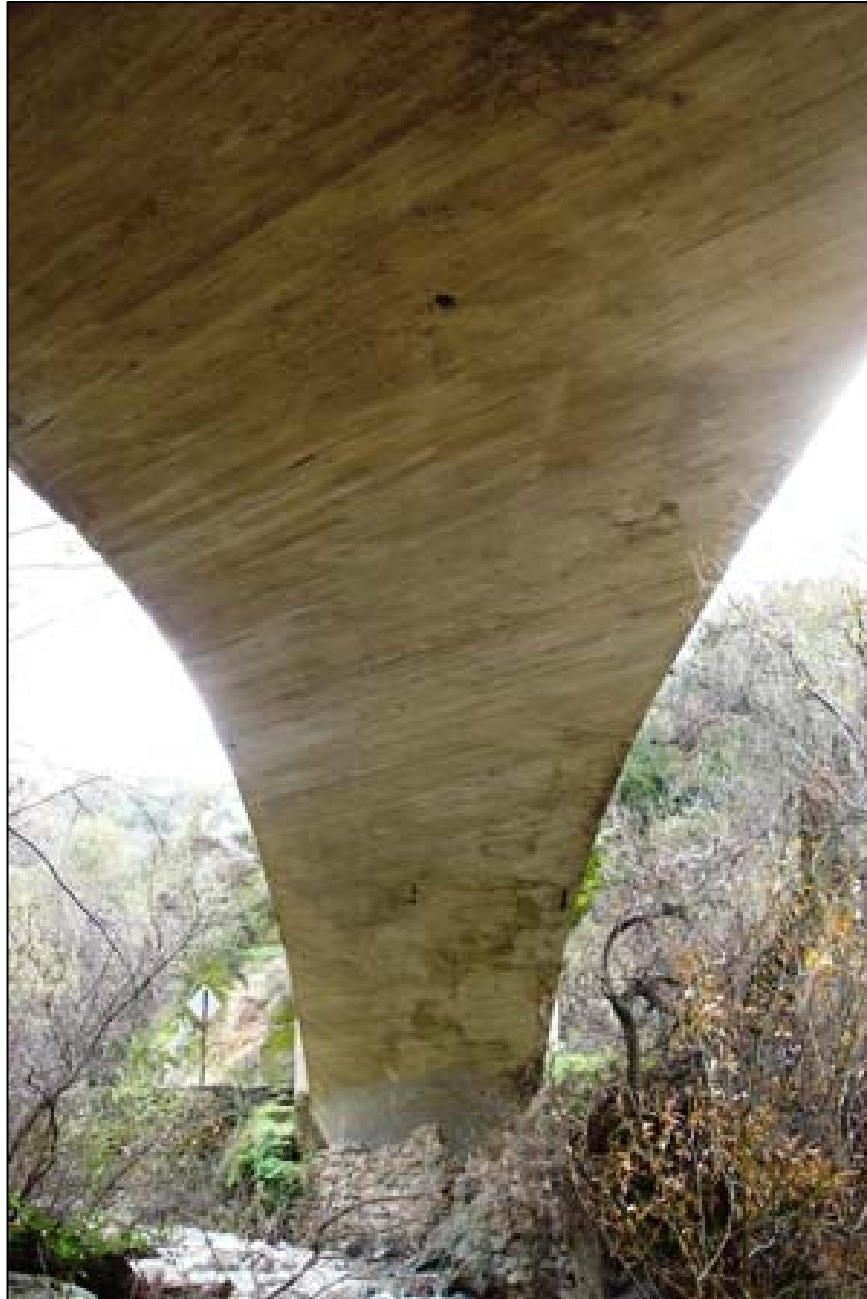
Pedestrian Bridge 5. Underside of Penitencia Creek arch span. View to the south.
