# Capital Improvement Program

## Monthly Status Report: September 2018

November 1, 2018

This report summarizes the progress and accomplishments of the Capital Improvement Program (CIP) for the San José-Santa Clara Regional Wastewater Facility (RWF) for September 2018.

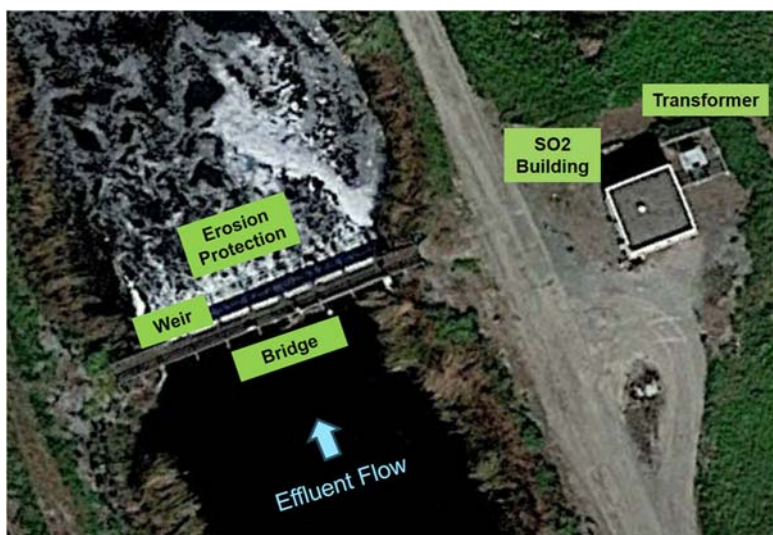
Figure 4: Project Site Map

This project has six components: (1) replacement of the footbridge above the outfall weir; (2) relocation and replacement of an electrical transformer located adjacent to the sulfur dioxide (SO<sub>2</sub>) building; (3) bolstering erosion protection along the downstream face of the outfall weir; (4) replacement of pH and dissolved oxygen probes on the footbridge; (5) replacement of the outfall pipes flow meters; and (6) provision of fiber optic communications to critical instrumentation from outfall bridge area to the main facility.
