TYPE OF SERVICES	Phase I Environmental Site Assessment
LOCATION	333 and 355 West San Fernando Street San Jose, California
CLIENT	W-S-D, A California Partnership and Park Center Supreme Court, Ltd., a California Limited Partnership
PROJECT NUMBER	510-25-1
DATE	February 26, 2016

Type of Services	Phase I Environmental Site Assessment
Location	333 and 355 West San Fernando Street San Jose, California
Client	W-S-D, A California Partnership and Park Center Supreme Court, Ltd., a California Limited Partnership
Client Address	99 Almaden Boulevard, Suite 565 San Jose, California 95113
Project Number	510-25-1
Date	February 26, 2016

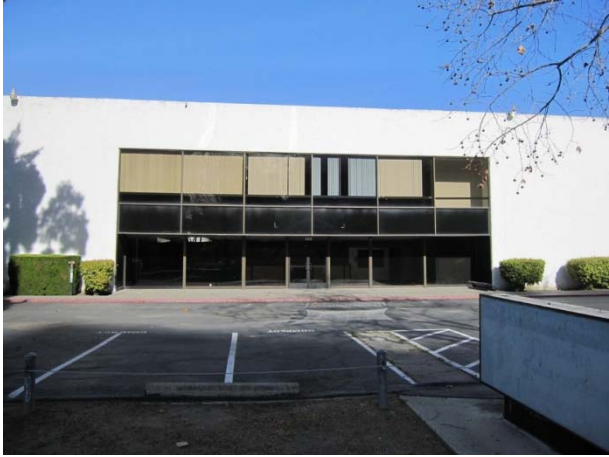
Photograph 1. View of the on-Site building looking north.

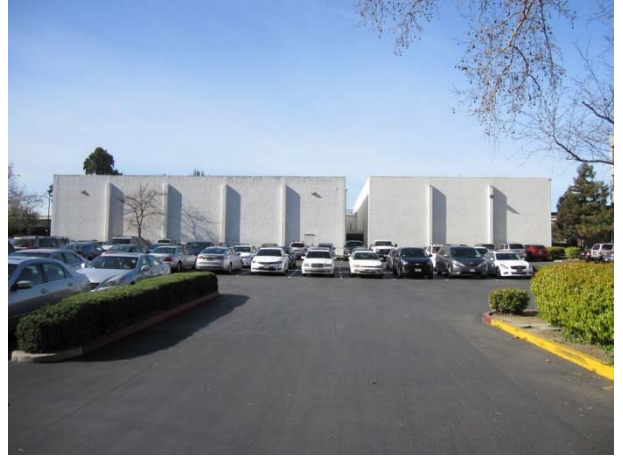
Photograph 2. East side of the on-Site building and on-Site parking lot, looking west.

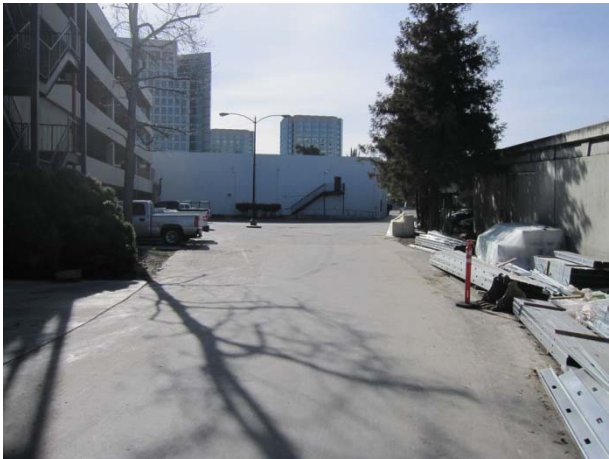
Exterior areas of the Site consisted mainly of asphalt paved parking areas. The northern portion of the Site was observed to be used for construction staging purposes and contractor parking associated the construction of an adjacent hotel.

Photograph 3. Northern portion of the Site, looking south toward the on-Site building.

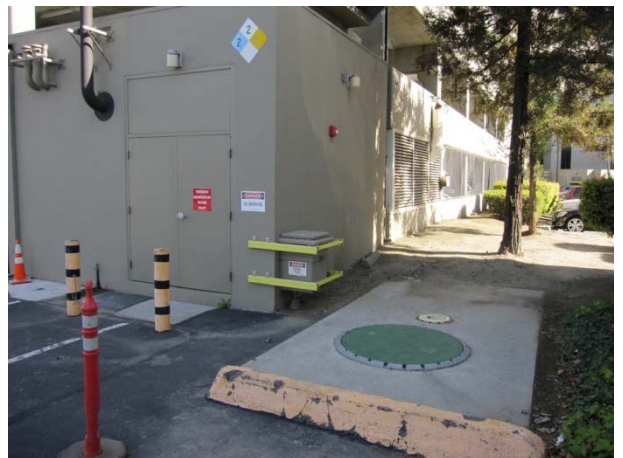
A diesel UST was observed between the on-Site building and the northerly adjacent multi-story parking garage. The UST appeared to be associated with a Verizon emergency generator room located within the southwest corner of the off-Site garage. The UST, as depicted on Figure 2, was observed to be located mainly on the northerly adjacent property; however, the western end of the UST appeared to encroach onto the Site based on an ALTA survey provided by Ms. Stewart.

Photograph 6. UST (partially on-Site) and off-Site generator room.

A diesel UST is present between the on-Site building and the northerly adjacent multi-story parking garage. The UST appears to be associated with a Verizon emergency generator room located within the southwest corner of the off-Site garage. The UST is located mainly on the northerly adjacent property; however, the western end of the UST encroaches onto the Site. We recommend that the adjacent property owner be contacted and that measures to resolve the encroachment issue be evaluated and implemented to avoid potential impacts to the planned development.

To attempt to obtain additional information regarding the UST, a cursory review of available on-line Fire Department documents was conducted for adjacent addresses. A UST removal report (attached in Appendix F) was identified, which indicates that a 2,000 gallon diesel UST was removed from the location of the existing UST in September 1998 under Fire Department oversight. No staining or other indications of leakage were reported (Ensaf, 1999). Two soil samples collected below the UST were analyzed for total petroleum hydrocarbons as diesel (TPHd); no TPHd was detected. A checklist form attached to the UST removal report indicates that a new 2,500 gallon UST was installed in October 1998, which presumably is the existing UST.
