A P P E N D I X C

HISTORIC RESOURCE
EVALUATION

Primary # P-
HRI #
Trinomial:
NRHP Status Code:
Resource Name or #: Calvelli Building

P3a. Description: This resource is a two-story, Commercial Modern office building completed in 1971. Constructed of concrete block, the building consists of three integrated volumes arranged linearly along E. Gish Road, encompassing the odd street numbers from 111 through 137. The wall plane of the primary facade is broken as the three volumes are set back from each other by four and a half feet. The roof is flat with an unadorned parapet. The first floor of the primary facade is marked by a series of storefront systems comprising swinging glass doors flanked by large glazed panes set in metal frames. Flat, projecting canopies extend above the storefronts on each volume. At the second floor, bands of aluminum slider windows are topped by quarter-round, cloth awnings. The remaining elevations have the same, primarily four-part, window ribbons but lack the cloth awnings. Entries at the rear elevation are recessed with metal-sashed, glass doors.

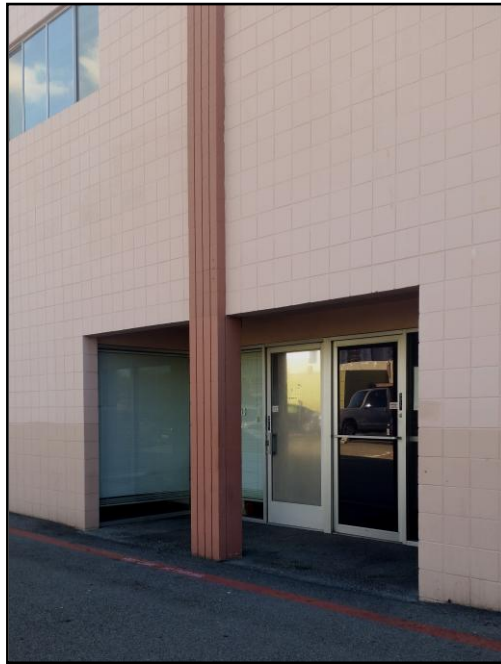
Figure 5. Recessed rear entries.

B6. Construction History: This building was completed in 1971. City of San Jose's permit histories show intended modifications to the interior, but no permits were issued for exterior work. No obvious alterations were noted in the field except for the metal sashing of the entry system at 115 E. Gish and the rear entries, which vary in color from other entries.

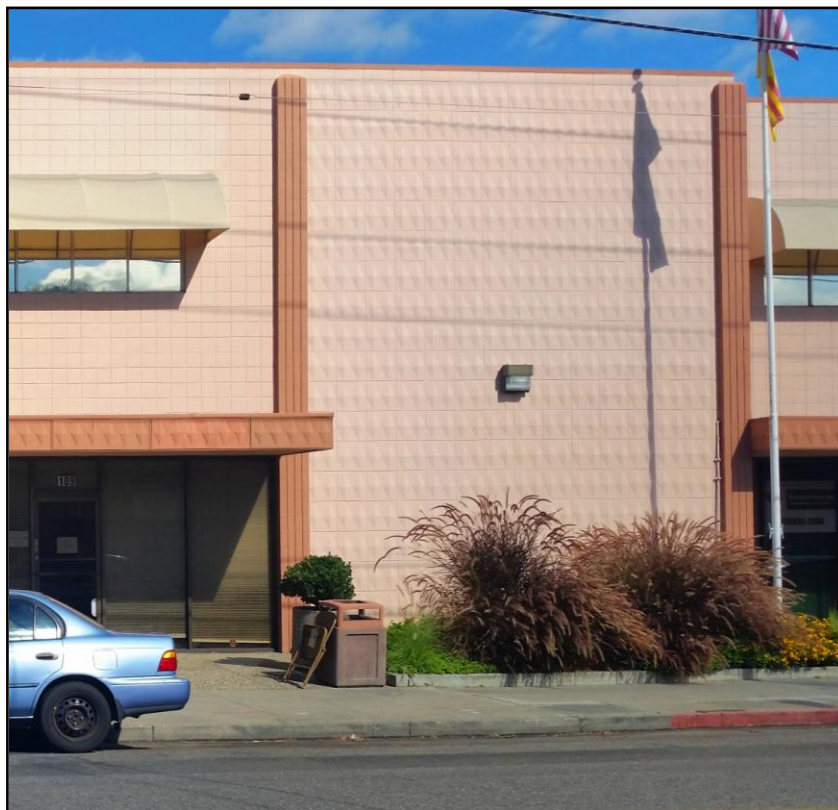
Figure 6. View of the west end of the primary facade showing various geometric patterns.

Geometric surface designs are the chief decorative element of the building. Double-V, shadow blocks are used on the primary facade walls of the east and west volumes to create a diamond motif. The diamond pattern is carried over to the edges of the projecting canopies. Single-scored, concrete blocks create a grid pattern on the remainder of the building. Pilasters are featured at the corners and at regular intervals across all wall planes. (Continued on page 2)
