# San José-Santa Clara Regional Wastewater Facility

## 2019 Annual Self-Monitoring Report

## 2019 Self-Monitoring Annual Report

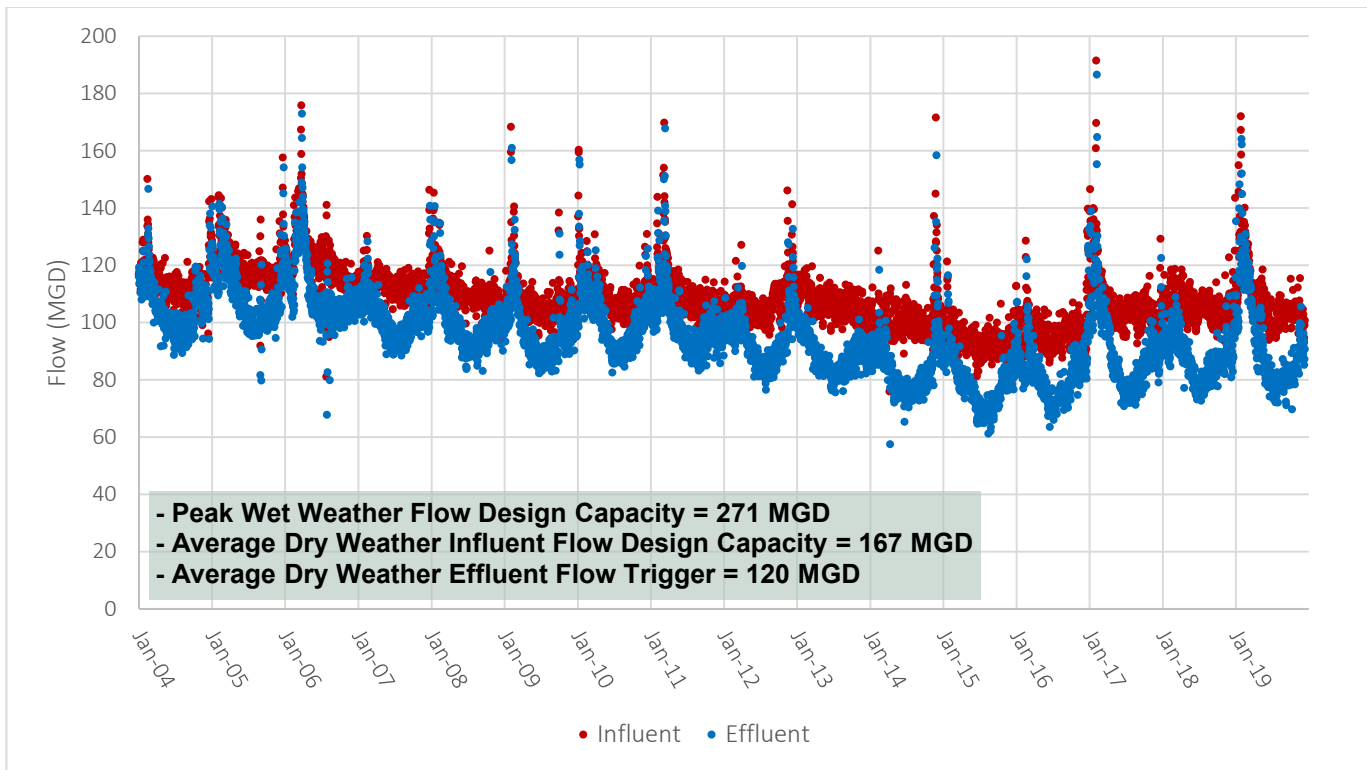
FIGURE 4 GRAPH OF DAILY AVERAGE FLOWS (MGD) 2004-2019

Year	Influent Flow	Effluent Flow			ADWIF Limit = 167 MGD ADWEF Trigger = 120 MGD	
		Low	High	Average	ADWIF	ADWEF
2017	106.9	70.8	186.5	91.3	107.3	77.8
2018	105.5	72.7	122.4	87.6	110.3	79.4
<b>2019</b>	<b>108.6</b>	<b>69.6</b>	<b>164.0</b>	<b>93.2</b>	<b>109.6</b>	<b>79.3</b>

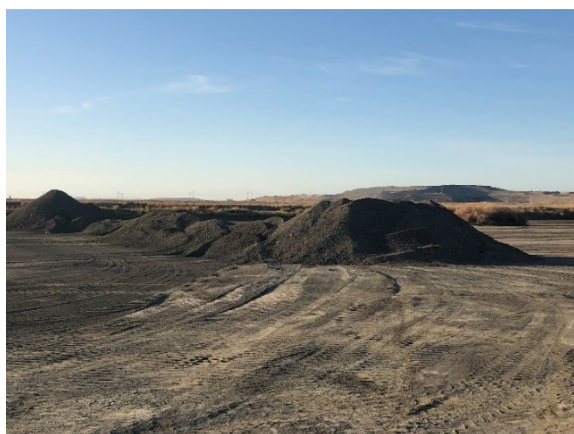
FIGURE 5 BIOSOLIDS SOLAR-DRIED, PILED, AND READY FOR HAULING FOR USE AS ALTERNATE DAILY COVER

Once biosolids have dried to a firmer consistency, the extra horsepower of a CAT D6 or D7 bulldozer is needed. Dried material is trucked to adjacent Newby Island Landfill where biosolids are used as Alternate Daily Cover (Figure 5).

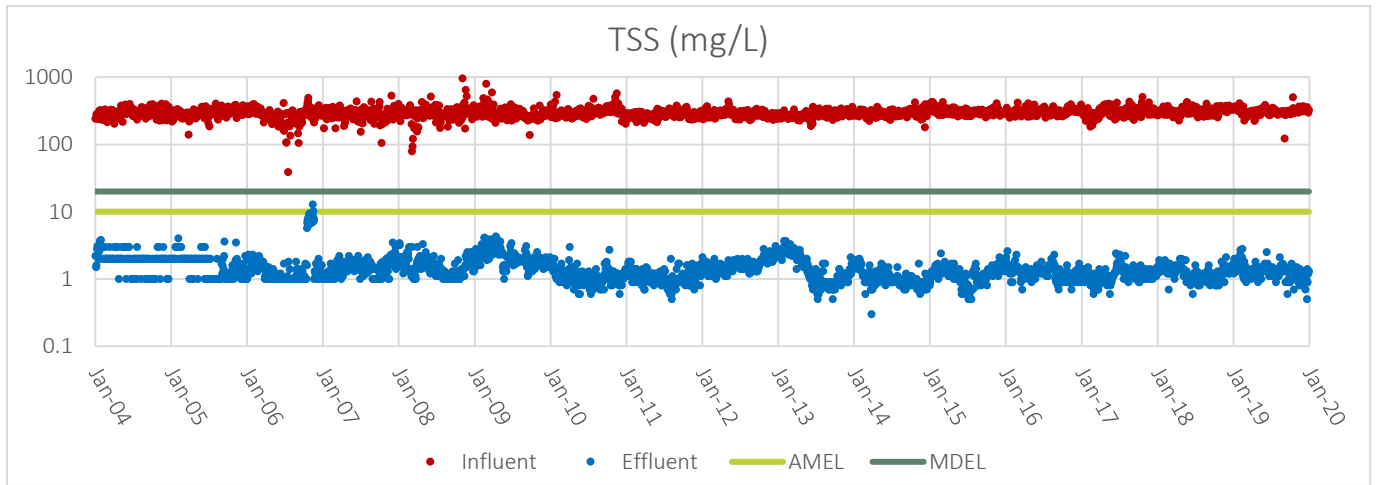
FIGURE 8 FACILITY TSS CONCENTRATIONS - 2004 THRU 2019

Year	Influent			Effluent			Removal
	Low	High	Average	Low	High	Average	
2017	185	507	305	1.0	2.0	1.0	99.6%
2018	227	428	315	2.0	2.0	1.0	99.6%
<b>2019</b>	<b>123</b>	<b>506</b>	<b>314</b>	<b>1.0</b>	<b>3.0</b>	<b>1.0</b>	<b>99.6%</b>

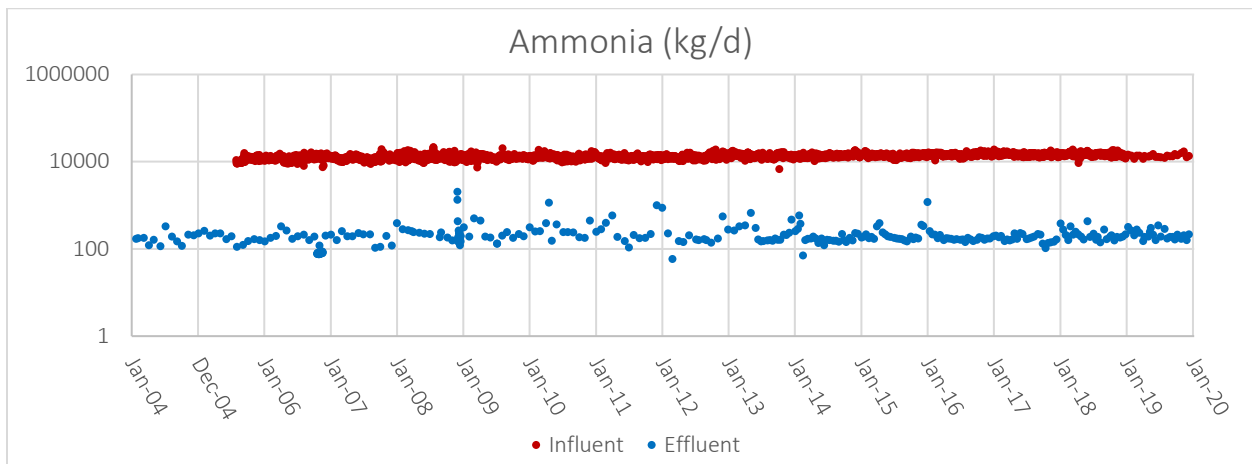
FIGURE 11 FACILITY AMMONIA LOADINGS - 2004 THRU 2019

Annual Total	Low	High	Average	2018 Averages
<i>Influent</i>	4,894,403 kg	11,413	16,946	13,409	14,602
<i>Effluent</i>	79,315 kg	150	344	217	217

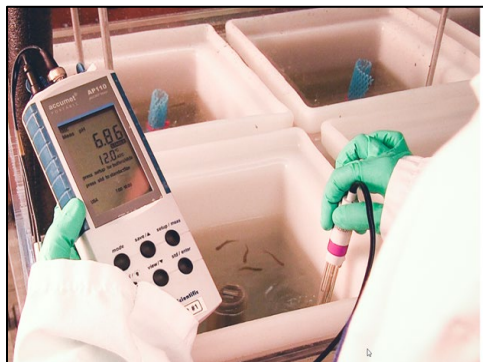
FIGURE 25 AN ANALYST MEASURING WATER QUALITY DURING AN ACUTE TOXICITY TEST

Larval rainbow trout (*Oncorhynchus mykiss*) are used to evaluate acute toxicity of facility effluent quarterly using a 96-hour flow-through test conducted in accordance with EPA methods (Figure 25). Four tests in

2019 resulted in 100% survival of rainbow trout (Table 32). SJ-SC RWF has not failed an acute toxicity effluent test since its inception in 1987. The acute toxicity test requires: a 3-sample median result of not less than 90% survival and a single-sample maximum of not less than 70% survival.

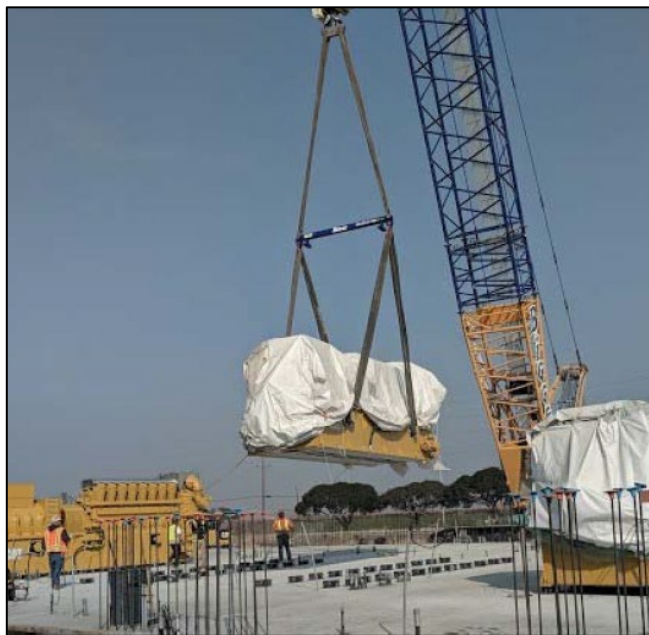
FIGURE 31 A 330-TON CRANE PLACED EACH OF THE FOUR COGENERATION ENGINES ON ITS BASE

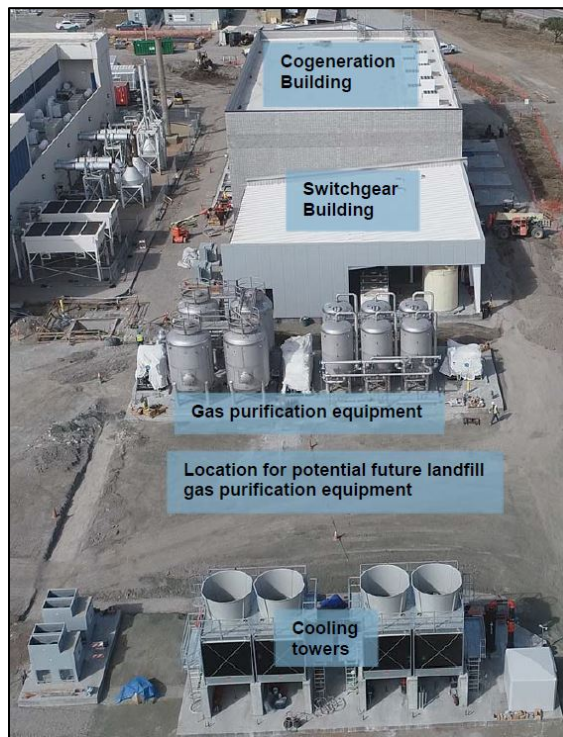
FIGURE 30 OCTOBER 2019: CONSTRUCTION OF THE NEW COGENERATION BUILDING

Construction of a new cogeneration building, adjacent to “Building 40” began in March 2018 and will house four new Caterpillar “CG 260-16” 3.5 MW engine generators (Figure 30). CG 260-16s are expected to fully replace existing cogeneration units by fall 2020. The new units are slightly smaller but more powerful with cleaner emissions than the 35 to 60-year old engines they will replace. After factory acceptance testing in Manheim, Germany in mid-2018, the four skid-mounted CG 260s were delivered in August and installed at the RWF (Figure 31). Beneficial use of the units is expected in September 2020 with final acceptance anticipated in January 2021.

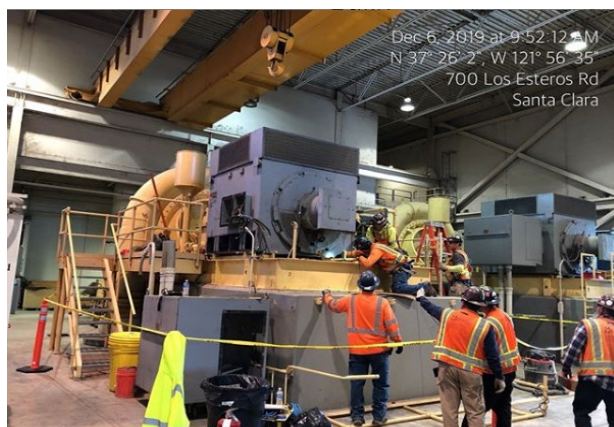
FIGURE 32 BLOWER IMPROVEMENTS PROJECT PREPARING TO INSTALL A NEW ELECTRIC MOTOR TO IMPROVE THE AERATION SYSTEMS’ RELIABILITY

All six engine-driven blowers in Secondary Blower Building (SBB) are operational. These blowers are also known as “Coopers,” built by Cooper-Bessemer Corp).

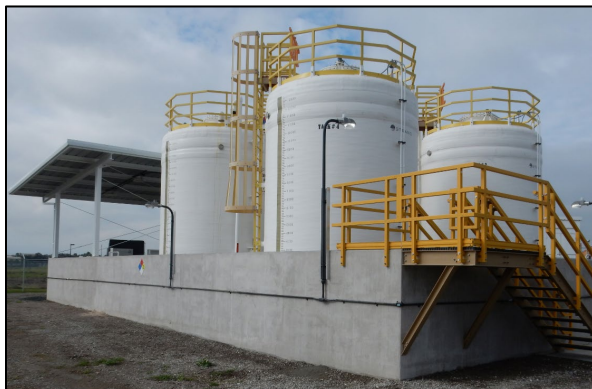
FIGURE 34 IRON SALT FEED STATION

An Iron Salt Feed Station at EBOS, after undergoing final testing in late 2018, was in service for 2019 (Figure 34). The Iron Salt station is comprised of four ferric chloride ( $\text{FeCl}_3$ ) tanks and a pump station for injecting  $\text{FeCl}_3$  into raw sewage as it enters the facility.  $\text{FeCl}_3$  binds with sulfides to help reduce odors and sulfide emissions from digesters and engines.

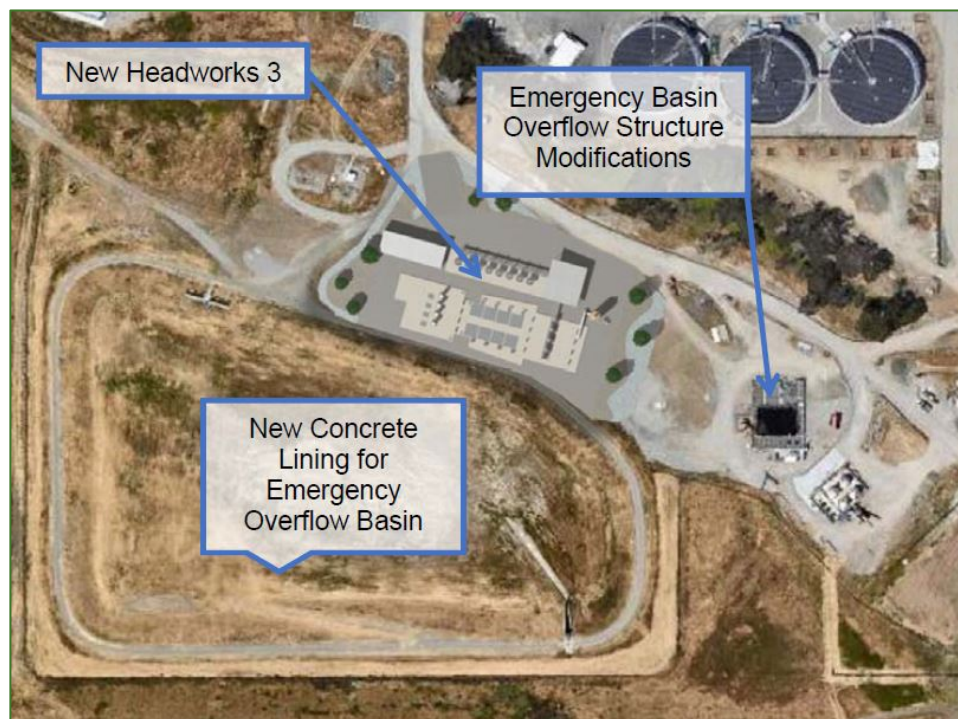
FIGURE 35 PROPOSED SITE FOR NEW HEADWORKS

A design-build project to construct a new headworks facility (Headworks 3 or HW3) to replace aging HW1 was awarded to CH2M Hill Engineers with Kiewit as the General Contractor in June 2018, and CDM Smith is serving as the Owner's Advisor. The project reached 60% design in 2019 following a comprehensive evaluation of cost, hydraulics, odor, O&M issues, environmental and social concerns, and selection of a new preferred site for the new HW3 that is near EBOS (Figure 35). Construction is expected to begin in Summer 2020. Estimated cost of HW3 is \$150M with an estimated operational date of December 2022.

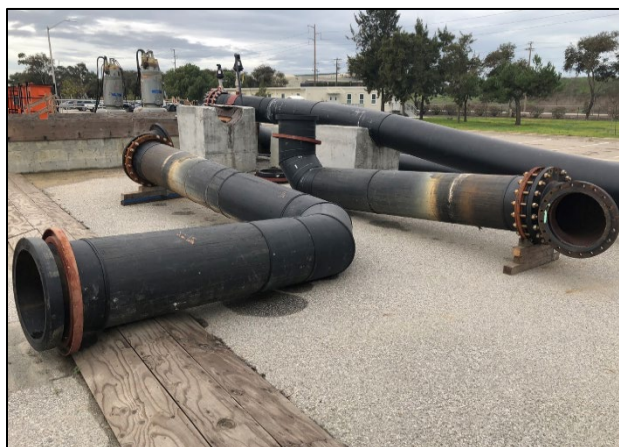
FIGURE 37 SECTIONS OF 36-INCH HDPE PIPE, USED AS A TEMPORARY PIPING SYSTEM IN 2018 THAT WILL BE USED AGAIN FOR THE SES REHABILITATION PROJECT

- Rehabilitating the 96-inch SES pipe and performing concrete crown repair and epoxy coating for the 87x136-inch pipeline.
- Use existing re-route equipment that was used in the repair of the 78-inch primary effluent line in 2018 to re-route SES flows as work on the pipelines begins (Figure 37, Figure 38).
- Construction work on the SES rehabilitation project is anticipated to begin in Summer 2020 after all procurement for necessary equipment is in place.

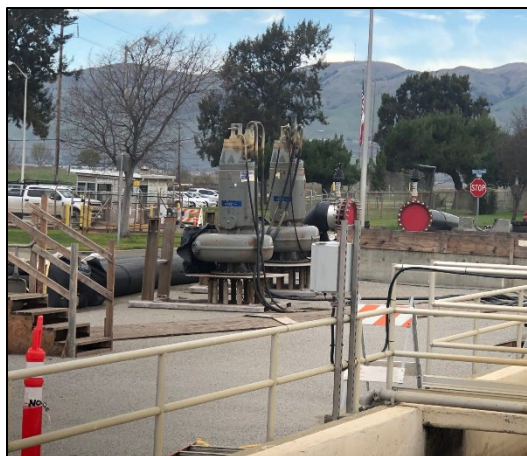
FIGURE 38 TWO OF THE PUMPS UTILIZED IN THE TEMPORARY PIPING SYSTEM THAT WAS USED IN 2018 AND WILL BE USED AGAIN FOR THE SES REHABILITATION PROJECT.

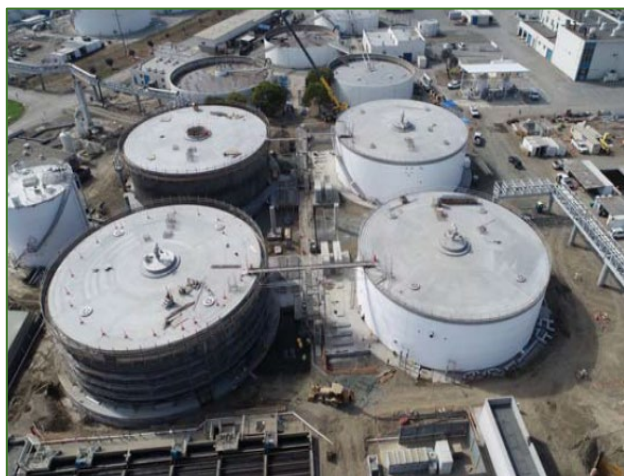
FIGURE 41 AERIAL IMAGE OF PROGRESS ON UPGRADES TO DIGESTERS 5 - 8

This project was initiated in 2016 and is currently at 85% completion (Figure 41). As part of this project, digesters 5 thru 8 will be converted to thermophilic digestion to allow Temperature-Phased Anaerobic Digestion (TPAD) in conjunction with the remaining mesophilic digesters, six DAFT tanks will be converted to operate as co-thickener units (primary and secondary sludges), a new primary sludge screening facility (Figure 40) will be constructed, along with two new electrical buildings, and external elevated gas piping and gas flare systems.

- Interior work on digesters 5 through 8 is nearly completed. Associated digester equipment, equipment pads and piping are still under construction.
- Permanent elevated, above-ground pipe racks nicknamed the “monorail” are nearly complete with all columns and foundations of the monorail complete (Figure 42).

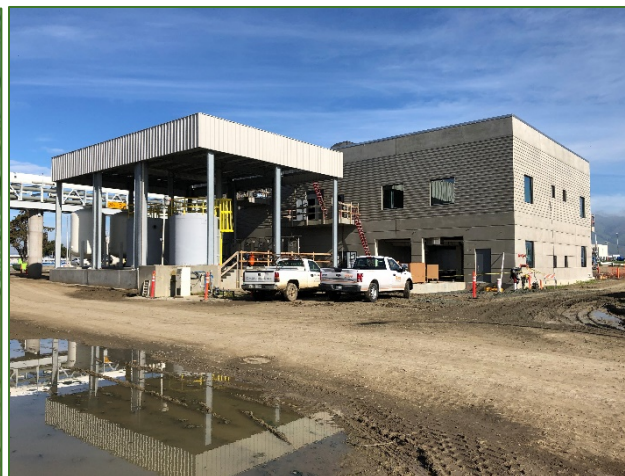
FIGURE 40 NEW SLUDGE SCREENING BUILDING NEARING COMPLETION

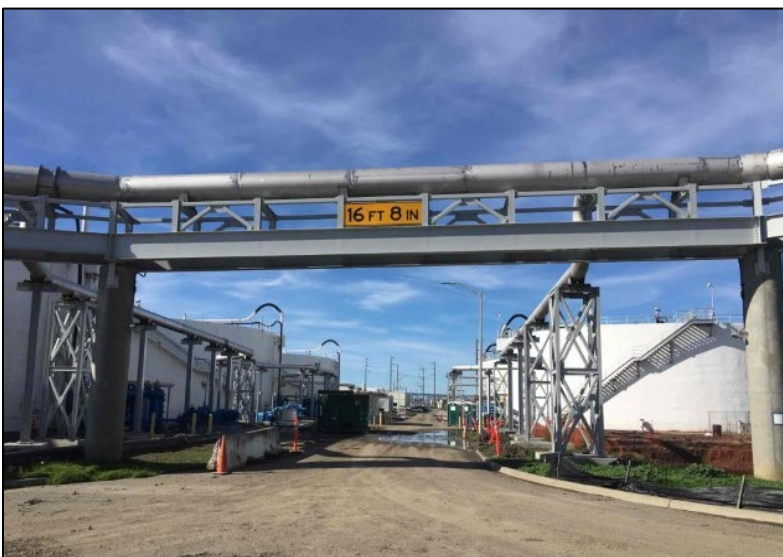
FIGURE 42 NEW PERMANENT ABOVE-GROUND PIPING RACKS: “THE MONORAIL” AT THE REMOTE DIGESTERS

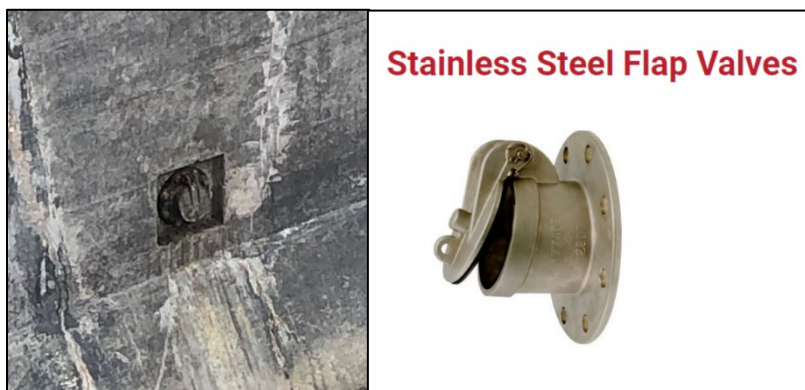
FIGURE 43 ALL FLAP VALVES GROUNDWATER PRESSURE RELIEF VALVES LIKE THE ONE IN BNR-1 (LEFT) WILL BE REPLACED WITH NEW STAINLESS STEEL VALVES (RIGHT)

Groundwater pressure relief valves (PRVs) are installed in all BNR aeration basins and clarifiers. These valves allow water from saturated soils around the subterranean concrete walls of the basins or clarifiers to enter empty basins if hydrostatic water pressure outside an emptied basin is sufficient to open the one-way PRV, preventing the basin from “floating” and experiencing

significant structural damage. Replacement of the PRVs in BNR-2 clarifiers is included in the Nitrification Clarifiers Rehabilitation CIP projects described below. However, in April 2019, aging PRVs in the BNR-1 section (Figure 43) were observed and identified as assets needing replacement sooner than what would be achieved through the CIP program. In summer 2019, Facility Maintenance ordered and began replacing all PRVs in BNR-1 beginning with B-side on a rotating basis as basins were taken out of service. New Groundwater PRVs are stainless steel to replace the older cast-iron PRVs.

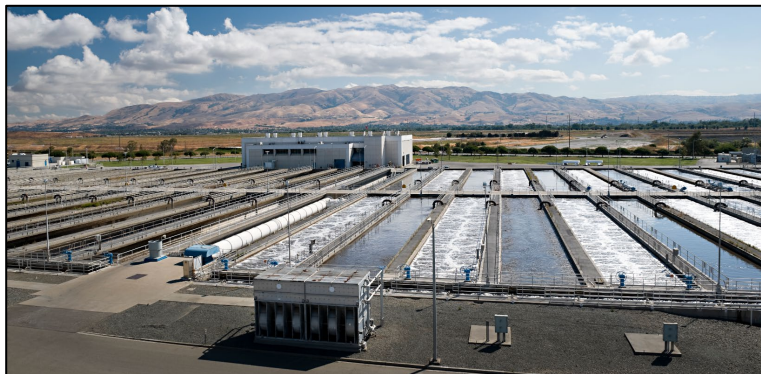
FIGURE 44 SECONDARY AREA (BNR-1)

An Advanced Facility and Meter Control Replacement Project has been underway since 2016 when the RWF selected Black & Veatch as the design consultant to provide engineering services. The project will replace aging flow meters, valves, actuators, and sensors to ensure accurate and effective process control in the BNR process areas.

- The Advanced Facility Meter Replacement Project is being implemented in two phases to align with planned maintenance shutdowns of the four BNR process areas.
- Phase 1 has been in the construction phase since July 2018 and will replace control equipment in the secondary (BNR-1, Figure 44) B-side batteries as well as the nitrification (BNR-2) B-side batteries and is expected to reach beneficial use by the end of 2020.
- Phase 2 will replace flow meters, valves and actuators, and sensors in the A-side batteries. Design work was completed in late 2019 and a contract is anticipated to be awarded by mid-2020.

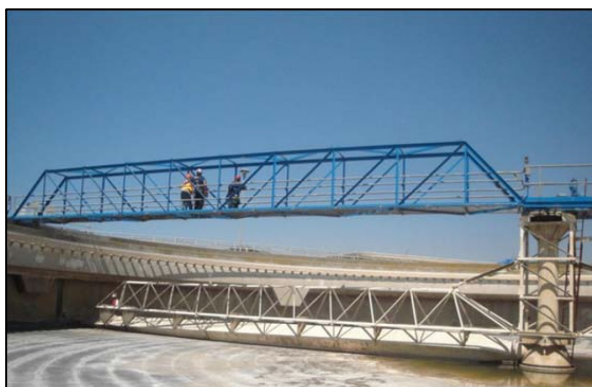
FIGURE 45 WORKER ON A CLARIFIER "TOW-BRO" ARM

The RWF's 16 clarifiers (Figure 45) in the nitrification-BNR-2 section were constructed in the 1970s and 1980s. Following a previous series of shut-downs in the BNR-1 section to evaluate necessary repairs to degraded Return Activated Sludge (RAS) lines, a two-phase project to enhance the efficiency of the clarifiers and minimize unscheduled maintenance began. Engineering services contract was awarded to HDR Engineers and the project will follow the conventional design-bid-build approach. HDR completed 60% design for both phases in November 2018 with an estimated project cost of \$46M for Phase 1 and \$18M for Phase 2.

- Phase 1 of the nitrification clarifiers rehabilitation project will replace clarifier mechanisms and appurtenances for 8 clarifiers, rehab up to 8 RAS pipelines, and install groundwater monitoring wells. Phase 1 will also replace drain valves, RAS valves, pressure relief valves, electrical and instrumentation control equipment for all 16 clarifiers in BNR-1. Design for phase 1 work was completed in April 2019 and construction is scheduled to start in January 2020.

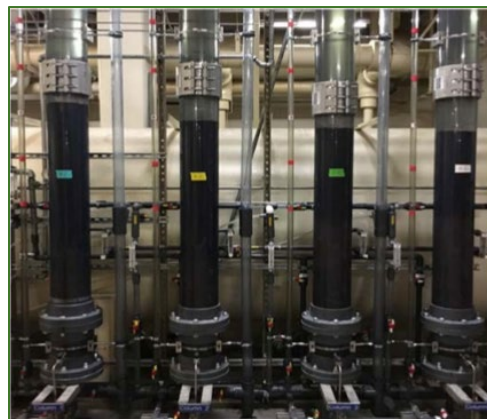
FIGURE 47 EVALUATION OF FOUR DIFFERENT FILTER MEDIA REPLACEMENT CONFIGURATIONS

- RWF Process Engineering Group completed a thorough evaluation of four different filter media configurations and included the use of air scour during filter backwash in their testing (Figure 47).
- Following extensive testing, the Process Engineering Group concluded that a filter media configuration of 34-inches of 1.4 – 1.5 mm anthracite mono media should be used in all 16 filters as part of the Filter Rehabilitation Project.
- In addition, the Process Engineering Group recommends that air scour should be installed in all 16 filters as part of the backwash process.

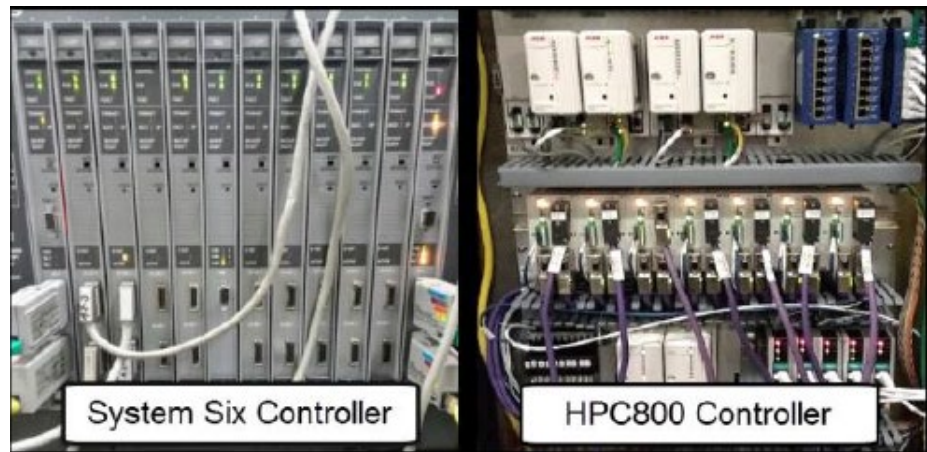
FIGURE 50 THE DCS WILL BE UPGRADE FROM SYSTEM SIX (LEFT) TO NEW HARMONY (RIGHT) CONTROLLERS

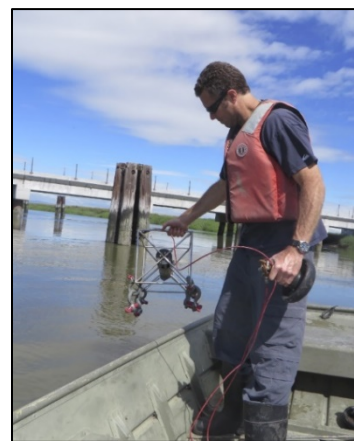
FIGURE 54 BRYAN FRUEH DEPLOYING A CONTINUOUS WATER QUALITY METER IN COYOTE CREEK

During 2019, a YSI 6600 sonde was deployed for 30-day intervals on a bi-monthly basis at the Railroad Bridge in Coyote Creek (Figure 55). The sonde

collects DO, pH, Conductivity, and Temperature data, at 15-minute intervals. This monitoring plan was an increase in the number (6) and duration (30 days) of deployments compared to 2017 when the continuous monitoring effort was piloted. The initial 2017 pilot effort was dubbed “Project Stonehenge” because 2-week deployments corresponded to seasonal equinoxes and solstices for 4 deployments per year. Repeated theft and vandalism of the deployed sonde in 2018 caused a number of setbacks and data loss. Data collection resumed in 2019 after RWF staff evaluated logistical and safety options before resuming continuous DO data collection. The partial year of data is still under QA/QC review.

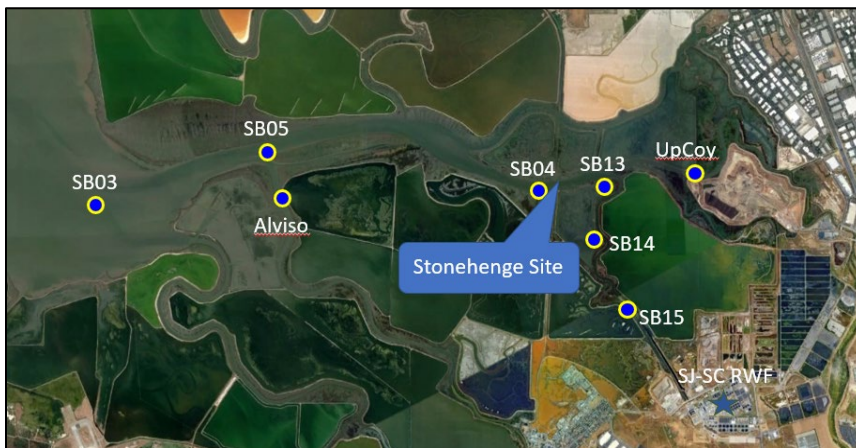
FIGURE 55 MAP OF MONITORING LOCATIONS FOR THE RWF'S LOWER SOUTH BAY AMBIENT MONITORING PROGRAM

To investigate nutrient impacts, SJ-SC RWF staff began sampling water and sediment samples for biota along Artesian Slough and Lower Coyote Creek in 2016, 2017, 2018, and 2019 (Figure 55).

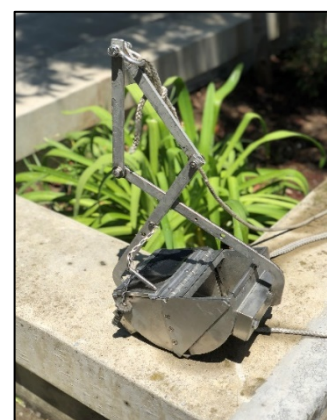
FIGURE 58 PETITE PONAR SEDIMENT GRAB FOR BENTHIC SAMPLING

RWF staff began collecting bimonthly benthic samples at phytoplankton monitoring stations in May 2016. Benthic samples are collected using a Ponar grab sampler (Figure 58) and delivered to ICF contract lab for benthic taxonomy services.

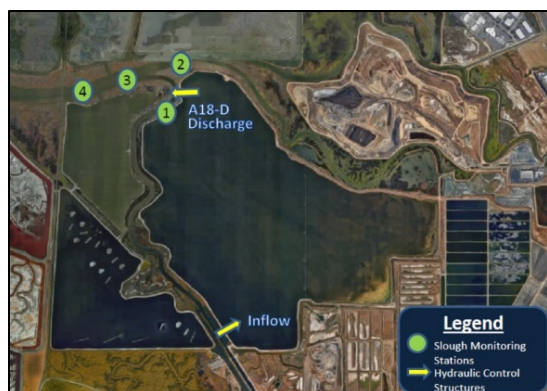
FIGURE 65 POND A18 "REVERSE FLOW"

The aging infrastructure of the pond's water control structures required improvements to the 14-year old structures and reinforcement of the adjacent levee. Beginning in January 2016 and into October 2018, pond flows were reversed compared to normal operations: Bay water was drawn in from southern hydraulic structure and discharged out from the north (Figure 65) to reduce stress on the aging southern structure and surrounding levee. Because southern structure is very close to SJ-SC RWF discharge, this configuration results in significantly higher nitrogen levels entering the pond, resulting in elevated chlorophyll values.

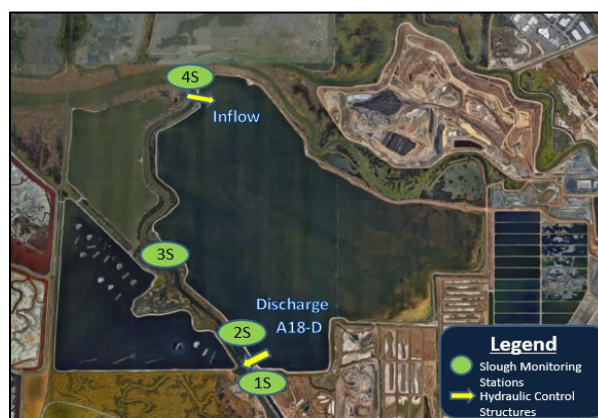
FIGURE 66 POND A18 "STANDARD FLOW" CONFIGURATION

After securing several permits from USACE, BCDC, and Water Board in 2018, the City, with engineer and construction contractors, repaired and bolstered the southern levee and structure with improvements completed in October 2018. Following completion of the repairs, the pond was reverted back to its standard directional flow with the intake through the north and discharge from the south structures (Figure 66). The pond was operated in this standard flow configuration for the entirety of 2019. As a result, the pond water quality had more stable dissolved oxygen levels and lower chlorophyll-*a* levels compared to the most recent years when the pond was operated in "reverse flow" configuration.
