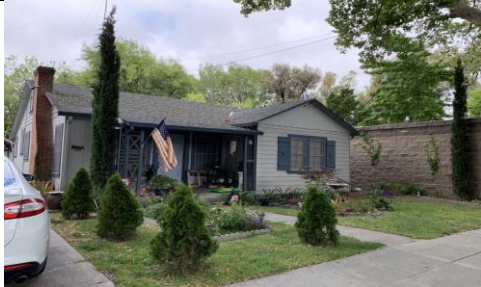
Map Ref #	APN	Built Date (circa)	Address	Architectural Style	Primary Number	OHP Status Code	City HRI Designation Classification	Survey Notes	Evaluation Recommendation	Photograph 1	Photograph 2
3	23506030	1930	1145 N 2ND ST SAN JOSE 95112-4954	Minimal Traditional	P43-001537	6Y	N/A	Displays original windows, façade door, wall cladding, and exterior brick chimney. Evaluated as individually ineligible for listing in the National Register. Has not been previously evaluated for the California Register or San Jose Historic Resources Inventory.	Yes

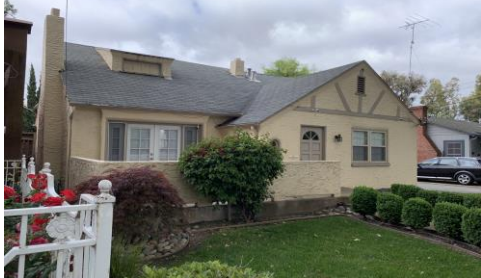
4	23506031	1927	1141 N 2ND ST SAN JOSE 95112-4954	Tudor Revival	N/A	N/A	N/A	Displays replacement windows and doors.	Yes

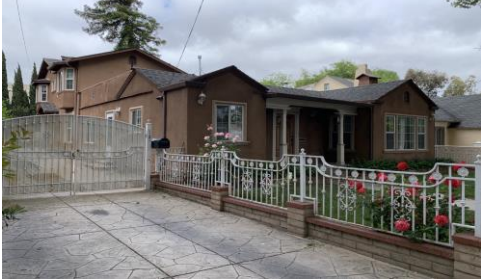
5	23506032	1927	1131 N 2ND ST SAN JOSE 95112-4954	Minimal Traditional	N/A	N/A	N/A	Displays replacement stucco wall cladding, vinyl windows, and facade door, as well as a major two-story addition on the west side of the house.	Yes

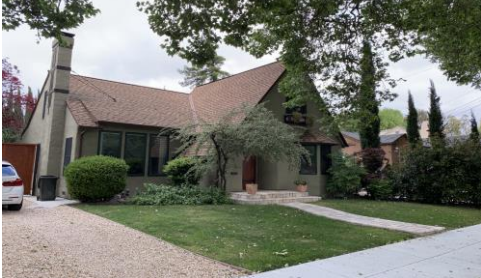
7	23506033	1928	1129 N 2ND ST SAN JOSE 95112-4954	Tudor Revival	N/A	N/A	N/A	Displays replacement windows.	Yes

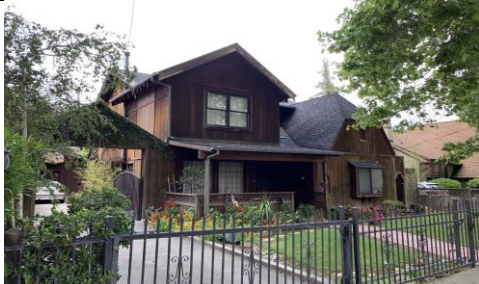
Map Ref #	APN	Built Date (circa)	Address	Architectural Style	Primary Number	OHP Status Code	City HRI Designation Classification	Survey Notes	Evaluation Recommendation	Photograph 1	Photograph 2
8	23506034	1926	1127 N 2ND ST SAN JOSE 95112-4954	Minimal Traditional	N/A	N/A	N/A	Displays original leaded glass, as well as replacement windows and doors.	Yes

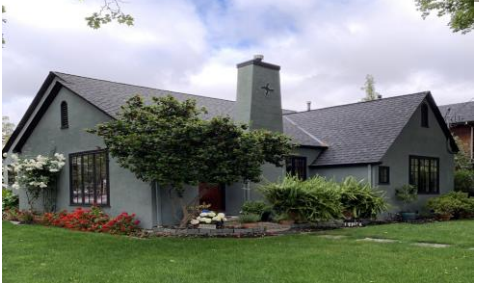
10	23506035	1928	1125 N 2ND ST SAN JOSE 95112-4954	Tudor Revival	N/A	N/A	N/A	Displays original and replacement windows and doors.	Yes

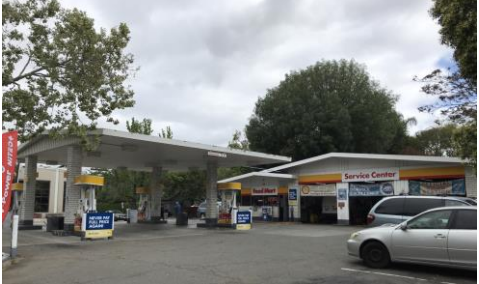
12	23507068	1967	1120 N 1ST ST SAN JOSE 95112-4924	Contemporary	N/A	N/A	N/A	Displays original windows, doors and cladding, and original gas pump canopy.	Yes

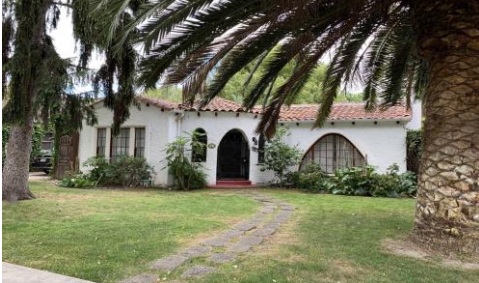
13	23507036	1930	1123 N 2ND ST SAN JOSE 95112-4953	Spanish Colonial Revival	N/A	N/A	N/A	Displays original windows.	Yes

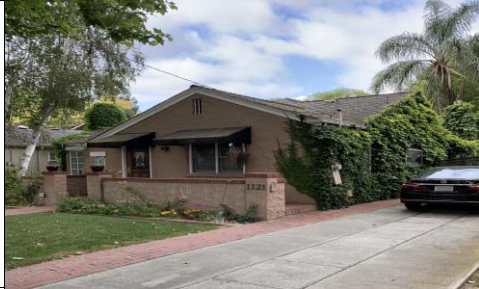
Map Ref #	APN	Built Date (circa)	Address	Architectural Style	Primary Number	OHP Status Code	City HRI Designation Classification	Survey Notes	Evaluation Recommendation	Photograph 1	Photograph 2
14	23507037	1930	1121 N 2ND ST SAN JOSE 95112-4953	Minimal Traditional	N/A	N/A	N/A	Displays replacement windows and doors.	Yes

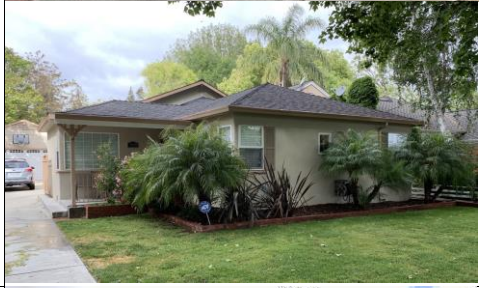
15	23507038	1939	1119 N 2ND ST SAN JOSE 95112-4953	Minimal Traditional	N/A	N/A	N/A	Displays replacement windows and doors. Likely large addition at back of residence.	Yes

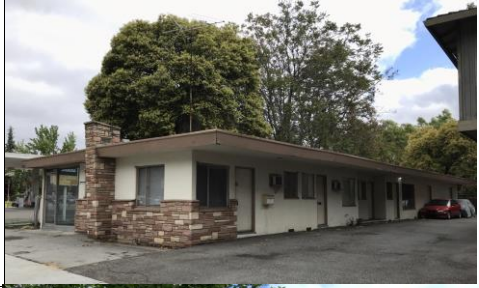
17	23507067	1953	1114 N 1ST ST SAN JOSE 95112-4924	Contemporary	N/A	N/A	N/A	Displays original windows, doors, and wall cladding. Stone wall cladding added to the west and south elevations.	Yes

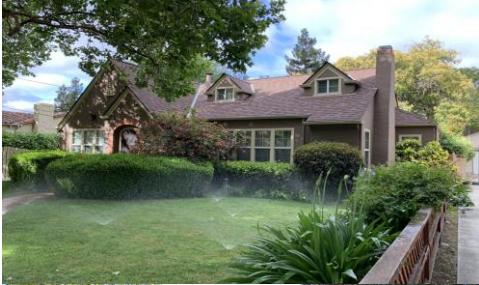
18	23507039	1930	1115 N 2ND ST SAN JOSE 95112-4953	Tudor Revival	N/A	N/A	N/A	Displays replacement windows.	Yes

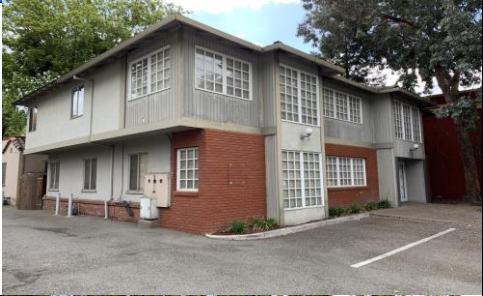
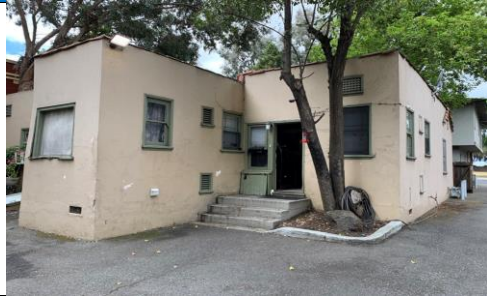
Map Ref #	APN	Built Date (circa)	Address	Architectural Style	Primary Number	OHP Status Code	City HRI Designation Classification	Survey Notes	Evaluation Recommendation	Photograph 1	Photograph 2
19	23507066	1930	1106 N 1ST ST SAN JOSE 95112-4924	Spanish Colonial Revival	N/A	N/A	N/A	Property contains two buildings: a circa 1960 apartment building and a circa 1930 single-family residence. According to the homeowner, the residence was relocated from the location of the apartment building to its current location at an unknown date.	Yes

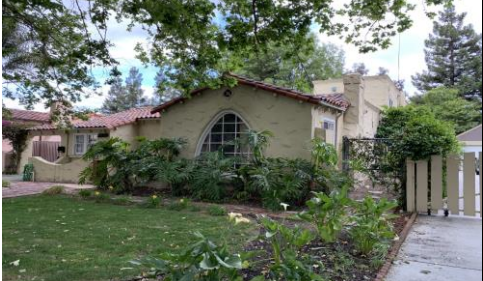
20	23507040	1940	1111 N 2ND ST SAN JOSE 95112-4953	Spanish Colonial Revival	N/A	N/A	N/A	Displays original windows.	Yes

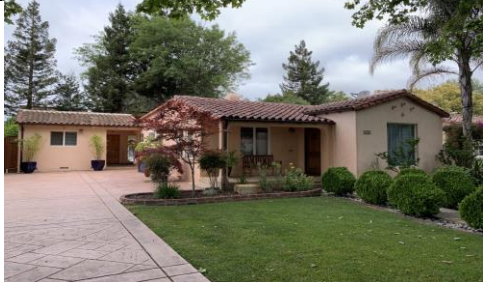
22	23507041	1933	1107 N 2ND ST SAN JOSE 95112-4953	Spanish Colonial Revival	N/A	N/A	N/A	Displays replacement windows, doors, and wall cladding.	Yes

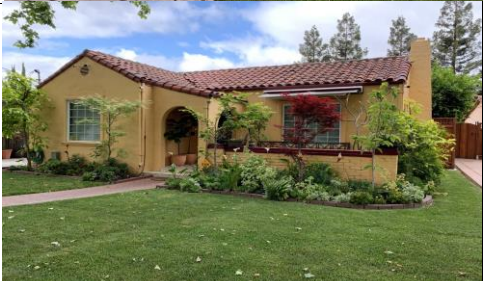
23	23507042	1936	1101 N 2ND ST SAN JOSE 95112-4953	Spanish Colonial Revival	N/A	N/A	N/A	Displays replacement windows and doors.	Yes

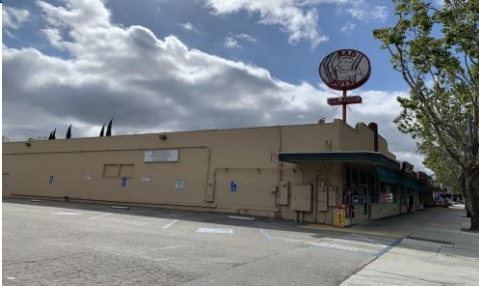
Map Ref #	APN	Built Date (circa)	Address	Architectural Style	Primary Number	OHP Status Code	City HRI Designation Classification	Survey Notes	Evaluation Recommendation	Photograph 1	Photograph 2
24	23507064	1939	1052 N 1ST ST SAN JOSE 95112-4922	Streamline Moderne	N/A	N/A	N/A	Displays replacement windows, doors, and stone wall cladding from circa 1960. A rooftop "Bad Boys Bail Bonds" sign is located at the northwest corner of the building. The building was previously evaluated as ineligible for listing in the National Register, California Register, and San Jose Historic Resources Inventory due to lack of historic significance.	No

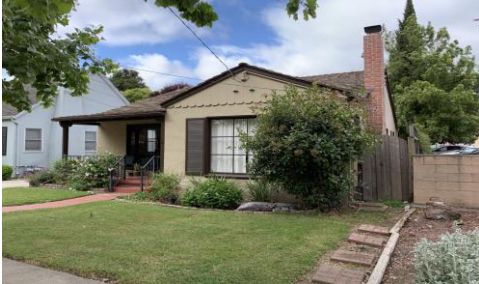
27	23507045	1940	1055 N 2ND ST SAN JOSE 95112-4931	Minimal Traditional	N/A	N/A	N/A	Displays original windows.	Yes

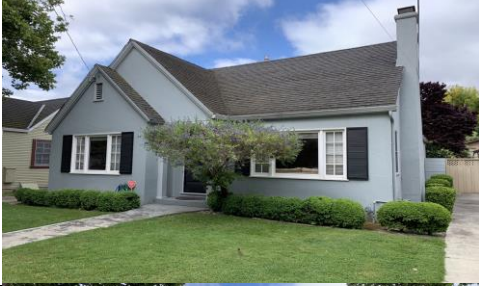
28	23507046	1930	1019 N 2ND ST SAN JOSE 95112-4931	Minimal Traditional	N/A	N/A	N/A	Displays original windows; has possible wall cladding replacement.	Yes

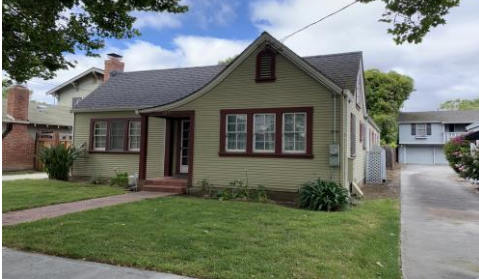
29	23507047	1929	1015 N 2ND ST SAN JOSE 95112-4931	Tudor Revival	N/A	N/A	N/A	Displays original windows and wood board wall cladding.	Yes

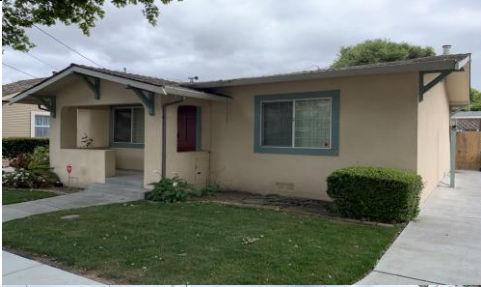
Map Ref #	APN	Built Date (circa)	Address	Architectural Style	Primary Number	OHP Status Code	City HRI Designation Classification	Survey Notes	Evaluation Recommendation	Photograph 1	Photograph 2
34	23507052	1924	17 E YOUNGER AVE SAN JOSE 95112-4917	Craftsman	N/A	N/A	N/A	Displays replacement windows and doors, and possible cladding replacement.	Yes

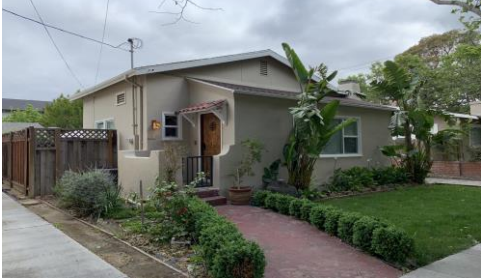
35	23507051	1929	19 E YOUNGER AVE SAN JOSE 95112-4917	Spanish Colonial Revival	N/A	N/A	N/A	Displays replacement windows, door, and wall cladding. Possible façade room addition.	Yes

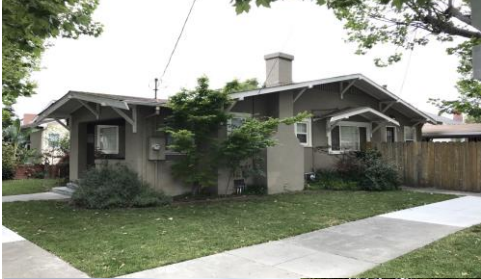
36	23507050	1924	49 E YOUNGER AVE SAN JOSE 95112-4917	Craftsman	N/A	N/A	N/A	Displays replacement windows, doors and wall cladding.	Yes

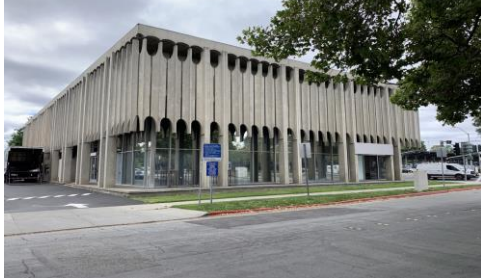
37	23508001	1964	990 N 1ST ST SAN JOSE 95112-4919	Brutalist	N/A	N/A	N/A	Displays the original curtain wall, mirrored windows, metal sashes, and scalloped fascia. The building has been previously evaluated as ineligible for listing in the National Register and California Register. It was also evaluated as a Candidate City Landmark and determined to meet Criterion 6 as it embodies many characteristics of Modern architectural design, and therefore qualified as a Structure of Merit.	Yes

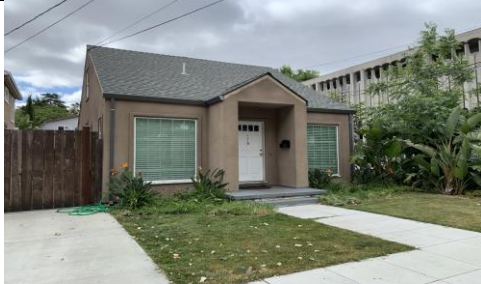
Map Ref #	APN	Built Date (circa)	Address	Architectural Style	Primary Number	OHP Status Code	City HRI Designation Classification	Survey Notes	Evaluation Recommendation	Photograph 1	Photograph 2
38	23508002	1924	16 E YOUNGER AVE SAN JOSE 95112-4916	Minimal Traditional	N/A	N/A	N/A	Displays replacement windows, doors, and wall cladding.	Yes

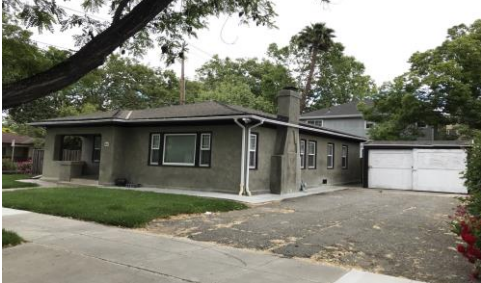
40	23508004	1924	48 E YOUNGER AVE SAN JOSE 95112-4916	Craftsman	N/A	N/A	N/A	Displays replacement windows, door, and wall cladding.	Yes

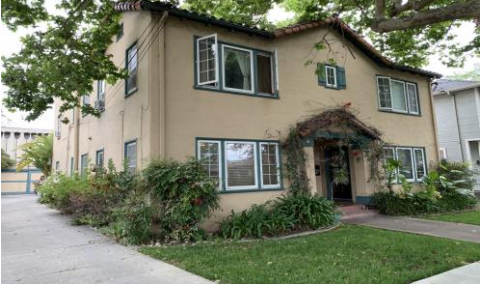
42	23508064	1940	985 N 2ND ST SAN JOSE 95112-4929	Spanish Colonial Revival	N/A	N/A	N/A	Displays replacement windows.	Yes

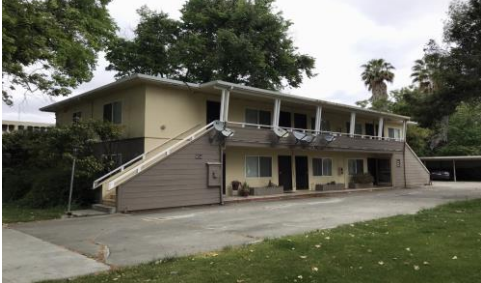
45	23508080	1951	954 N 1ST ST SAN JOSE 95112-4949	Contemporary	N/A	N/A	N/A	Displays replacement windows with original wall cladding and doors. This building has been previously evaluated as ineligible for listing in the National Register, California Register, and San Jose Historic Resources Inventory due to lack of historic significance.	No

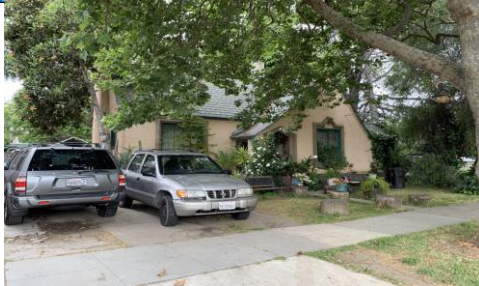
Map Ref #	APN	Built Date (circa)	Address	Architectural Style	Primary Number	OHP Status Code	City HRI Designation Classification	Survey Notes	Evaluation Recommendation	Photograph 1	Photograph 2
46	23508066	1928	943 N 2ND ST SAN JOSE 95112-4929	Tudor Revival	N/A	N/A	N/A	Displays original windows and doors.	Yes

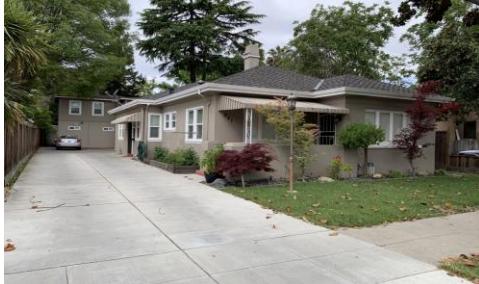
47	23508067	1925	941 N 2ND ST SAN JOSE 95112-4929	Minimal Traditional	N/A	N/A	N/A	Displays replacement windows and wall cladding.	Yes

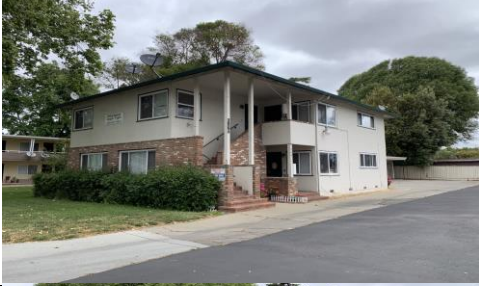
48	23508079	1951	940 N 1ST ST SAN JOSE 95112-4921	Minimal Traditional	N/A	N/A	N/A	Displays replacement windows and original doors. This building has been previously evaluated as ineligible for listing in the National Register, California Register, and San Jose Historic Resources Inventory due to lack of historic significance.	No

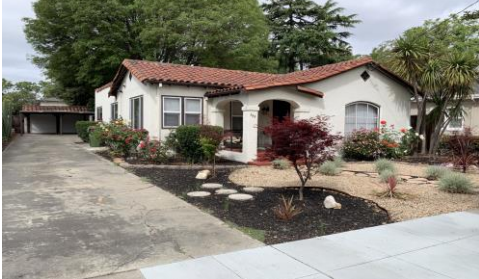
49	23508068	1932	935 N 2ND ST SAN JOSE 95112-4929	Spanish Colonial Revival	N/A	N/A	N/A	Displays some original and replacement windows.	Yes

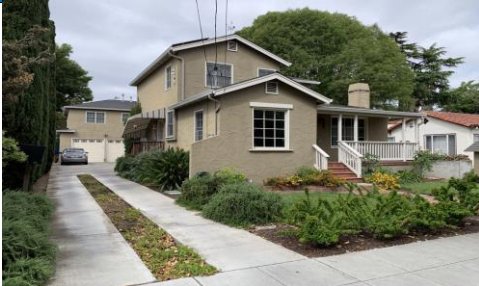
Map Ref #	APN	Built Date (circa)	Address	Architectural Style	Primary Number	OHP Status Code	City HRI Designation Classification	Survey Notes	Evaluation Recommendation	Photograph 1	Photograph 2
51	23508069	1937	927 N 2ND ST SAN JOSE 95112-4929	Minimal Traditional	N/A	N/A	N/A	Displays replacement windows, original wall cladding, and a two-story addition.	Yes

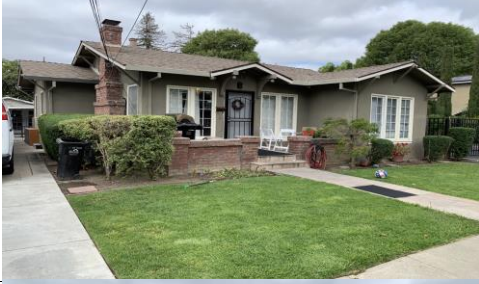
55	23508071	1929	915 N 2ND ST SAN JOSE 95112-4929	Craftsman	N/A	N/A	N/A	Displays original windows and replacement vinyl door.	Yes

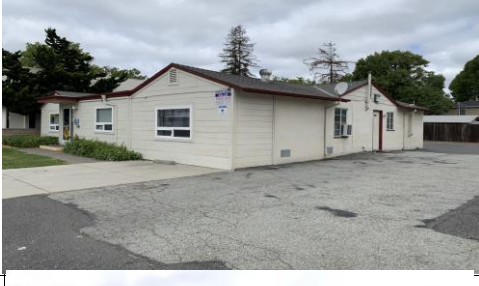
58	23508073	1947	25 E HEDDING ST SAN JOSE 95112-4910	None	N/A	N/A	N/A	Displays some original metal sash windows. Facade appears to be an addition off the original building.	No

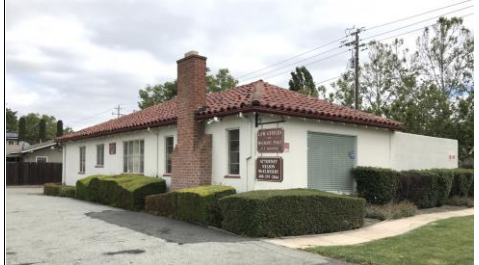
59	23508072	1947	37 E HEDDING ST SAN JOSE 95112-4910	Minimal Traditional	N/A	N/A	N/A	Displays original windows, doors, and wall cladding with added courtyard walls and slatted wooden privacy screens over windows on in the east facade.	Yes

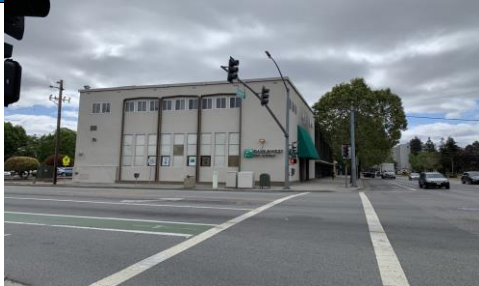
Map Ref #	APN	Built Date (circa)	Address	Architectural Style	Primary Number	OHP Status Code	City HRI Designation Classification	Survey Notes	Evaluation Recommendation	Photograph 1	Photograph 2
60	24902073	1960	890 N 1ST ST SAN JOSE 95112-6312	New Formalism	N/A	N/A	N/A	Constructed circa 1960 based on metal sash fixed windows and original metal entry door. Displays vinyl louvers and some replacement vinyl windows. This building has been previously evaluated as ineligible for listing in the National Register, California Register, and San Jose Historic Resources Inventory due to lack of historic significance.	No

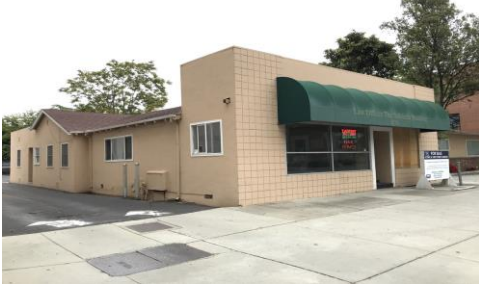
65	24902009	1946	870 N 1ST ST SAN JOSE 95112-6312	Contemporary	N/A	N/A	N/A	Displays partial window, door, and wall cladding replacements. Storefront added to west elevation of original residence in circa 1960. This building has been previously evaluated as ineligible for listing in the National Register, California Register, and San Jose Historic Resources Inventory due to lack of historic significance.	No

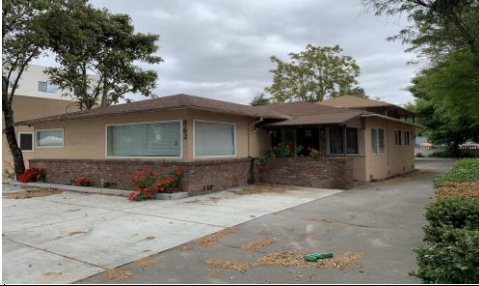
67	24902008	1946	864 N 1ST ST SAN JOSE 95112-6312	Ranch	N/A	N/A	N/A	Displays replacement vinyl windows and original wood doors. This building has been previously evaluated as ineligible for listing in the National Register, California Register, and San Jose Historic Resources Inventory due to lack of historic significance.	No

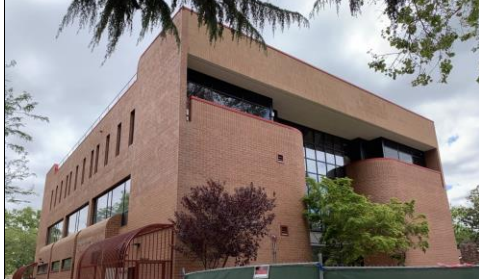
69	24902069	1978	852 N 1ST ST SAN JOSE 95112-6370	Corporate Modern	N/A	N/A	N/A	Displays original brick veneer, windows, and doors.	Yes

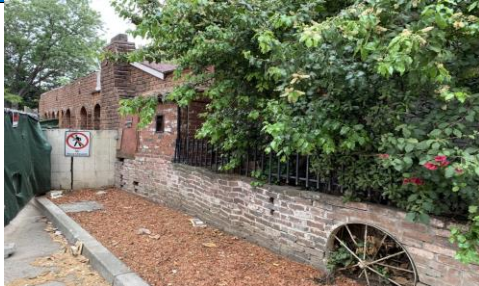
Map Ref #	APN	Built Date (circa)	Address	Architectural Style	Primary Number	OHP Status Code	City HRI Designation Classification	Survey Notes	Evaluation Recommendation	Photograph 1	Photograph 2
72	24902072	1927	848 N 1ST ST SAN JOSE 95112-6312	Storybook	N/A	N/A	N/A	<p>Displays unevenly laid brick with a "California" stamp mark. Original exterior was likely plaster and the brick added at an unknown date. Mature foliage obscures the view of the building. The building was originally a single-family residence and converted to restaurant use in 1978.</p> <p>This building has been previously evaluated as ineligible for listing in the National Register, California Register, and San Jose Historic Resources Inventory due to lack of historic significance.</p>	No

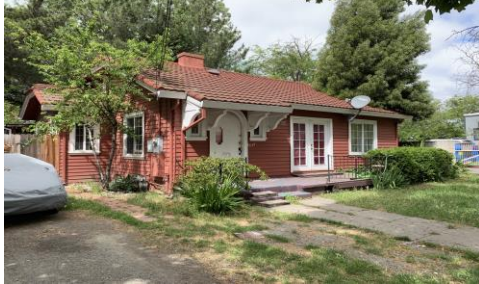
73	24902020	1925	848 N 2ND ST SAN JOSE 95112-6318	Folk with Dutch Colonial Revival detailing	N/A	N/A	N/A	<p>Displays some original windows and facade door, and replacement vinyl windows.</p>	Yes

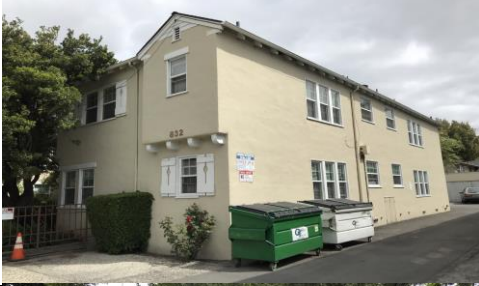
77	24902074	1939	832 N 1ST ST SAN JOSE 95112-6327	Minimal Traditional	N/A	N/A	N/A	<p>Displays original doors, windows, and cladding.</p> <p>This building has been previously evaluated as ineligible for listing in the National Register, California Register, and San Jose Historic Resources Inventory due to lack of historic significance.</p>	No

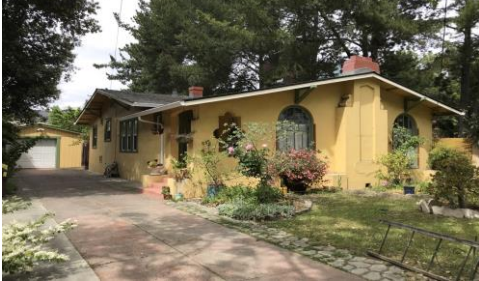
78	24902023	1925	831 N 2ND ST SAN JOSE 95112-6318	Spanish Colonial Revival	N/A	N/A	N/A	<p>Displays original windows, doors, and wall cladding.</p>	Yes

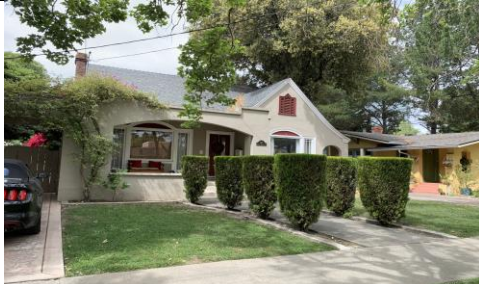
Map Ref #	APN	Built Date (circa)	Address	Architectural Style	Primary Number	OHP Status Code	City HRI Designation Classification	Survey Notes	Evaluation Recommendation	Photograph 1	Photograph 2
79	24902024	1924	825 N 2ND ST SAN JOSE 95112-6318	Tudor Revival	N/A	N/A	N/A	Displays original windows.	Yes

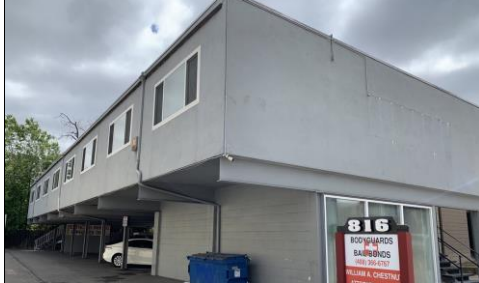
80	24902064	1961	816 N 1ST ST SAN JOSE 95112-6301	Contemporary	N/A	N/A	N/A	Displays cinderblock walls and original stucco, and original windows and doors. This building has been previously evaluated as ineligible for listing in the National Register, California Register, and San Jose Historic Resources Inventory due to lack of historic significance.	No

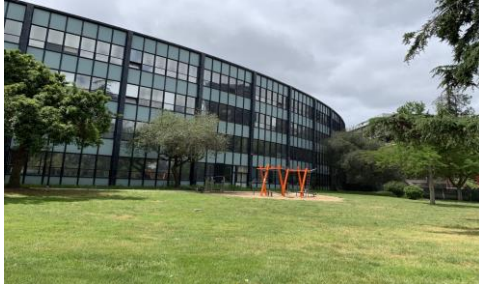
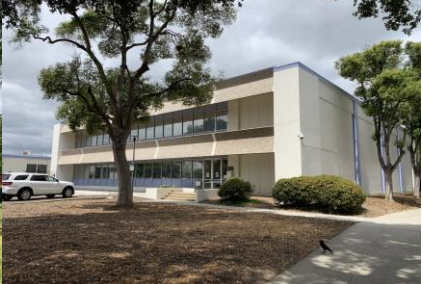
82	25904023	1956-1958	801 N 1ST ST SAN JOSE 95110	International	P43-000720 P43-000986	N/A	N/A	City Hall (P43-000720) - Displays original mirrored and frosted windows and doors. Architect - Donald F. Haines. Builder - Carl N. Swenson. The 1976-built 6-story annex was being demolished during time of the survey. In 2012, the building was evaluated and recommended eligible for listing in the National Register and California Register under Criteria A/1, B/2, and C/3. It was also found eligible for listing as a Santa Clara County Landmark under the County's Historic Preservation Ordinance. Lastly, the building was rated using the City of San Jose Historic Evaluation Rating system and found to likely qualify as a City Historic Landmark. Health Building (P43-000986) - Displays original windows and doors. Architect - Hollis Logue. Builders- Harrod & Williams and Don Gordon Co. The building was evaluated as ineligible for listing in the National Register, California Register, Santa Clara County Landmark, or San Jose City Landmark due to lack of integrity.	No

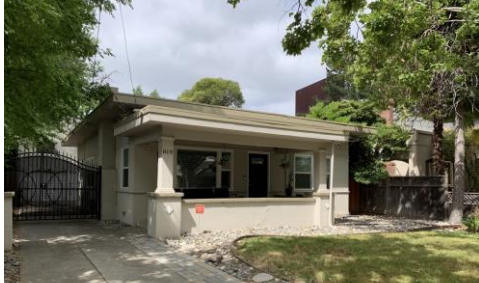
83	24902025	1935	817 N 2ND ST SAN JOSE 95112-6318	Prairie	N/A	N/A	N/A	Displays replacement windows and doors, and original cladding.	Yes

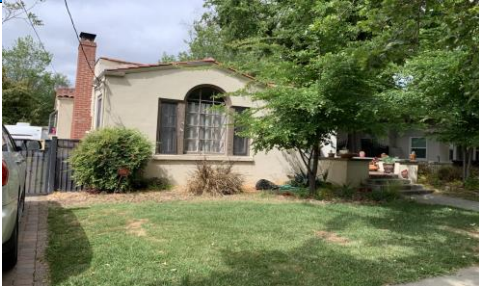
Map Ref #	APN	Built Date (circa)	Address	Architectural Style	Primary Number	OHP Status Code	City HRI Designation Classification	Survey Notes	Evaluation Recommendation	Photograph 1	Photograph 2
84	24902026	1926	813 N 2ND ST SAN JOSE 95112-6318	Spanish Colonial Revival	N/A	N/A	N/A	Displays original windows and replacement façade door.	Yes

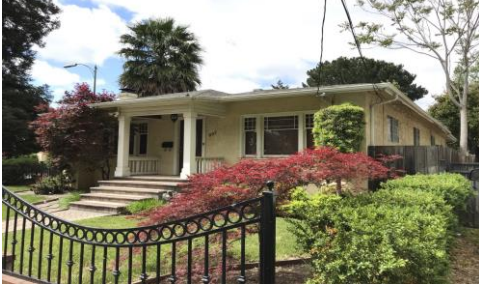
85	24902027	1926	807 N 2ND ST SAN JOSE 95112-6318	Prairie	N/A	N/A	N/A	Displays replacement doors and wall cladding with original windows.	Yes

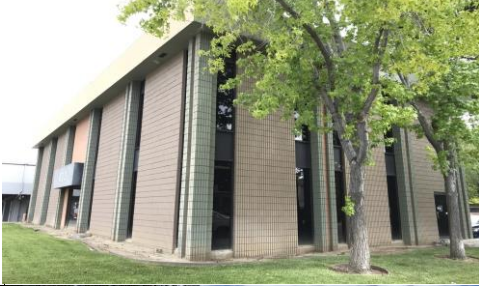
86	24902068	1975	800 N 1ST ST SAN JOSE 95112-6312	Brutalist	N/A	N/A	N/A	Displays original doors, windows, and wall cladding.	Yes

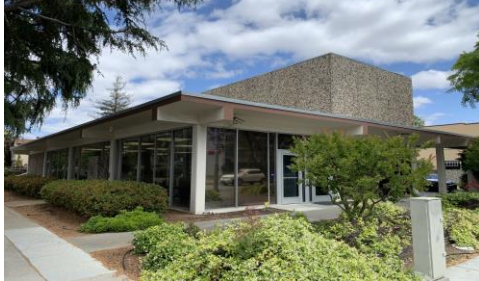
87	24901066	1963	798 N 1ST ST SAN JOSE 95112-6302	Contemporary	N/A	N/A	N/A	Displays original windows, doors, and wall cladding. This building has been previously evaluated as ineligible for listing in the National Register, California Register, and San Jose Historic Resources Inventory due to lack of historic significance.	Yes

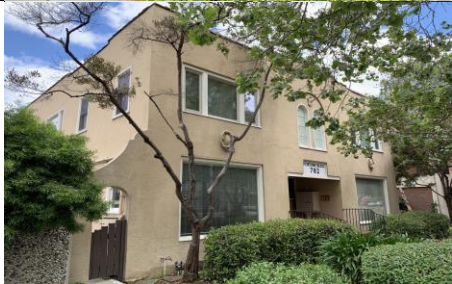
Map Ref #	APN	Built Date (circa)	Address	Architectural Style	Primary Number	OHP Status Code	City HRI Designation Classification	Survey Notes	Evaluation Recommendation	Photograph 1	Photograph 2
88	24901028	1920	782 N 1ST ST SAN JOSE 95112-6326	Spanish Colonial Revival and Beaux Arts	N/A	N/A	N/A	The Fortune Building displays some replacement vinyl windows and original windows, and replacement doors dating to circa 1965.	Yes

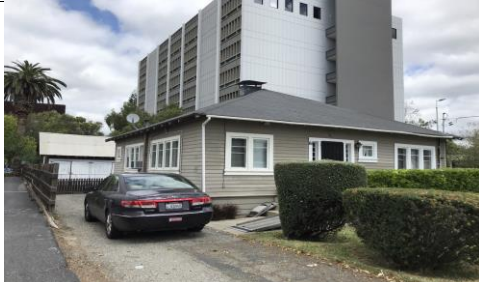
94	25905008	1910	61 ASBURY ST SAN JOSE 95110-2104	Craftsman	N/A	N/A	N/A	Displays original windows, doors, and cladding. This building was evaluated as ineligible for listing in the National Register, California Register, and as a San Jose City Landmark.	No

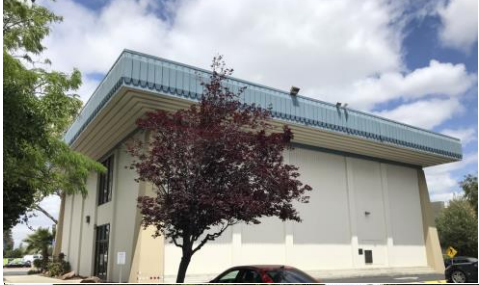
111, 112	25917109 25917113	1973	681 N SAN PEDRO ST SAN JOSE 95110	New Formalism	N/A	N/A	N/A	Displays original doors, windows, and wall cladding.	Yes

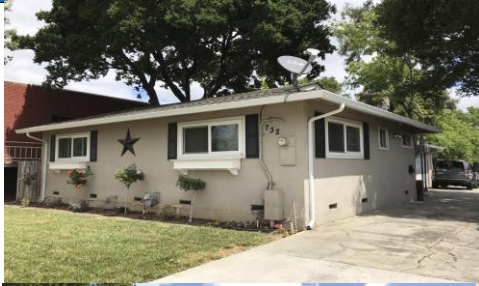
Map Ref #	APN	Built Date (circa)	Address	Architectural Style	Primary Number	OHP Status Code	City HRI Designation Classification	Survey Notes	Evaluation Recommendation	Photograph 1	Photograph 2
115	25905075	1961	732 N SAN PEDRO ST SAN JOSE 95110-2127	Minimal Traditional	N/A	N/A	N/A	Displays replacement windows and doors, and original wall cladding.	Yes

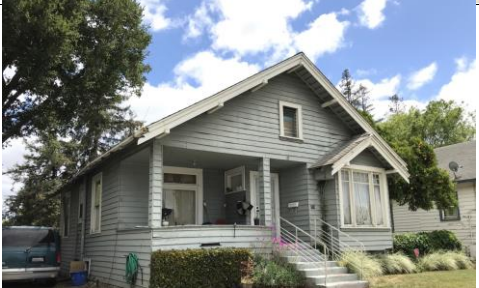
116	25905076	1910	724 N SAN PEDRO ST SAN JOSE 95110-2127	Craftsman	P43-003439	N/A	N/A	Displays original windows and wall cladding, and replacement facade door. This building was previously evaluated as ineligible for listing in the National Register.	Yes

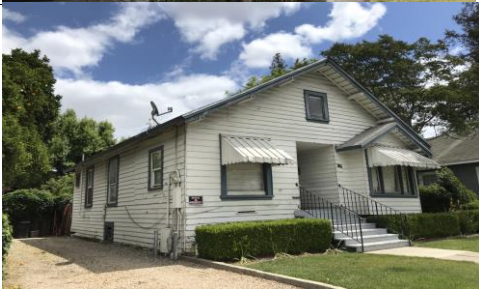
117	25905050	1910	718 N SAN PEDRO ST SAN JOSE 95110-2127	Craftsman	P43-003437	N/A	N/A	Displays original windows, doors, and wall cladding. This building was previously evaluated as ineligible for listing in the National Register.	Yes

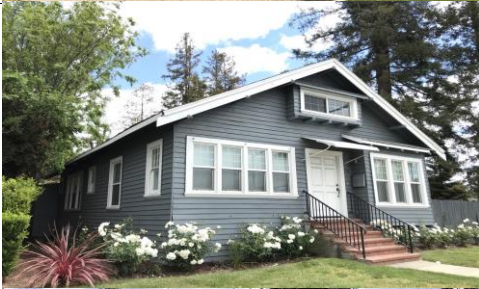
118	25905077	1910	712 N SAN PEDRO ST SAN JOSE 95110-2127	Craftsman	P43-003436	N/A	N/A	Displays original wall cladding and a mix of replacement and original windows and doors. This building was previously evaluated as ineligible for listing in the National Register.	Yes

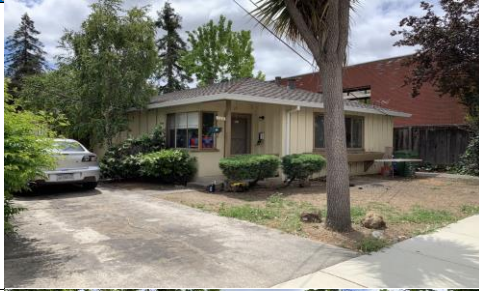
Map Ref #	APN	Built Date (circa)	Address	Architectural Style	Primary Number	OHP Status Code	City HRI Designation Classification	Survey Notes	Evaluation Recommendation	Photograph 1	Photograph 2
120	25905053	1953	120 ASBURY ST SAN JOSE 95110-2105	Minimal Traditional	N/A	N/A	N/A	Displays original windows and board and batten siding.	Yes

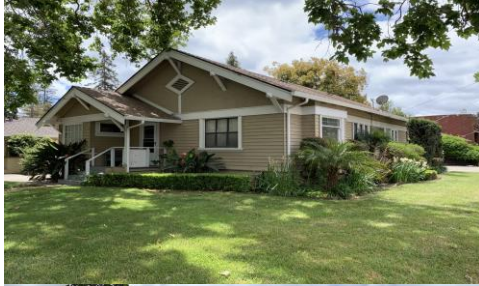
121	25905040	1914	747 MILLER ST SAN JOSE 95110-2121	Craftsman	N/A	N/A	N/A	Displays a mix of original and replacement windows, and replacement stucco and wood board wall cladding.	Yes

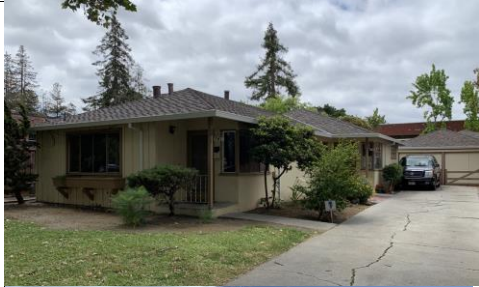
123	25905041	1953	741 MILLER ST SAN JOSE 95110-2121	Minimal Traditional	N/A	N/A	N/A	A duplex with original metal casement windows, doors, stucco and board and batten siding.	Yes

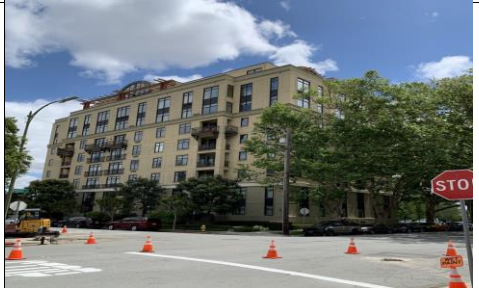
125		2005	750 MILLER ST SAN JOSE	NA	N/A	N/A	N/A	A building constructed circa 2005.	No

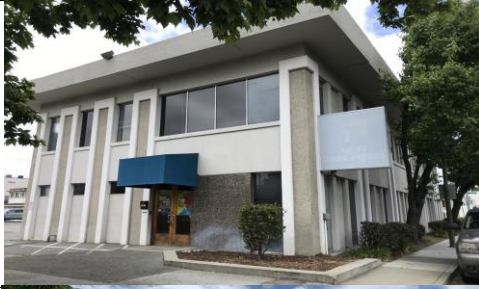
Map Ref #	APN	Built Date (circa)	Address	Architectural Style	Primary Number	OHP Status Code	City HRI Designation Classification	Survey Notes	Evaluation Recommendation	Photograph 1	Photograph 2
129	25905065	1965	701 N 1ST ST SAN JOSE 95112-6303	New Formalism	N/A	N/A	N/A	Displays original windows and wall cladding; a mix of replacement and original doors, and new granite tile wall cladding.	Yes

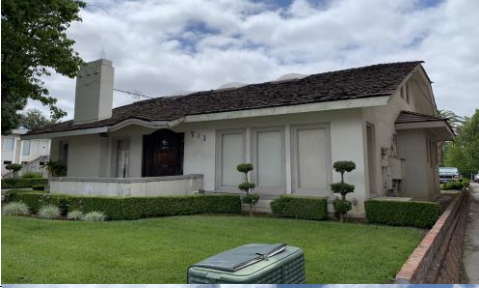
133	25905070	1940	711 N 1ST ST SAN JOSE 95112-6322	French Eclectic	P43-002365	N/A	N/A	Displays original windows, doors, and a wood shingle roof. Evaluated in 2000 as ineligible for listing in the National Register and California Register.	Yes

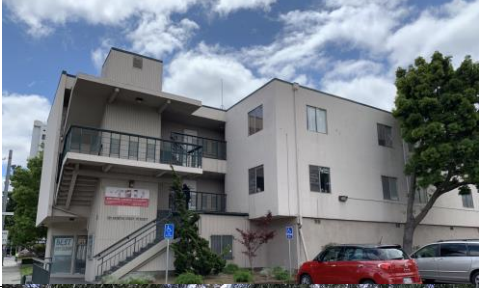
134	25905058	1962	715 N 1ST ST SAN JOSE 95112-6309	Contemporary	N/A	N/A	N/A	Displays original windows and doors.	Yes

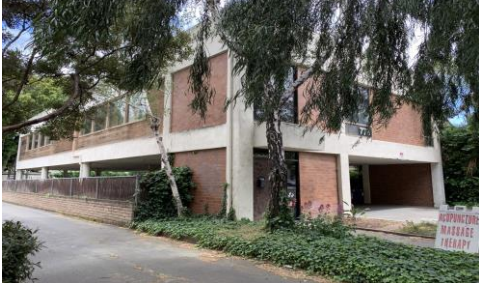
137	24901027	0	778 N 1ST ST SAN JOSE 95112-6302	Contemporary	N/A	N/A	N/A	Displays a pier foundation, and original doors, windows, and wood and stucco cladding.	Yes

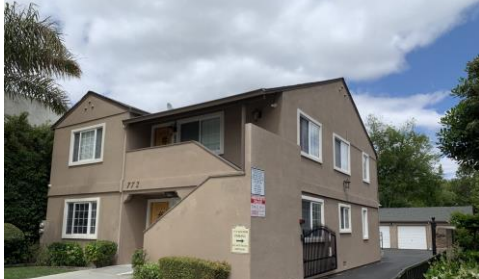
Map Ref #	APN	Built Date (circa)	Address	Architectural Style	Primary Number	OHP Status Code	City HRI Designation Classification	Survey Notes	Evaluation Recommendation	Photograph 1	Photograph 2
138	24901026	1946	772 N 1ST ST SAN JOSE 95112-6302	Minimal Traditional	N/A	N/A	N/A	Displays new stucco wall cladding, windows and doors.	Yes

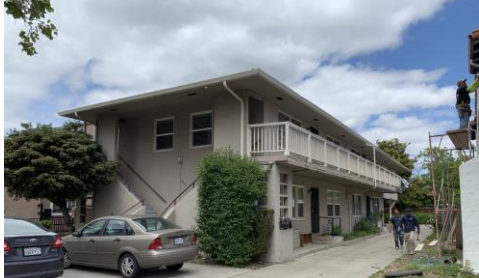
139	24901025	1950	766 N 1ST ST SAN JOSE 95112-6330	Minimal Traditional	N/A	N/A	N/A	Displays replacement windows.	Yes

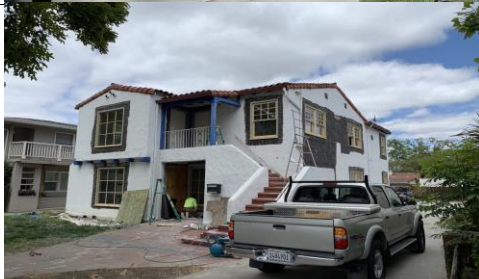
140	24901024	1941	760 N 1ST ST SAN JOSE 95112-6302	Spanish Colonial Revival	N/A	N/A	N/A	Installation of new windows, doors, and wall cladding during time of survey.	Yes

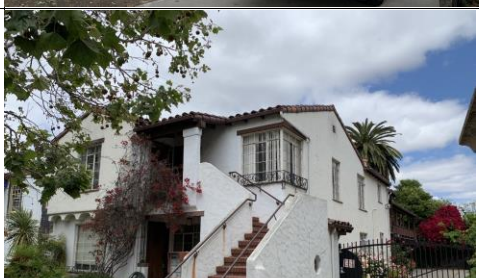
141	24901023	1941	754 N 1ST ST SAN JOSE 95112-6325	Spanish Colonial Revival	N/A	N/A	N/A	Displays original windows, doors, and exterior staircase.	Yes

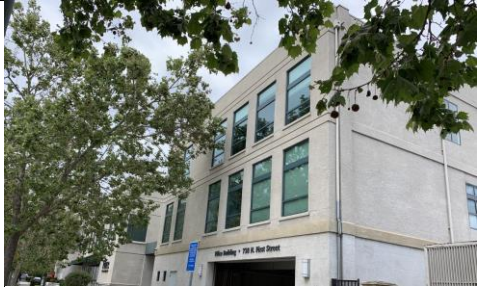
Map Ref #	APN	Built Date (circa)	Address	Architectural Style	Primary Number	OHP Status Code	City HRI Designation Classification	Survey Notes	Evaluation Recommendation	Photograph 1	Photograph 2
142	24901070	2000	738 N 1ST ST SAN JOSE 95112-6302	N/A	N/A	N/A	N/A	Built circa 2000.	No

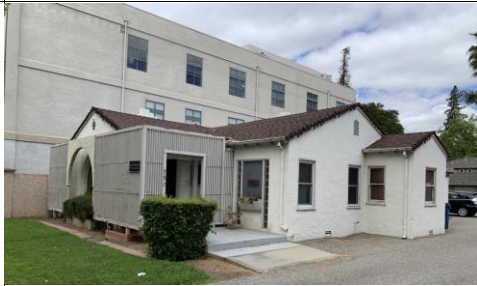
143	24901019	1934	730 N 1ST ST SAN JOSE 95112-6302	Spanish Colonial Revival	N/A	N/A	N/A	Displays curtain wall addition on façade and original windows.	Yes

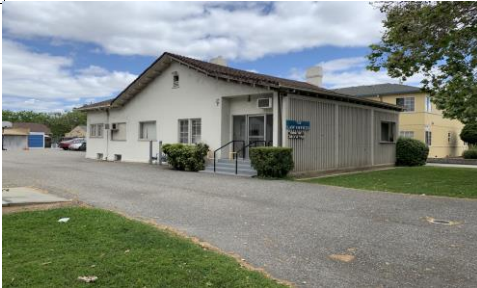
144	24901018	1920	724 N 1ST ST SAN JOSE 95112-6302	N/A	N/A	N/A	N/A	Displays curtain wall addition on façade, altered entry location, replacement stucco, and original wood windows.	No

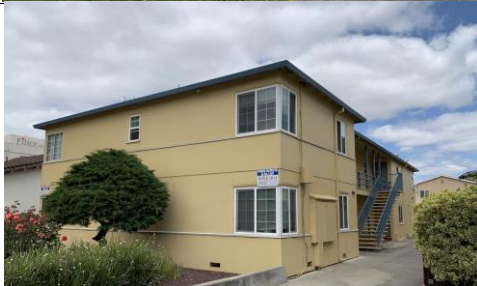
145	24901017	1948	716 N 1ST ST SAN JOSE 95112-6324	Minimal Traditional	N/A	N/A	N/A	Displays replacement vinyl windows.	Yes

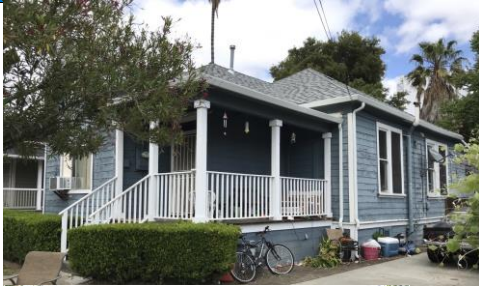
Map Ref #	APN	Built Date (circa)	Address	Architectural Style	Primary Number	OHP Status Code	City HRI Designation Classification	Survey Notes	Evaluation Recommendation	Photograph 1	Photograph 2
151	25918002	1910	664 N SAN PEDRO ST SAN JOSE 95110-2125	Greek Revival	N/A	N/A	N/A	Residence dates to circa 1910 and displays original wall cladding and mix of original and replacement windows.	Yes

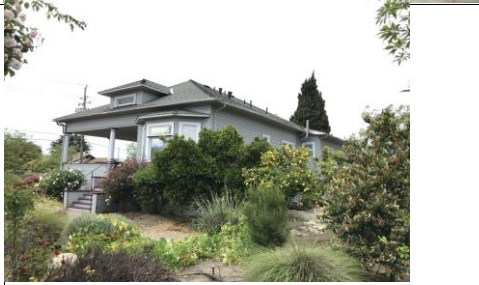
152	25918001	1915	145 GEORGE ST SAN JOSE 95110-2116	Folk Victorian and Colonial Revival	N/A	N/A	N/A	Displays original windows, doors, wall cladding and decorative elements. Built circa 1915.	Yes

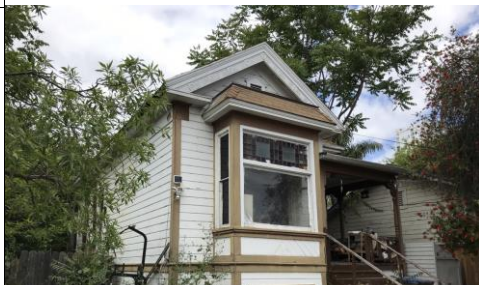
153	25918020	1910	141 GEORGE ST SAN JOSE 95110-2116	Greek Revival	N/A	N/A	N/A	Displays original wall cladding, windows, and a replacement door. The bay window appears to be a later addition.	Yes

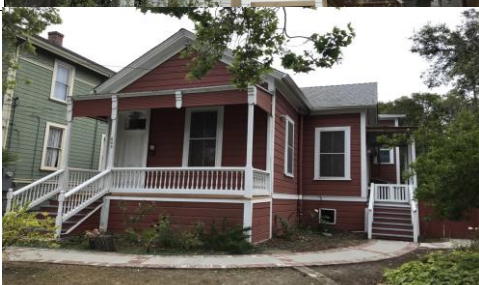
154	25918016	1890	665 MILLER ST SAN JOSE 95110-2119	Folk	N/A	N/A	IS	Displays original windows, doors and wall cladding, with addition off the west elevation. Building dates to circa 1890. This resource is listed in the City's Historic Resources Inventory as an Identified Structure.	Yes

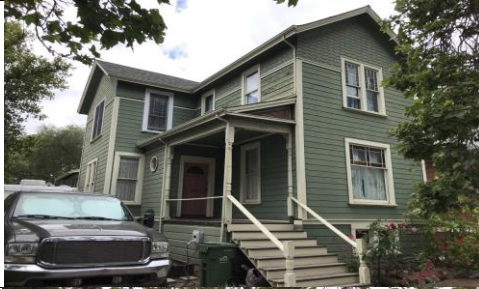
Map Ref #	APN	Built Date (circa)	Address	Architectural Style	Primary Number	OHP Status Code	City HRI Designation Classification	Survey Notes	Evaluation Recommendation	Photograph 1	Photograph 2
155	25918017	1900	663 MILLER ST SAN JOSE 95110-2119	Folk Victorian	N/A	N/A	IS	Displays original windows, door and wall cladding. Dates to circa 1900. This resource is listed in the City's Historic Resources Inventory as an Identified Structure.	Yes

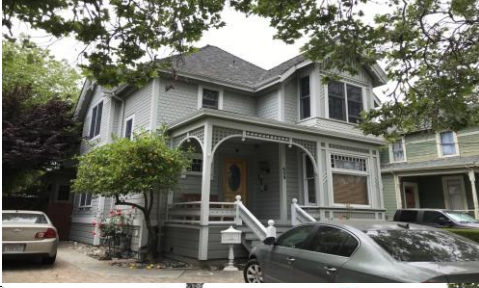
156	25918018	1900	659 MILLER ST SAN JOSE 95110-2119	Queen Anne	N/A	N/A	IS	Displays a replacement facade door and original wall cladding, windows, and decorative elements. Porch decorative detailing may not be original. An addition is located off the west elevation. Built circa 1900. This resource is listed in the City's Historic Resources Inventory as an Identified Structure.	Yes

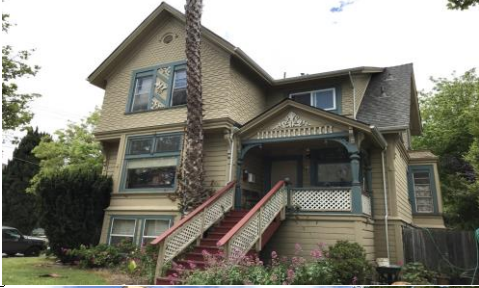
157	25918019	1900	651 MILLER ST SAN JOSE 95110-2119	Queen Anne	N/A	N/A	IS	This property includes two buildings: a circa 1900 Queen Anne-style residence and a circa 1965 Minimal Traditional-style duplex. Both have original wall cladding, replacement doors, and a mix of replacement and original windows. This resource is listed in the City's Historic Resources Inventory as an Identified Structure.	Yes

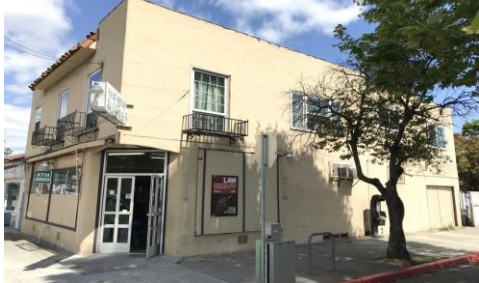
159	25918039	1931	148 GEORGE ST SAN JOSE 95110-2115	Mission	N/A	N/A	N/A	Displays replacement windows and doors and partial wall cladding replacement on the north elevation.	Yes

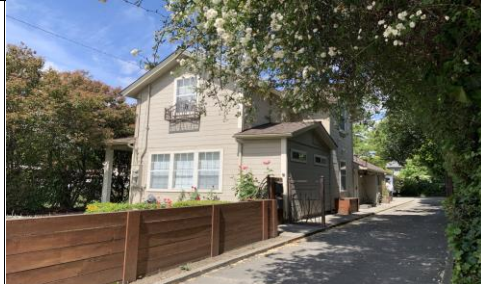
Map Ref #	APN	Built Date (circa)	Address	Architectural Style	Primary Number	OHP Status Code	City HRI Designation Classification	Survey Notes	Evaluation Recommendation	Photograph 1	Photograph 2
170	25918038	0	638 N SAN PEDRO ST SAN JOSE 95110-2262	N/A	N/A	N/A	N/A	Possibly a circa 1900 residence recently renovated. Displays new wall cladding, windows, and doors. No original decorative features remain.	No

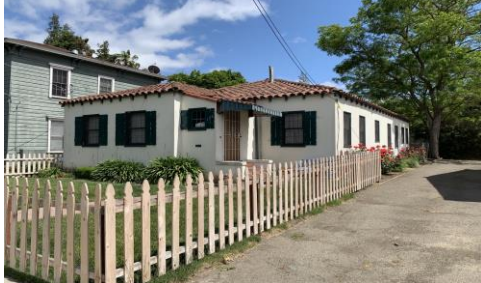
171	25918042	1931	126 GEORGE ST SAN JOSE 95110-2115	Minimal Traditional	N/A	N/A	N/A	Displays original windows and wall cladding.	Yes

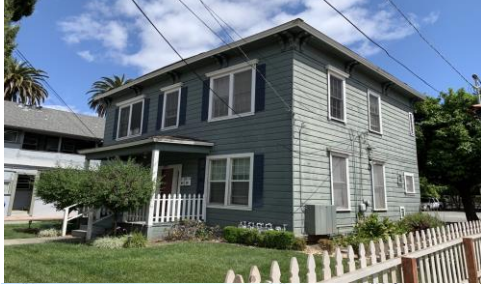
172	25918043	1900	112 GEORGE ST SAN JOSE 95110-2115	Italianate	N/A	N/A	IS	Displays a mix of replacement and original windows, original wide wood board siding, and a replacement railing. Dates to circa 1900. This resource is listed in the City's Historic Resources Inventory as an Identified Structure.	Yes

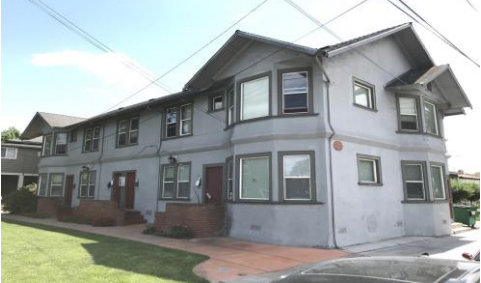
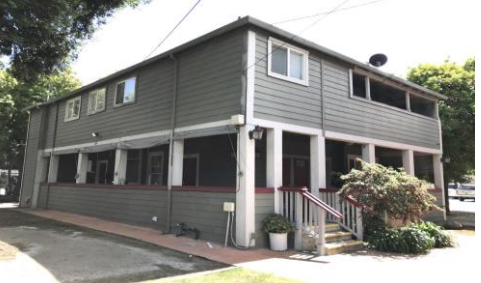
173	25918044	1925	80 GEORGE ST SAN JOSE 95110-2112	None	N/A	N/A	N/A	The property contains two buildings: a circa 1900 and circa 1925 multi-family building. The circa 1900 residence was likely converted to apartments around 1950. It displays major alterations to the windows, wall cladding, and fenestration patterns, as well as the addition of large porches on the west side of the building. The building may have once represented the Queen Anne style, but many of the character-defining features of the style no longer remain. The circa 1925 styleless apartment building displays window and door alterations.	No

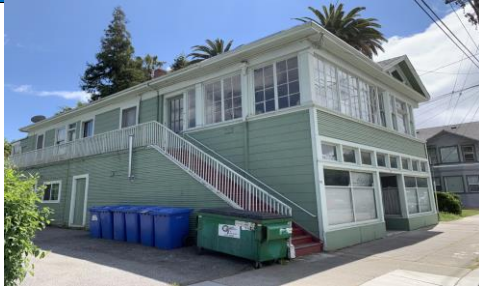
Map Ref #	APN	Built Date (circa)	Address	Architectural Style	Primary Number	OHP Status Code	City HRI Designation Classification	Survey Notes	Evaluation Recommendation	Photograph 1	Photograph 2
174	25918045	1912	68 GEORGE ST SAN JOSE 95110-2112	Queen Anne	N/A	N/A	N/A	Displays original windows, storefront, replacement asbestos siding, and some original triple bevel wood siding. It is unclear if the building originally displayed this ground plan or if it displays an addition dating to the early 20th century.	Yes

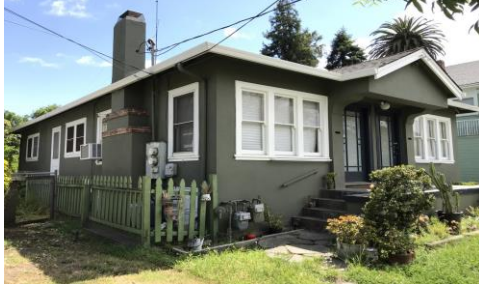
175	25918046	1927	64 GEORGE ST SAN JOSE 95110-2112	Prairie	N/A	N/A	N/A	Displays original windows and doors, and replacement stucco wall cladding. The façade entry is likely a reconfiguration for a duplex conversion completed at an unknown date.	Yes

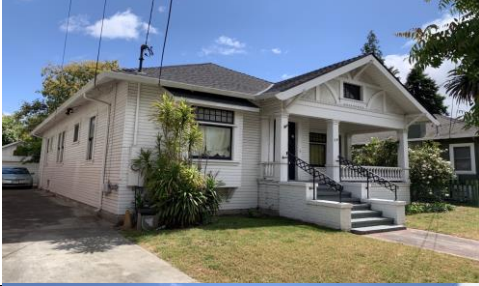
176	25918047	1920	54 GEORGE ST SAN JOSE 95110-2112	Craftsman	N/A	N/A	IS	Displays original windows, double beveled wall cladding, and door, as well as replacement stucco in gable and staircase railing. This resource is listed in the City's Historic Resources Inventory as an Identified Structure.	Yes

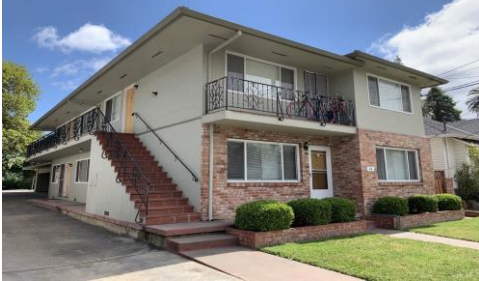
177	25918048	1958	44 GEORGE ST SAN JOSE 95110-2114	Minimal Traditional	N/A	N/A	N/A	Displays replacement windows and original wood doors.	Yes

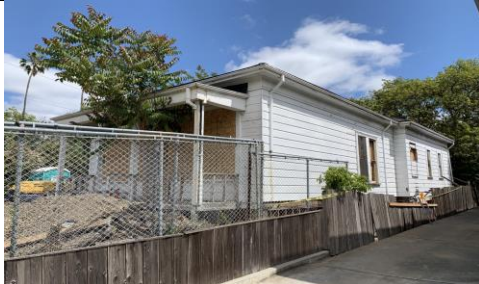
Map Ref #	APN	Built Date (circa)	Address	Architectural Style	Primary Number	OHP Status Code	City HRI Designation Classification	Survey Notes	Evaluation Recommendation	Photograph 1	Photograph 2
178	25918049	1910	34 GEORGE ST SAN JOSE 95110-2112	Folk	N/A	N/A	IS	Under construction during the survey. Displays original wide wood board wall cladding and wood double hung windows. Some window glazing missing. Foundation work in progress. Dates to circa 1910. This resource is listed in the City's Historic Resources Inventory as an Identified Structure.	Yes

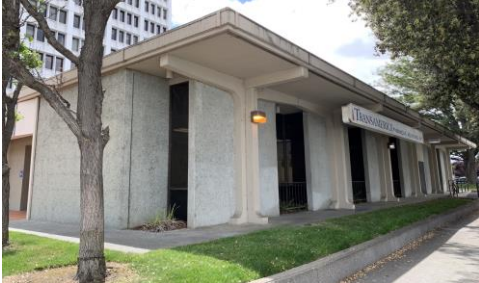
183	25918061	1966	675 N 1ST ST SAN JOSE 95112-5118	Corporate Modern, New Formalism	N/A	N/A	N/A	Three buildings on the property.	Yes

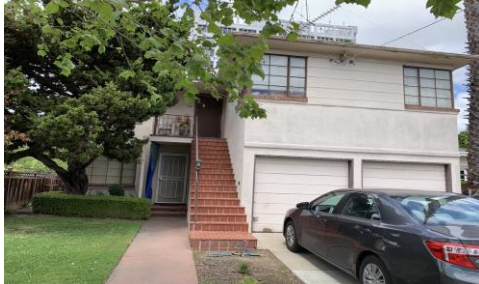
185	25918033	1941	35 GEORGE ST SAN JOSE 95110-2113	Contemporary	N/A	N/A	N/A	Displays original windows and possible cladding replacement.	Yes

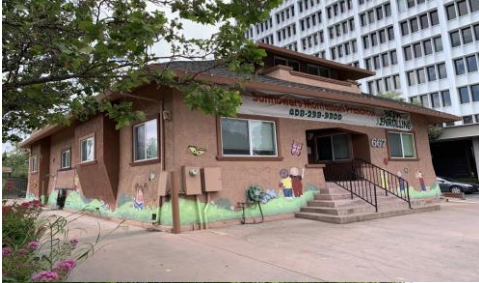
186	25918066	1901	667 N 1ST ST SAN JOSE 95112-5117	N/A	N/A	7R	N/A	Displays replacement windows, doors, wall cladding, window frames, and staircase.	No

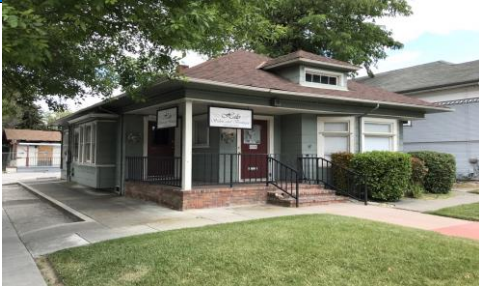
Map Ref #	APN	Built Date (circa)	Address	Architectural Style	Primary Number	OHP Status Code	City HRI Designation Classification	Survey Notes	Evaluation Recommendation	Photograph 1	Photograph 2
188	24942070	1915	698 N 1ST ST SAN JOSE 95112-5109	Folk Victorian	N/A	3D	N/A	Displays original windows, doors, and wall cladding.	Yes

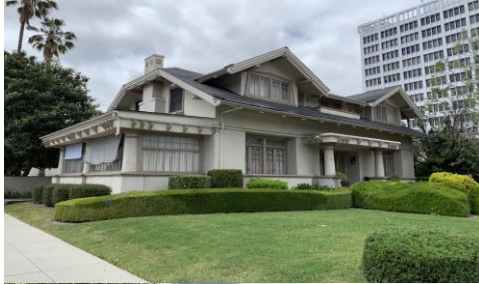
189	25918032	1920	651 N 1ST ST SAN JOSE 95112-5117	Craftsman and Colonial Revival	N/A	7R	CS	Displays original windows and doors. Replacement stucco dates to circa 1980s. This resource is listed in the City's Historic Resources Inventory as a Contributing Structure.	Yes

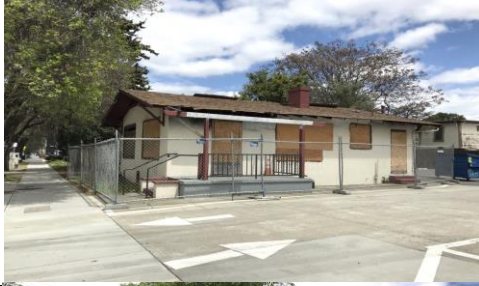
190	24942071	1920	20 E TAYLOR ST SAN JOSE 95112-5007	Craftsman	N/A	7R	N/A	The building's interior, windows, and doors were destroyed by fire at an unknown date.	No

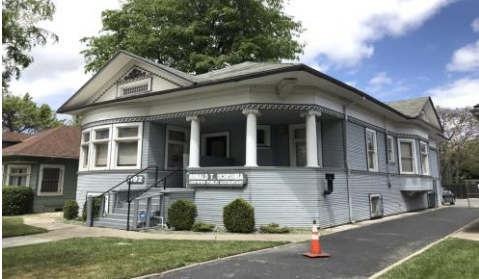
191	24942069	1906	692 N 1ST ST SAN JOSE 95112-5109	Folk Victorian and Colonial Revival	N/A	7R	N/A	Displays original windows, doors, wall cladding, and decorative elements.	Yes

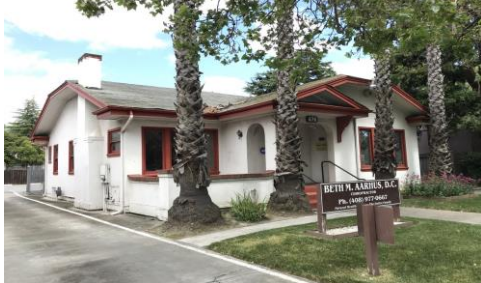
Map Ref #	APN	Built Date (circa)	Address	Architectural Style	Primary Number	OHP Status Code	City HRI Designation Classification	Survey Notes	Evaluation Recommendation	Photograph 1	Photograph 2
192	24942068	1918	684 N 1ST ST SAN JOSE 95112-5109	Prairie	N/A	7R	N/A	Displays original doors and windows, and replacement stucco wall cladding.	Yes	 	
193	24942067	1920	678 N 1ST ST SAN JOSE 95112-5109	Dutch Colonial Revival	N/A	7R	N/A	Displays original doors and windows, and replacement stucco wall cladding.	Yes

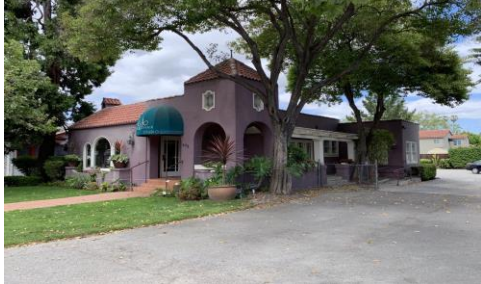
194	24942086	1922	672 N 1ST ST SAN JOSE 95112-5109	Spanish Colonial Revival	N/A	7R	N/A	Displays original doors, windows, and bell tower.	Yes

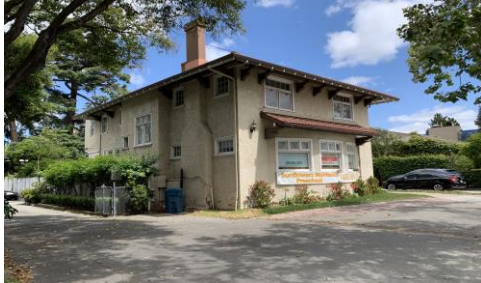
195	24942065	1908	668 N 1ST ST SAN JOSE 95112-5109	Craftsman	N/A	3D	CS	Displays replacement stucco, original windows, and doors. Listed in the City's Historic Resources Inventory as a Contributing Structure.	Yes

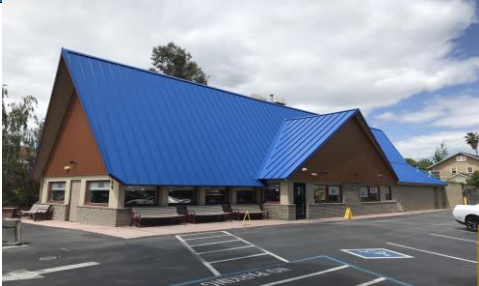
Map Ref #	APN	Built Date (circa)	Address	Architectural Style	Primary Number	OHP Status Code	City HRI Designation Classification	Survey Notes	Evaluation Recommendation	Photograph 1	Photograph 2
198	24942073	1964	644 N 1ST ST SAN JOSE 95112-5109	A-frame	N/A	7R	N/A	Displays original windows, doors, and wall cladding, and replacement gable metal cladding.	Yes

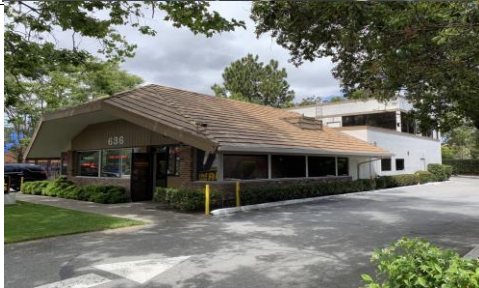
199	24942079	1969	636 N 1ST ST SAN JOSE 95112-5109	Contemporary	N/A	7R	N/A	Displays prominent roofline, original windows, and doors. Possible addition at rear.	Yes
