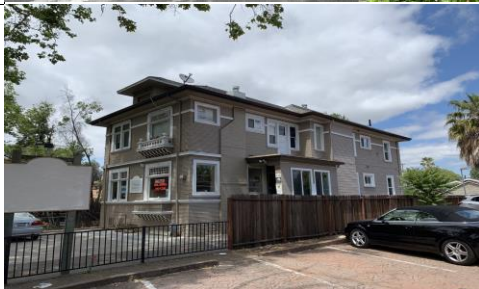
200	24942057	1905	638 N 1ST ST SAN JOSE 95112-5149	Prairie	N/A	7R	CS	Displays original windows, doors, and wall cladding, and altered entryway. Also has address: 630 N 1st Street. Listed in the City's Historic Resources Inventory as a Contributing Structure.	Yes

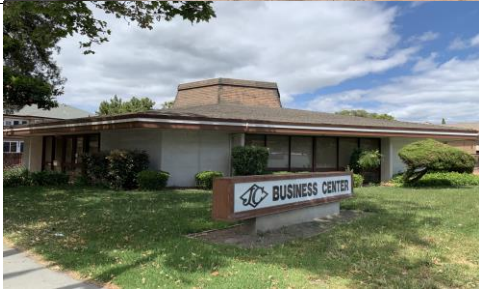
201, 202	24942075 24942074	1968	606 N 1ST ST SAN JOSE 95112-5109	Contemporary	N/A	7R	N/A	Display original wall cladding, roofline, windows, doors, and prominent roofline.	Yes

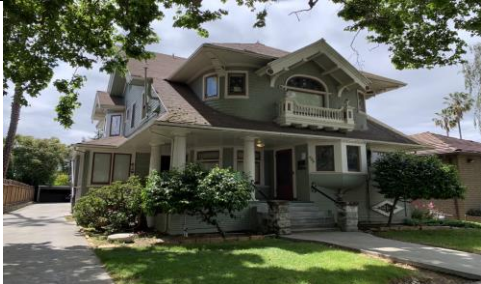
Map Ref #	APN	Built Date (circa)	Address	Architectural Style	Primary Number	OHP Status Code	City HRI Designation Classification	Survey Notes	Evaluation Recommendation	Photograph 1	Photograph 2
203	25918052	1900	629 N 1ST ST SAN JOSE 95112-5135	Queen Anne	N/A	7R	CS	Displays original windows, wall cladding, leaded glass, bay window, decorative dentil molding, and cornice moldings. Highly decorative cornice brackets. Built circa 1900. This resource is listed in the City's Historic Resources Inventory as a Contributing Structure.	Yes

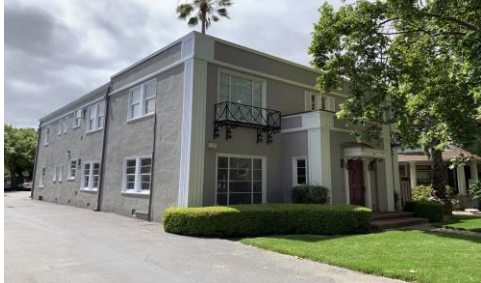
204	25918053	1939	625 N 1ST ST SAN JOSE 95112-5134	Art Deco	N/A	7R	N/A	Displays original windows, molding, and wall cladding.	Yes

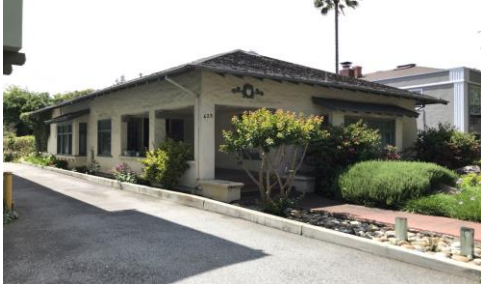
205	25918054	1914	623 N 1ST ST SAN JOSE 95112-5110	Craftsman	N/A	7R	CS	Displays original windows, doors, and wall cladding. This resource is listed in the City's Historic Resources Inventory as a Contributing Structure.	Yes

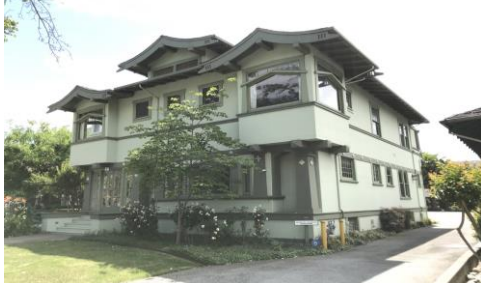
206	25918055	1907	619 N 1ST ST SAN JOSE 95112-5110	Craftsman	N/A	7R	CS	Displays original windows, doors, and wall cladding. This resource is listed in the City's Historic Resources Inventory as a Contributing Structure.	Yes

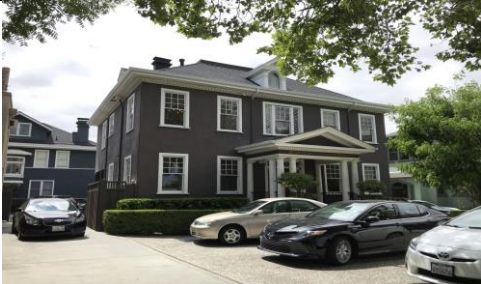
Map Ref #	APN	Built Date (circa)	Address	Architectural Style	Primary Number	OHP Status Code	City HRI Designation Classification	Survey Notes	Evaluation Recommendation	Photograph 1	Photograph 2
207	25918064	1925	607 N 1ST ST SAN JOSE 95112-5110	Colonial Revival	N/A	3D	CS	Karl H. Plate House (aka Carter Waxman Building) Displays original door and windows with replacement stucco wall cladding. This resource is listed in the City's Historic Resources Inventory as a Contributing Structure.	Yes

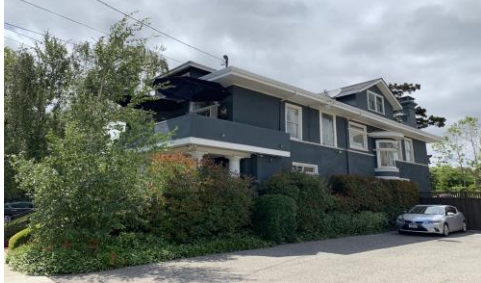
208	25918058	1906	35 HOBSON ST SAN JOSE 95110-2252	Colonial Revival	N/A	N/A	N/A	Displays a mix of original and replacement windows, and replacement stucco.	Yes

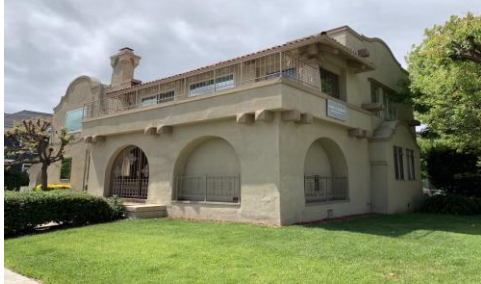
209	25918057	1907	601 N 1ST ST SAN JOSE 95112-5110	Mission	N/A	7R	CS	Displays replacement windows, doors, and stucco. This resource is listed in the City's Historic Resources Inventory as a Contributing Structure.	Yes

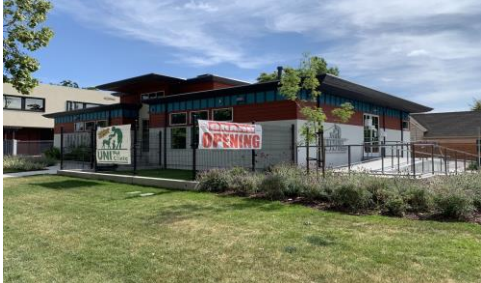
210	25919103	1975	595 N 1ST ST SAN JOSE 95112-5314	Contemporary	N/A	7R	N/A	Appears recently renovated.	Yes

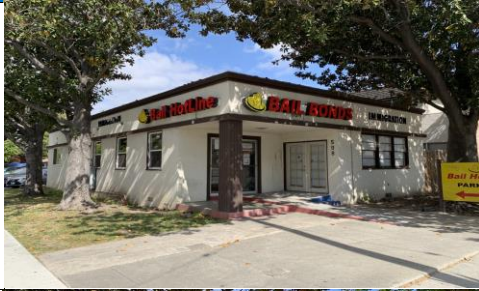
Map Ref #	APN	Built Date (circa)	Address	Architectural Style	Primary Number	OHP Status Code	City HRI Designation Classification	Survey Notes	Evaluation Recommendation	Photograph 1	Photograph 2
211	24943051	1947	588 N 1ST ST SAN JOSE 95112-5319	Minimal Traditional	N/A	7R	N/A	Displays original windows and replacement entry doors.	Yes

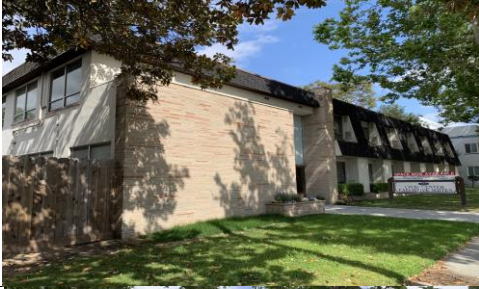
212	24943050	1947	588 N 1ST ST SAN JOSE 95112-5327	Mansard	N/A	7R	N/A	Displays replacement windows and doors. Composite shingle on the mansard roof.	Yes

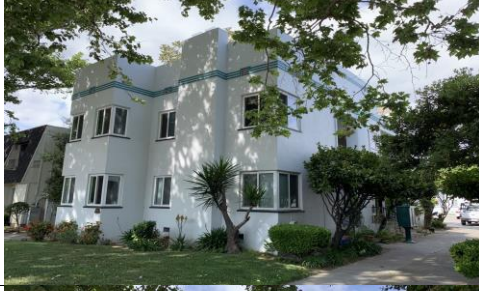
213	24943049	1936	576 N 1ST ST SAN JOSE 95112-5349	Streamline Moderne	N/A	7R	N/A	Name: "The Maxwell." Displays replacement windows.	Yes

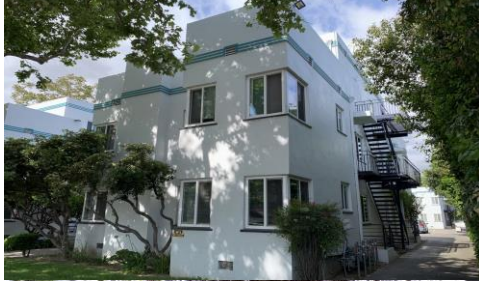
214	24943048	1936	568 N 1ST ST SAN JOSE 95112-5348	Streamline Moderne	N/A	7R	CS	Name: "The Maxwell." Displays replacement windows. Listed in the City's Historic Resources Inventory as a Contributing Structure.	Yes

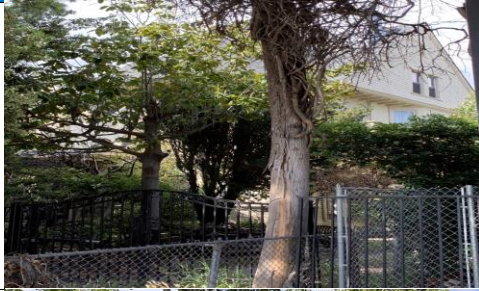
Map Ref #	APN	Built Date (circa)	Address	Architectural Style	Primary Number	OHP Status Code	City HRI Designation Classification	Survey Notes	Evaluation Recommendation	Photograph 1	Photograph 2
215	24943047	1901	560 N 1ST ST SAN JOSE 95112-5319	Unknown	N/A	7R	CS	Building obscured by vegetation. Cannot provide description. Listed in the City's Historic Resources Inventory as a Contributing Structure.	Yes

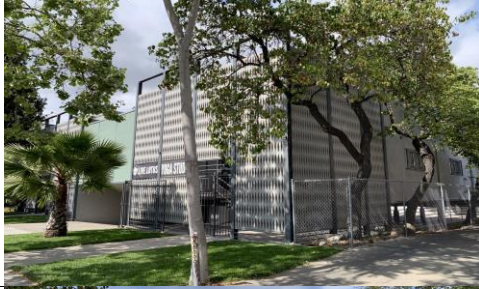
216	24943083	1961	556 N 1ST ST SAN JOSE 95112-5300	Contemporary	N/A	7R	N/A	Displays original concrete curtain wall, concrete pier foundation, windows, and doors.	Yes

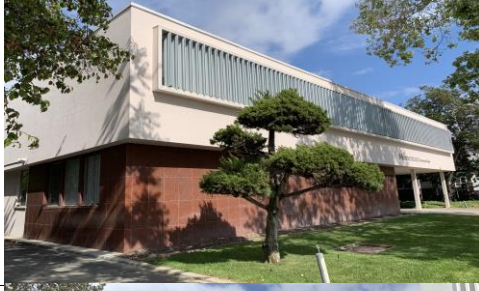
217	24943045	1959	540 N 1ST ST SAN JOSE 95112-5319	International	N/A	7R	N/A	Displays original aluminum windows and doors, and stone wall cladding.	Yes

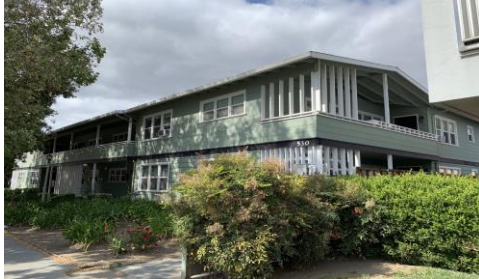
218	24943042	1948	523 N 2ND ST SAN JOSE 95112-5316	Ranch	N/A	N/A	N/A	Displays replacement vinyl windows.	Yes

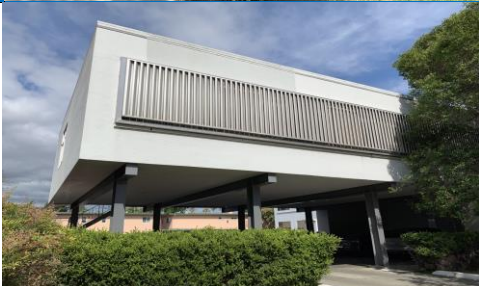
Map Ref #	APN	Built Date (circa)	Address	Architectural Style	Primary Number	OHP Status Code	City HRI Designation Classification	Survey Notes	Evaluation Recommendation	Photograph 1	Photograph 2
219	24943044	1965	510 N 1ST ST SAN JOSE 95112-5321	International	N/A	N/A	N/A	Name: "Empire Building." Displays original windows, doors, and metal shade structures. Built circa 1965.	Yes

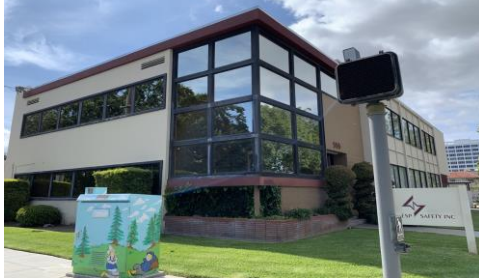
220	25919098	1968	555 N 1ST ST SAN JOSE 95112-5326	Corporate Modern	N/A	7R	N/A	Displays original wall cladding, brick veneer, windows, and possibly replacement door.	Yes

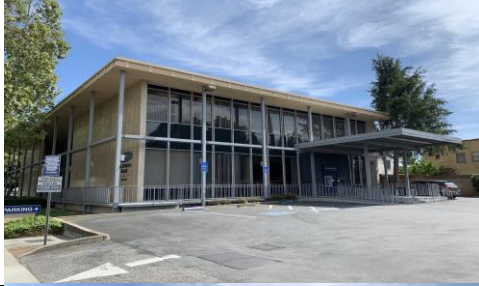
222	25919104	1962	515 N 1ST ST SAN JOSE 95112-5320	International	N/A	7R	N/A	Displays original stone cladding, windows, and doors.	Yes

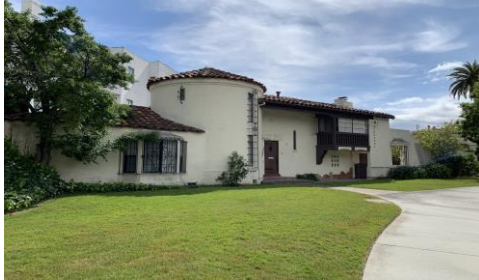
223	25919061	1936	16 AYER AVE SAN JOSE 95110-2201	Spanish Colonial Revival	N/A	7R	CS	Displays replacement and original windows. This resource is listed in the City's Historic Resources Inventory as a Contributing Structure.	Yes

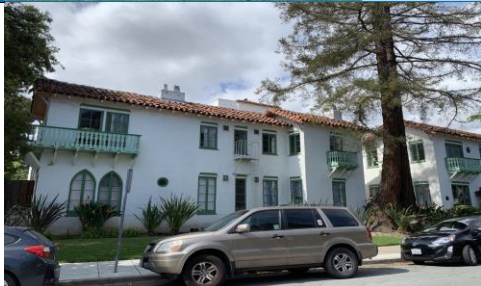
Map Ref #	APN	Built Date (circa)	Address	Architectural Style	Primary Number	OHP Status Code	City HRI Designation Classification	Survey Notes	Evaluation Recommendation	Photograph 1	Photograph 2
224	25919062	1932	15 HAWTHORNE WAY SAN JOSE 95110-2247	Spanish Colonial Revival	N/A	5S2	CS	Displays original windows, doors, and balconies. This resource is listed in the City's Historic Resources Inventory as a Contributing Structure.	Yes

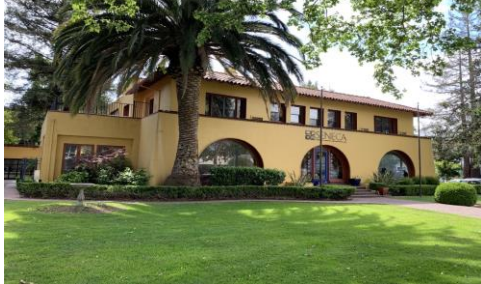
225	25919086	1917	485 N 1ST ST SAN JOSE 95112-4041	Spanish Colonial Revival	N/A	N/A	CS	The McMahon Building displays original door and replacement windows. This resource is listed in the City's Historic Resources Inventory as a Contributing Structure.	Yes

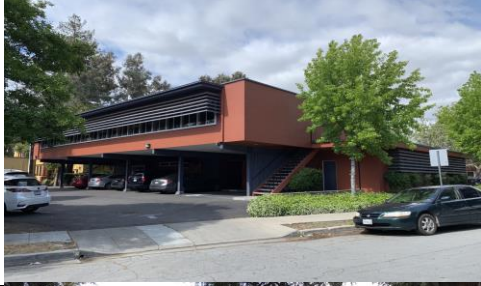
226	25919087	1955	481 N 1ST ST SAN JOSE 95112-4031	International	N/A	N/A	N/A	Displays original windows, doors, and rock veneer.	Yes

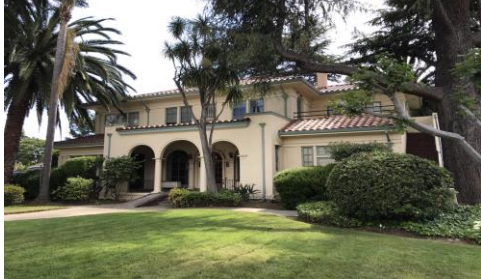
227	25920013	1925	475 N 1ST ST SAN JOSE 95112-4018	Spanish Colonial Revival	N/A	7N	CS	Displays original windows, doors and wall cladding. This resource is listed in the City's Historic Resources Inventory as a Contributing Structure.	Yes

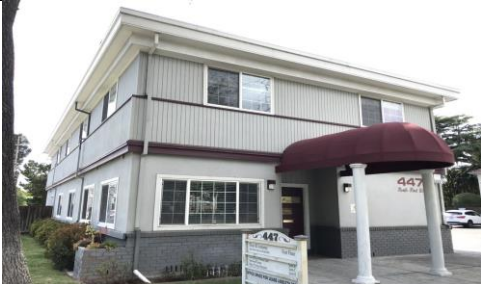
Map Ref #	APN	Built Date (circa)	Address	Architectural Style	Primary Number	OHP Status Code	City HRI Designation Classification	Survey Notes	Evaluation Recommendation	Photograph 1	Photograph 2
231	25920015	1955	447 N 1ST ST SAN JOSE 95112-4018	Minimal Traditional	N/A	N/A	N/A	Displays replacement windows and doors, and replacement wall cladding on second story.	Yes

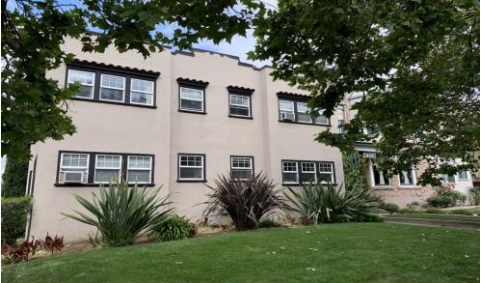
232	24944044	1920	20 HENSLEY ST SAN JOSE 95112-4026	Mission	N/A	N/A	N/A	Displays replacement windows.	Yes

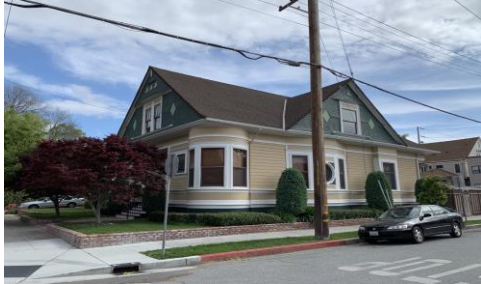
233	24944067	1890	447 N 2ND ST SAN JOSE 95112-4012	Queen Anne	N/A	N/A	CS	Displays original windows and doors. Built circa 1890. Listed in the City's Historic Resources Inventory as a Contributing Structure.	Yes

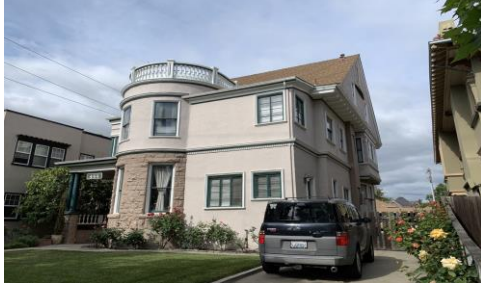
234	24944045	1890	444 N 1ST ST SAN JOSE 95112-4001	Shingle and Richardsonian Romanesque	N/A	N/A	CS	Displays original windows and doors. Large facade addition with stucco cladding. Original cladding was wood shingle. Built circa 1890. Listed in the City's Historic Resources Inventory as a Contributing Structure.	Yes

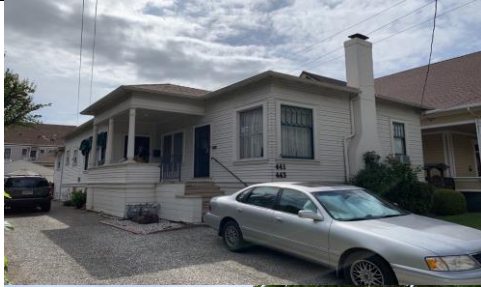
Map Ref #	APN	Built Date (circa)	Address	Architectural Style	Primary Number	OHP Status Code	City HRI Designation Classification	Survey Notes	Evaluation Recommendation	Photograph 1	Photograph 2
235	24944066	1890	443 N 2ND ST SAN JOSE 95112-4012	Folk	N/A	N/A	IS	Displays original and replacement windows. Built circa 1890. Listed in the City's Historic Resources Inventory as an Identified Structure.	Yes

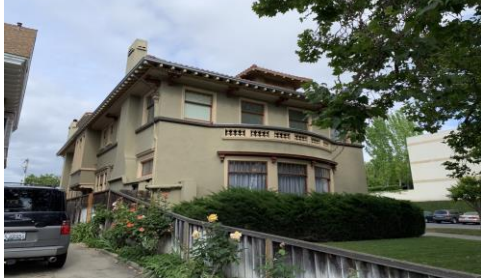
236	24944068	1915	440 N 1ST ST SAN JOSE 95112-4024	Craftsman and Mission	N/A	N/A	N/A	Displays original windows and doors with large addition of rear.	Yes

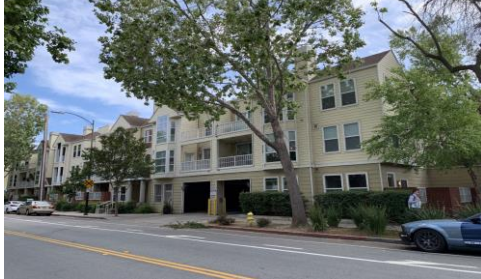
237		1990		N/A	N/A	N/A	N/A	Circa 1990 apartment complex.	No

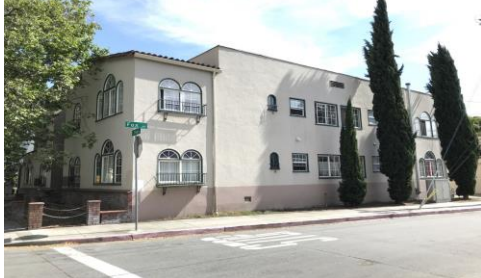
239	25920043	1924	445 N 1ST ST SAN JOSE 95112-4030	Mission and Beaux Arts	N/A	N/A	CS	Displays replacement vinyl windows, original doors, and mostly original wall cladding with recent brick cladding added to east elevation. This resource is listed in the City's Historic Resources Inventory as a Contributing Structure.	Yes

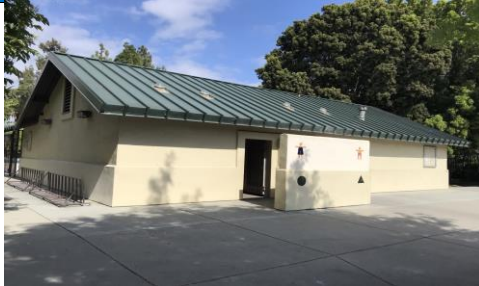
Map Ref #	APN	Built Date (circa)	Address	Architectural Style	Primary Number	OHP Status Code	City HRI Designation Classification	Survey Notes	Evaluation Recommendation	Photograph 1	Photograph 2
241	25920045	1940	Ryland Park	None	N/A	N/A	CCL	<p>Ryland Park includes a playground, pool, pool house, hardscaped areas, and landscaped areas. The park dates to circa 1940. Many features of the park appear to have been renovated in the 2000s.</p> <p>The Ryland Pool was evaluated in 2007 as not eligible for listing in the National Register or California Register, but was identified as a City Landmark candidate and listed in the City's Historic Resources Inventory as such.</p>	No

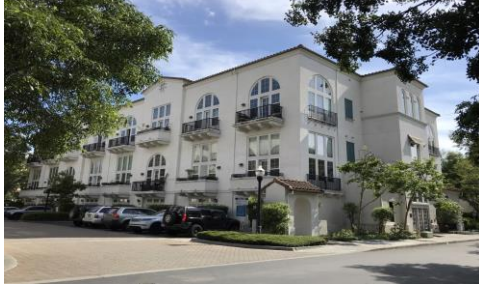
244		1909		N/A	N/A	N/A	N/A	The 1909 building is no longer extant and replaced by a circa 2000 apartment building.	No

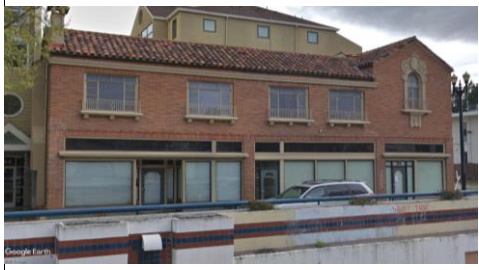
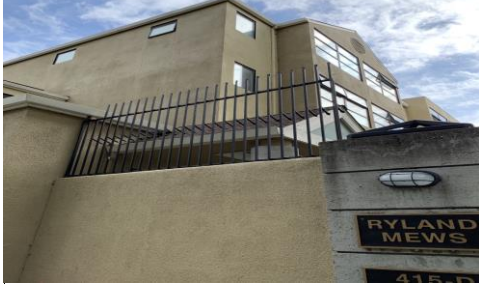
246		1909	396 N 1ST ST SAN JOSE 95112-4050	Spanish Colonial Revival with Beaux Arts detailing	P43-002354	5S2	CLS	The Borchers Bros. 1909 building façade remains extant along North First Street; however, the remainder of the building is a circa 1990 apartment building. Listed in the City's Historic Resources Inventory as a City Landmark.	Yes

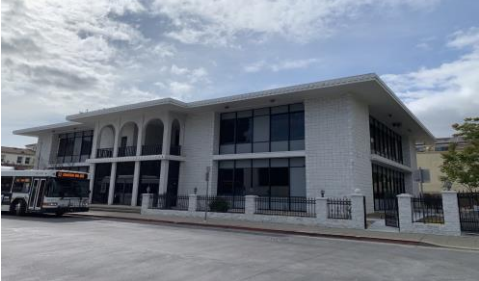
249	24944088	1964	380 N 1ST ST SAN JOSE 95112-4050	New Formalism	N/A	N/A	N/A	Displays original windows, doors, and detailing.	Yes

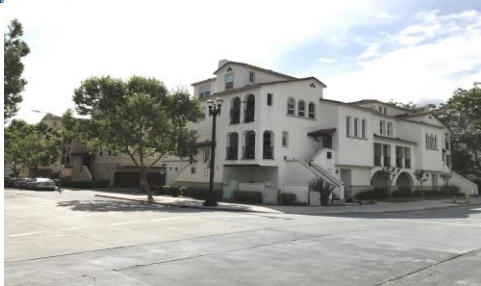
Map Ref #	APN	Built Date (circa)	Address	Architectural Style	Primary Number	OHP Status Code	City HRI Designation Classification	Survey Notes	Evaluation Recommendation	Photograph 1	Photograph 2
251		2007		N/A	N/A	N/A	N/A	The 1909 building was replaced with circa 2007 multi-family housing development.	No

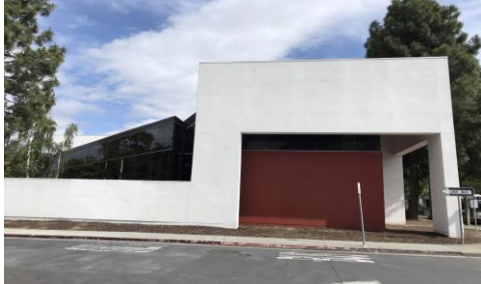
253	24944087	1984	360 N 1ST ST SAN JOSE 95113	N/A	N/A	N/A	N/A	Built between 1980 and 1987.	No

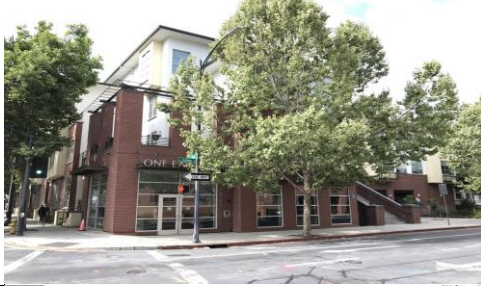
254		2007	1 E JULIAN ST SAN JOSE	N/A	N/A	N/A	N/A	The 1909 building was replaced by a circa 2007 building.	No

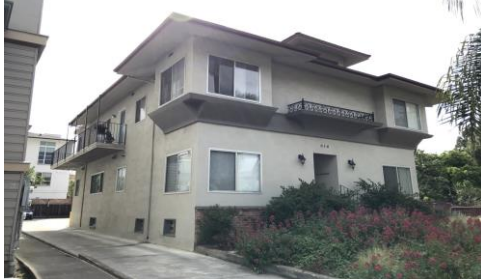
255	24944060	1915	315 N 2ND ST SAN JOSE 95112-4028	Prairie	N/A	N/A	N/A	Displays the original door and replacement vinyl windows and stucco wall cladding. Built circa 1915.	Yes

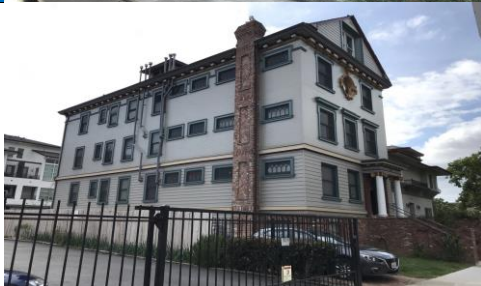
Map Ref #	APN	Built Date (circa)	Address	Architectural Style	Primary Number	OHP Status Code	City HRI Designation Classification	Survey Notes	Evaluation Recommendation	Photograph 1	Photograph 2
256	24944059	1900	311 N 2ND ST SAN JOSE 95112-4003	Classical Revival	N/A	1D, 5S2	NRD: CLS	The Moody Flats Apartments is within a National Register-listed historic district and is a City Landmark.	Yes

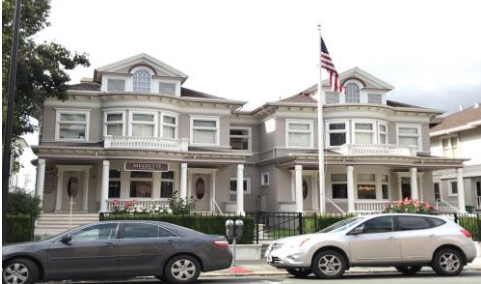
257	24944057	1905	31 E JULIAN ST SAN JOSE 95112-4006	Colonial Revival	N/A	1D, 2S	NRD: CLD	The Nathan Flats & House is within a National Register-listed historic district and within a City Landmark District.	Yes

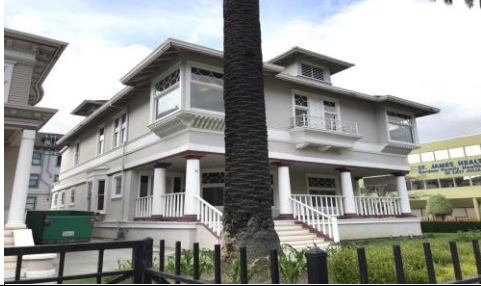
258	24944090	1905	45 E JULIAN ST SAN JOSE 95112-4006	Colonial Revival	N/A	1D	NRD: CLD	Nathan House. Listed in the City's Historic Resources Inventory as being within both a National Register-listed historic district and a City Landmark District.	Yes

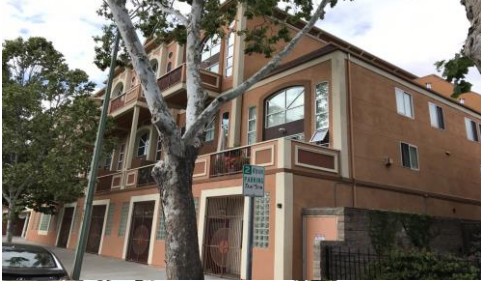
259		2005	350 N 2ND ST SAN JOSE	N/A	N/A	N/A	N/A	The 1909 building was replaced by a building constructed in 2005.	No

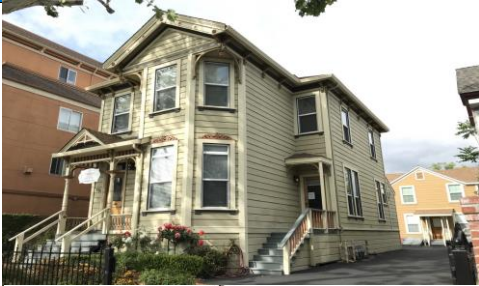
Map Ref #	APN	Built Date (circa)	Address	Architectural Style	Primary Number	OHP Status Code	City HRI Designation Classification	Survey Notes	Evaluation Recommendation	Photograph 1	Photograph 2
264	24944031	1901	336 N 2ND ST SAN JOSE 95112-4015	Queen Anne/Eastlake	N/A	1D	NRD; CLD; CS	Displays original doors and wall cladding, and replacement windows. Built circa 1888. The building is within a National Register-listed historic district and a City Landmark District, as well as listed in the City's Historic Resources Inventory as a Contributing Structure.	Yes

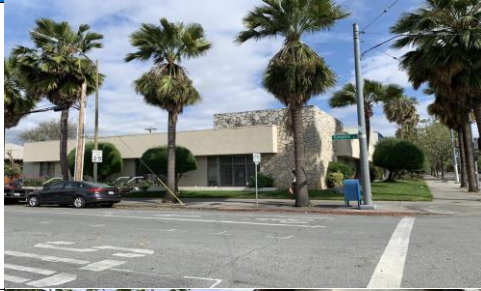
Map Ref #	APN	Built Date (circa)	Address	Architectural Style	Primary Number	OHP Status Code	City HRI Designation Classification	Survey Notes	Evaluation Recommendation	Photograph 1	Photograph 2
269	24943088	1959	490 N 1ST ST SAN JOSE 95112-4043	Contemporary	N/A	7R	N/A	Displays original metal windows and doors.	Yes

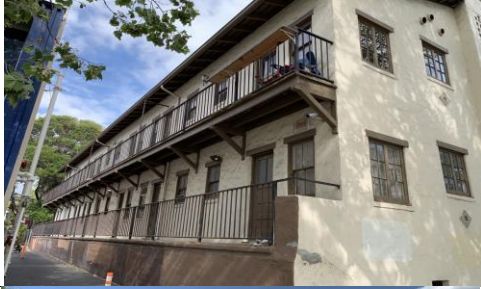
270	24943064	1907	460 N 1ST ST SAN JOSE 95112-4044	Spanish Colonial Revival	N/A	N/A	CS	Mission Court Apartments. Displays original windows and doors. Listed in the City's Historic Resources Inventory as a Contributing Structure.	Yes

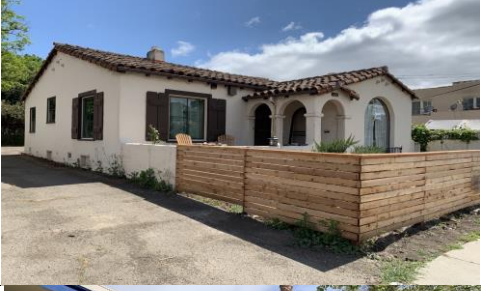
276	25918041	1931	142 GEORGE ST SAN JOSE 95110-2115	Spanish Colonial Revival	N/A	N/A	N/A	Displays replacement and original windows.	Yes

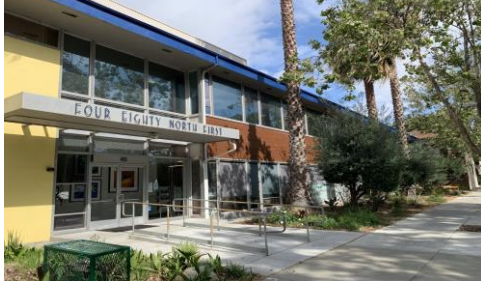
277	24943087	1957	480 N 1ST ST SAN JOSE 95112-4040	International	N/A	N/A	N/A	Connected to 490 North First Street. Displays original windows and doors. May have replacement wall cladding.	Yes

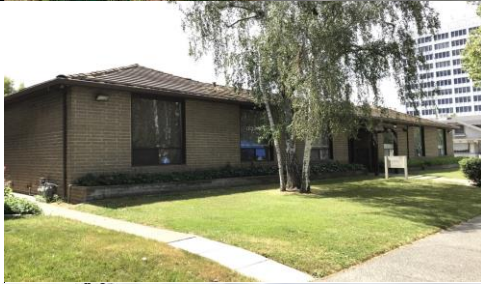
Map Ref #	APN	Built Date (circa)	Address	Architectural Style	Primary Number	OHP Status Code	City HRI Designation Classification	Survey Notes	Evaluation Recommendation	Photograph 1	Photograph 2
179, 180	25918051	1965	633 N 1ST ST SAN JOSE 95112-5110	Ranch	N/A	N/A	N/A	Dates to circa 1965. Original windows, doors and wall cladding.	Yes
