State of California & The Resources Agency
 DEPARTMENT OF PARKS AND RECREATION
PRIMARY RECORD

Page 1 of 36 *Resource Name or #: (Assigned by recorder) 100-104 E. Santa Clara St. San Jose

P1. Other Identifier: Hotel Clariana

B1. Historic Name: San Jose YMCA
 B2. Common Name: Hotel Clariana
 B3. Original Use: Social Organization B4. Present Use: Commercial(Hotel & parking lot)

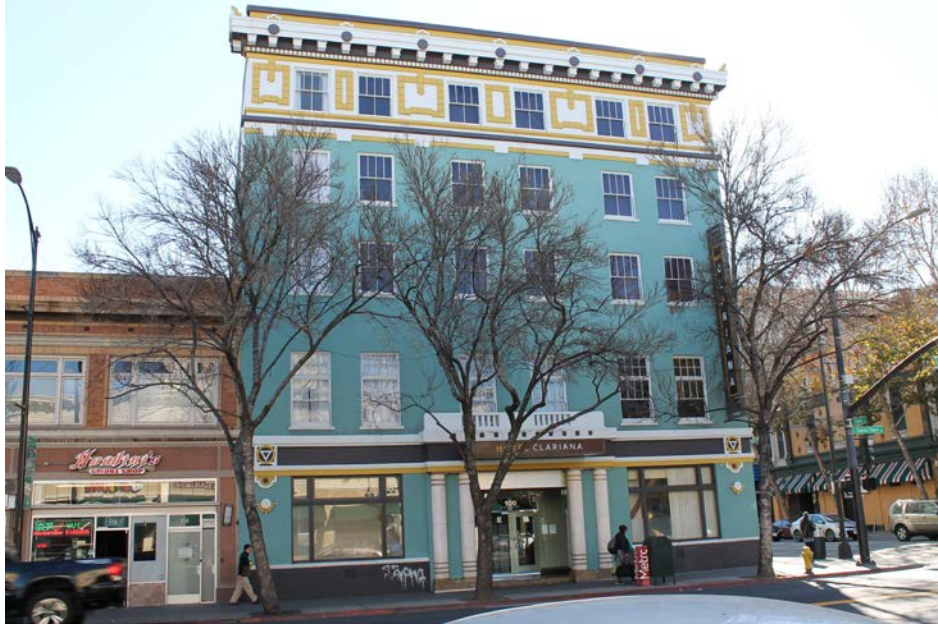
P5a. Photograph or Drawing (Photograph required for buildings, structures, and objects)

P5b. Description of Photo: (view, date, accession #) Front Façade 2016

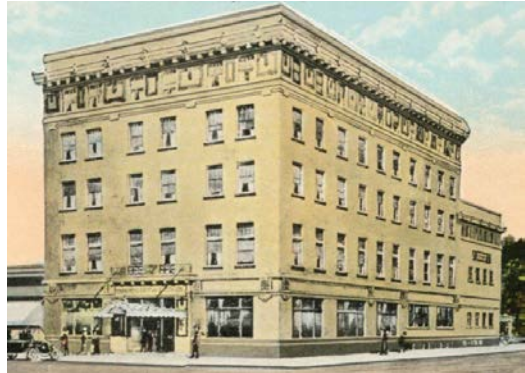
c.1915 Post Card: San Jose YMCA

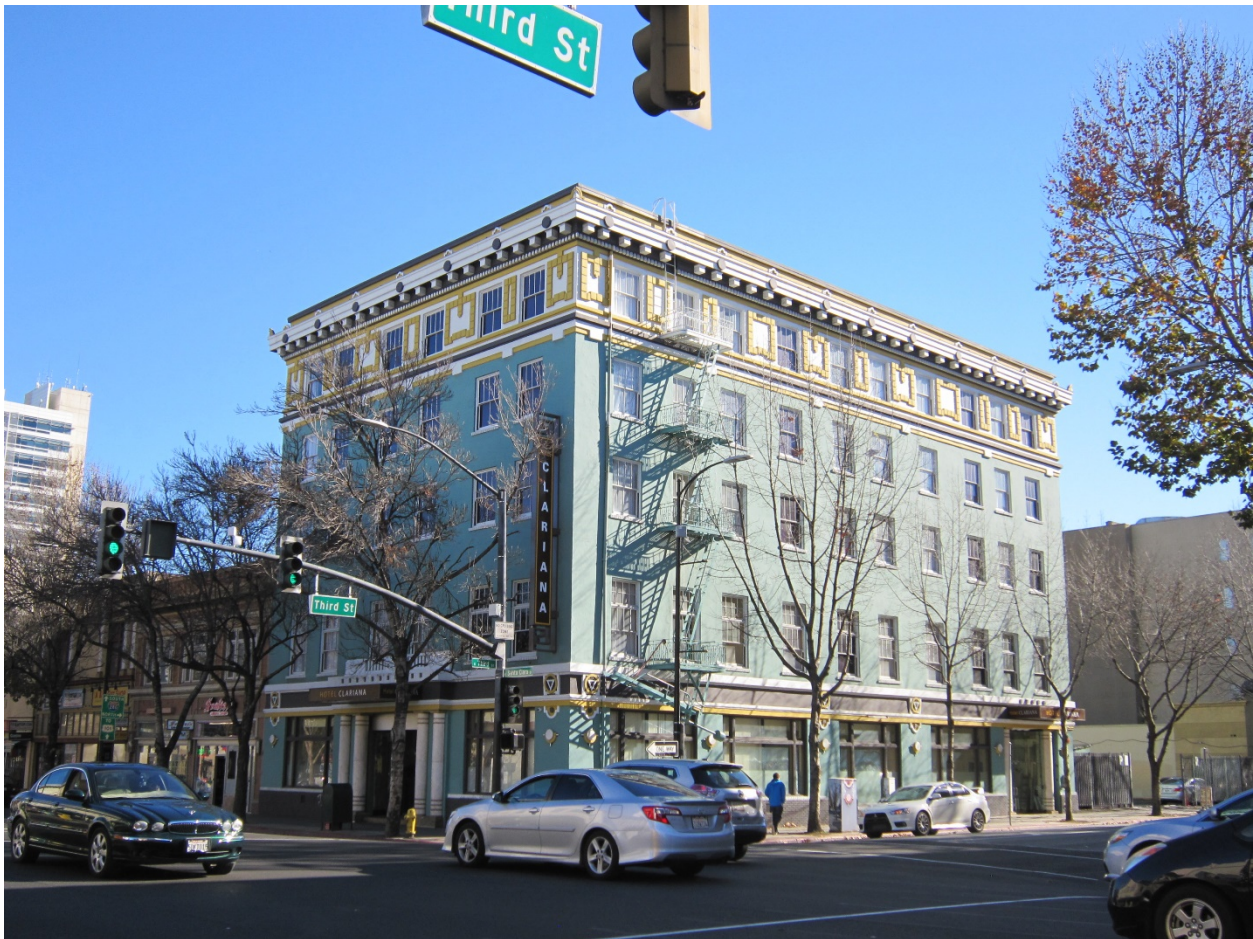
Picture 1 100-104 E. Santa Clara St. (historic YMCA)

View: The corner of E. Santa Clara St. and S. Third Street. The historic entrance is on E. Santa Clara St. The hotel entrance is on S. 3rd Street.

Camera facing: SE

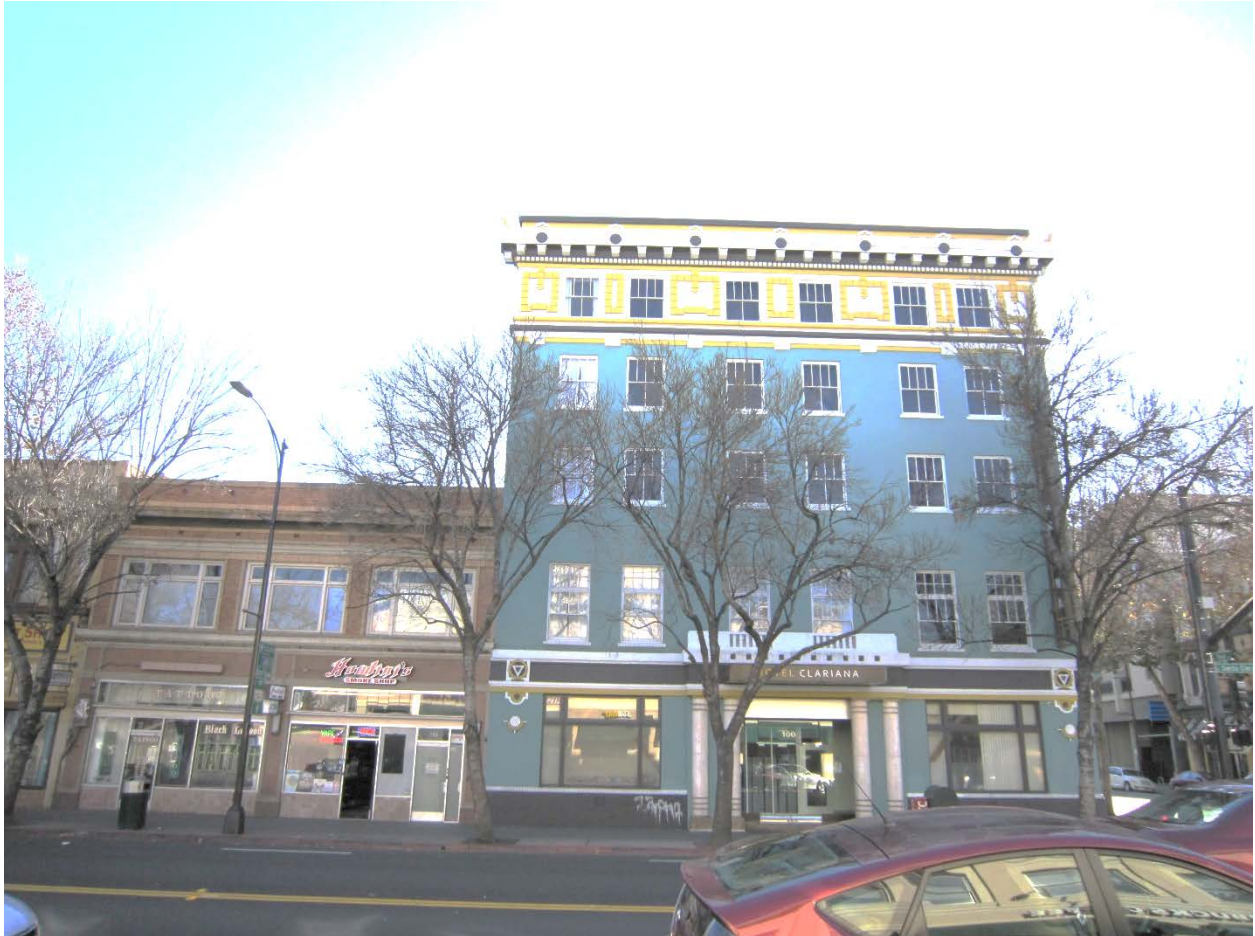
Picture 2 100-104 E. Santa Clara St. (historic YMCA)

View: The front facade of the building at the corner of E. Santa Clara St. and S. Third Street. The historic entrance on E. Santa Clara St. has been remodeled, adding the columns and a contemporary glass door system.

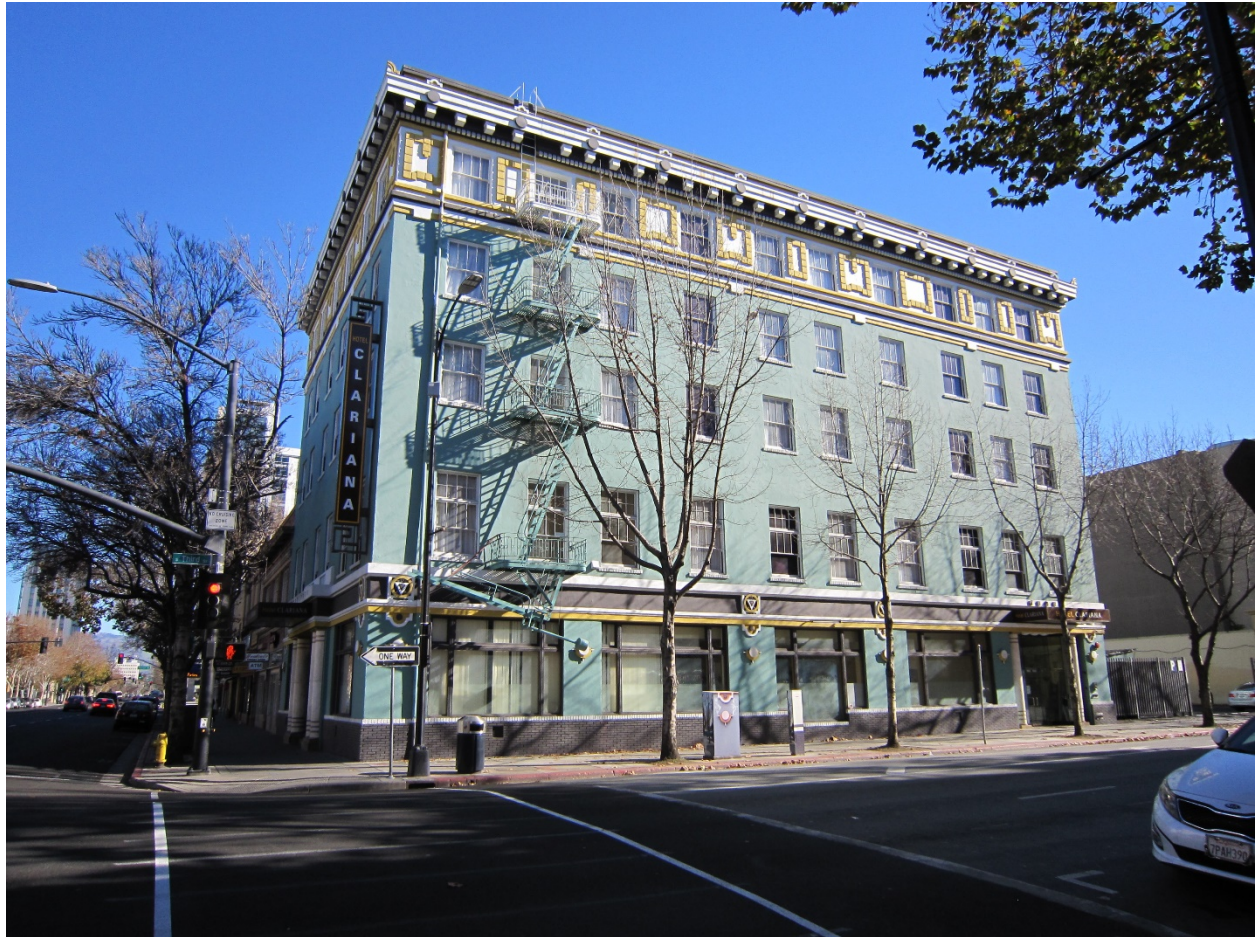
Picture 3 100-104 E. Santa Clara St. (historic YMCA)

View: The S. Third Street facade. The entrance on the right was added to the building.

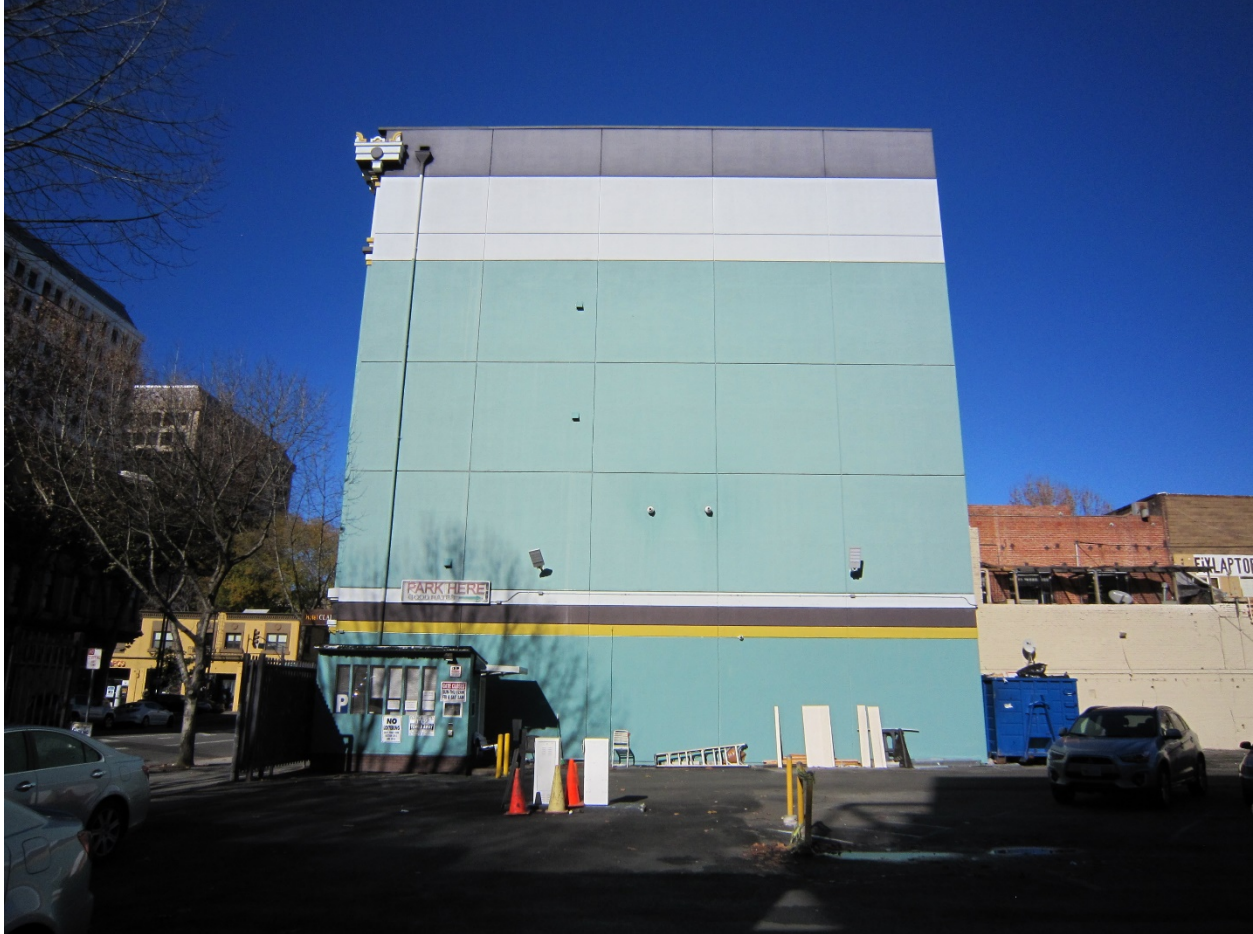
Picture 4 100-104 E. Santa Clara St. (historic YMCA)

View: The rear facade without openings. This is where the three story gym building was attached to the main building. The area in front of this facade is a surface parking lot.

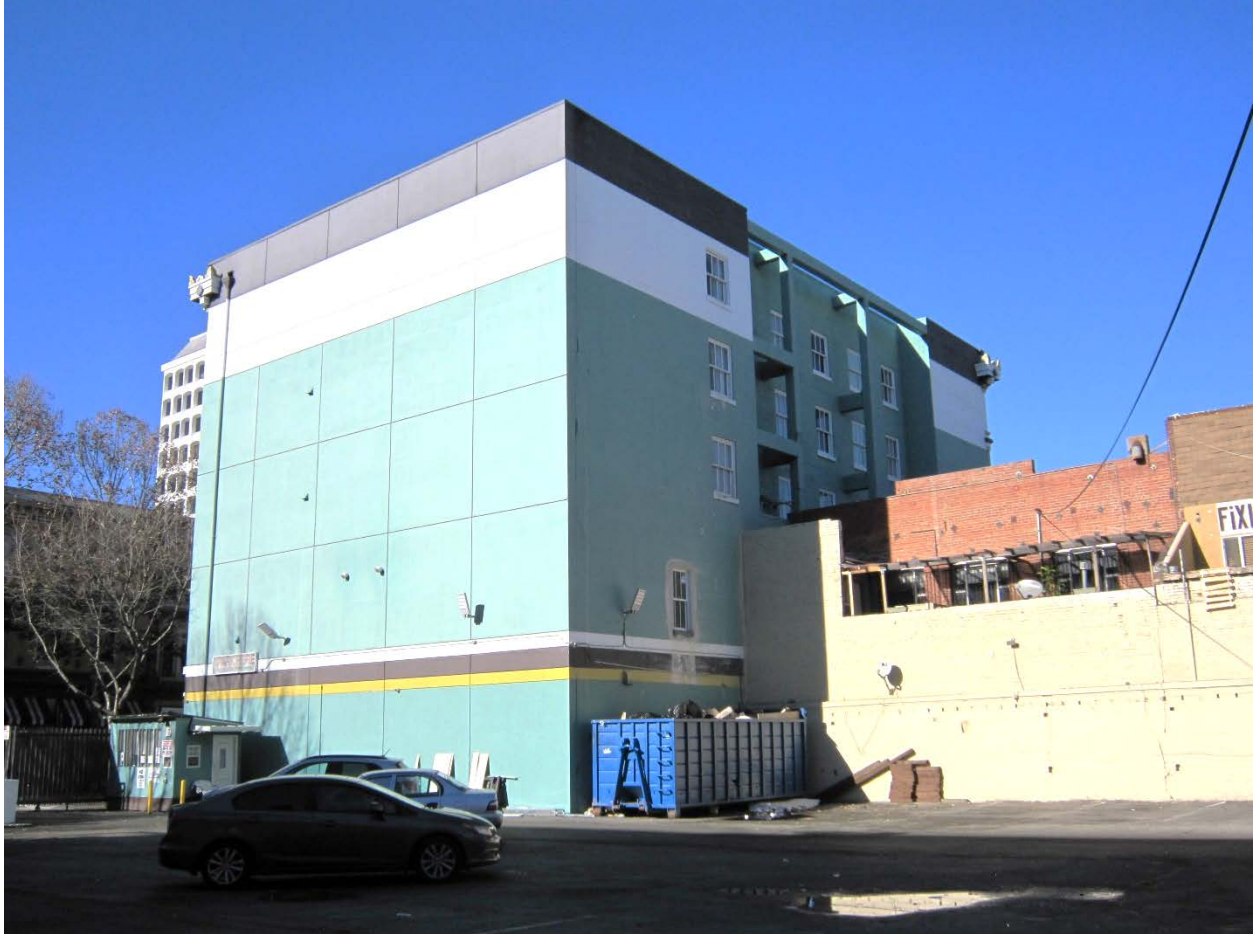
Picture 5 100-104 E. Santa Clara St. (historic YMCA)

View: The rear corner showing the blank facade and the east facade with the exposed structure. A surface parking lot fills the rear of the parcel.

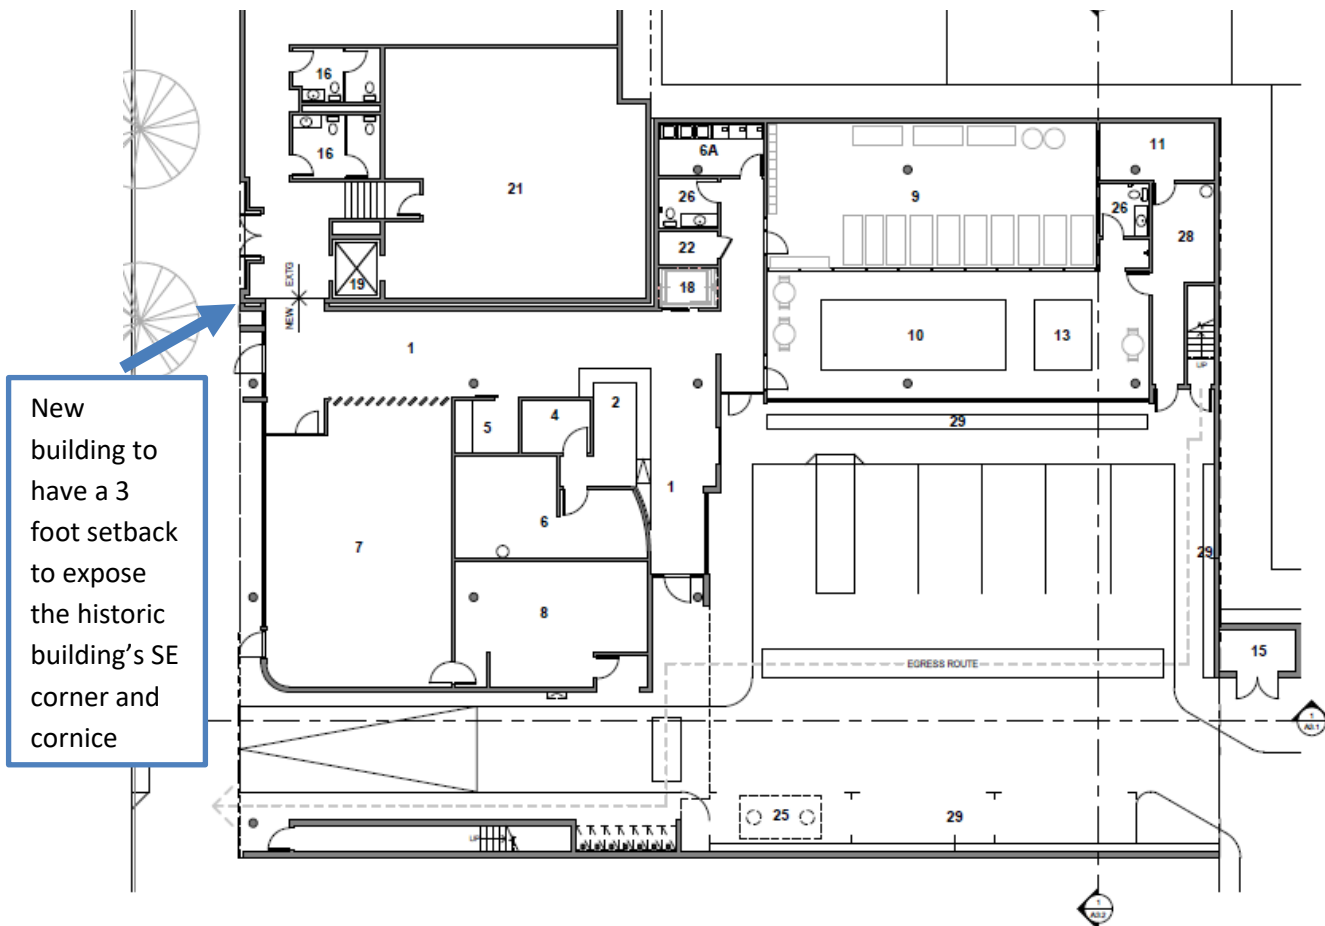
Dewing: TCA Architects, A-2-1. July 18,2018 not updated

The set-back from the historic building is approximately 3 feet on the ground level sufficient to provide a distinction between the historic building and the new addition. Beginning on the second floor, the recess between the building was not shown on Sheet A1.3 (floors 3-5) and did not show a the cornice return of the historic building. A revision was made to move the new wall back and retain the cornice return as part of the SE Corner. ³

³ RFI ! from Urban Programmers was sent to TCA requesting the revision. The document is in the appendix.

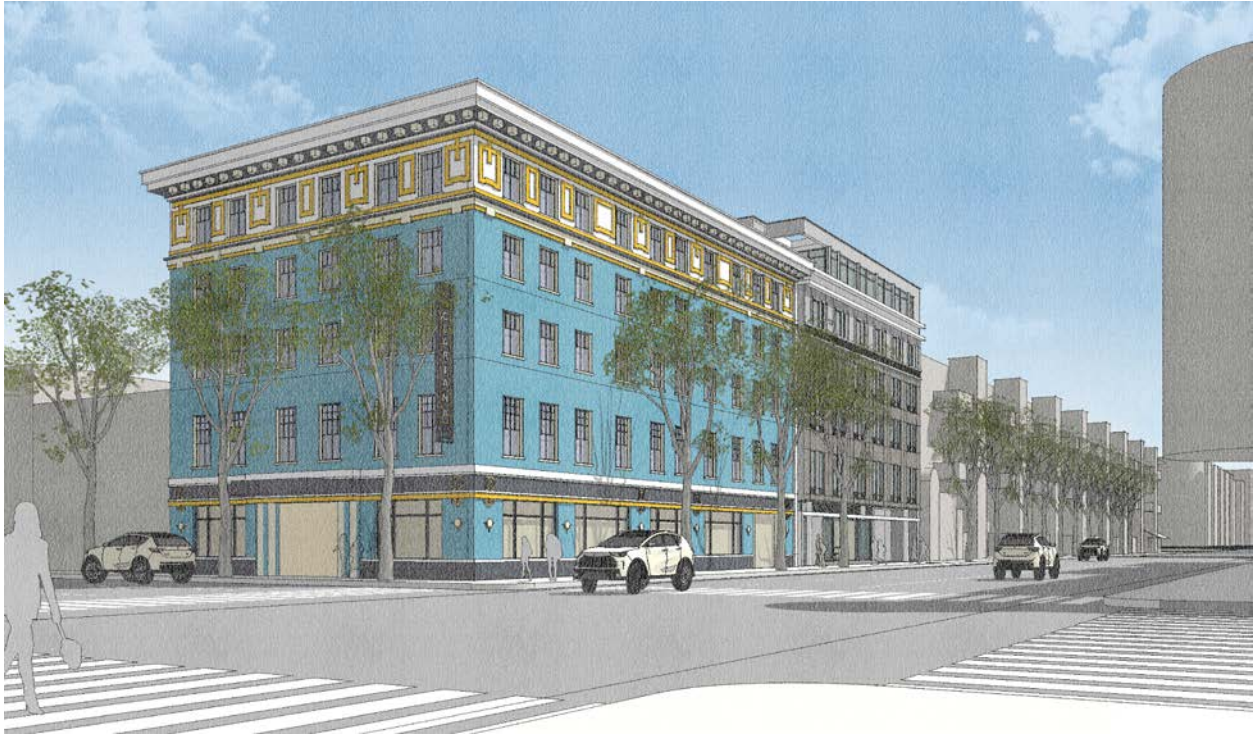
Architectural Sheet A.1.1 Showing the perspective from the north west corner of the historic building and the addition to the south in line with the other urban streetscape. The addition retains the horizontal blocks and lines of the historic building and is compatible with the materials and design rhythm of the historic building.

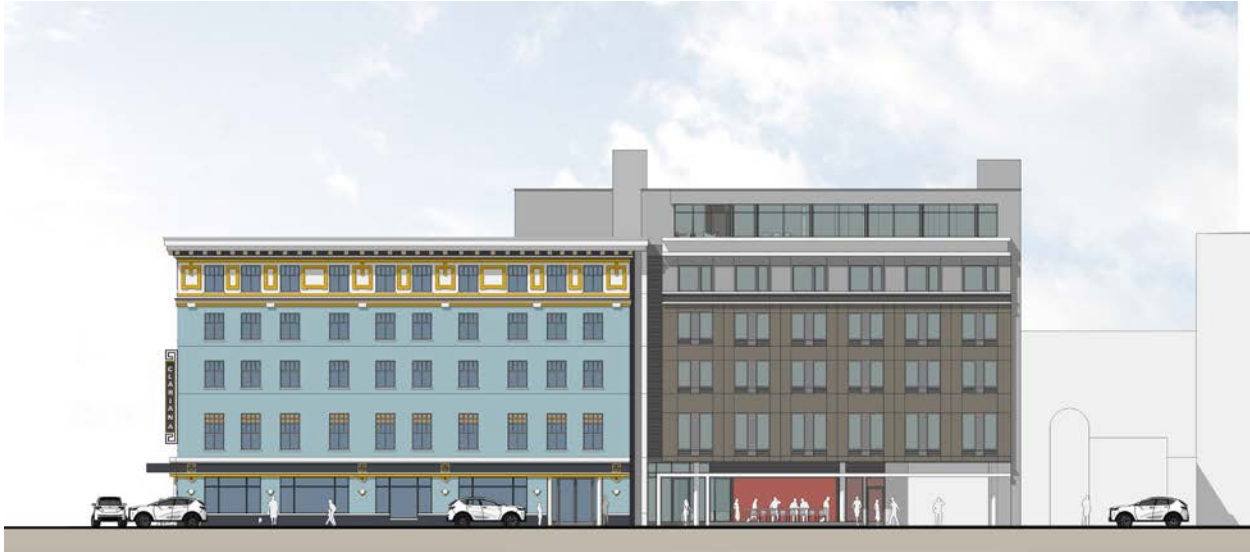
Architectural Sheer A.4.1 shows the proposed plan for where the buildings are attached at the S. Third Street elevation. The proposed addition does not intrude upon the historic building and does not mimic the historic style of the former YMCA

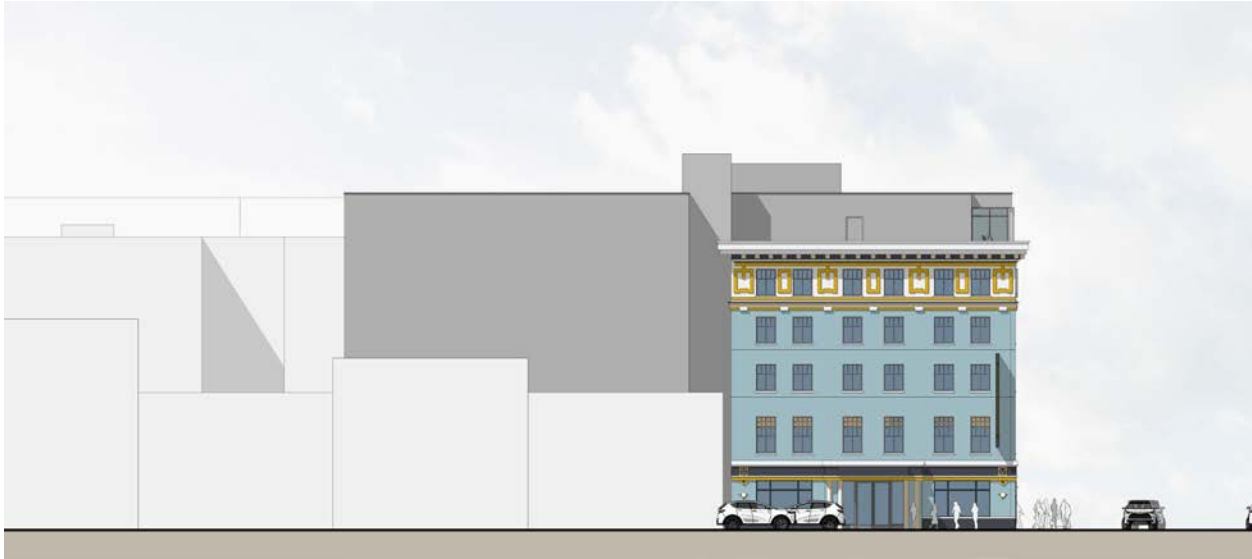
Architectural Sheet A.4.2 showing the E. Santa Clara elevation of the historic building and the general street scape of other buildings that are in front of the proposed addition. From the street level the addition will not be visible and when visible will not appear as part of the historic building.

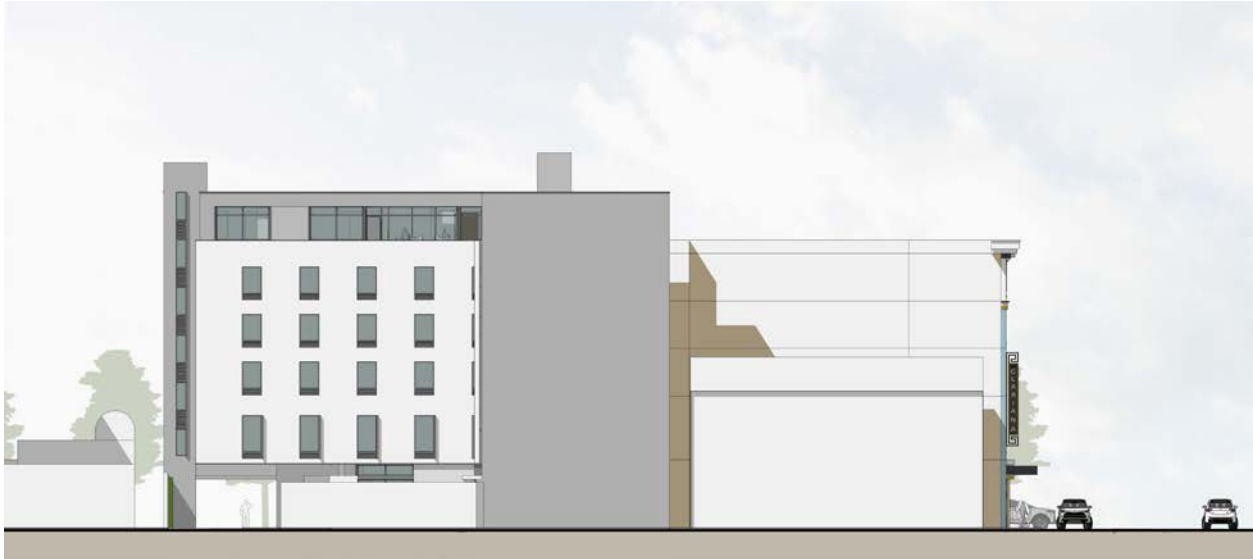
Architectural Sheet A.4.3 Showing the east elevation of the addition. This side of the addition does not detract from the historic building.

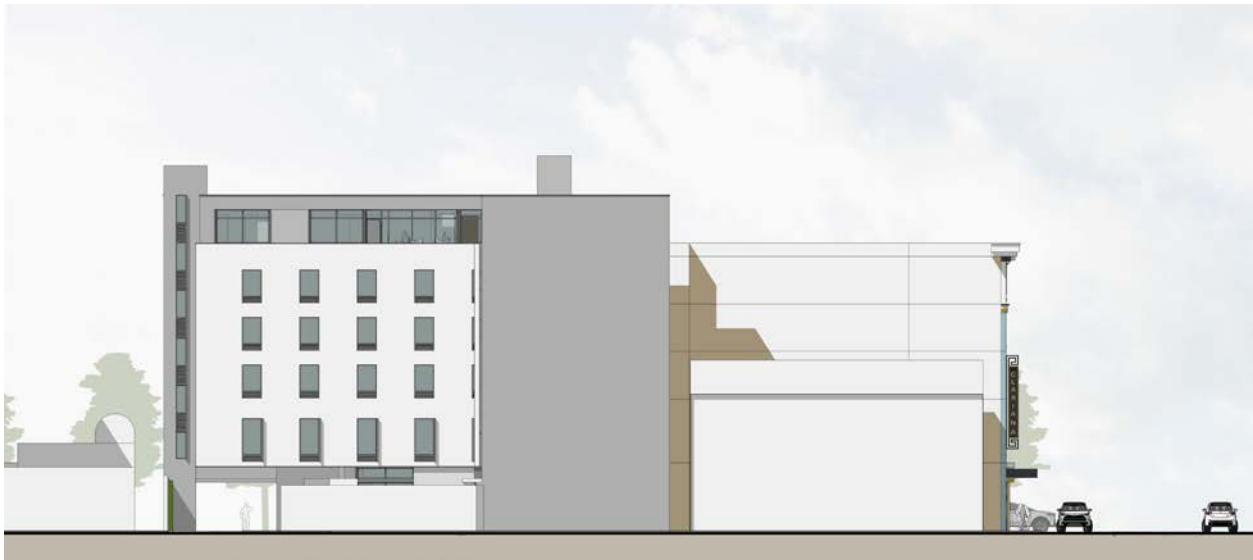
Architectural Sheet A.4.4 Showing the south elevation of the addition. This façade will not adjacent to existing buildings and does not diminish the historic character of the former YMCA.

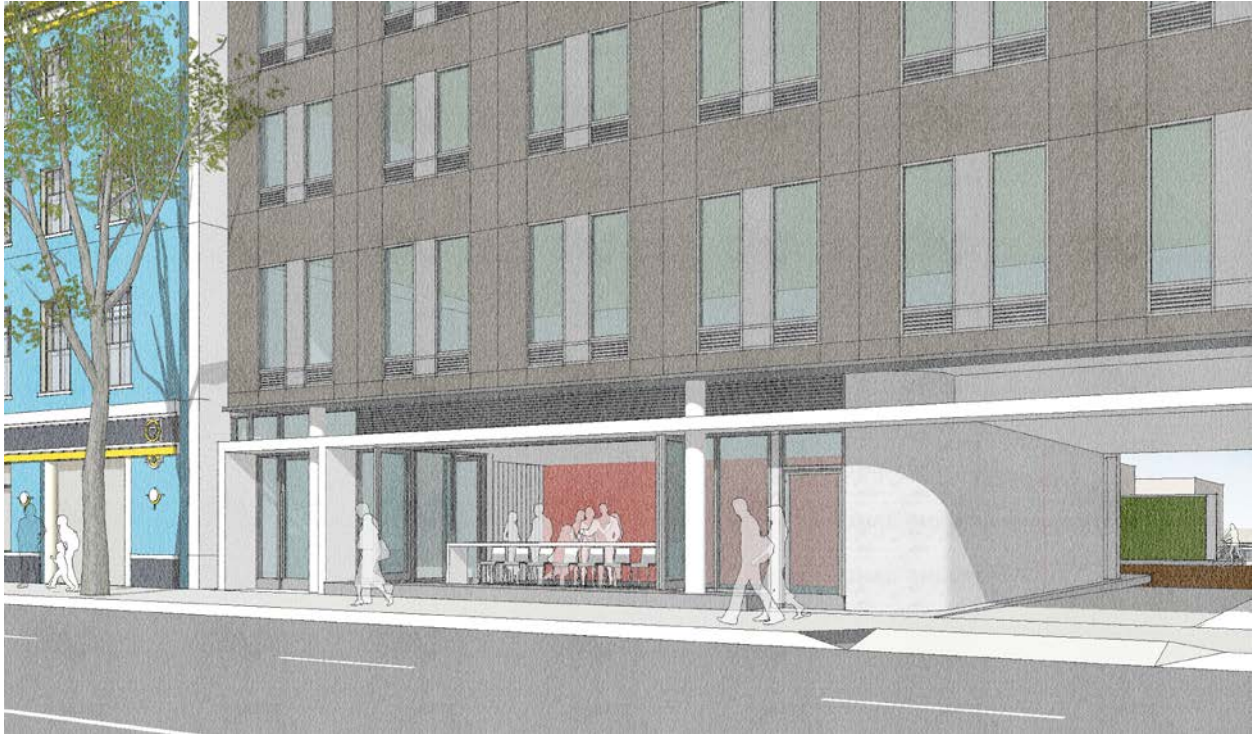
Architectural Sheet A.1.3 showing the interface between the proposed addition and the historic building on S. Third Street. This perspective shows the setback of the addition that allows the historic building to be seen as a separate building from the street level.

Area of concern: The proposed addition creates an end wall that may obscure the south west corner of the historic building. A recommendation is made to keep the new wall behind the corner of the historic building to allow the historic building to define its corner. The following RFI was submitted by Urban Programmers to TCA Architects. Agreement was reached to allow at least the lower floor to show the historic corner and to maintain a setback at the cornice line and the return at the top of the historic building.

Correspondence between TCA Architects and Urban Programmers regarding the face of building connection between the historic building and the proposed addition. This is the only area of concern as it may not meet the Secretary of the Interiors Standards #9 which infers the new addition should not obscure the character defining features of the historic building. The corner and cornice are features of the historic building.
