Phase I Environmental Site Assessment

Proposed 7-Eleven Store
#1042240
6211 Santa Teresa Road
San Jose, CA 95119

Project No.: 185850582

December 14, 2017

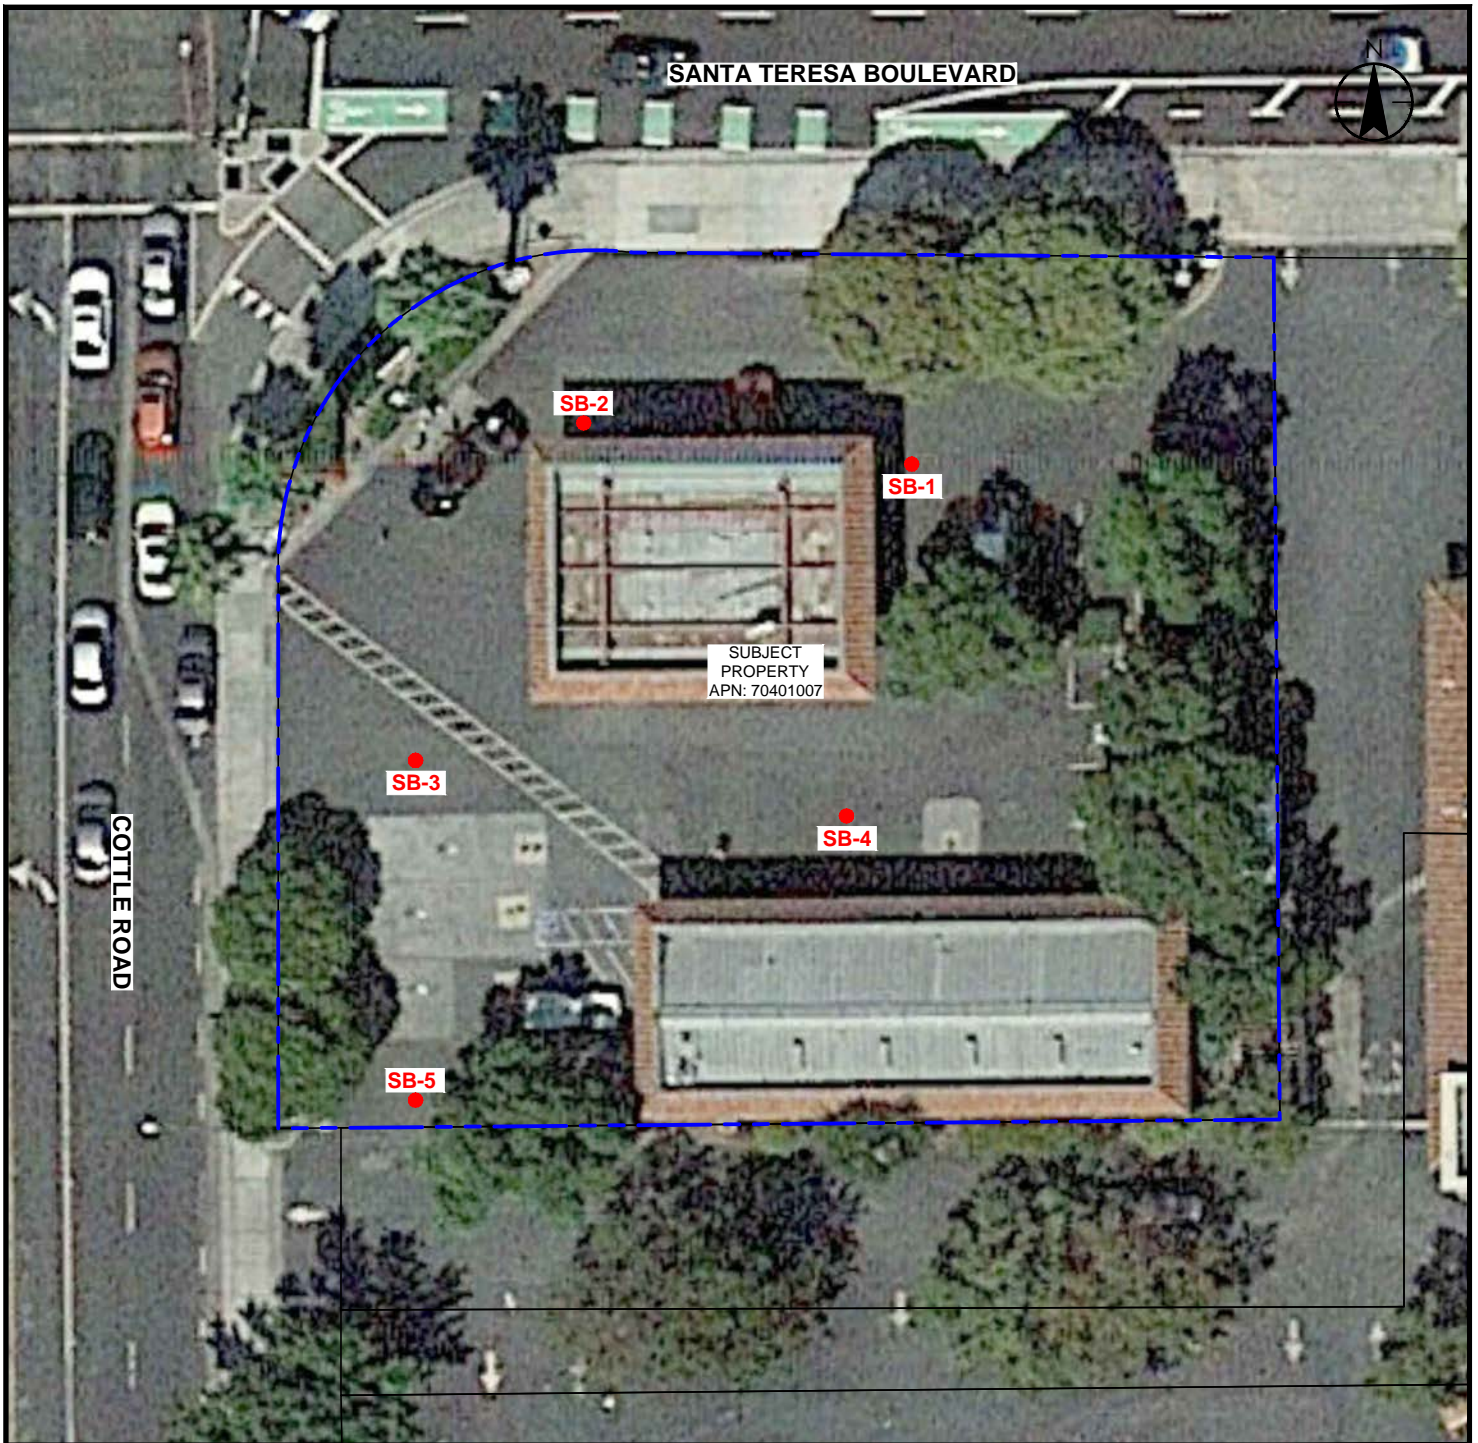
- APPROXIMATE SUBJECT PROPERTY
- SB-1 SOIL BORING LOCATIONS
