GHD Asbestos and Limited Lead Assessment Report

The DANCO Group

750 W San Carlos Street
San Jose, California

Multi-unit Residential Structure
Demolition Project

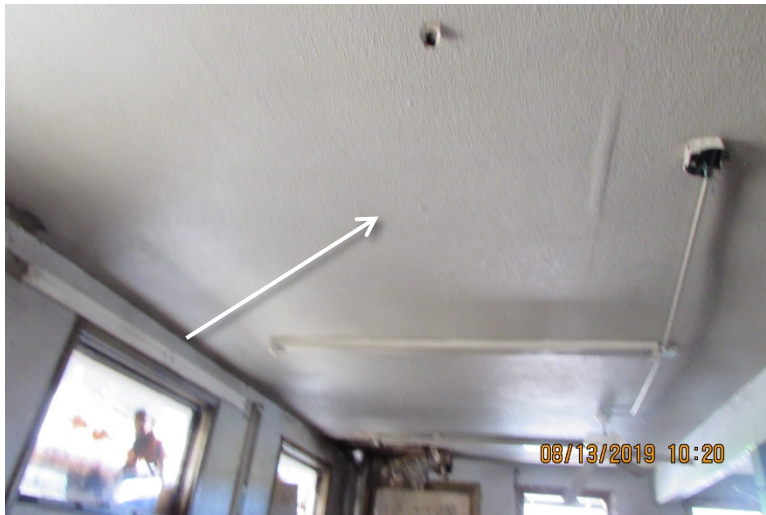
Photograph 1 – Interior– Knockdown Surface Texture (white),(typical location noted with white arrow) reported to contain asbestos.

It is recommended that all asbestos material be removed by a licensed abatement contractor prior to the commencement of other project renovation and/or demolition work. Agency notifications, as summarized in Table 6.1 in Section 5, must be submitted by the contractor or the site owner prior to the commencement of any abatement, renovation or demolition work at the project site.

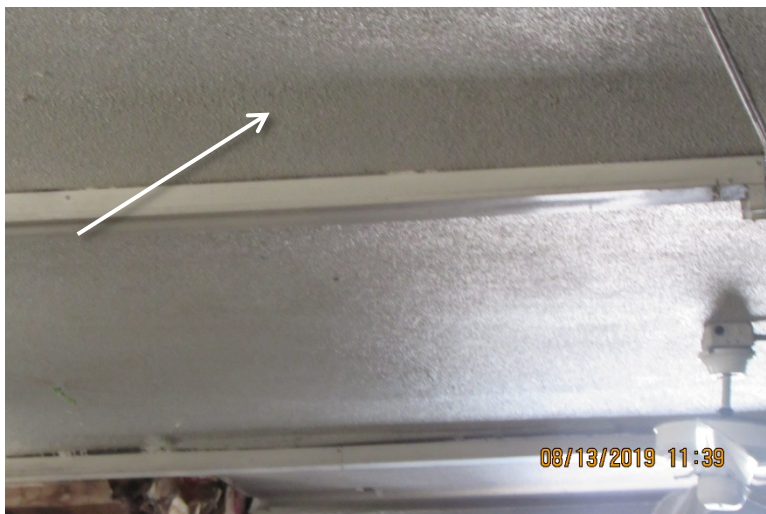
Photograph 2 – Interior– Popcorn Surface Texture (white) (typical, noted with white arrow) reported to contain asbestos.

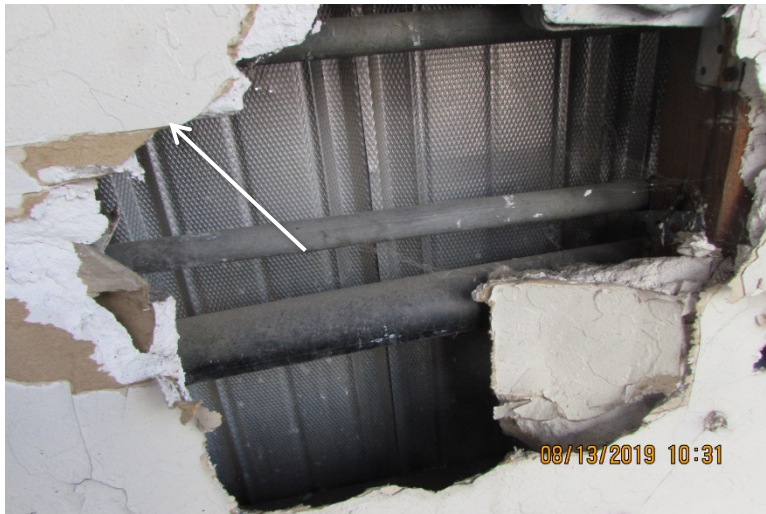
Photograph 3 – Interior – Surface Texture (white) + Drywall (white) and Joint Compound (white)(typical, noted with white arrow) surface texture and JC reported to contain asbestos.

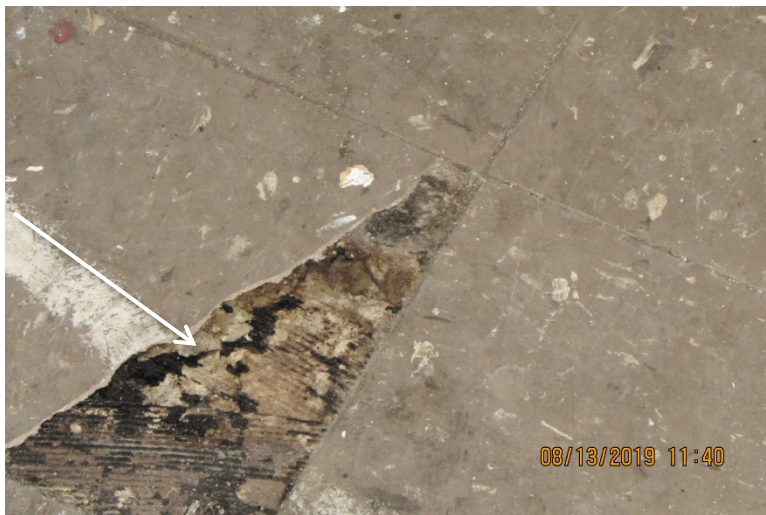
Photograph 4 – Interior– Mastic (black) associated with 9"X9" vinyl floor tile (shown) (noted with white arrow) reported to contain asbestos.
