## ***Phase I Environmental Site Assessment***

<b>TYPE OF SERVICES</b>	Phase I Environmental Site Assessment
<b>LOCATION</b>	95 South Almaden Avenue San Jose, California
<b>CLIENT</b>	JP DiNapoli Companies Inc.
<b>PROJECT NUMBER</b>	510-29-1
<b>DATE</b>	July 9, 2019

Cornerstone Earth Group, Inc. (Cornerstone) understands that JP DiNapoli Companies Inc. intends to redevelop the Site with a 12-story office building with two to three floors of underground parking. We performed this Phase I ESA to support JP DiNapoli Companies Inc. in evaluation of Recognized Environmental Conditions at the Site. This Phase I ESA is intended to reduce, but not eliminate, uncertainty regarding the potential for Recognized Environmental Conditions at the Site.

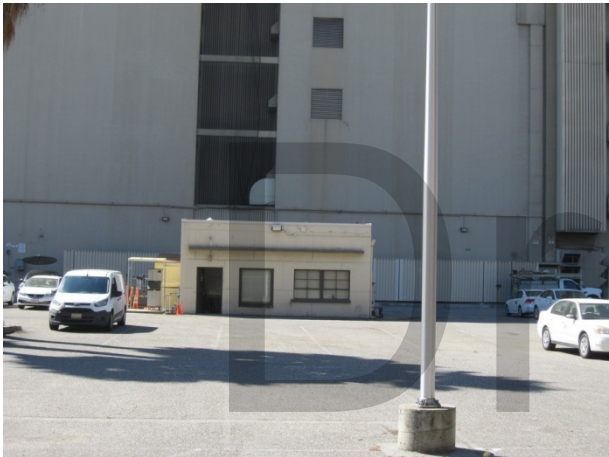
At the time of our visit, the Site was observed to consist mainly of a paved parking lot associated with the southeasterly adjacent (off-Site) multi-story building occupied by AT&T. A small on-Site, single-story structure used as an office for facility maintenance staff was observed within the parking lot. A pre-manufactured storage shed adjacent to the office building was observed to be used for storage of hazardous wastes generated at the facility including electrical devices, dry cell batteries and aerosol cans. A trailer mounted emergency generator with an integral diesel fuel storage tank also was located adjacent to the on-Site office building.

Photograph 3. On-Site, singly-story office building.

Due to the age of the on-Site office structure, building materials may contain asbestos. If demolition, renovation, or re-roofing of the building is planned, an asbestos survey is required by local authorities and/or National Emissions Standards for Hazardous Air Pollutants (NESHAP) guidelines. NESHAP guidelines require the removal of potentially friable ACBMs prior to building demolition or renovation that may disturb the ACBM.

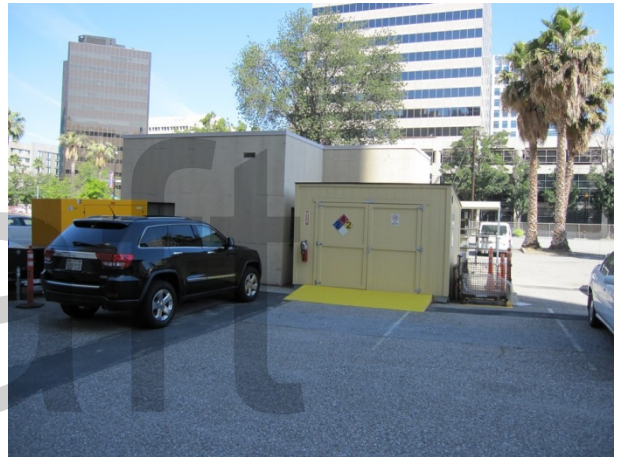
Photograph 4. Hazardous waste storage shed (at right) and trailer mounted generator (at left).

An on-Site storage shed is used for storage of hazardous wastes generated at the AT&T facility including electrical devices, dry cell batteries and aerosol cans. A portable trailer mounted emergency generator with an integral diesel fuel storage tank also is located on-Site. No hazardous materials spills within the shed were readily apparent and general housekeeping appeared orderly.

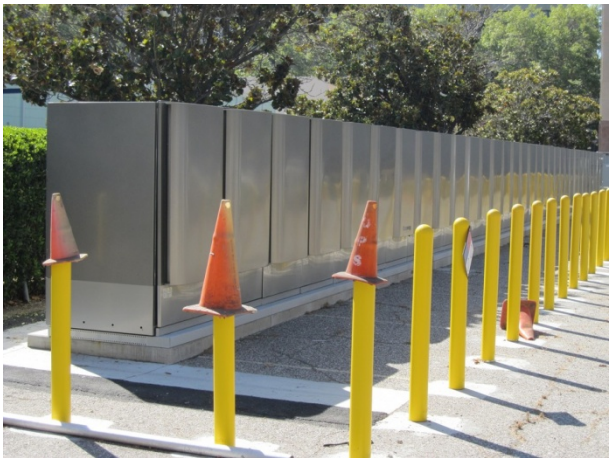
A Bloom Energy fuel cell installation was present on the northeast portion of the Site. Mr. Marthens indicated that the Bloom Energy equipment is fueled by natural gas. Several electrical transformers were observed within an equipment enclosure on the southeast portion of the Site, and near the Bloom Energy equipment. No evidence of transformer oil leaks was observed.

Photograph 5. Bloom Energy fuel cell installation.

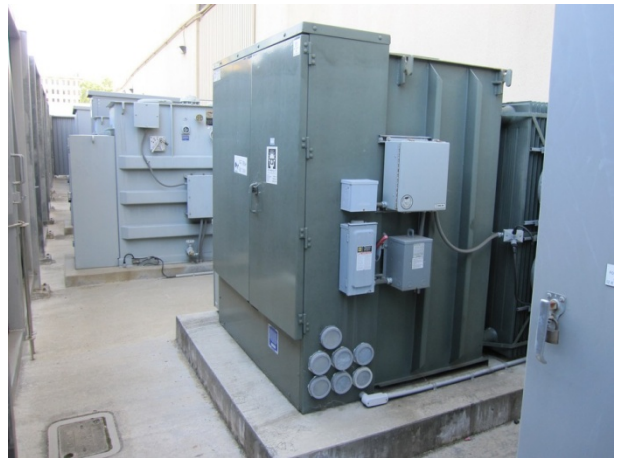
Photograph 6. Electrical transformers.

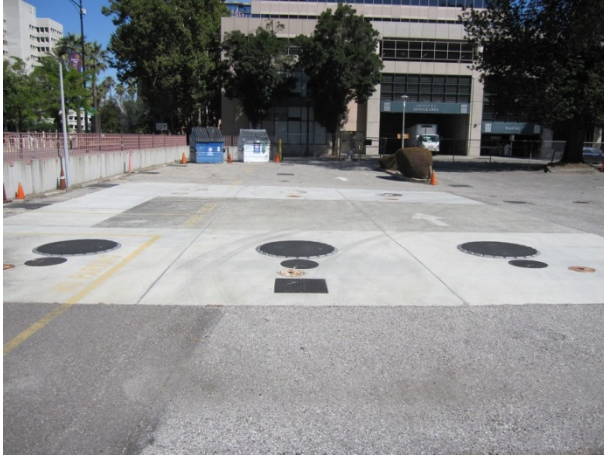
Three USTs containing diesel fuel were observed on the southwest portion of the Site. Below ground piping extended from the USTs to fuel pumps within an enclosure attached to the exterior northwest wall of the AT&T building. Fuel from the USTs was observed to be pumped to emergency generators located on the roof of the AT&T building via piping attached to the northwest exterior wall of the building. A small storage shed (formerly used as a pump house) was observed near the USTs on the southwest side of the Site.

Photograph 7. Three diesel storage USTs.

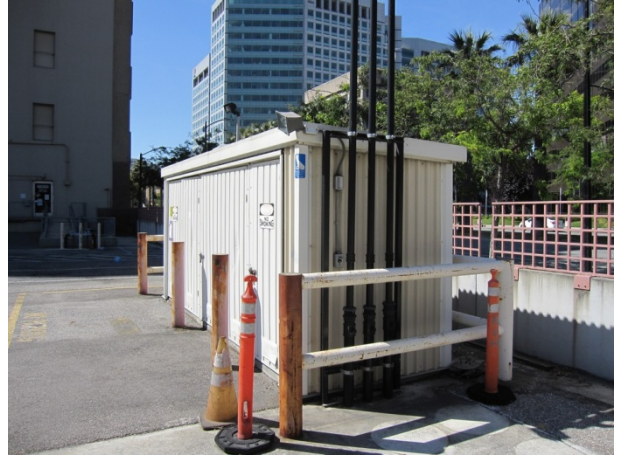
Photograph 8. Storage shed and UST vent pipes (former fuel pump house).

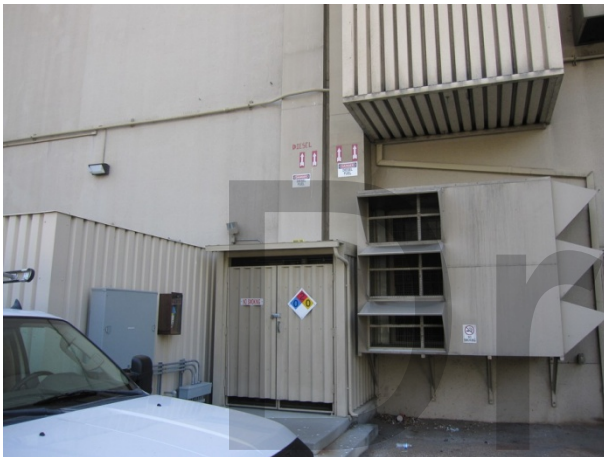
Photograph 9. Current fuel pump enclosure and wall-mounted diesel fuel supply piping.

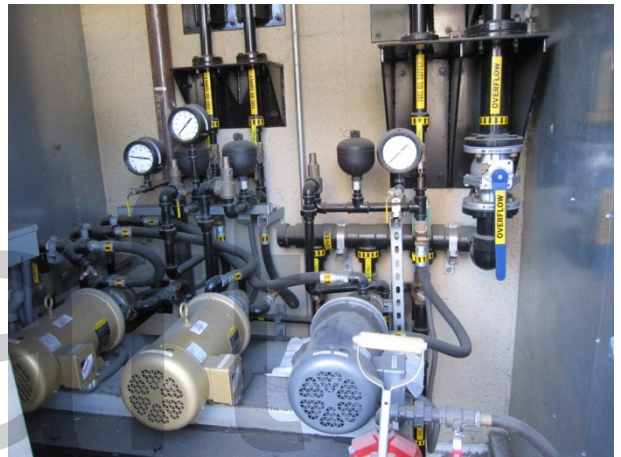
Photograph 10. Fuel pumps within enclosure.
