## PHASE II SUBSURFACE INVESTIGATION REPORT

1544 West San Carlos Street  
San Jose, California 95126

July 25, 2019  
Partner Project Number: 19-250390.2

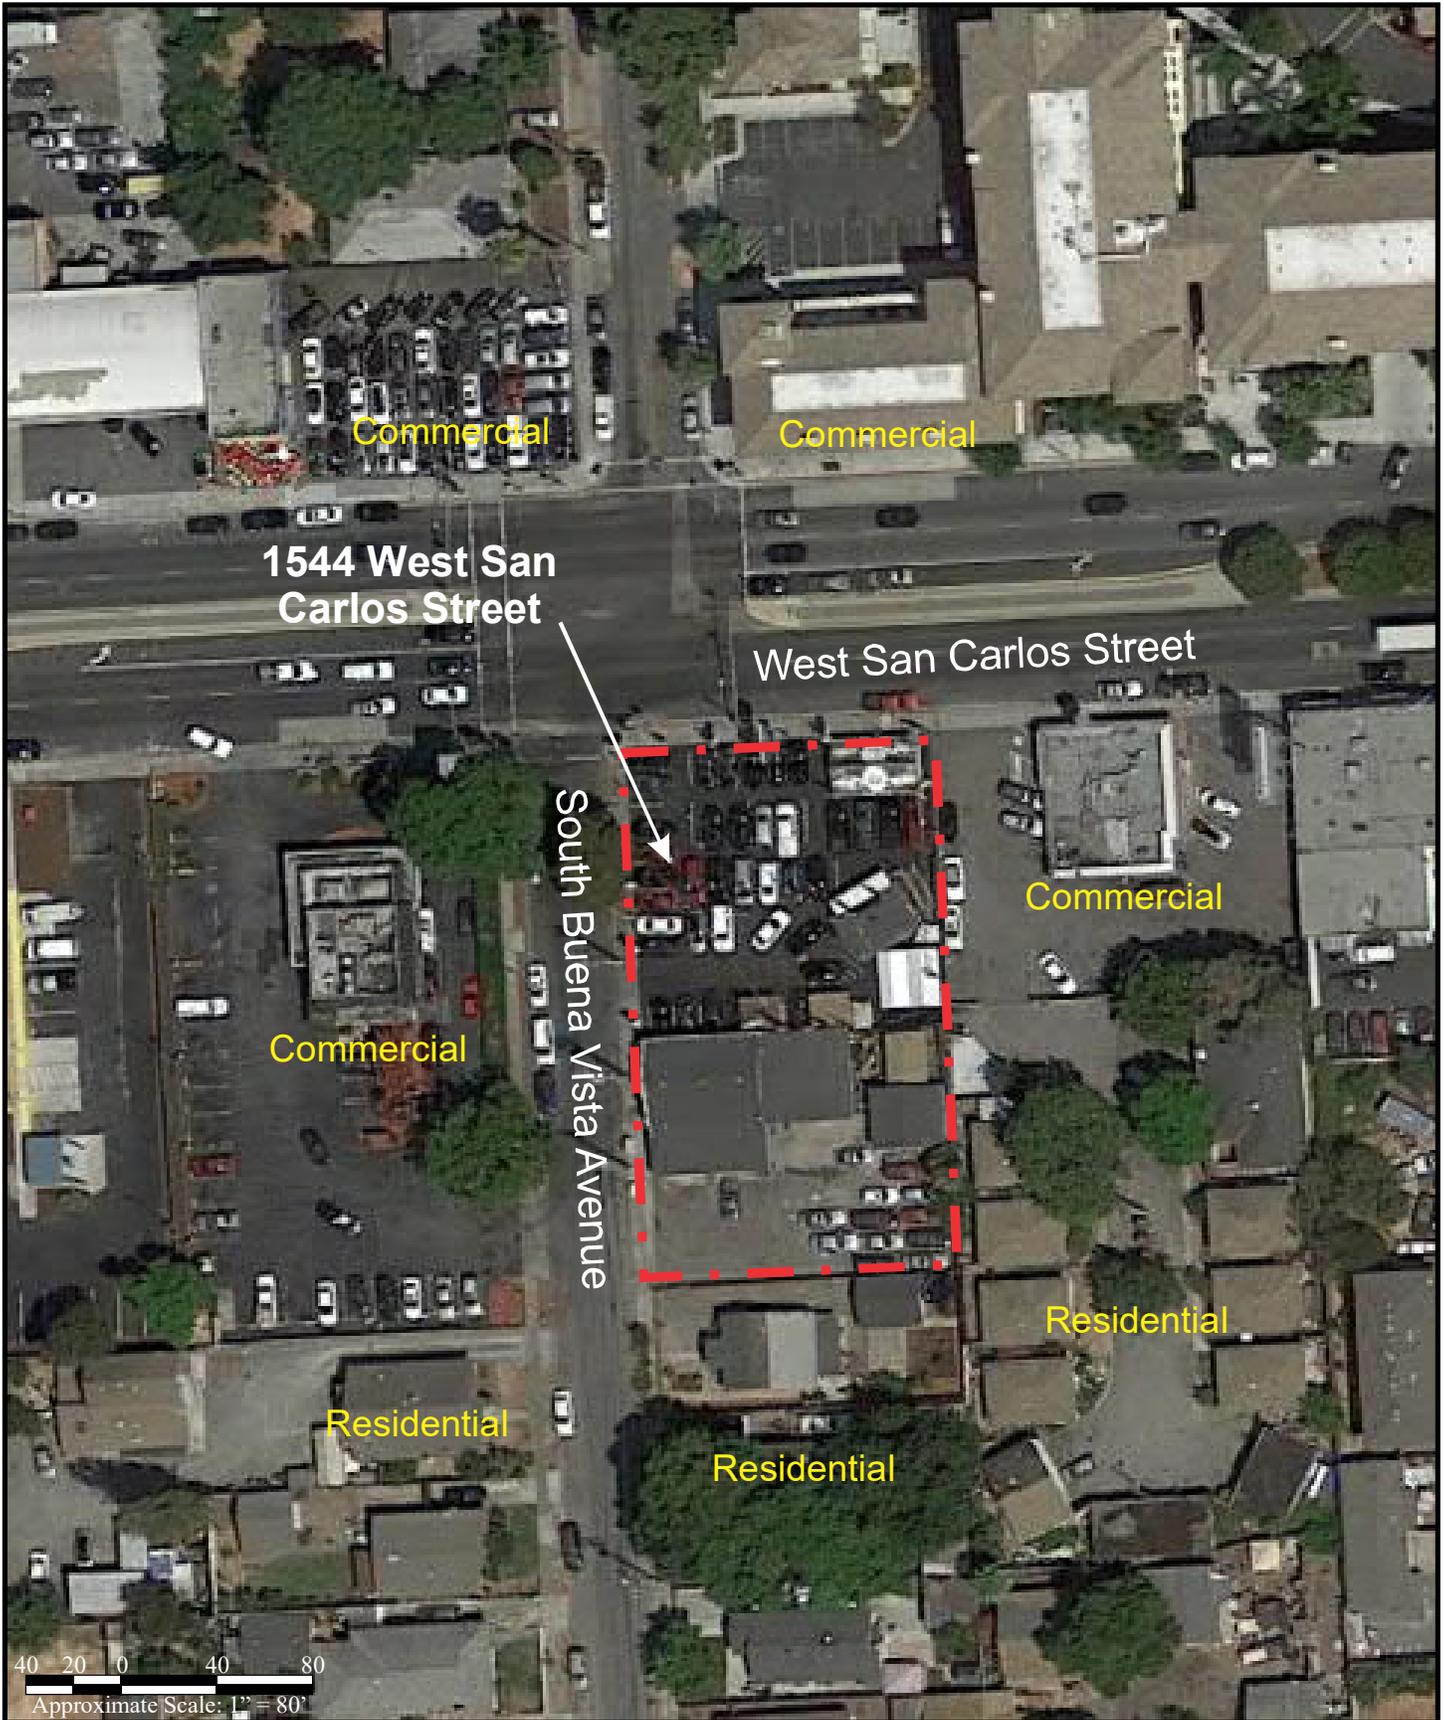
**Site Plan**

The subject property is bound by commercial properties to the north across West San Carlos Street, commercial and residential properties to the east, residential properties to the south, and commercial property to the west across South Buena Vista Avenue. Refer to Figure 1 for a site plan showing site features and surrounding properties.

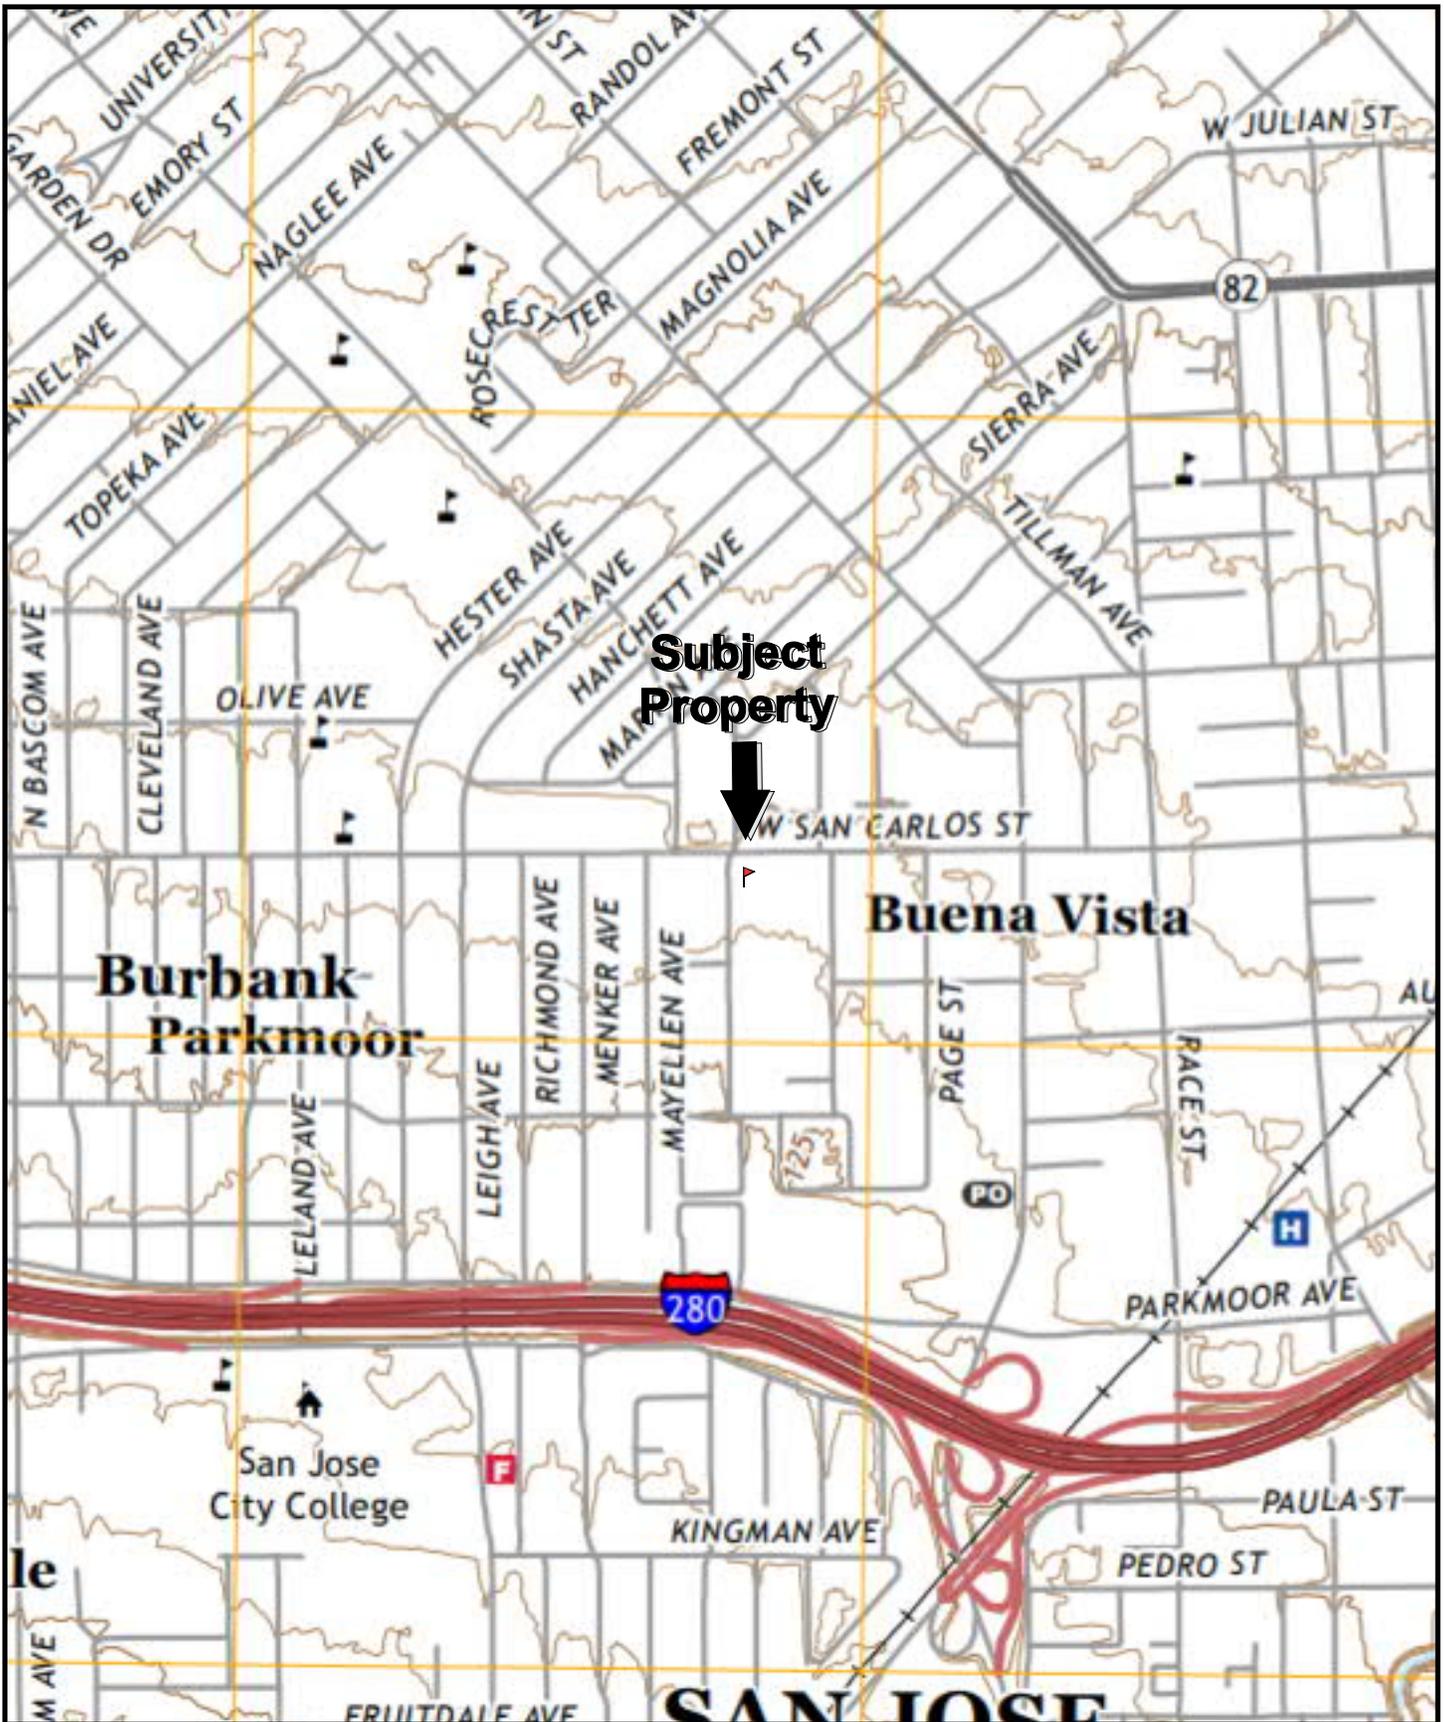
**Topographic Map**

Review of the United States Geological Survey (USGS) San Jose West, CA Quadrangle topographic map, indicates the subject property is situated approximately 118 feet above mean sea level, and the local topography is sloping gently to the north. Refer to Figure 2 for a topographic map of the site vicinity.

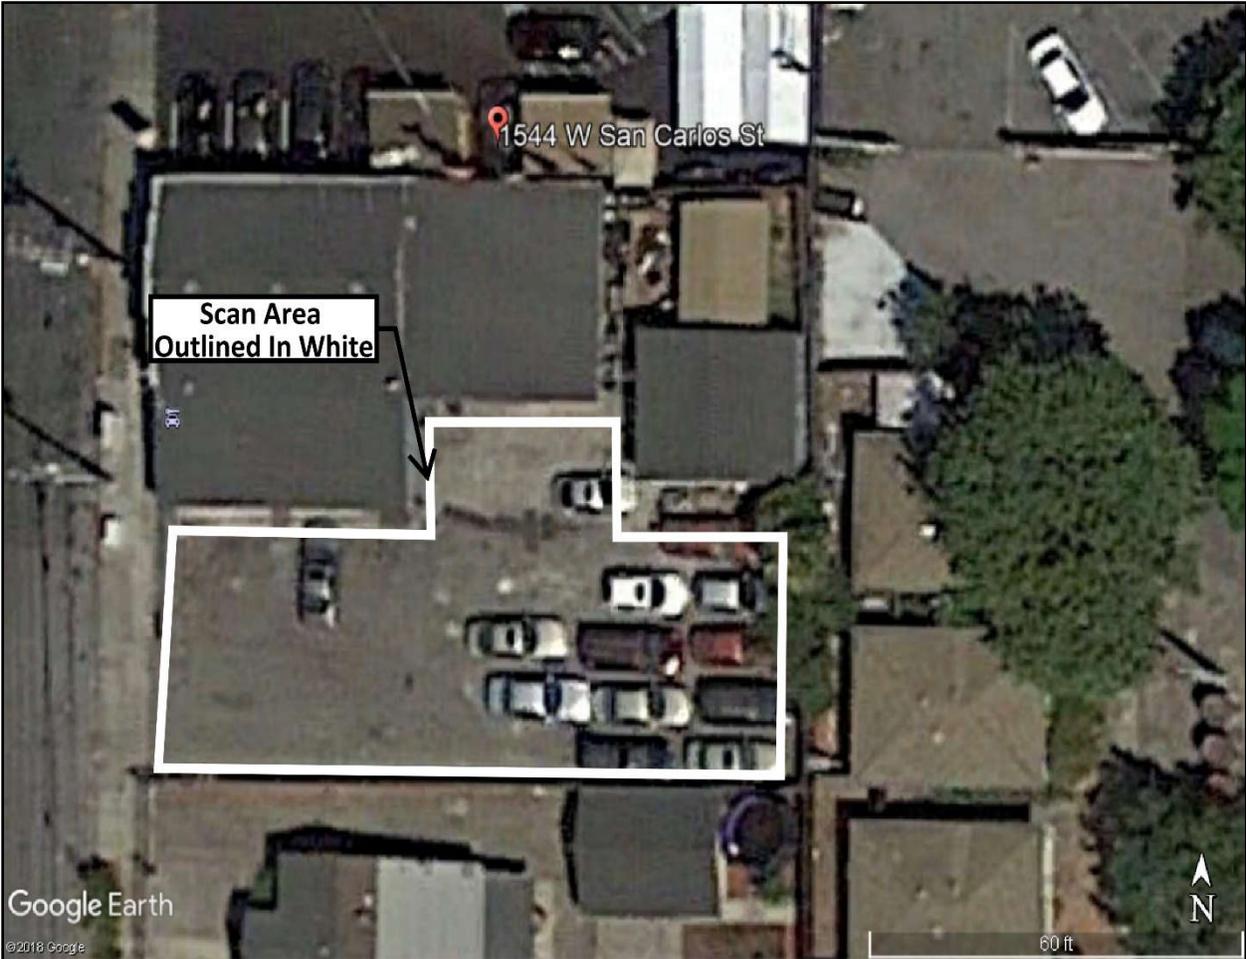
We found that the soil allowed for maximum GPR depth penetration of 2' in most areas. In the photos below there are cars that are parked in the scan area that were moved around for a thorough scan. Scanning did not reveal any findings consistent with a UST remaining on the property in the areas scanned.

Scan area is indicated by the white outlined area in this photo.

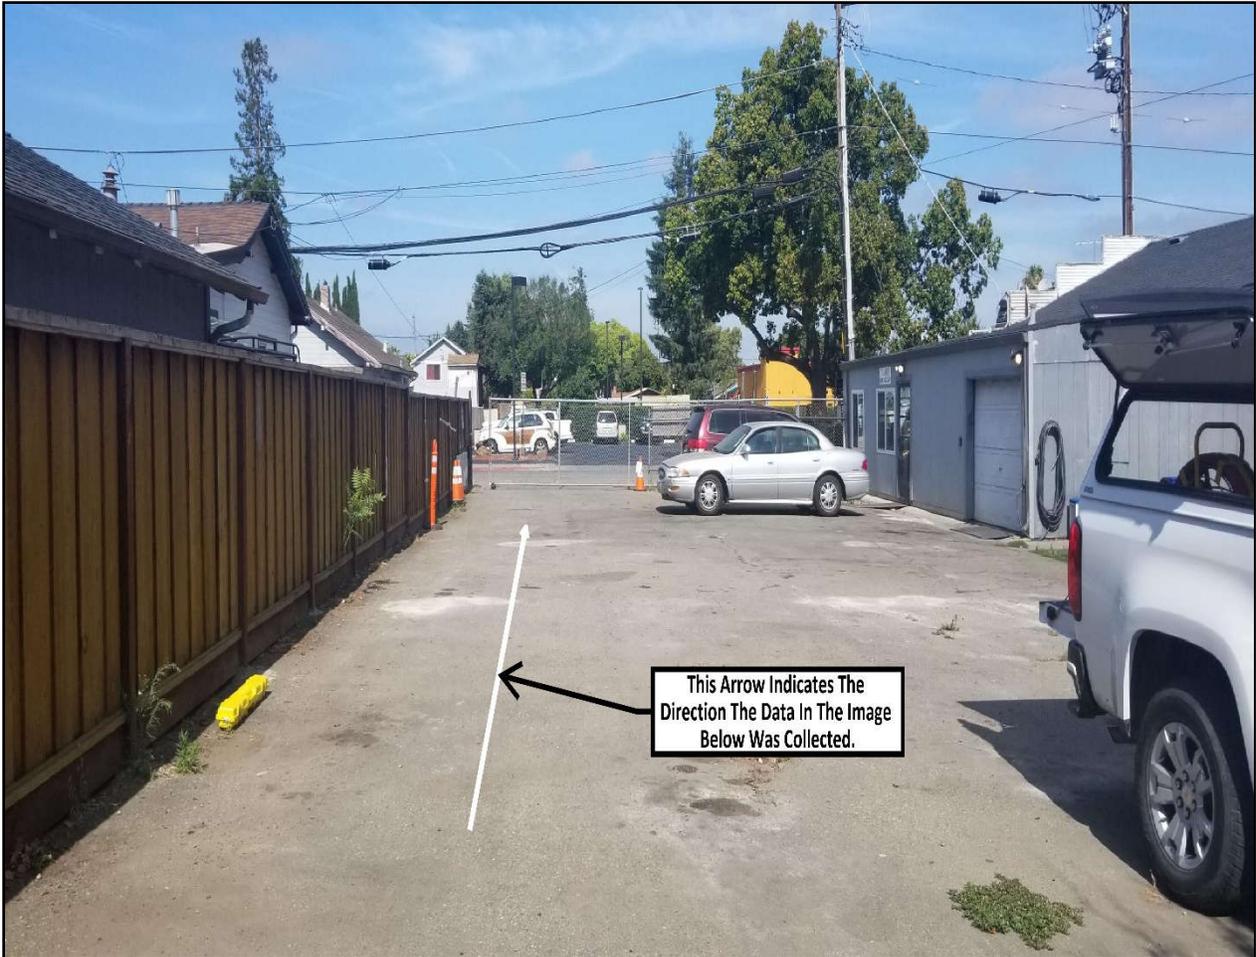
The white arrow in this photo indicates the direction the data shot below was collected.
