PHASE I ENVIRONMENTAL SITE ASSESSMENT San Jose Assisted Living Facility Project

3315 Almaden Expressway
San Jose, California 95118

Report Date: July 31, 2018

**Subject: Phase I Environmental Site Assessment
San Jose Assisted Living Facility Project
3315 Almaden Expressway
San Jose, California 95118**

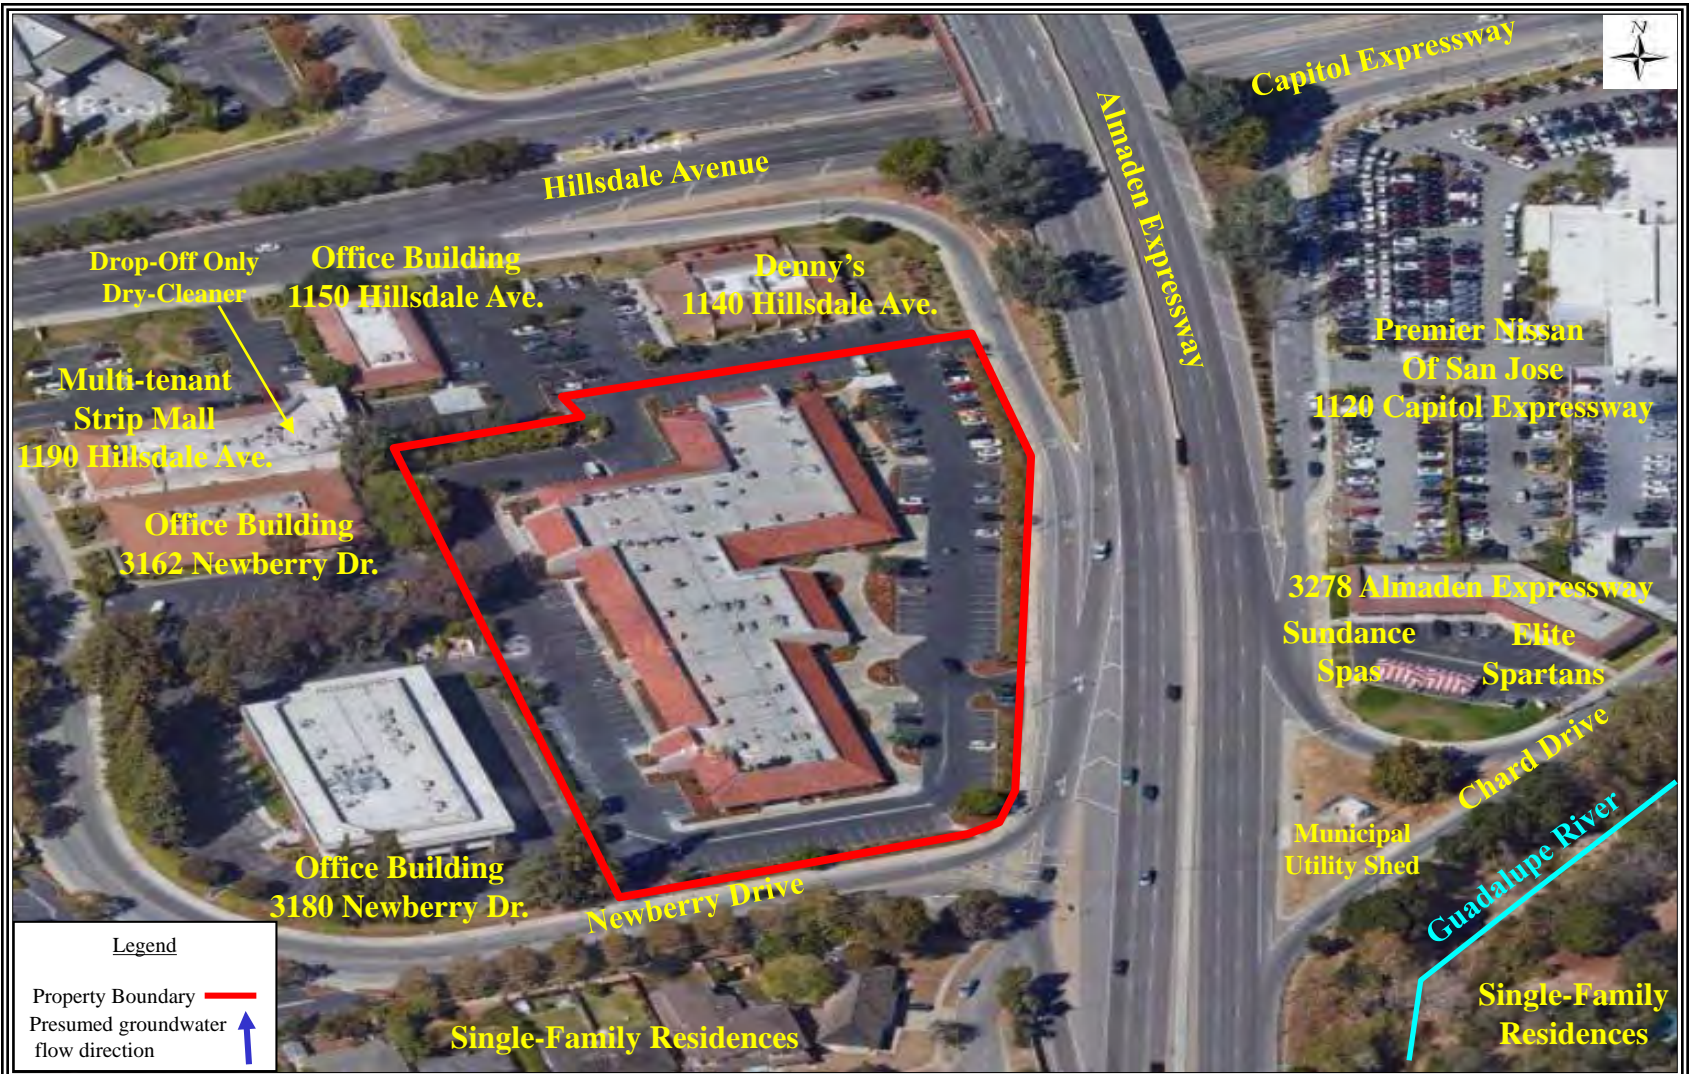
SITE PLAN

3315 Almaden Expressway
San Jose, California 95118

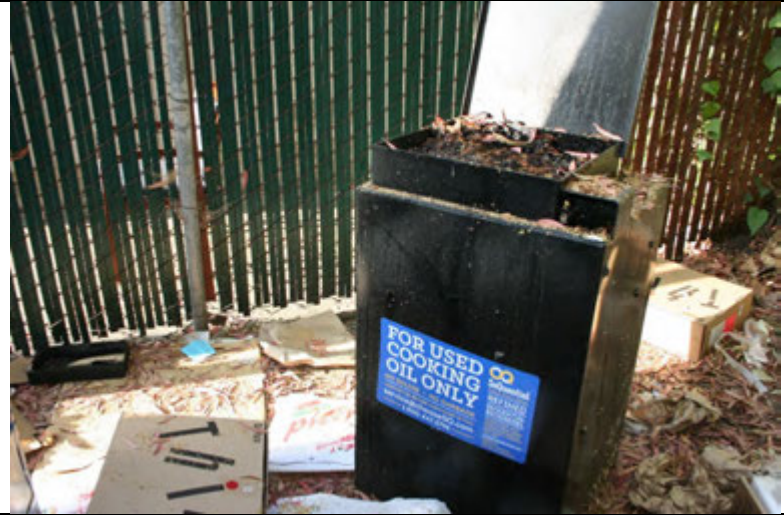
View of on-site restaurant grease trap within dumpster area

No clarifiers or sumps were observed or noted within or next to the Property during the site reconnaissance. An aboveground grease trap, associated with an on-site coffee house tenant, is located within the Property's dumpster area and is utilized for the collection of used cooking oil only. No significant staining was observed in this area during the site reconnaissance.

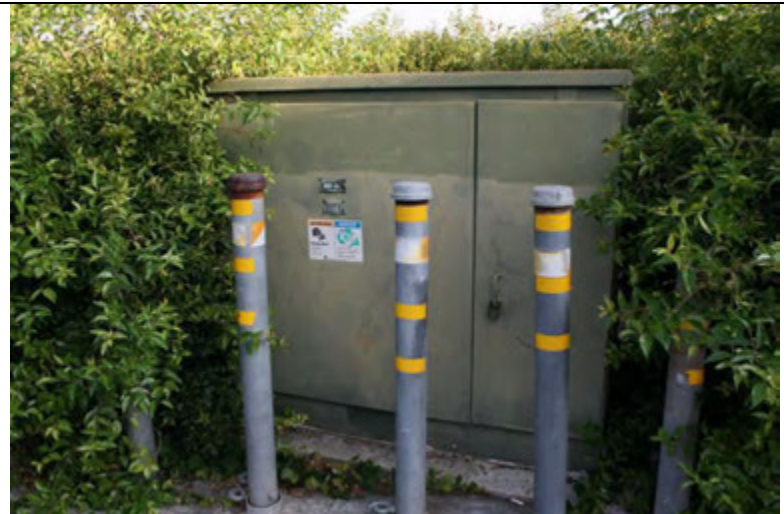
View of on-site utility-owned electrical transformer

No leaking or stained equipment that would have the potential to contain PCBs (e.g., transformers, capacitors, light ballasts, hydraulic equipment) was observed on or adjacent to the Property during the site reconnaissance.

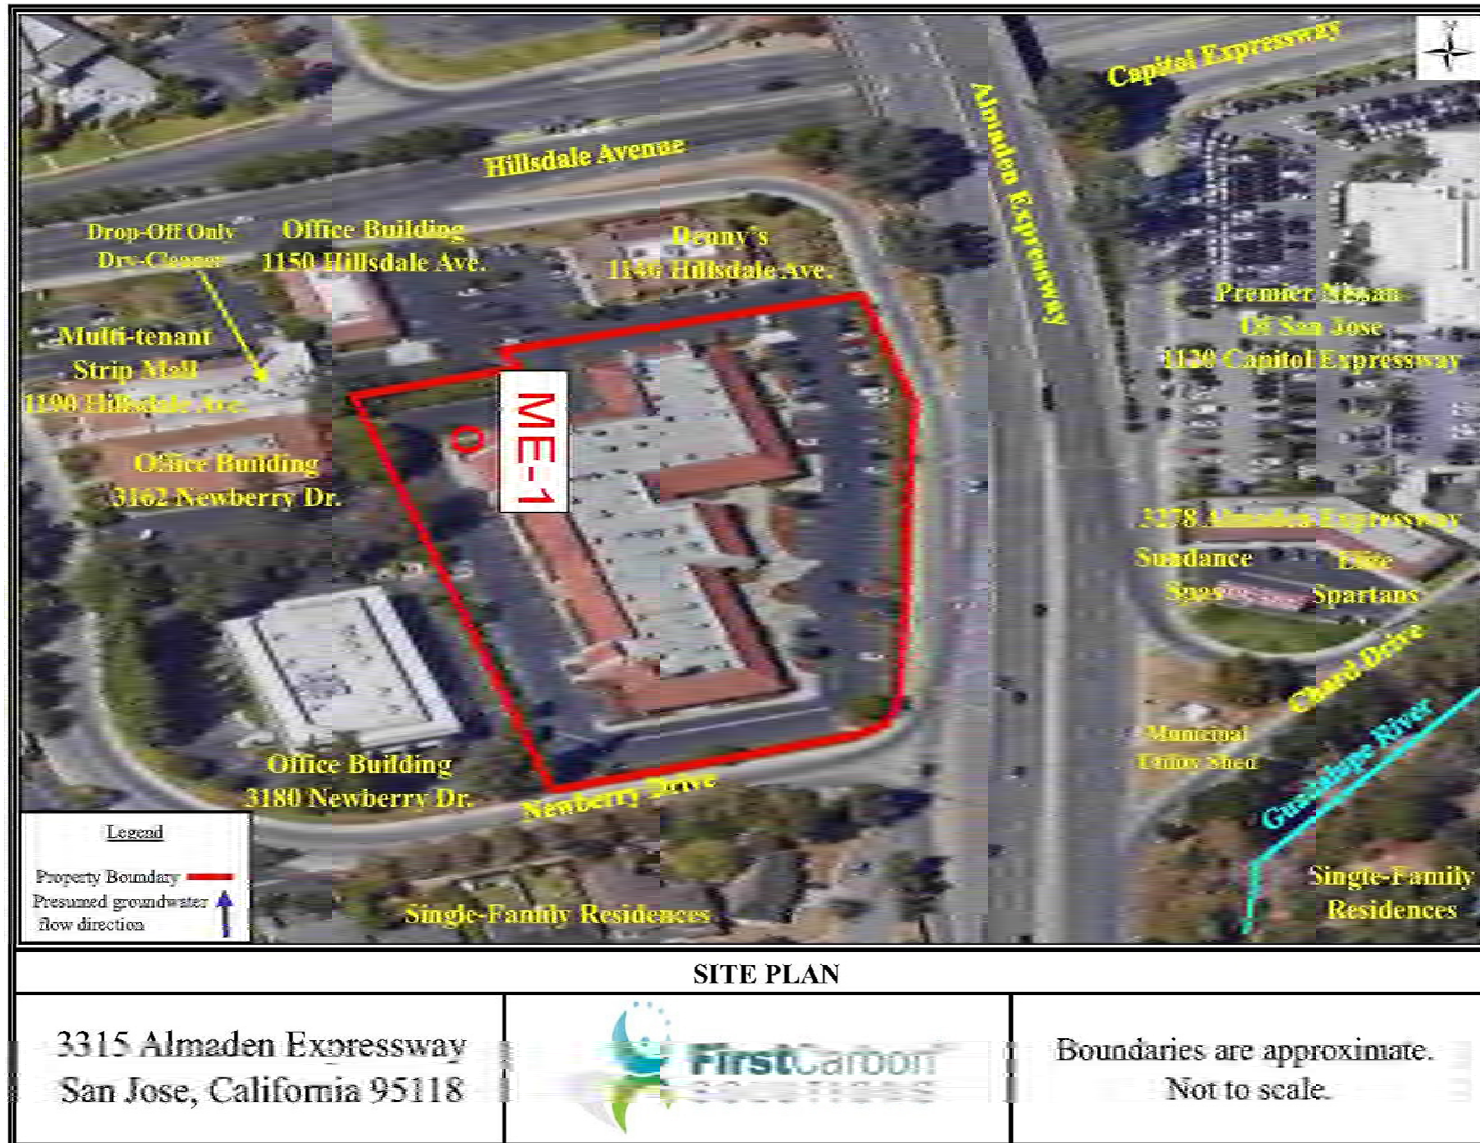
Exhibit 1: Site Plan

FCS collected one (1) soil sample from boring ME-1 at a depth of 10 feet bgs. Additionally, two (2) nested temporary soil vapor probes were installed and sampled at five (5) and 10 feet bgs. The soil vapor probe installation and sampling was conducted in accordance with the "Advisory—Active Soil Gas Investigations", prepared in July 2015 by the Department of Toxic Substances Control and the Los Angeles and San Francisco Regional Water Quality Control Boards.

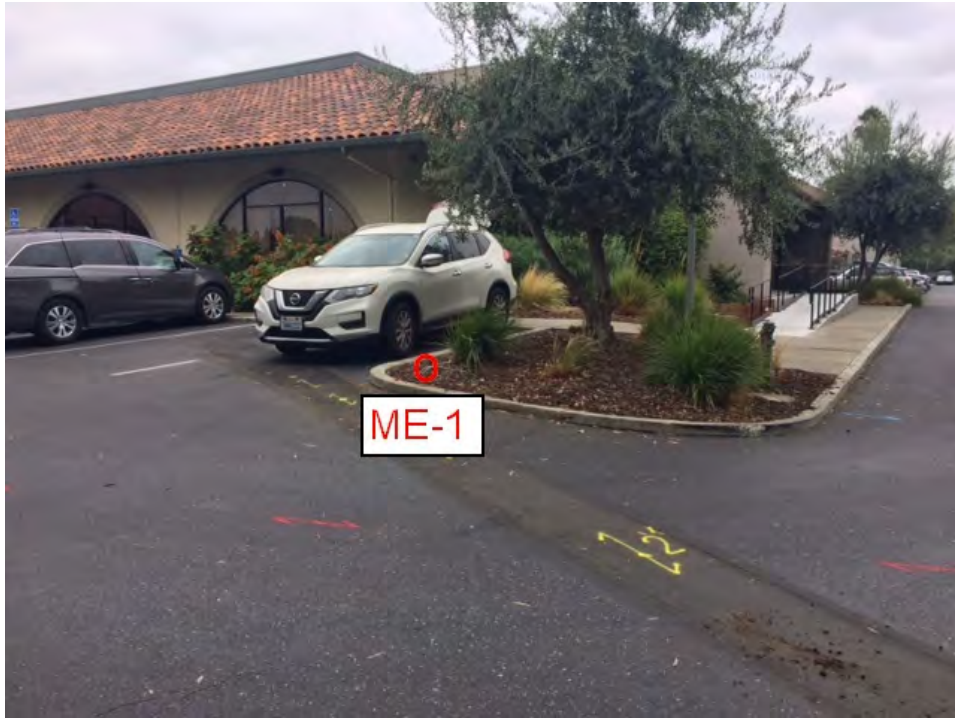
Exhibit 2: Boring ME-1 Location

Photograph 1: Boring ME-1 looking southeast

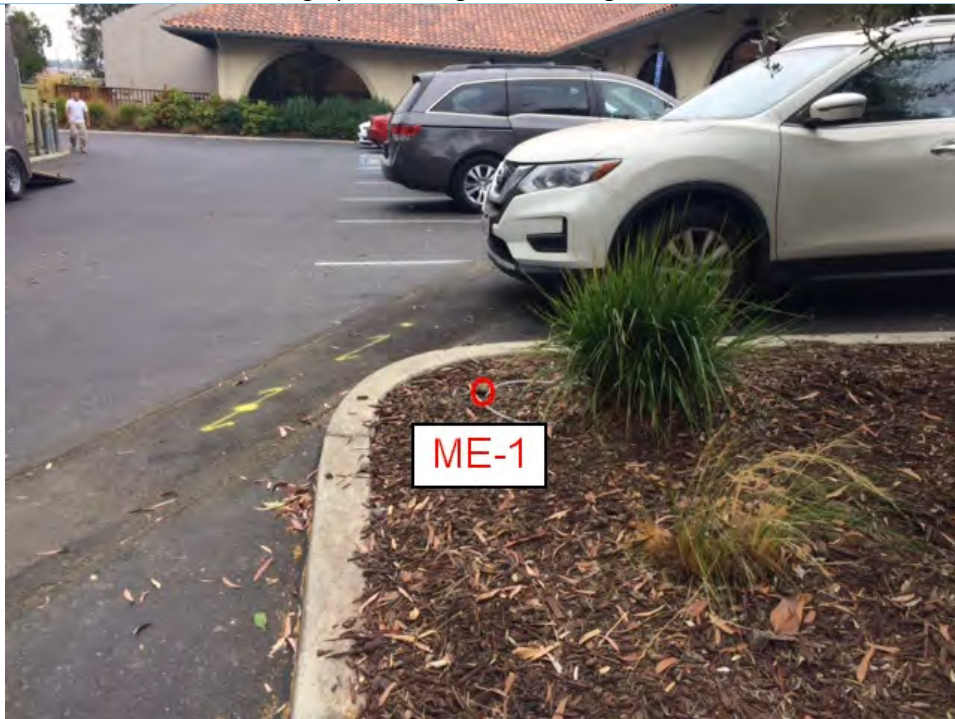
Photograph 2: Boring ME-1 looking east

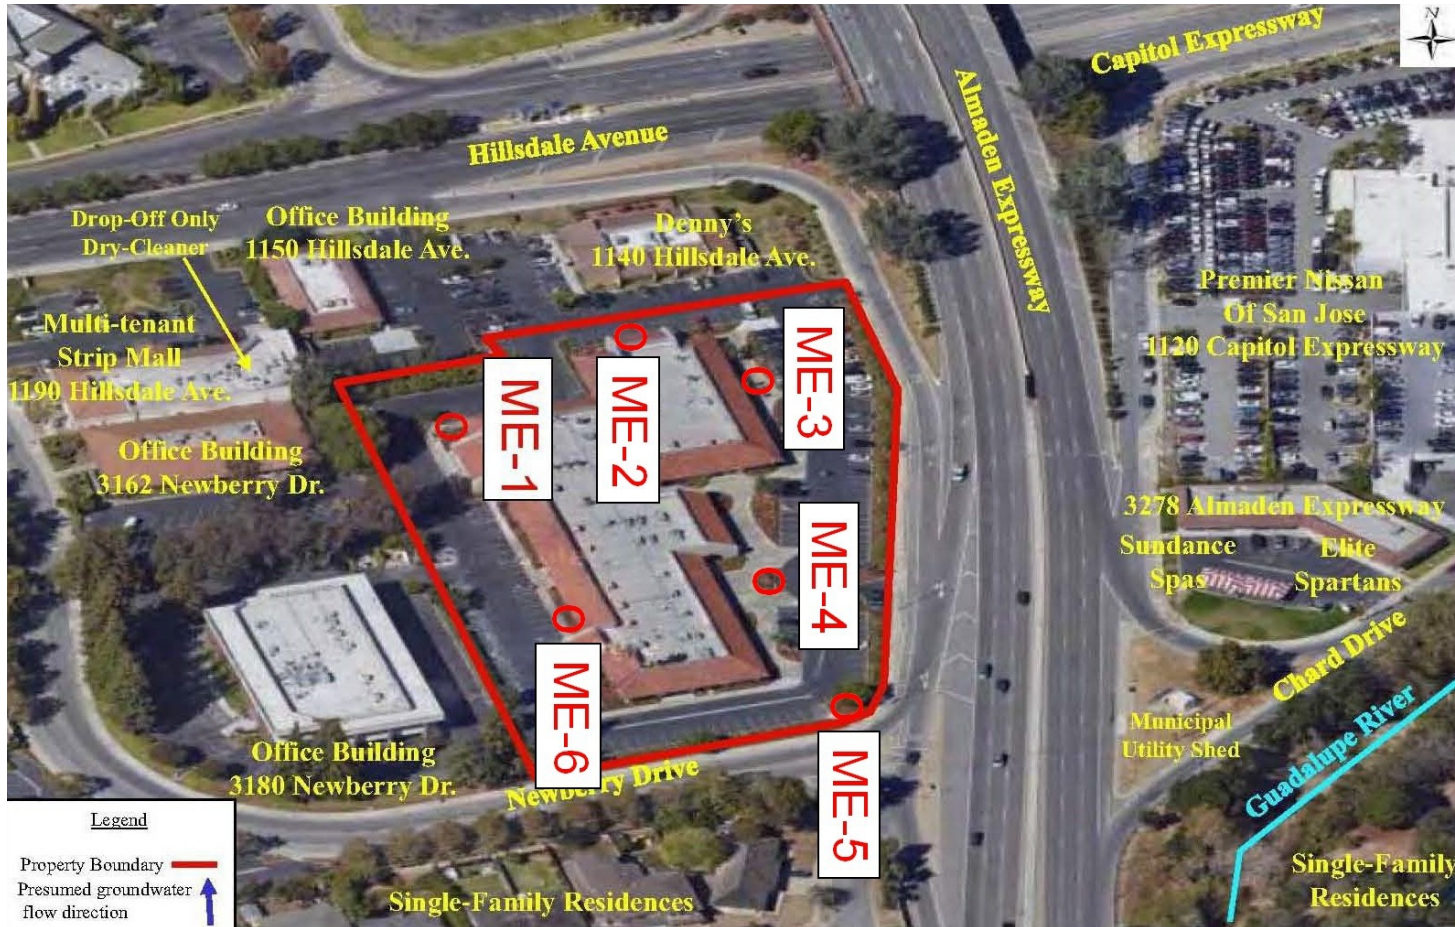
Concentrations in µg/m3
 ND=Not Detected
Bold=Largest detected concentration
 ESL= Environmental Screening levels Subslab/Soil Gas (January 2019)
 ESL Residential=Vapor intrusion (Human Health Risk levels) for residential areas.
Exceeds ESLs (Tier 1 and Cancer Risk)

As mentioned on the memorandum issued by the City on October 23, 2020, *“Benzene and tetrachloroethene soil vapor readings are above residential ESLs for cancer risk.”* Please note that the Cancer Risk ESLs for those two compounds are the same as their respective Tier 1 ESLs. The reported concentrations are much lower than the Non-Cancer Hazard ESLs.
