484 EAST ST. JOHN STREET,  
488 EAST ST. JOHN STREET,  
93-97 NORTH 11TH STREET,  
HISTORIC RESOURCE EVALUATION

SAN JOSE, CALIFORNIA  
[20033]

PREPARED FOR:  
JITIAN TAN

**PAGE & TURNBULL**

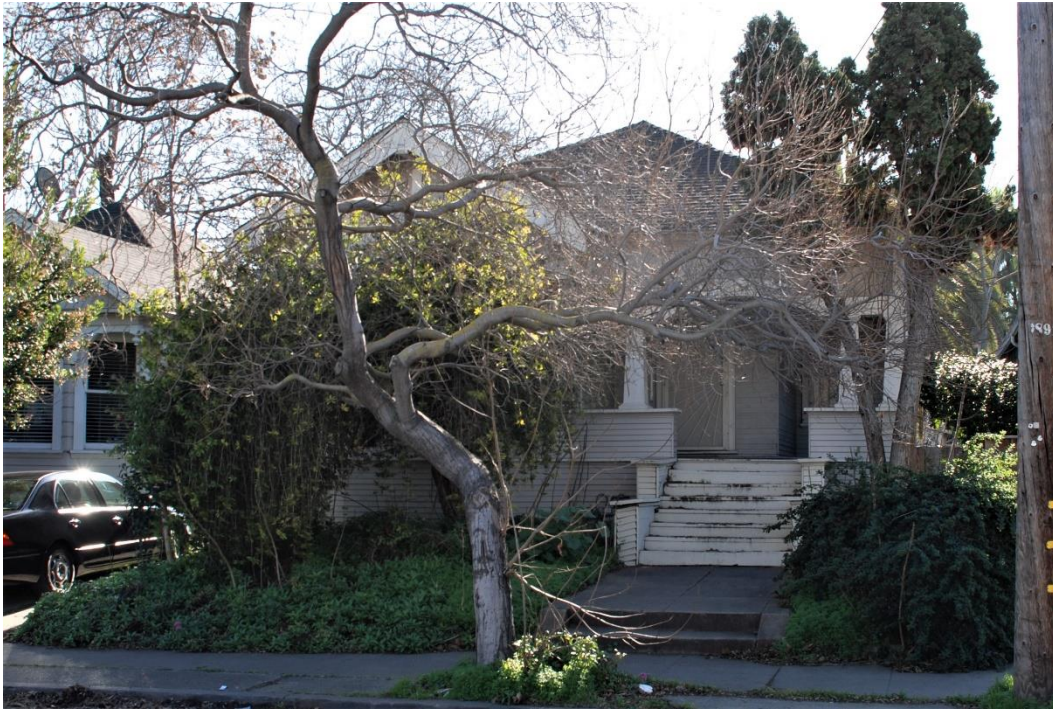
Figure 3. Primary (northwest) facade of 484 East St. John Street, view southeast.

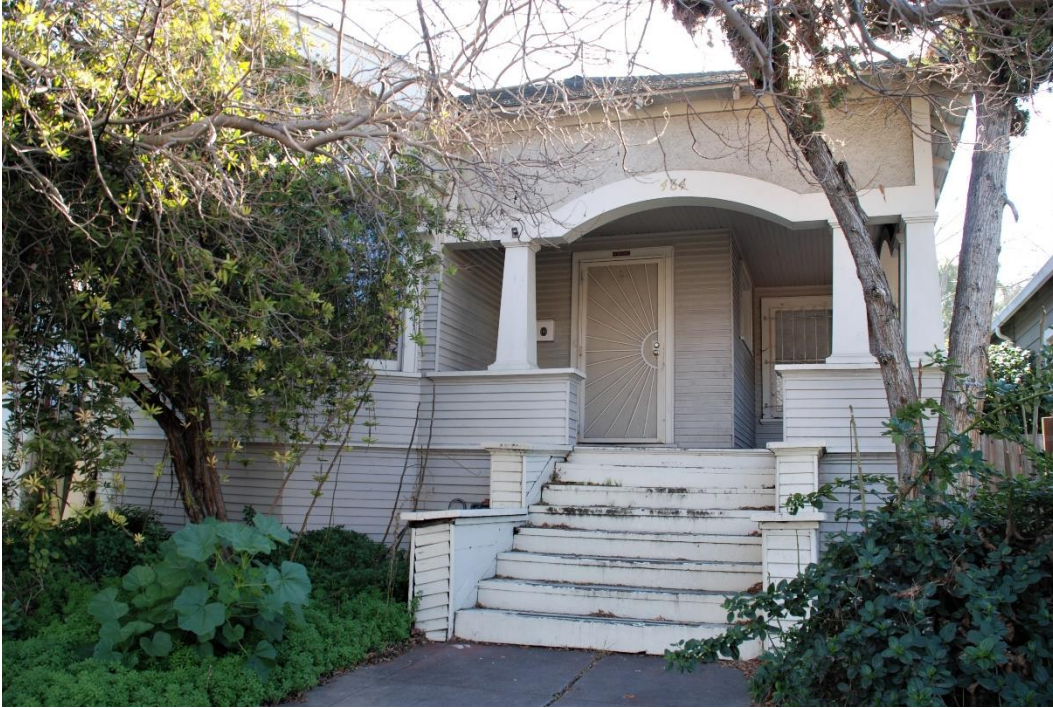
**Figure 6. Porch at southwest side of primary facade, 484 East St. John Street, view southeast.**

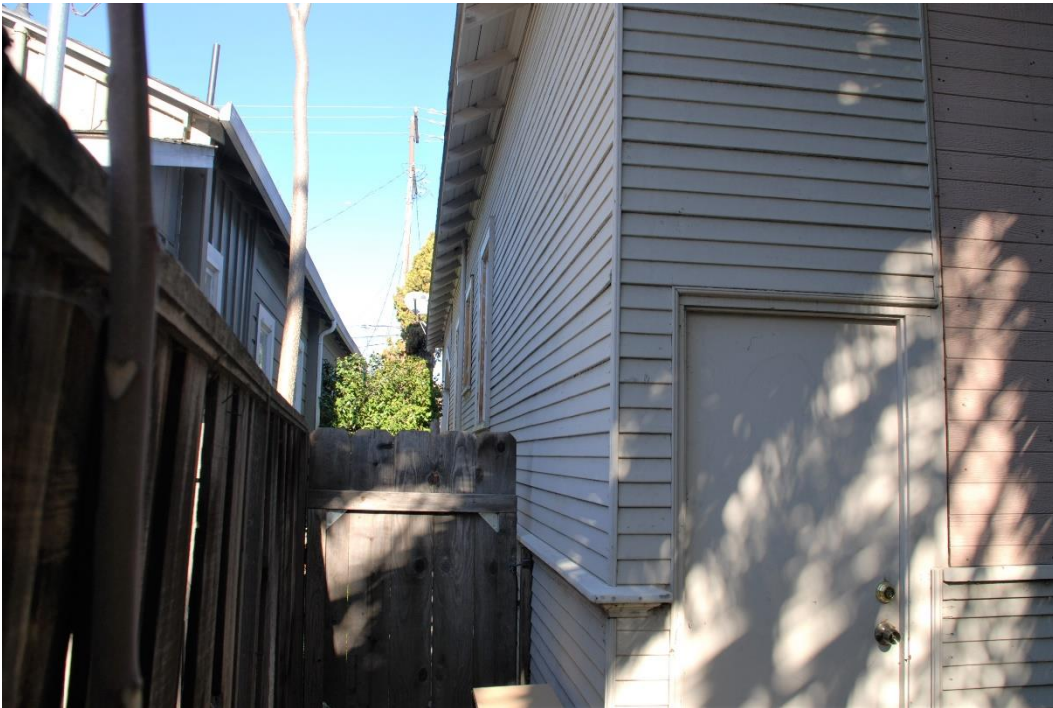
**Figure 9. Southwest facade, 484 East St. John Street, view northwest from rear yard.**

The southwest facade is set close to the neighboring property line, obstructed from close inspection by fences. At the left (northwest) side, the facade features the west-facing portion of the L-shaped porch, with battered columns and arched entablature. The west facade inside the porch includes one fixed rectangular window with leaded glass in a diamond configuration and original trim (**Figure 7 and Figure 8**). Other openings on the west facade include three rectangular replacement windows with what appears to be a combination of replacement and original wood trim (**Figure 9**).

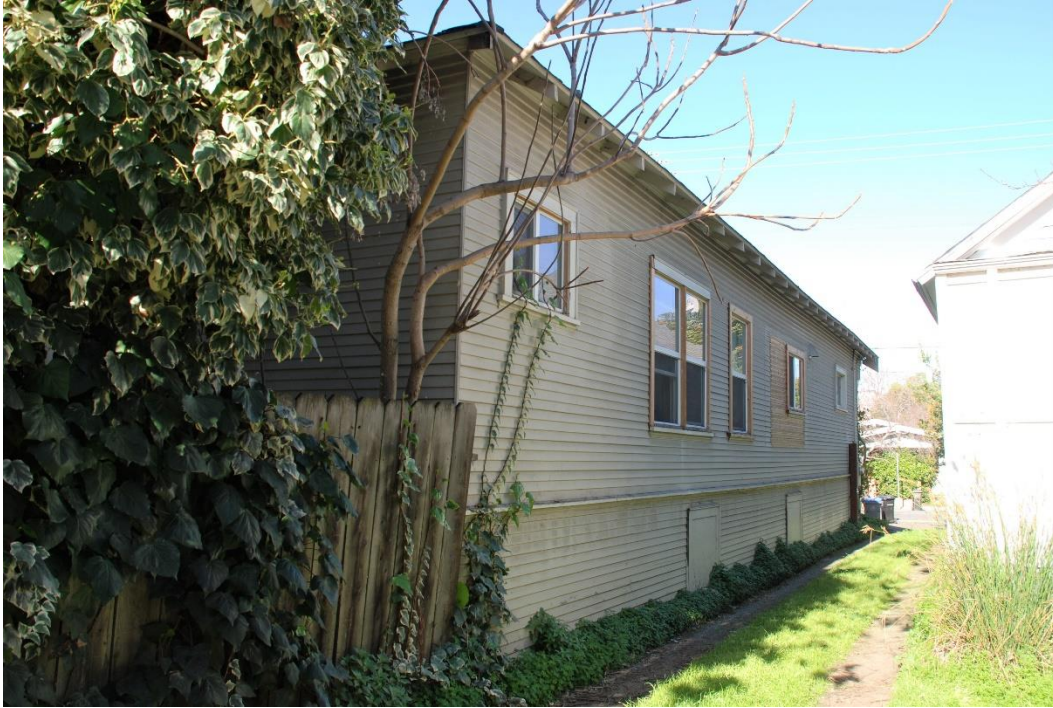
**Figure 13. Northeast facade, 484 East St. John Street, view northwest.**

The east facade overlooks a narrow, unpaved driveway between 484 and 488 E St. John Street (**Figure 13**). First-floor openings in the facade include, from left (southeast) to right (northwest): A small, rectangular vinyl-frame slider window surrounded by what appears to be original trim; three replacement double hung windows, the two leftmost set in a pair, with flat wood trim; one small, rectangular vinyl-frame slider window with flat wood trim set in a patched area of siding that appears to be a former window opening; and a small, rectangular leaded glass fixed window with what appears to be original trim (**Figure 14**). Two crawl-space openings are set at ground level near the center of the facade.

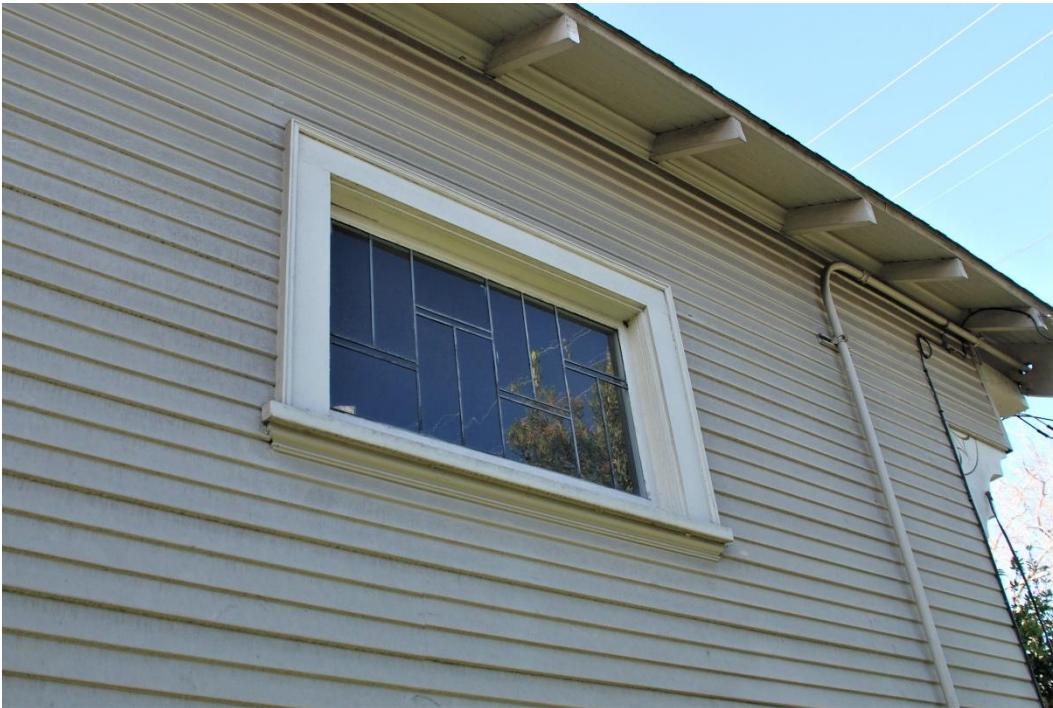
**Figure 14. Detail of leaded window at northwest side of northeast facade, view northwest.**

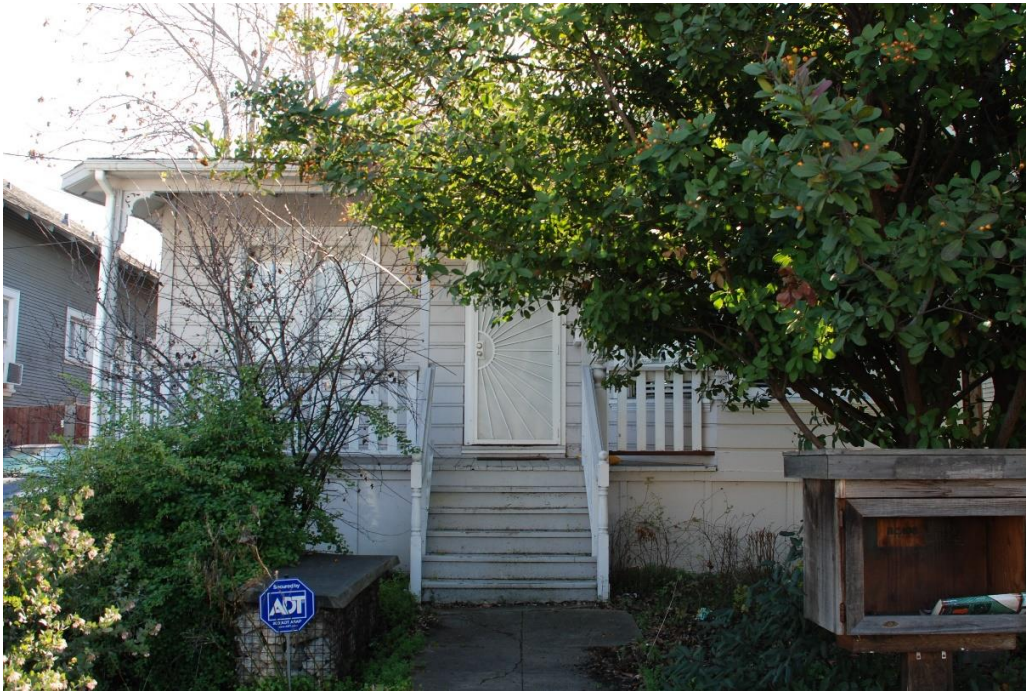
Figure 15. Primary, northwest facade, 488 East St. John Street, view southeast.

The primary, northwest facade overlooks a small, unenclosed front yard with a mature tree and shrubs (**Figure 15**). The left (northeast) side of the primary facade includes a porch with an overhanging shed roof supported by rectangular and turned and square wood posts, incised, shaped brackets, exposed ceiling rafters, and a simple wood railing (**Figure 16**). Within the porch, openings include, from left to right, one pair of typical windows and the main entrance door, which is obscured by a modern metal security door and has a fixed rectangular transom window with wide wood trim. The porch is accessed by a wood staircase with turned newel posts, aligned with the entrance door. At its right (southwest) side, the facade features an angled window bay set below a projecting gabled roof (**Figure 17**). Two typical original windows flank a central fixed rectangular window with an undivided smaller upper and larger lower lite. Incised L-shaped brackets are placed at each soffit edge of the window bay, and there is a drop pendant at the west corner. The front gable features scalloped shingles and simple eave returns. The lower portion of the facade, including the porch skirting, includes some sections of plywood cladding.

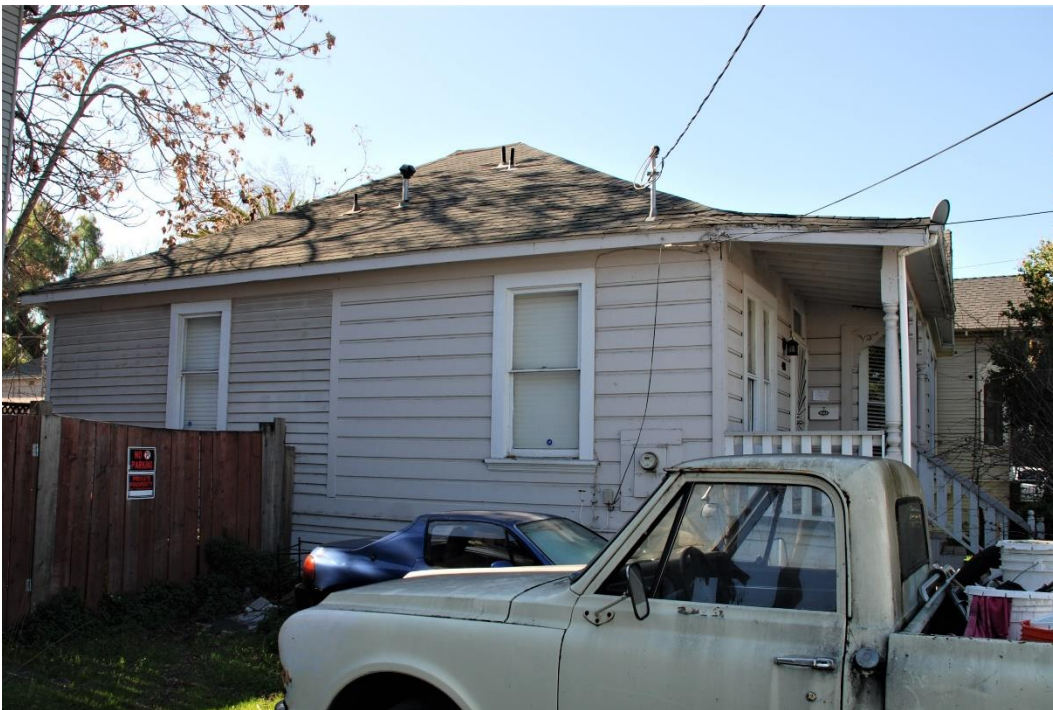
**Figure 21. Northeast facade, 488 East St. John Street, view southwest.**

The northeast facade overlooks an unpaved parking area and a portion of the rear yard of the neighboring property at 97 North 11th Street (**Figure 21**). The rear (southeast) half of the facade is clad in narrow lap siding while the front (northwest) half is clad with wide rustic-vee siding. The junction of the two siding types is marked by a flat vertical trim piece. One typical window is set in each of the rear and front halves of the facade. A small wood crawl space access door is set at ground level near the front (northwest) extent of the facade.

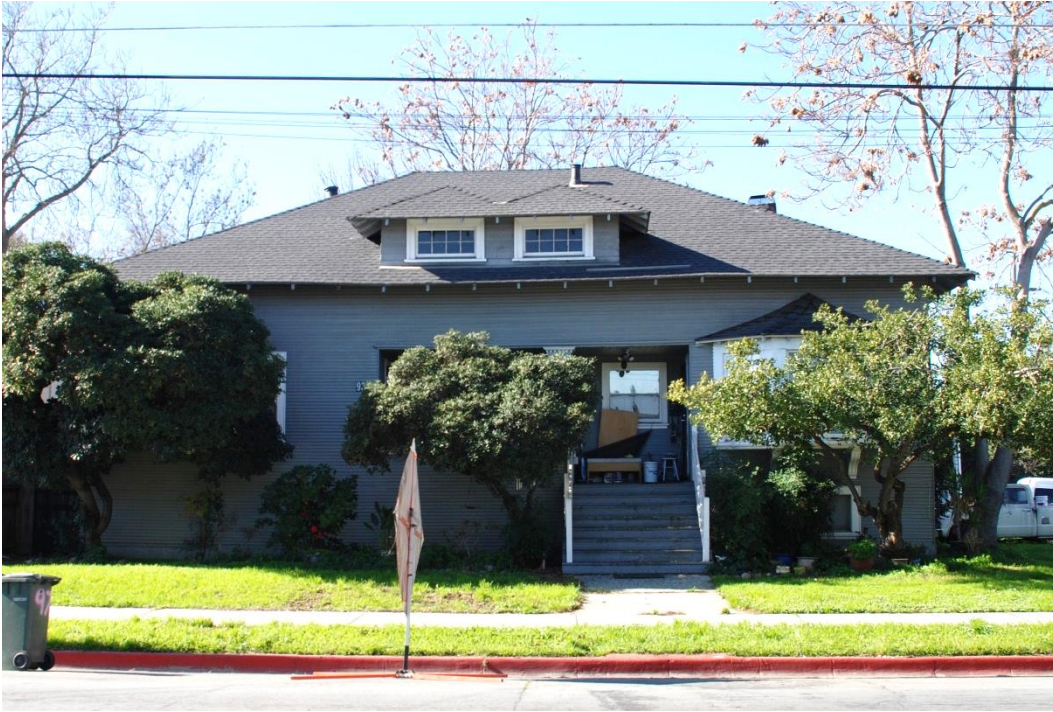
Figure 22. Primary, northeast facade, 93-97 North 11th Street, view southwest.

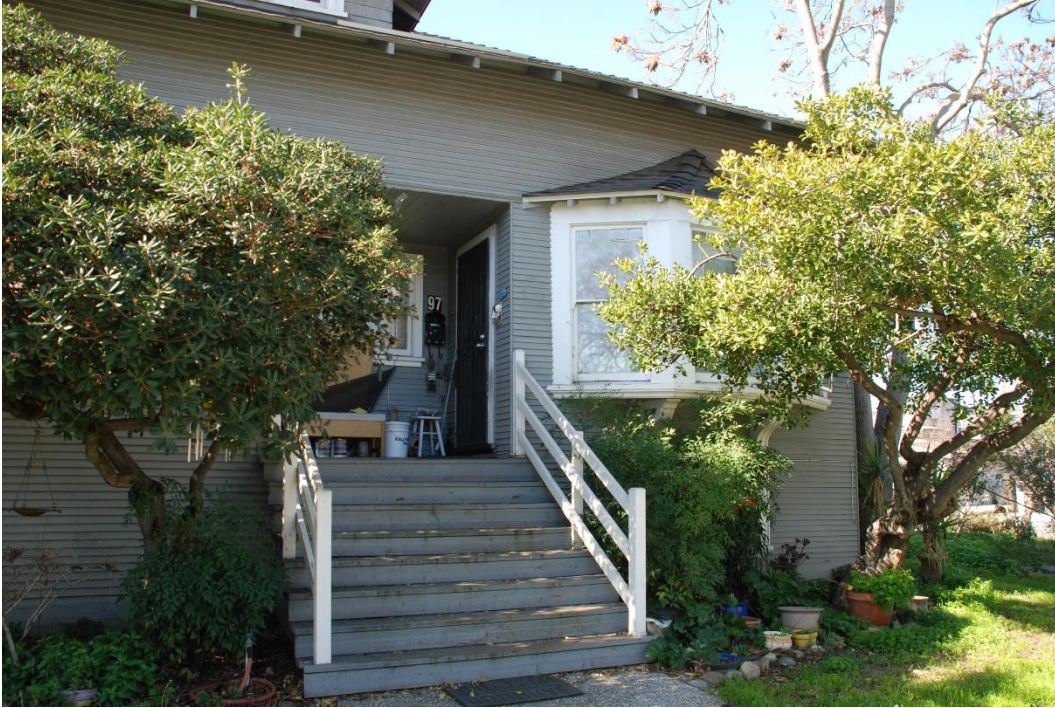
Figure 24. Staircase and window bay at northeast side of primary facade, 93-97 North 11th Street, view west.

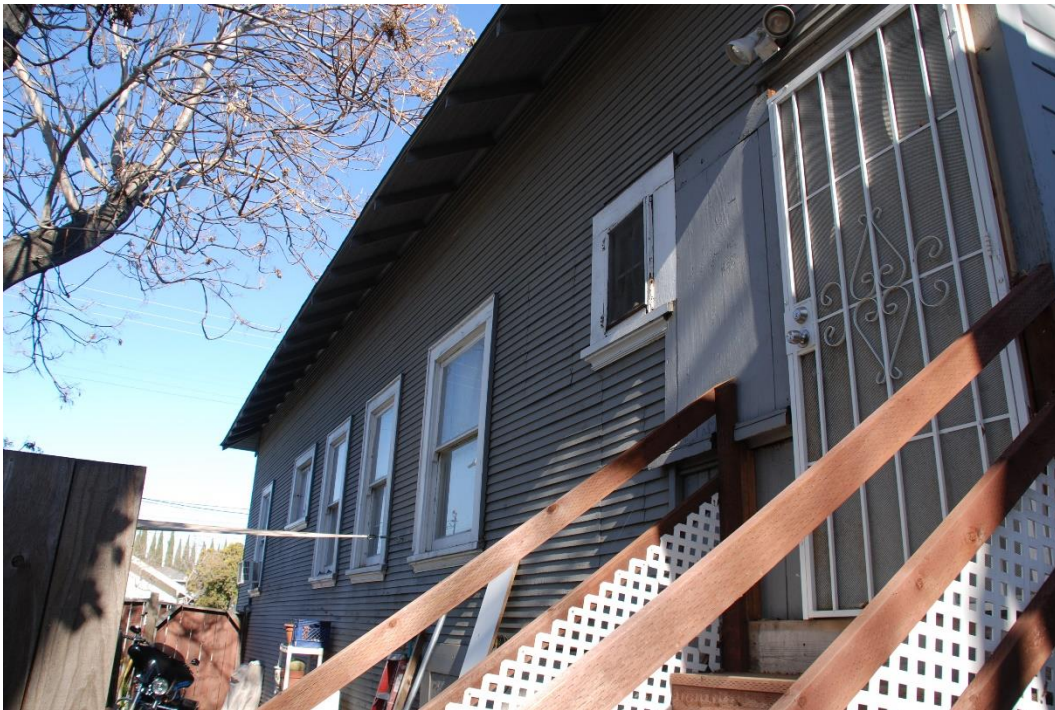
Figure 27. Southwest facade, 93-97 North 11th Street, view north.

The rear, west, facade overlooks a small enclosed rear yard and the east facade of the neighboring house at 488 East St. John Street (**Figure 27**). Openings in the rear facade include, from left (north) to right (south): one typical original window with an air conditioning unit set in its lower sash; one small rectangular modern sliding window with metal or vinyl frame, and trim matching the typical original double-hung windows; three typical original windows; and one small rectangular double-hung window with a hinged, wood-frame screen.<sup>4</sup> To the right of this small window, paneled and vertical tongue-and-groove planks fill what appear to have been an original porch opening. An entrance with a modern metal security door is set at the right side of the facade, and is accessed by a non-original wood staircase with lattice panels and wood rails.

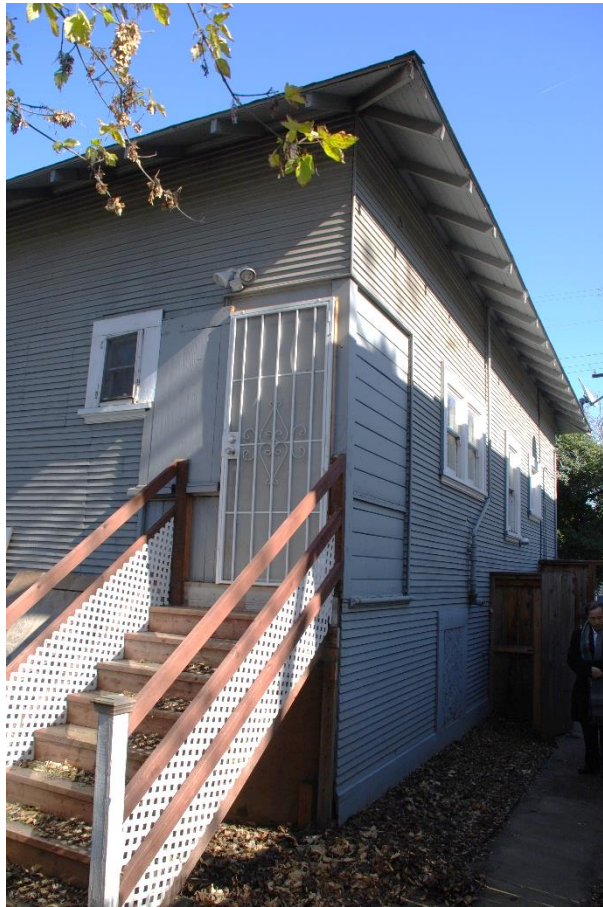
Figure 28. Southwest and southeast facades, 93-97 North 11th Street, view east.

The southeast facade overlooks a fenced passageway at the south side of the parcel, with an east-facing gate set back approximately six feet from the east corner of the façade (**Figure 28**). Openings in the south facade include, from left (west) to right (east): one pair of small typical original windows, one typical original window, and one fixed rectangular window with frame and trim matching the typical original double-hung windows. At the left (west) side of the south facade, a rectangular patch of wide, rustic siding appears to indicate an infilled original porch opening at the rear entrance. A rectangular crawl-space opening is set at ground level near the left (west) side of the facade.

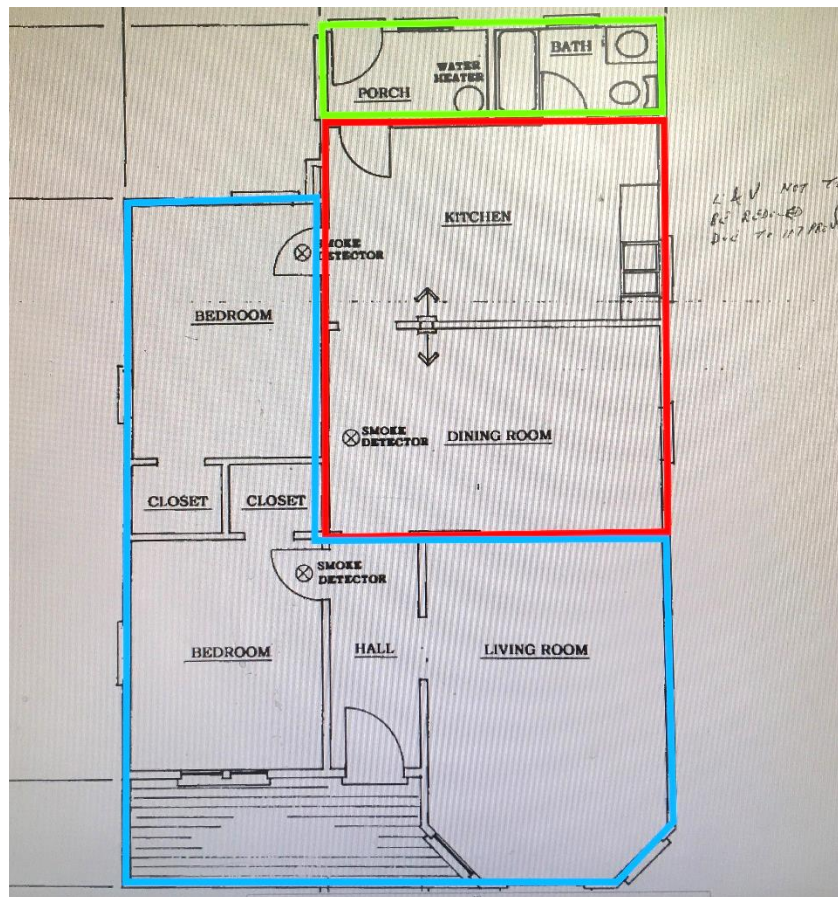
Figure 37. Edited floor plan from 1993 drawing set showing original (likely nineteenth-century) gabled rear portion outlined red, additions ca. 1901-1915 outlined in blue, and addition ca. 1915-1939 outlined in green.

The building does not appear to have changed much in its overall massing and general exterior treatment from its early twentieth century Queen Anne cottage style redesign. Aerial photographs from 1939 and 1965, and the 1950 Sanborn fire insurance map, also indicate that the overall footprint of 488 East St. John Street has remained relatively unchanged since its early twentieth century alteration. A shallow rear addition appears visible in the 1939 and 1965 aerial photographs (Figure 37).

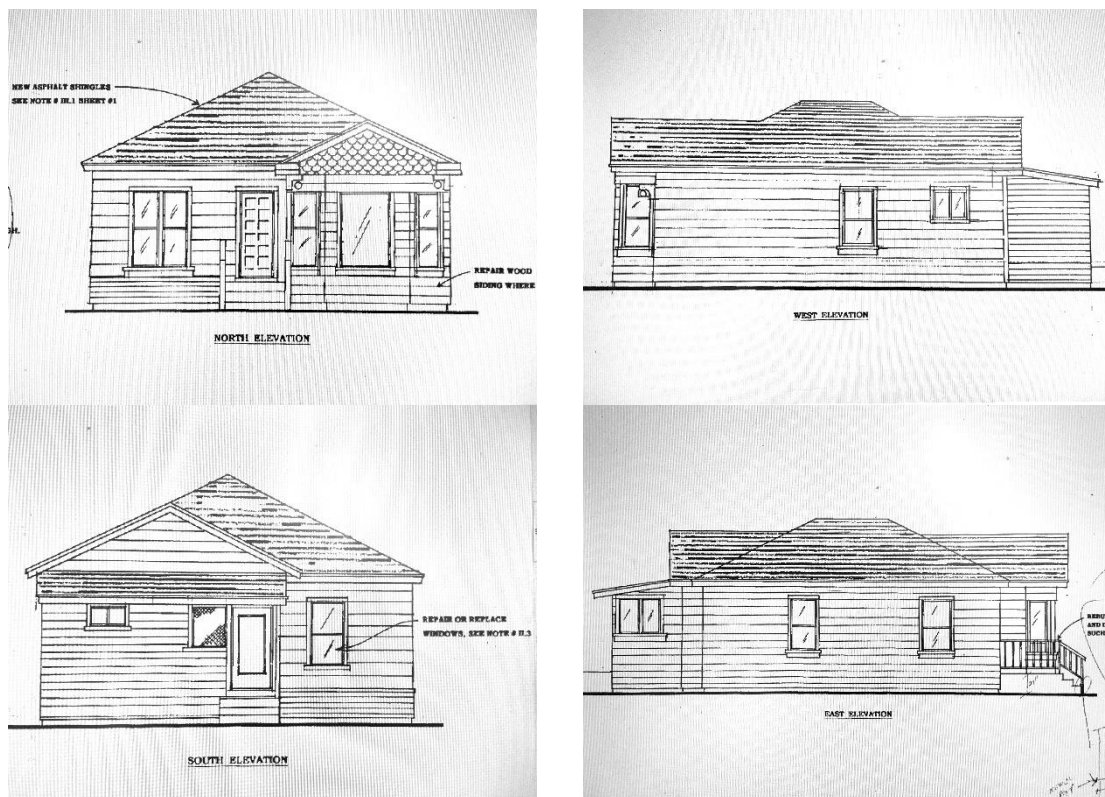
Figure 38. 1994 elevation drawings for proposed improvements to 488 East St. John Street, by Guerra & Associates.

Elevation drawings by Guerra & Associates from September 1993 that accompany this permit application show the small rear shed-roof addition (**Figure 38**). These drawings do not depict the front porch or its shed roof, though previous owner Glenn Brown confirmed that it was replaced ca. 1993.<sup>35</sup> It appears that the finish boards and railing on the porch and the stairs were replaced, but the structure underneath appears original, as are the two turned wood posts and brackets at either end. According to an undated photo provided by Mr. Brown, prior to the porch remodel, the drop pendant extant at the outer corner of the bay window matched a drop pendant on the opposite corner of the bay window adjacent to the porch, which is now missing. In its place is now one of two original turned wood posts, but placed where a post was not previously located. It appears that one of the turned posts that likely was located at the east side of the stairs was moved to the west side of the stairs, adjacent to the bay window, and a new square wood post was inserted in its original location. The Guerra & Associates drawings also do not show the differences in siding width between the front (north) and rear (south) sections of the house. The East Elevation drawing shows a window at the northeast facade of the rear shed-roof addition where there is currently only plywood sheeting.
