## PHASE I ENVIRONMENTAL SITE ASSESSMENT *with a Limited Site Investigation*

**1660 Old Bayshore Hwy  
Oakland, California**

**Prologis, Inc.  
Pier 1, Bay 1  
San Francisco, California**

**28 January 2020  
750661601**

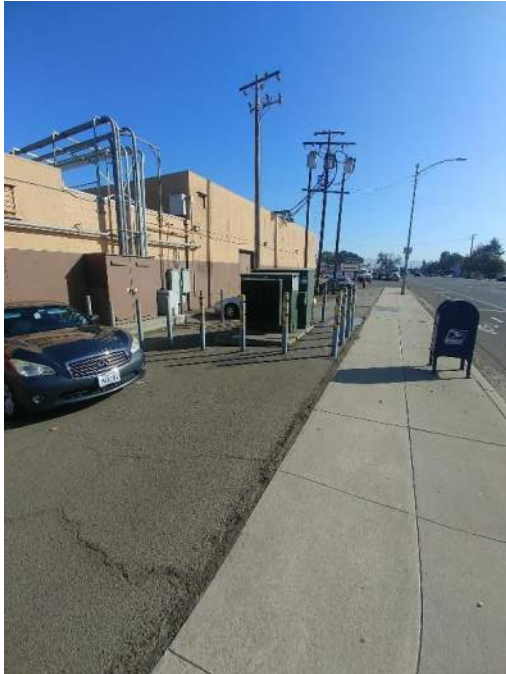
Langan observed one pad-mounted transformer at the Site, on the south side of the 1660 parcel. Langan also observed three pole-mounted transformers on the south side of the 1660 parcel. The 1660 parcel transformer was labeled as PG&E owned. Langan was unable to observe the details relative to the pole-mounted transformers. No visible labelling regarding PCB content or transformer type was observed, and no staining was observed on the concrete pad, or at the base of the poles. Langan did not observe other Site equipment or operations suggestive of PCB storage or use.

**Photograph 3.** Pad-mounted and pole-mounted, PGE owned transformers.

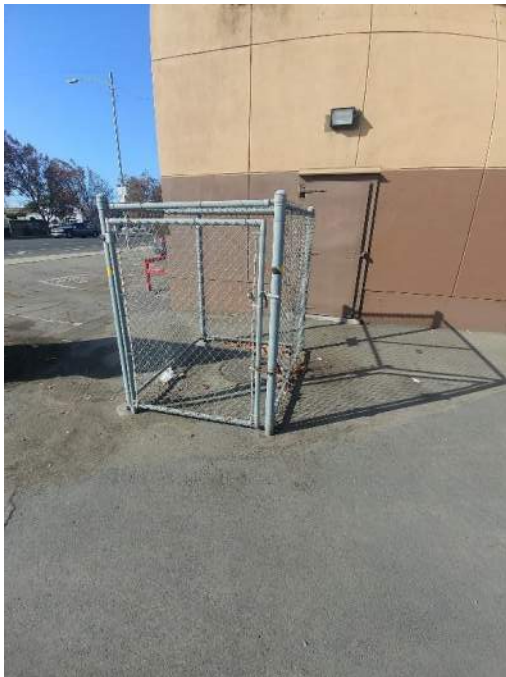
**Photograph 4.** Manhole access point for sampling stormwater discharge. Facing west, located on the southeast corner of the Smithfield facility.

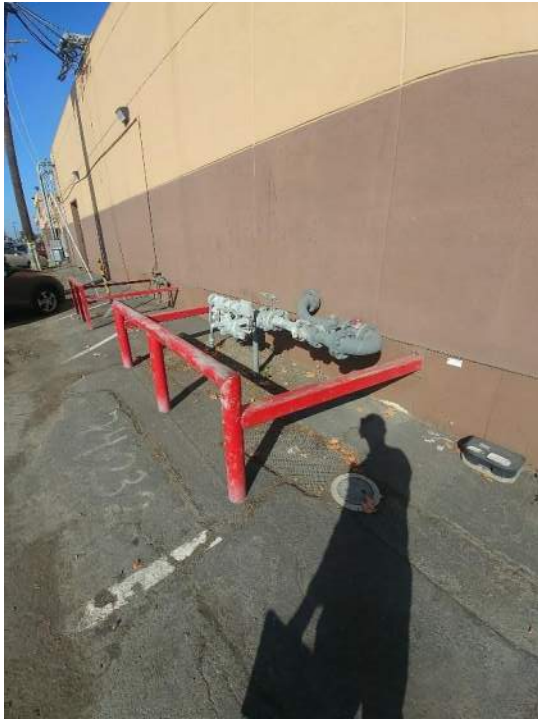
**Photograph 5.** PGE gas supply on the south side of the Smithfield facility.

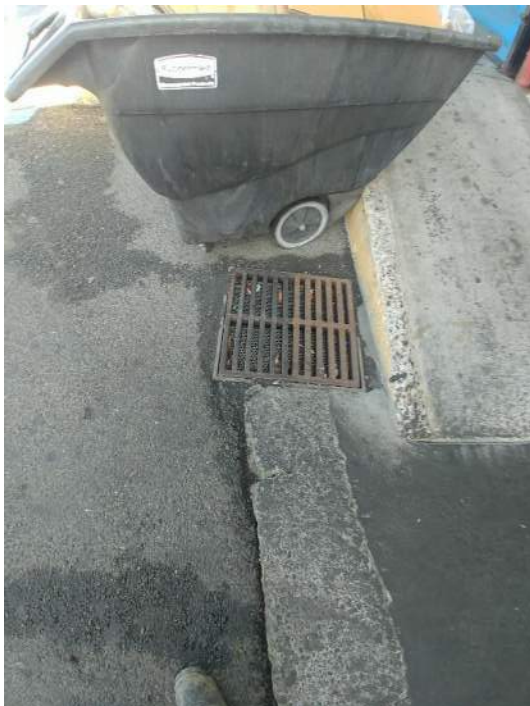
**Photograph 6.** Water catch-basin on the north side of Smithfield packing operations. This catch-basin feeds a grease-trap and water treatment system.

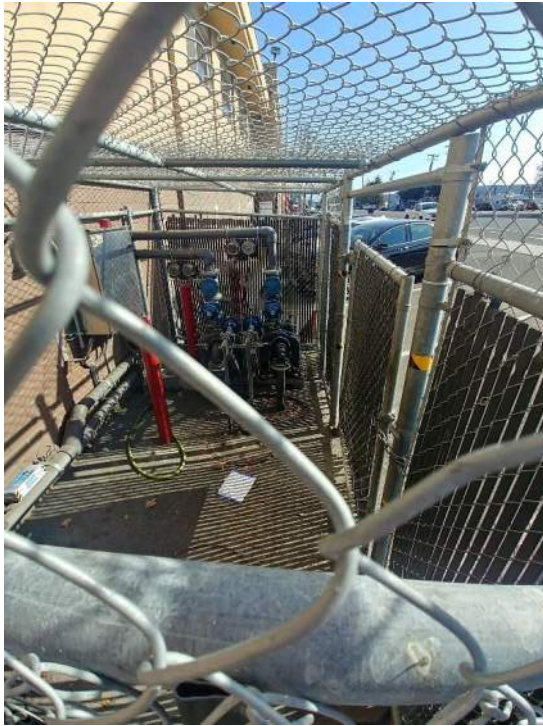
**Photograph 7.** Grease trap on the south side of the Smithfield facility.

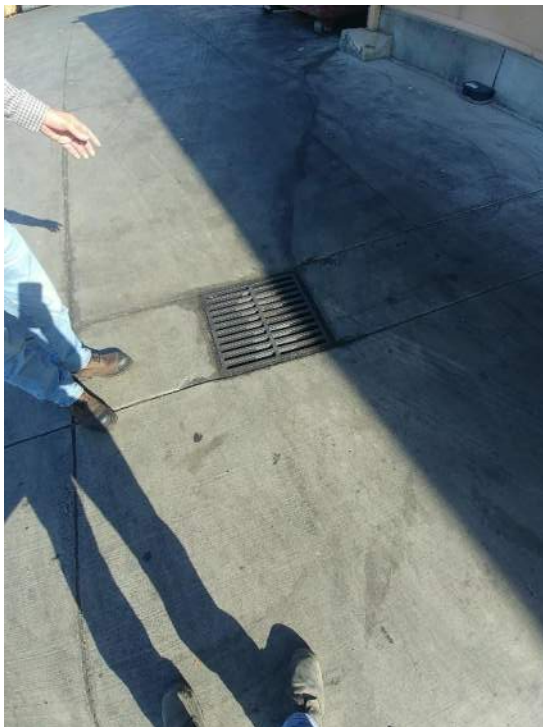
**Photograph 8.** The Smithfield facility also has storm water catch basins that drain directly to the municipal storm sewer. This drain is located in the driveway on the west side of the packing operations.

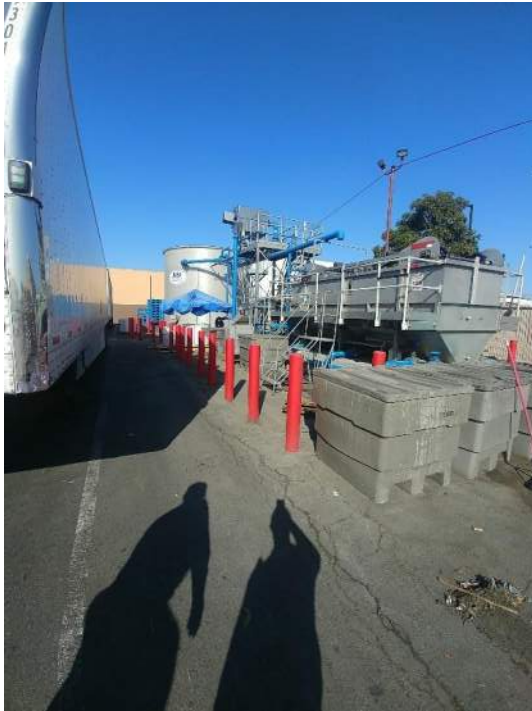
Mr. Molcan stated that the Smithfield/Mohawk meat packing operation received several notices of violation for discharging water to the City of San Jose sanitary sewer that did not meet permitted conditions for pH. In response to those violations, the pH balancing stage and additional grease trap were added to their waste water treatment process approximately three years ago.

**Photograph 9.** Water treatment system located in the northern portion of the Smithfield facility. The system has a grease removal component, and a pH balancing portion. Discharge pH is regulated by titration with proprietary solution containing sodium hydroxide.

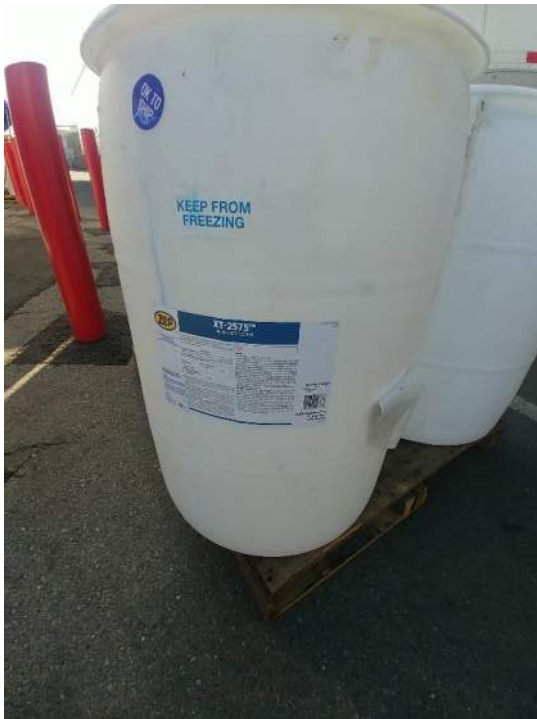
**Photograph 10.** The solution is stored in 55-gallon polyethylene drums which are palletized.

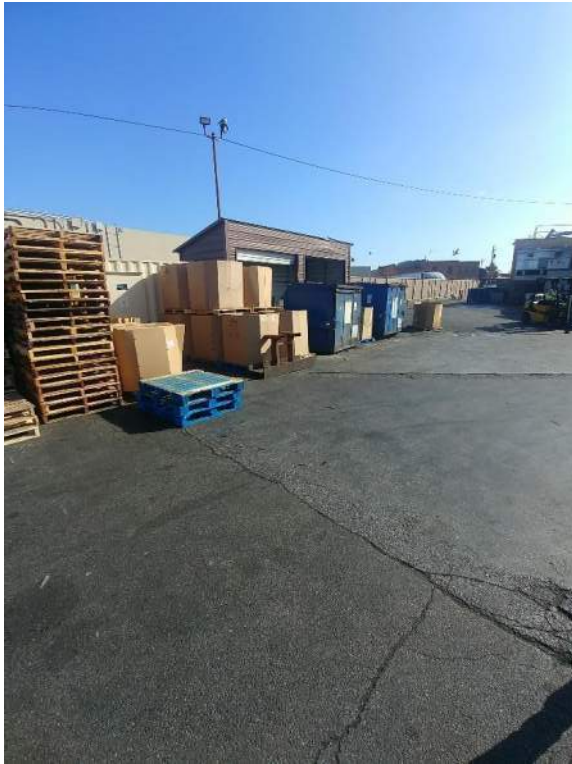
**Photograph 11.** General storage in the northern portion of the facility.

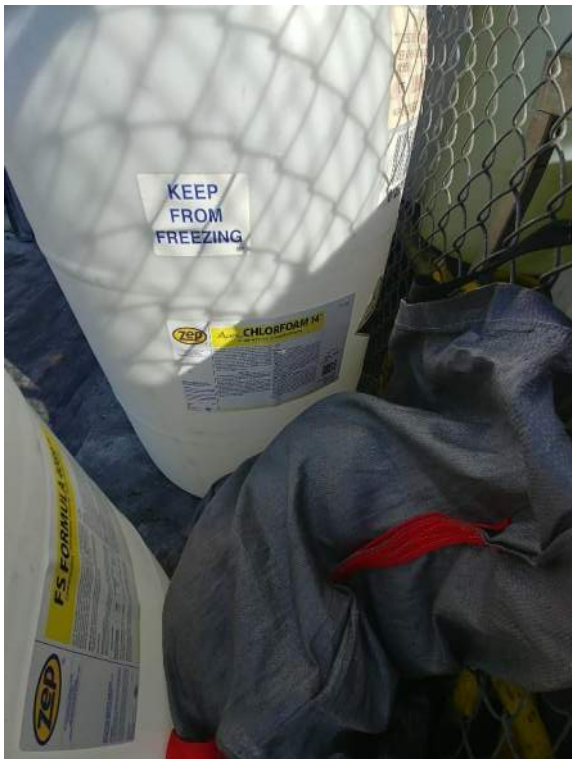
**Photograph 12.** Detergent storage on the northern side of the packing operation.

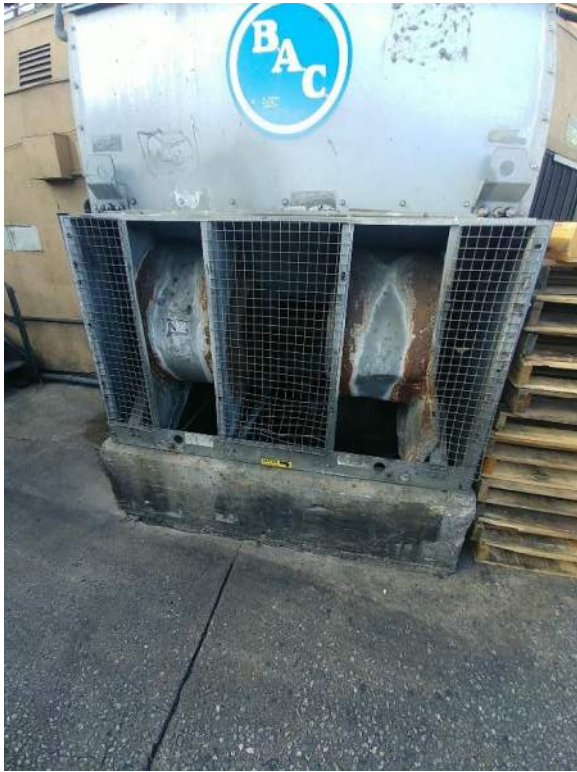
**Photograph 13.** Air-conditioner at the Smithfield facility. The other A/C units are roof-mounted. This unit is mounted on an 8-inch pad that appears free of staining.

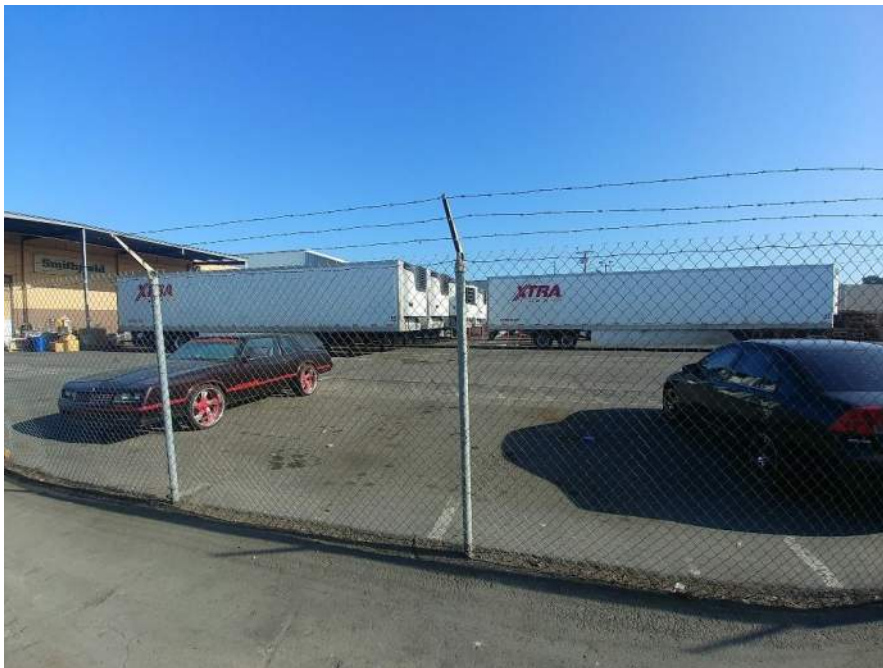
**Photograph 14.** Refrigerated truck-trailers waiting to be loaded on the northern side of the Smithfield facility. At left is the equipment and materials storage warehouse.

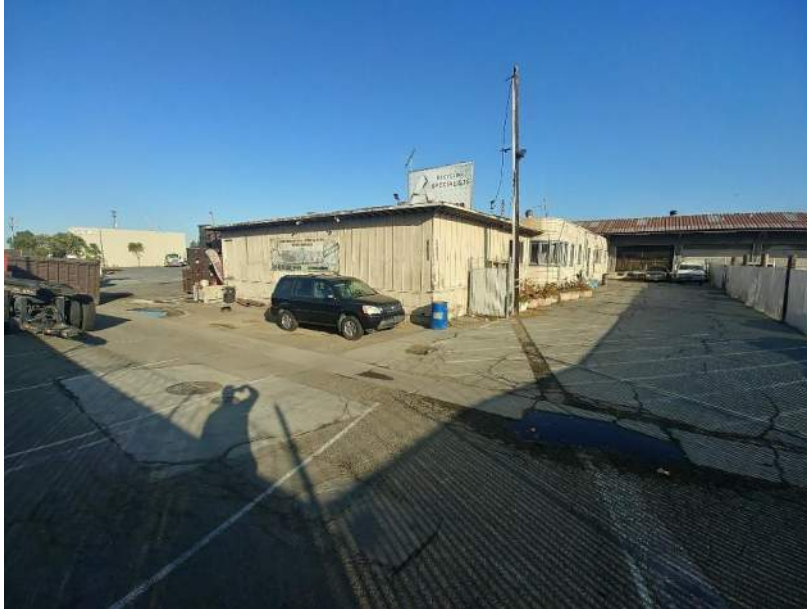
**Photograph 15.** Southern portion of the Recycling Specialists facility fronting along Old Bayshore; standing inside the fenceline. A manhole access point and storm water culvert are visible in the foreground.

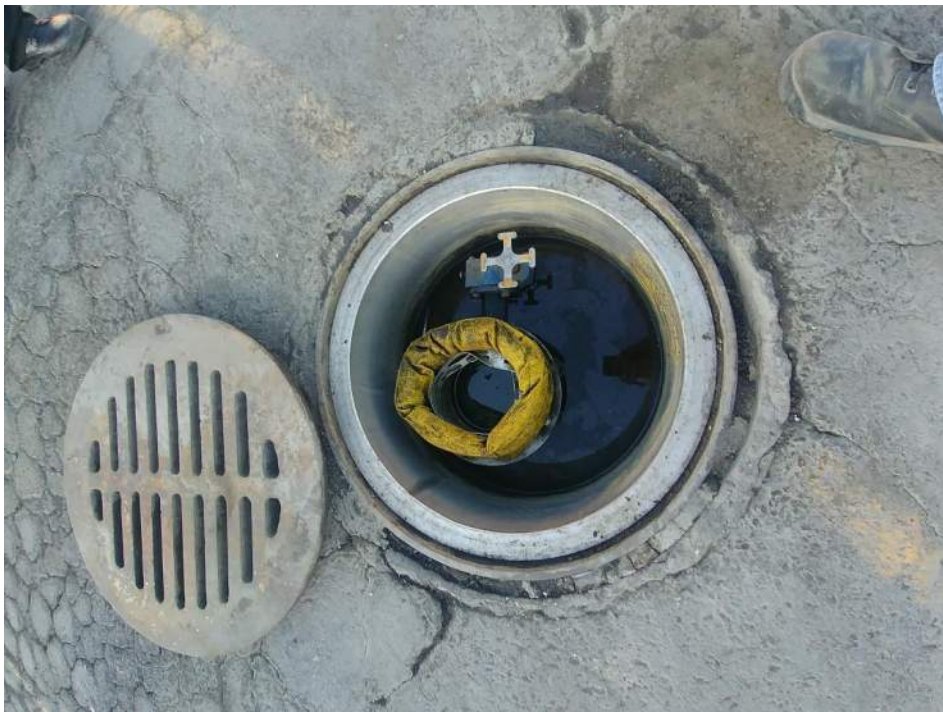
Four storm drain catch basins were observed in the paved area on the north side of the 1736 parcel. A storm water collection culvert, lined with concrete, was observed on the southern side of the 1736 parcel. That culvert had a catch basin and manhole access point near its approximate center. Three storm water catch basins were observed across the 1720 and 1660 parcels. These basins are understood to drain to the municipal storm sewer. In San Jose, the municipal storm

**Photograph 16.** Storm water catch basin outfitted with a silt filter. There are four storm water catch basins on this facility; three have the silt filter.

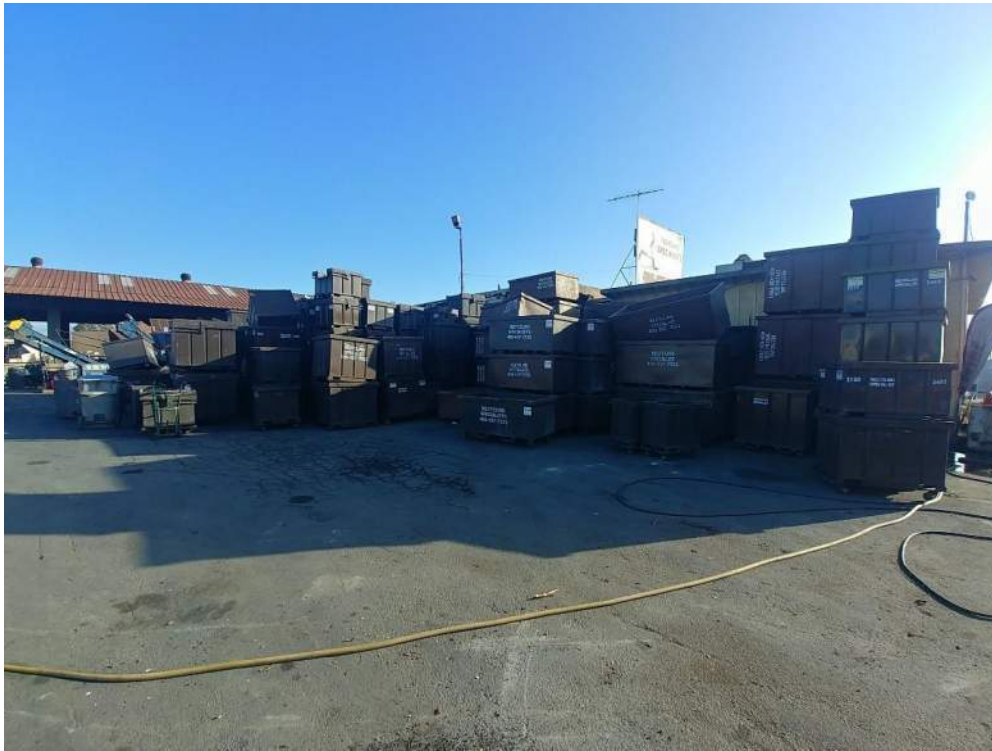
**Photograph 17.** Recycling Specialists is in the process of vacating the facility. Pictured here are empty bins staged outside the receiving portion of the facility.

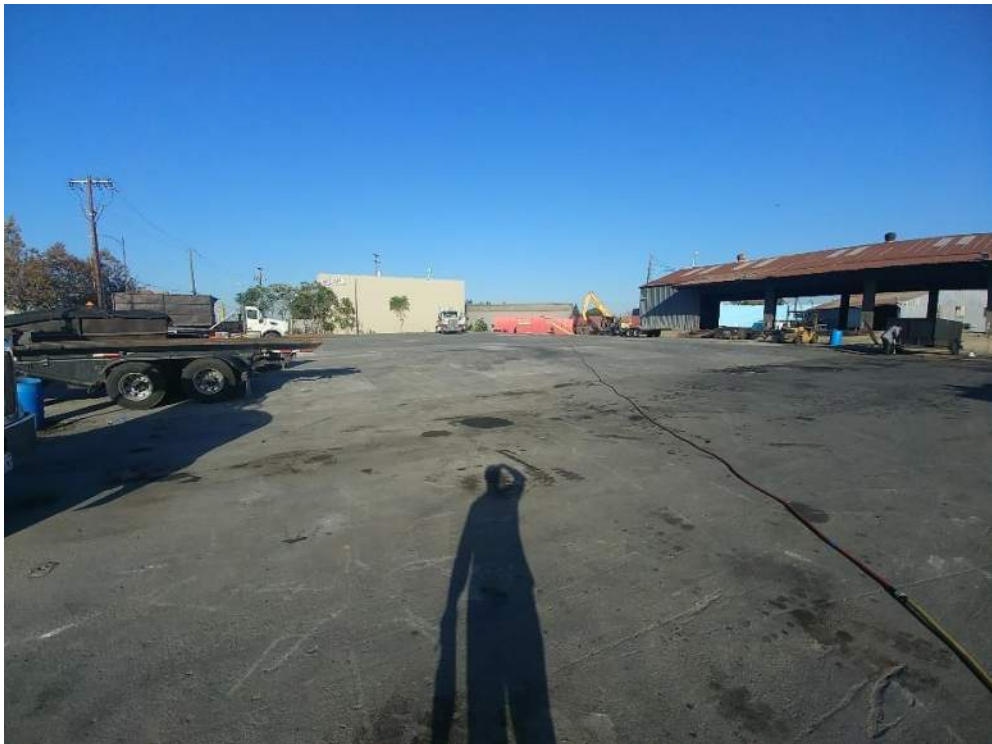
**Photograph 18.** Facing the western portion of the site, and the footprint of the former Chevron gas station. That area is now covered with a concrete pad approximately six to 12 inches thick.

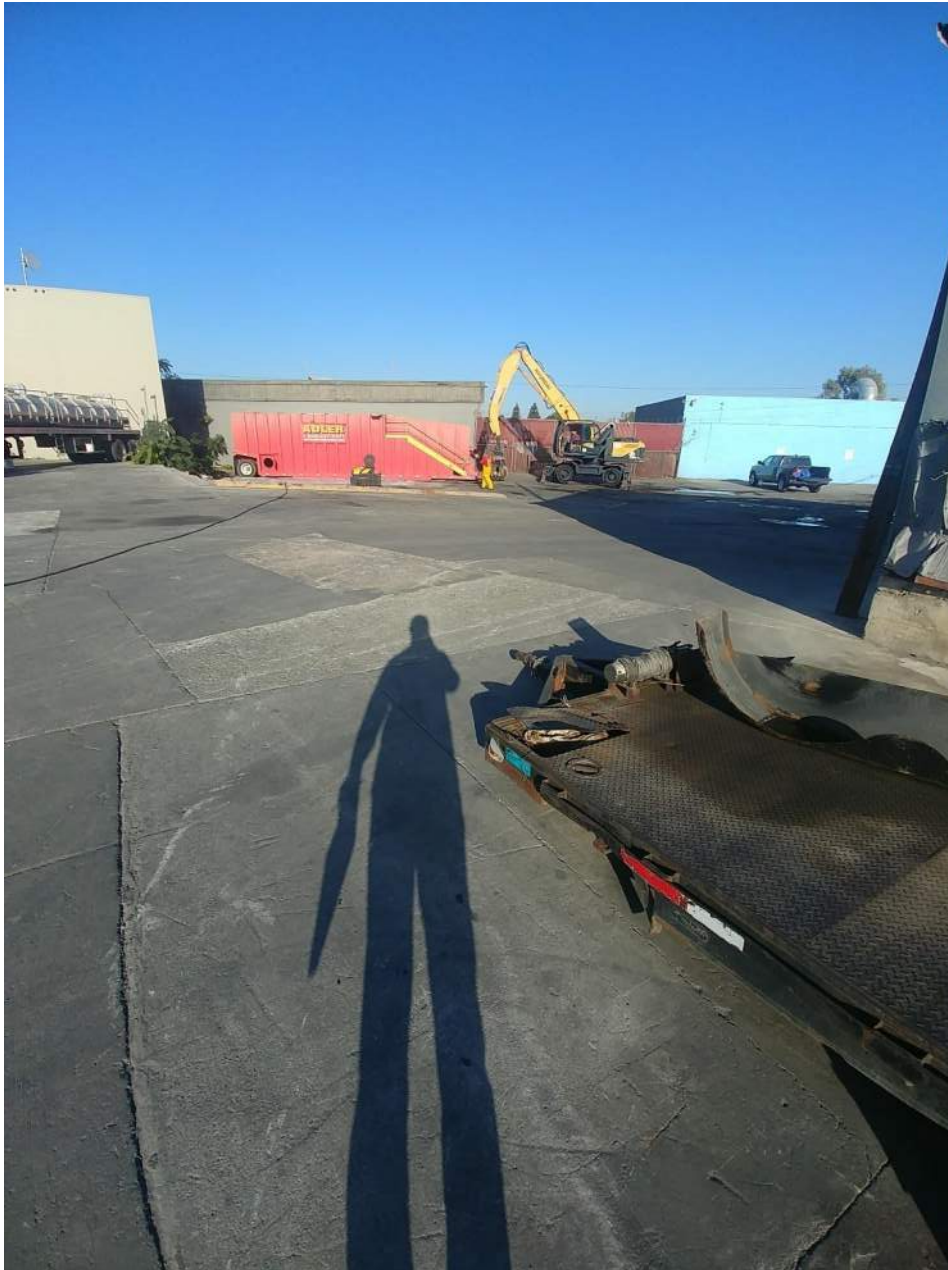
**Photograph 19.** Recycling Specialists was removing ponded water which had been accumulated into the pictured baker tank on the west side of the site. The water reportedly had ponded around the former metal scrap piles, and contained lubricating oils from the metal cuttings. Refer to features 1 and 4 in Photograph 20.

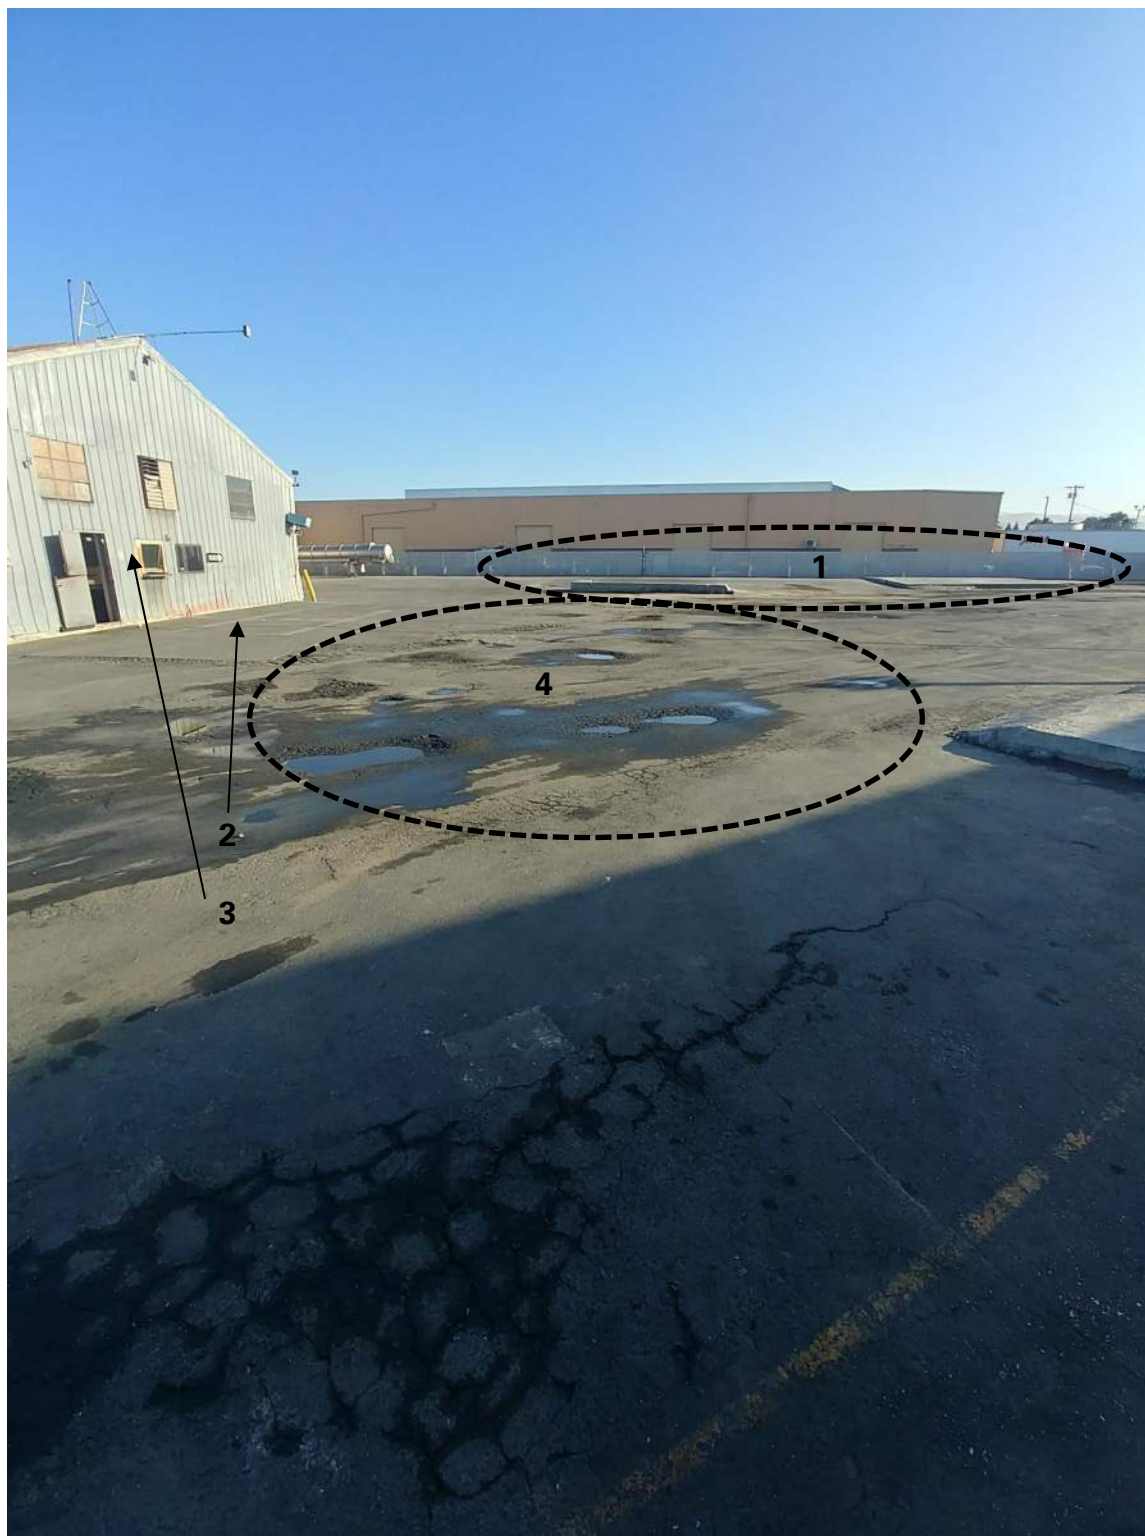
Langan observed potholes in the asphalt on the 1736 parcel, suggestive of heavy truck traffic. As discussed above, ponded water was observed in some of these potholes. The potholes appeared most concentrated in the area immediately south of the former recycled metals staging piles. The larger feature inferred to be ponded water, as noted in NearMap imagery and discussed in Section 4.1, was not observed.

The Site is almost entirely paved, with some exposed soil in the potholes previously noted. Some staining was observed in the potholes. Drip stains were also observed on paved surfaces across the facility. In general, the staining appeared localized on the Recycling Specialists portion of the facility.

An in-ground truck-scale set in concrete was observed in front of an ancillary building at the 1736 parcel. The ancillary building appeared to have been used as a cashier's office, employee breakroom, and tool storage area. The at-grade truck scale appeared to be an electronic scale, as hydraulic components were not observed, and was set in approximately 12 inches of concrete.

**Photograph 20.** Feature 1 (circled) is where metal scrap piles have historically been staged. Feature 2 is a truck scale. Feature 3 is a building containing a cashier's office and an employee breakroom. Feature 4 indicates pits in the asphalt containing exposed soil.

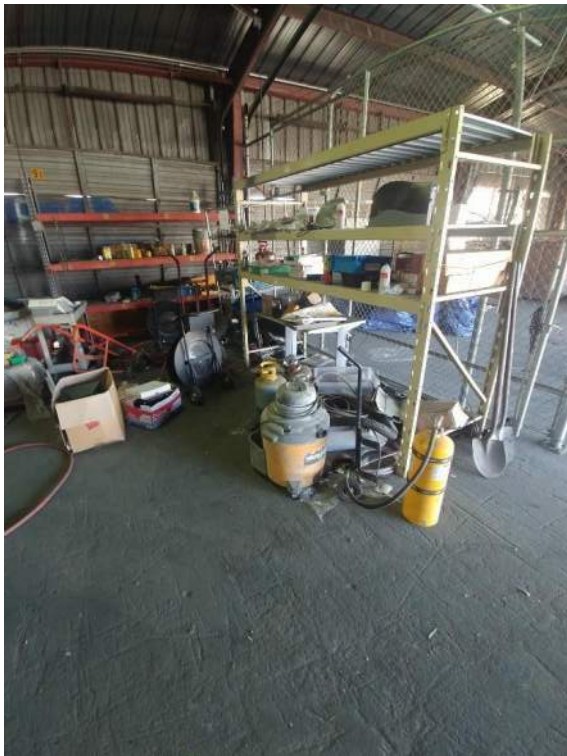
**Photograph 22.** Receiving and shipping portion of the Recycling Specialists facility (east end). Some tool and chemical storage suggestive of light vehicle maintenance (2 of 4).

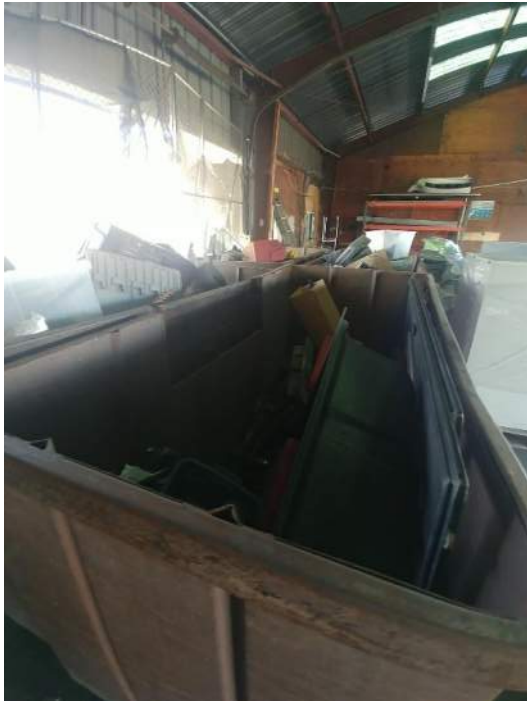
**Photograph 23.** Approximately three bins still contain recycled metals components (including sheet metal and wiring) (3 of 4).

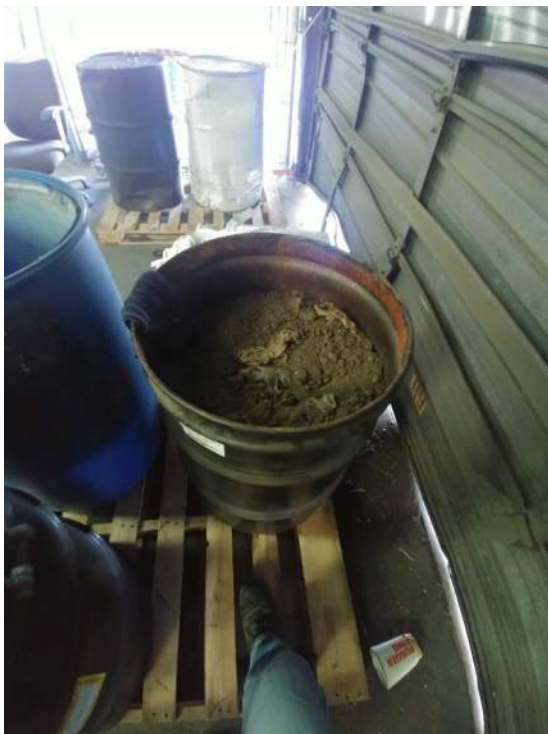
At the 1736 parcel, Langan observed a pile of empty storage bins; these reportedly contained recycled metals during active site operations. Langan also observed a 55-gallon steel drum containing waste oil; the label indicated an accumulation date in 2017. Langan also observed an unlabeled 55-gallon steel drum, which was uncovered, and accumulated with what appeared to be absorbent material. Several storage bins measuring approximately 4 feet by 8 feet containing recycled metal (mostly sheet metal) were also observed. A storage bin measuring approximately 10 cubic yards was filled with plastic pellets. During the Site Reconnaissance, the metals piles described in Section 4.1 were not present, and additional clarification on pile staging was not provided during the site interviews.

**Photograph 24.** Approximately five 55-gallon drums (four steel, and one polyethylene) containing motor oil, used oil, and the pictured drum which contains soil. The soil did not appear stained, and did not have an odor.

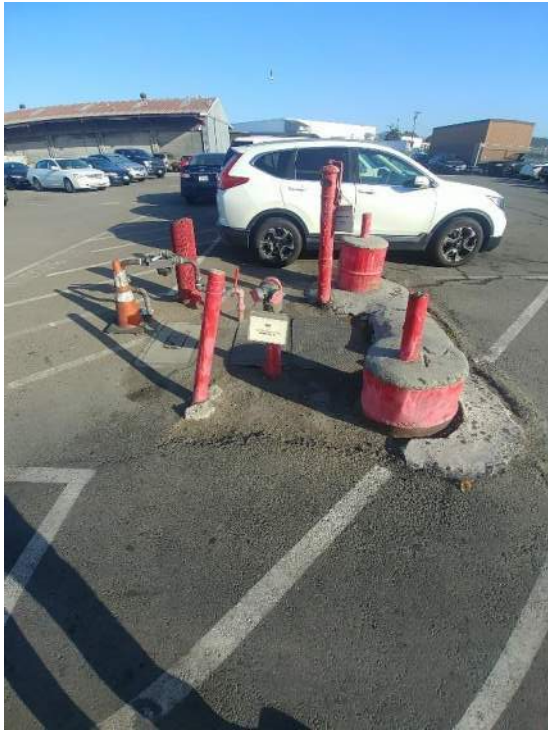
**Photograph 27.** Fire suppression water supply to the Site. Located in the Recycling Specialists parking lot, near Old Bayshore Highway.

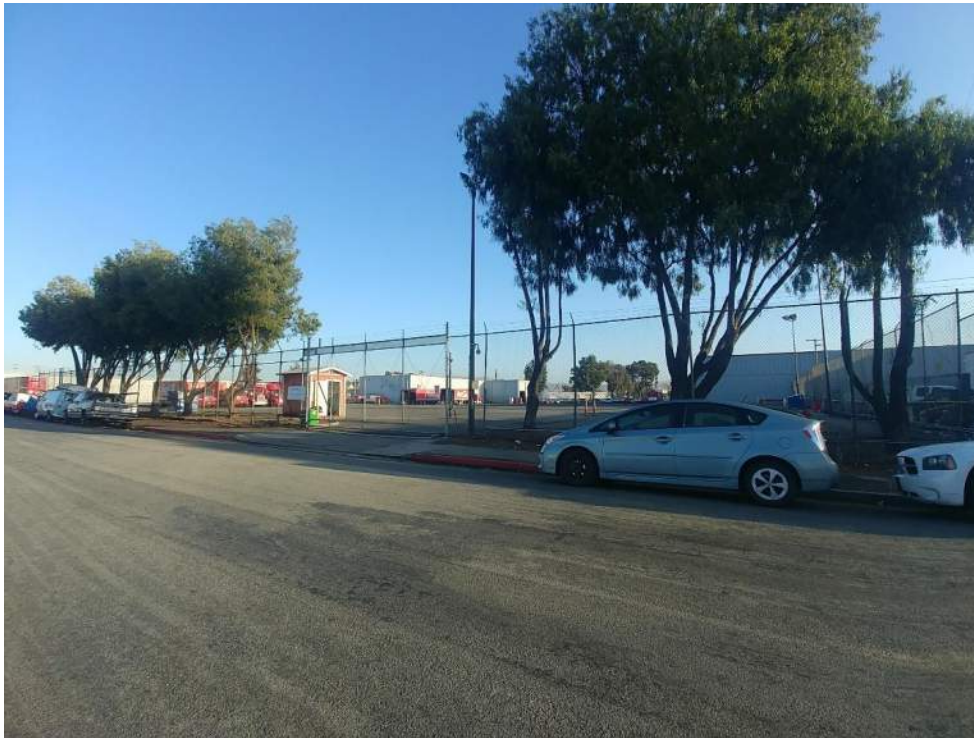
**Photograph 35.** Coca Cola Bottling Co. located at 1555 Old Bayshore Hwy. Distribution appears to be a part of the operation, with a fleet and associated maintenance facilities visible from Terminal Ave.
