**PHASE I ENVIRONMENTAL SITE ASSESSMENT
BLOSSOM HILL ROAD RETAIL
620 BLOSSOM HILL ROAD
SAN JOSE, SANTA CLARA COUNTY, CALIFORNIA 95125**

Ninyo & Moore
Geotechnical and Environmental Sciences Consultants
1401 Halyard Drive, Suite 110
West Sacramento, California 95691

July 03, 2017
Project No. 403075001

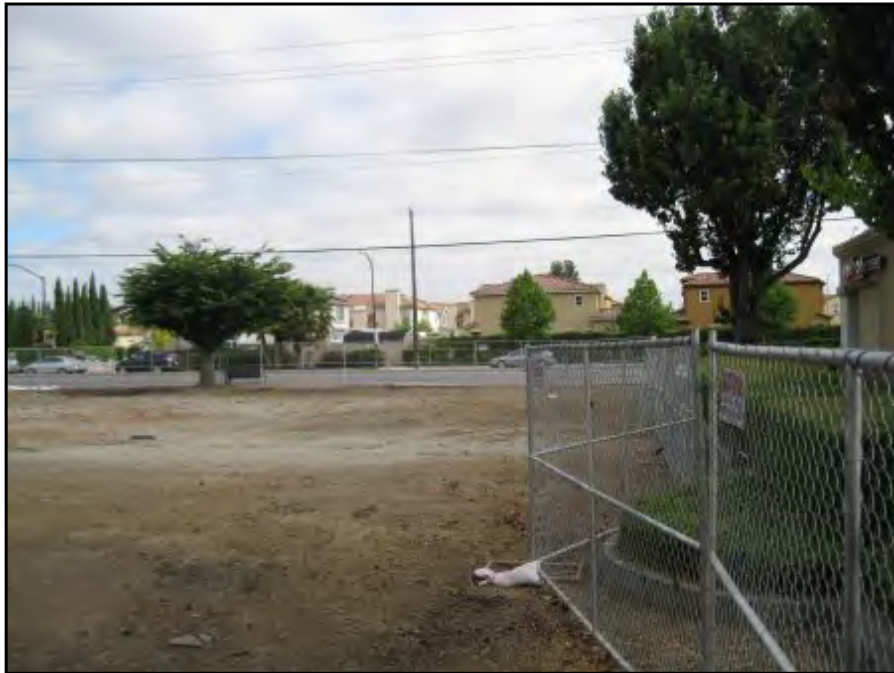
Facilities of Potential Concern	
Site Name	CONOCOPHILLIPS # 5444/UNOCAL #5444/
Site Address	696 BLOSSOM HILL RD
Distance from Site	Adjacent
Direction from Site	Northwest
Database	HIST LUST SANTA CLARA, LUST, SWEEPS UST
Comments	Two 10,000-gallon gasoline underground storage tanks (USTs) and one 280-gallon waste oil UST were installed in 1964 and removed in 1985. Three new USTs were installed in 1985, and consisted of two 12,000-gallon gasoline USTs, and one 520-gallon waste oil UST. According to the SCCDEH, the USTs were upgraded with proper leak detection, spill/overflow protection and corrosion protection in 1995. These three USTs, piping and dispensers were subsequently removed on April 23, 2015. Twelve soil samples were collected following removal and were reported to have maximum concentrations of 12.9 part per million (ppm) total petroleum hydrocarbons as gasoline (TPHg), 141 ppm chromium, 128 ppm nickel, 47.6 ppm zinc and 4.4 ppm lead; all other chemicals of concern were not reported to be present above the laboratory reporting limits. The SCCDEH issued case closure notices for the removed USTs. Based on this information,

Comments	concentrations of 12.9 ppm TPHg, 141 ppm chromium, 128 ppm nickel, 47.6 ppm zinc and 4.4 ppm lead; all other COCs were not reported to be present above the laboratory reporting limits. Based on this information, the SCCDEH responded that they would not be re-opening the previously closed fuel leak case (closed in 1996) or opening a new fuel leak case for the facility. Based on this information, the former Unocal Station is not considered a REC.
-----------------	--

View of adjacent former gasoline station to the northwest.

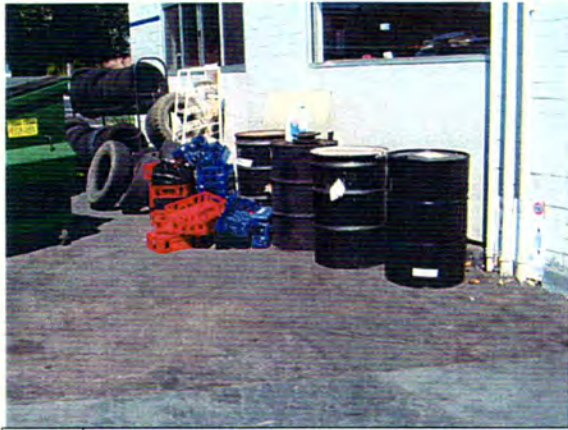
Photo #19: Drums of waste automotive repair fluids at Union 76 gas station

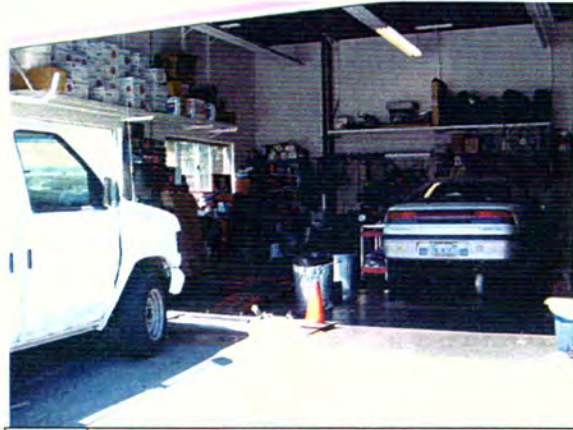
Photo #20: Auto repair area at Union 76 gas station (note two hydraulic lifts)

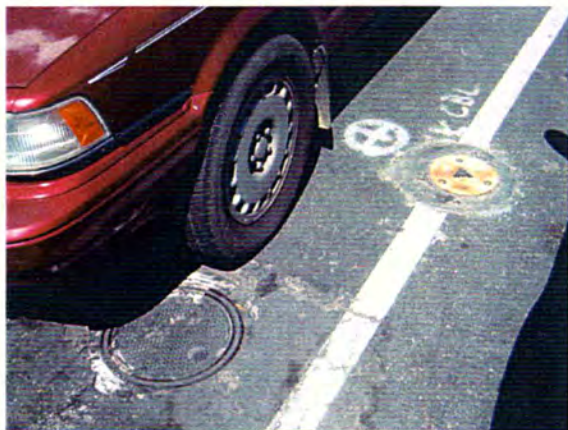
Photo #21: Typical groundwater monitoring wells observed at Union 76 gas station
