Phase I Environmental Site Assessment and Screening-Level Phase II Subsurface Investigation

Dupont Street Parcels
San Jose, California

Prepared for:
M&M Diridon LLC

DRAFT - 20 January 2020
EKI B90107.00

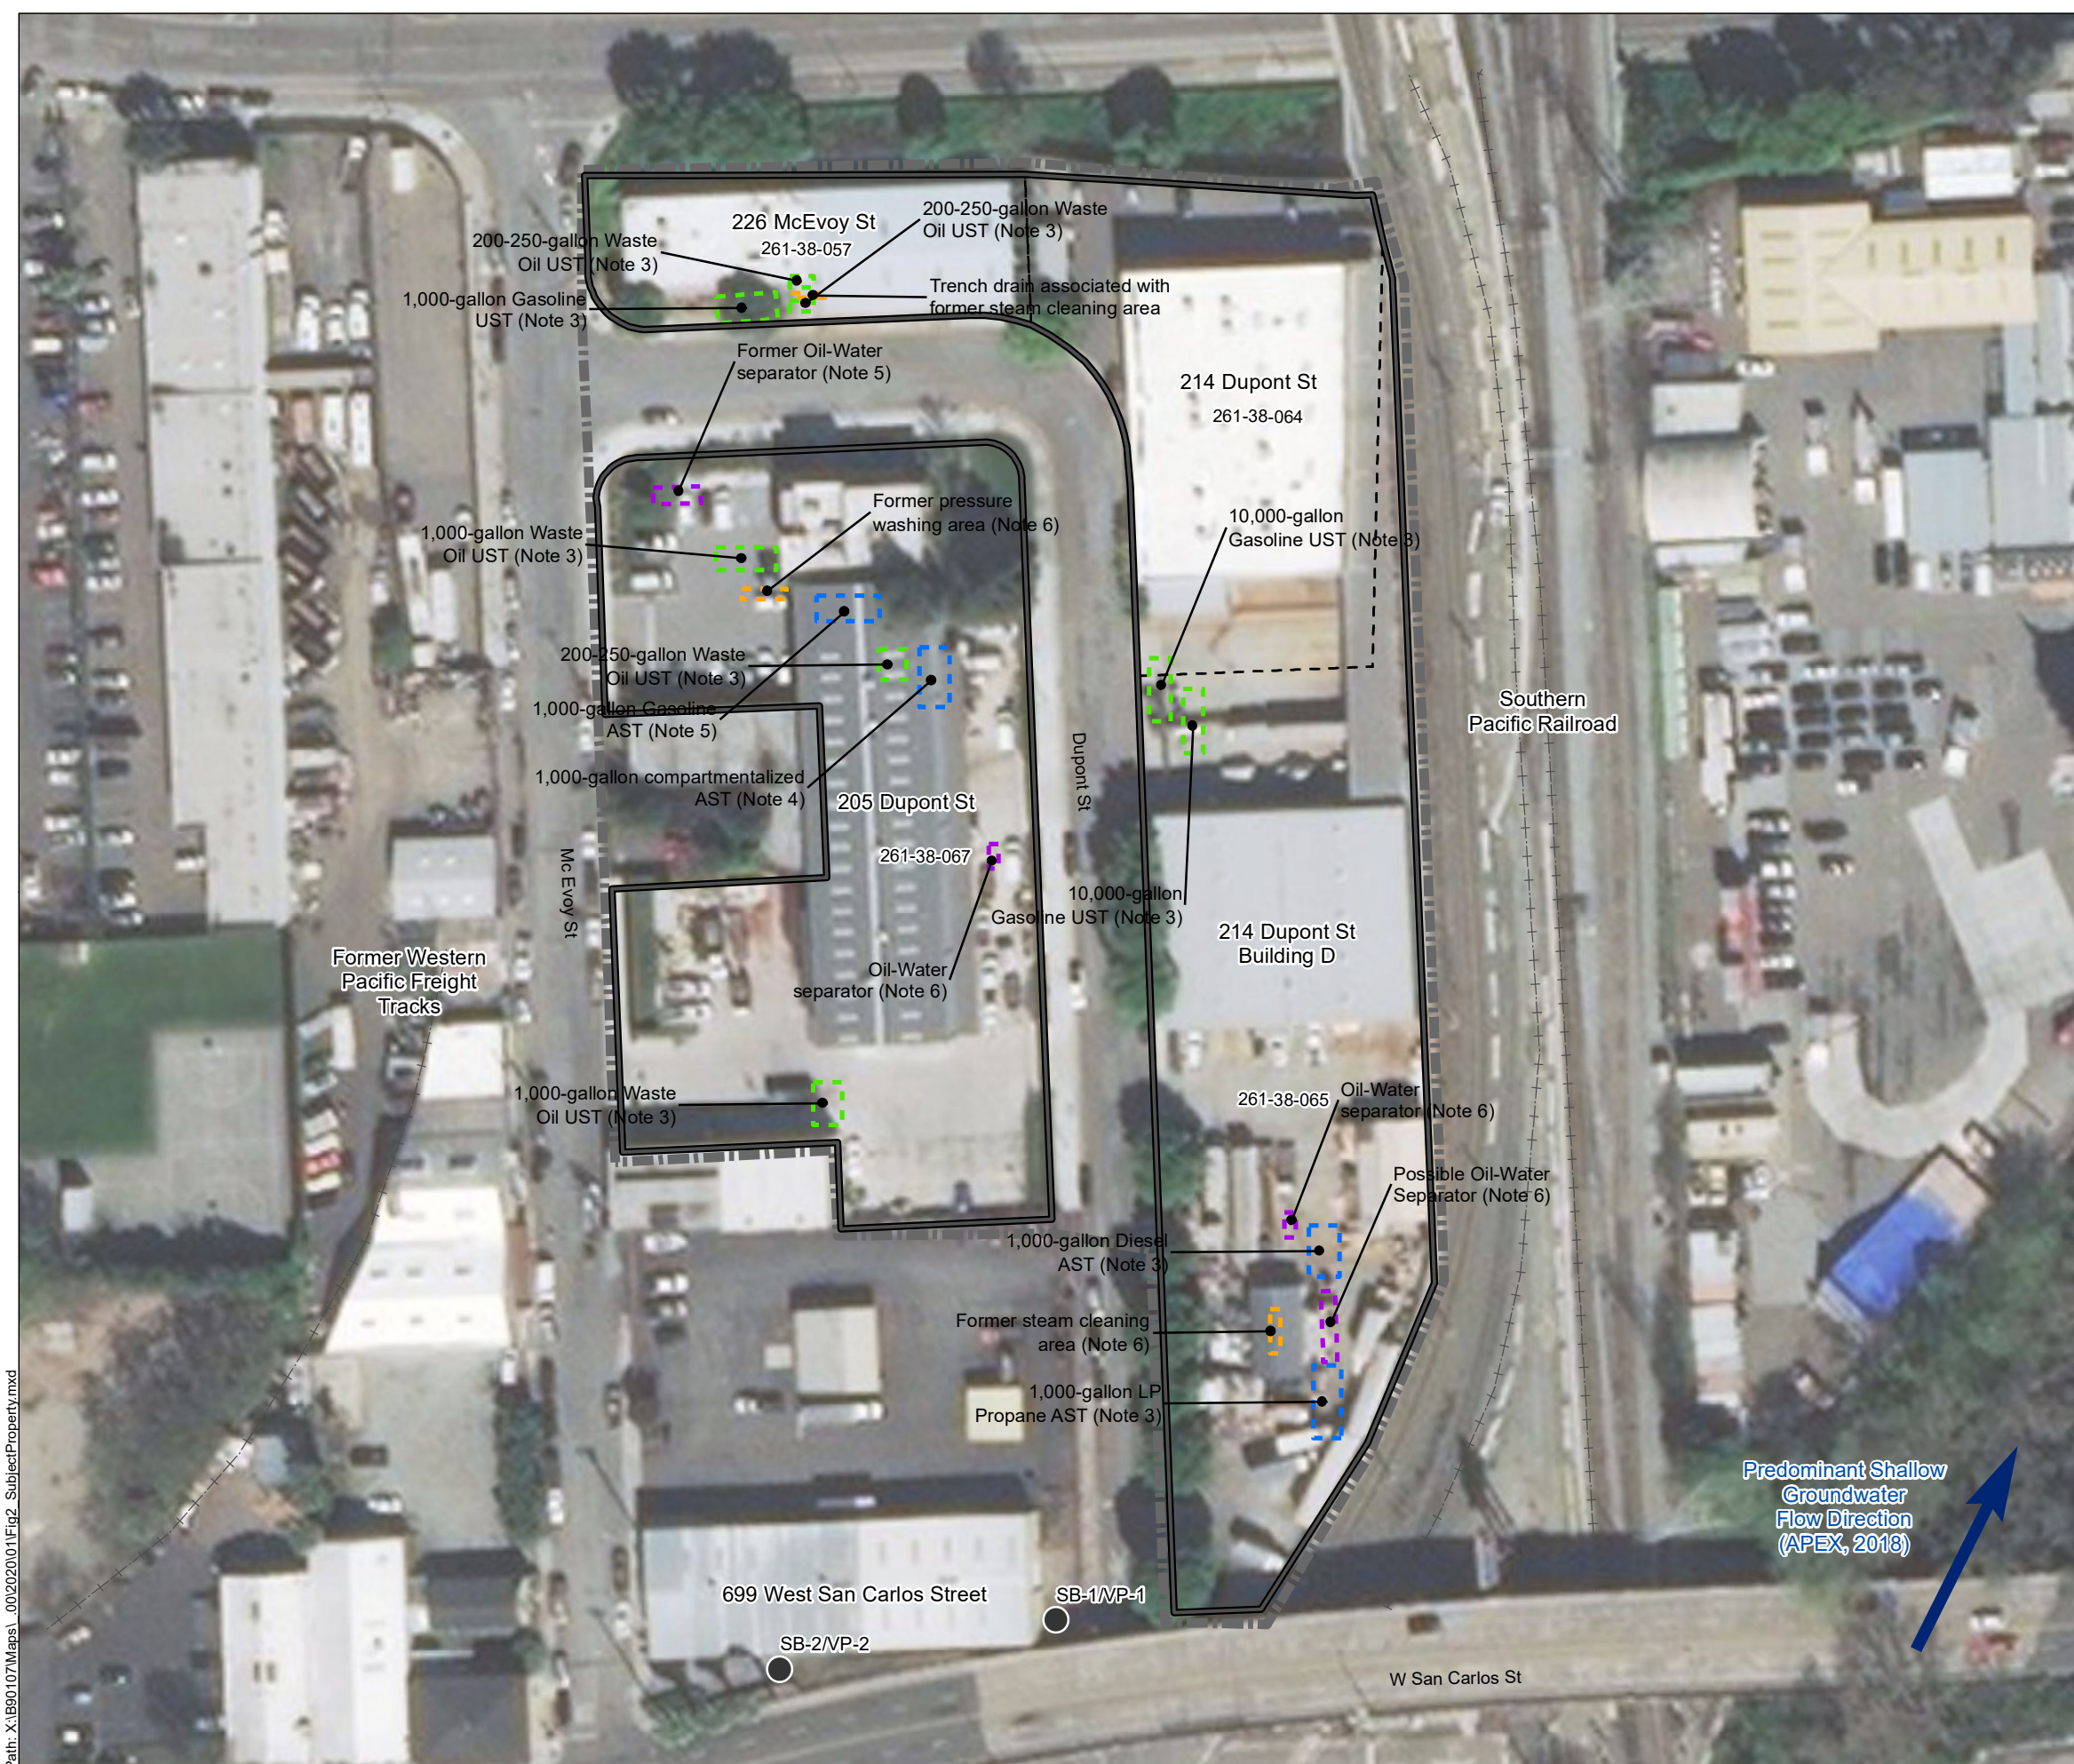
Figure 2

- A historical 1,000-gallon leaking underground storage tank (“UST”) identified in closure documents as formerly containing waste oil was removed in 1995 at 236 McEvoy Street (southern portion of current 205 Dupont Street; see Figure 2). Contaminated soil was excavated, aerated, sampled, and then placed on site in landscaping areas. The tank

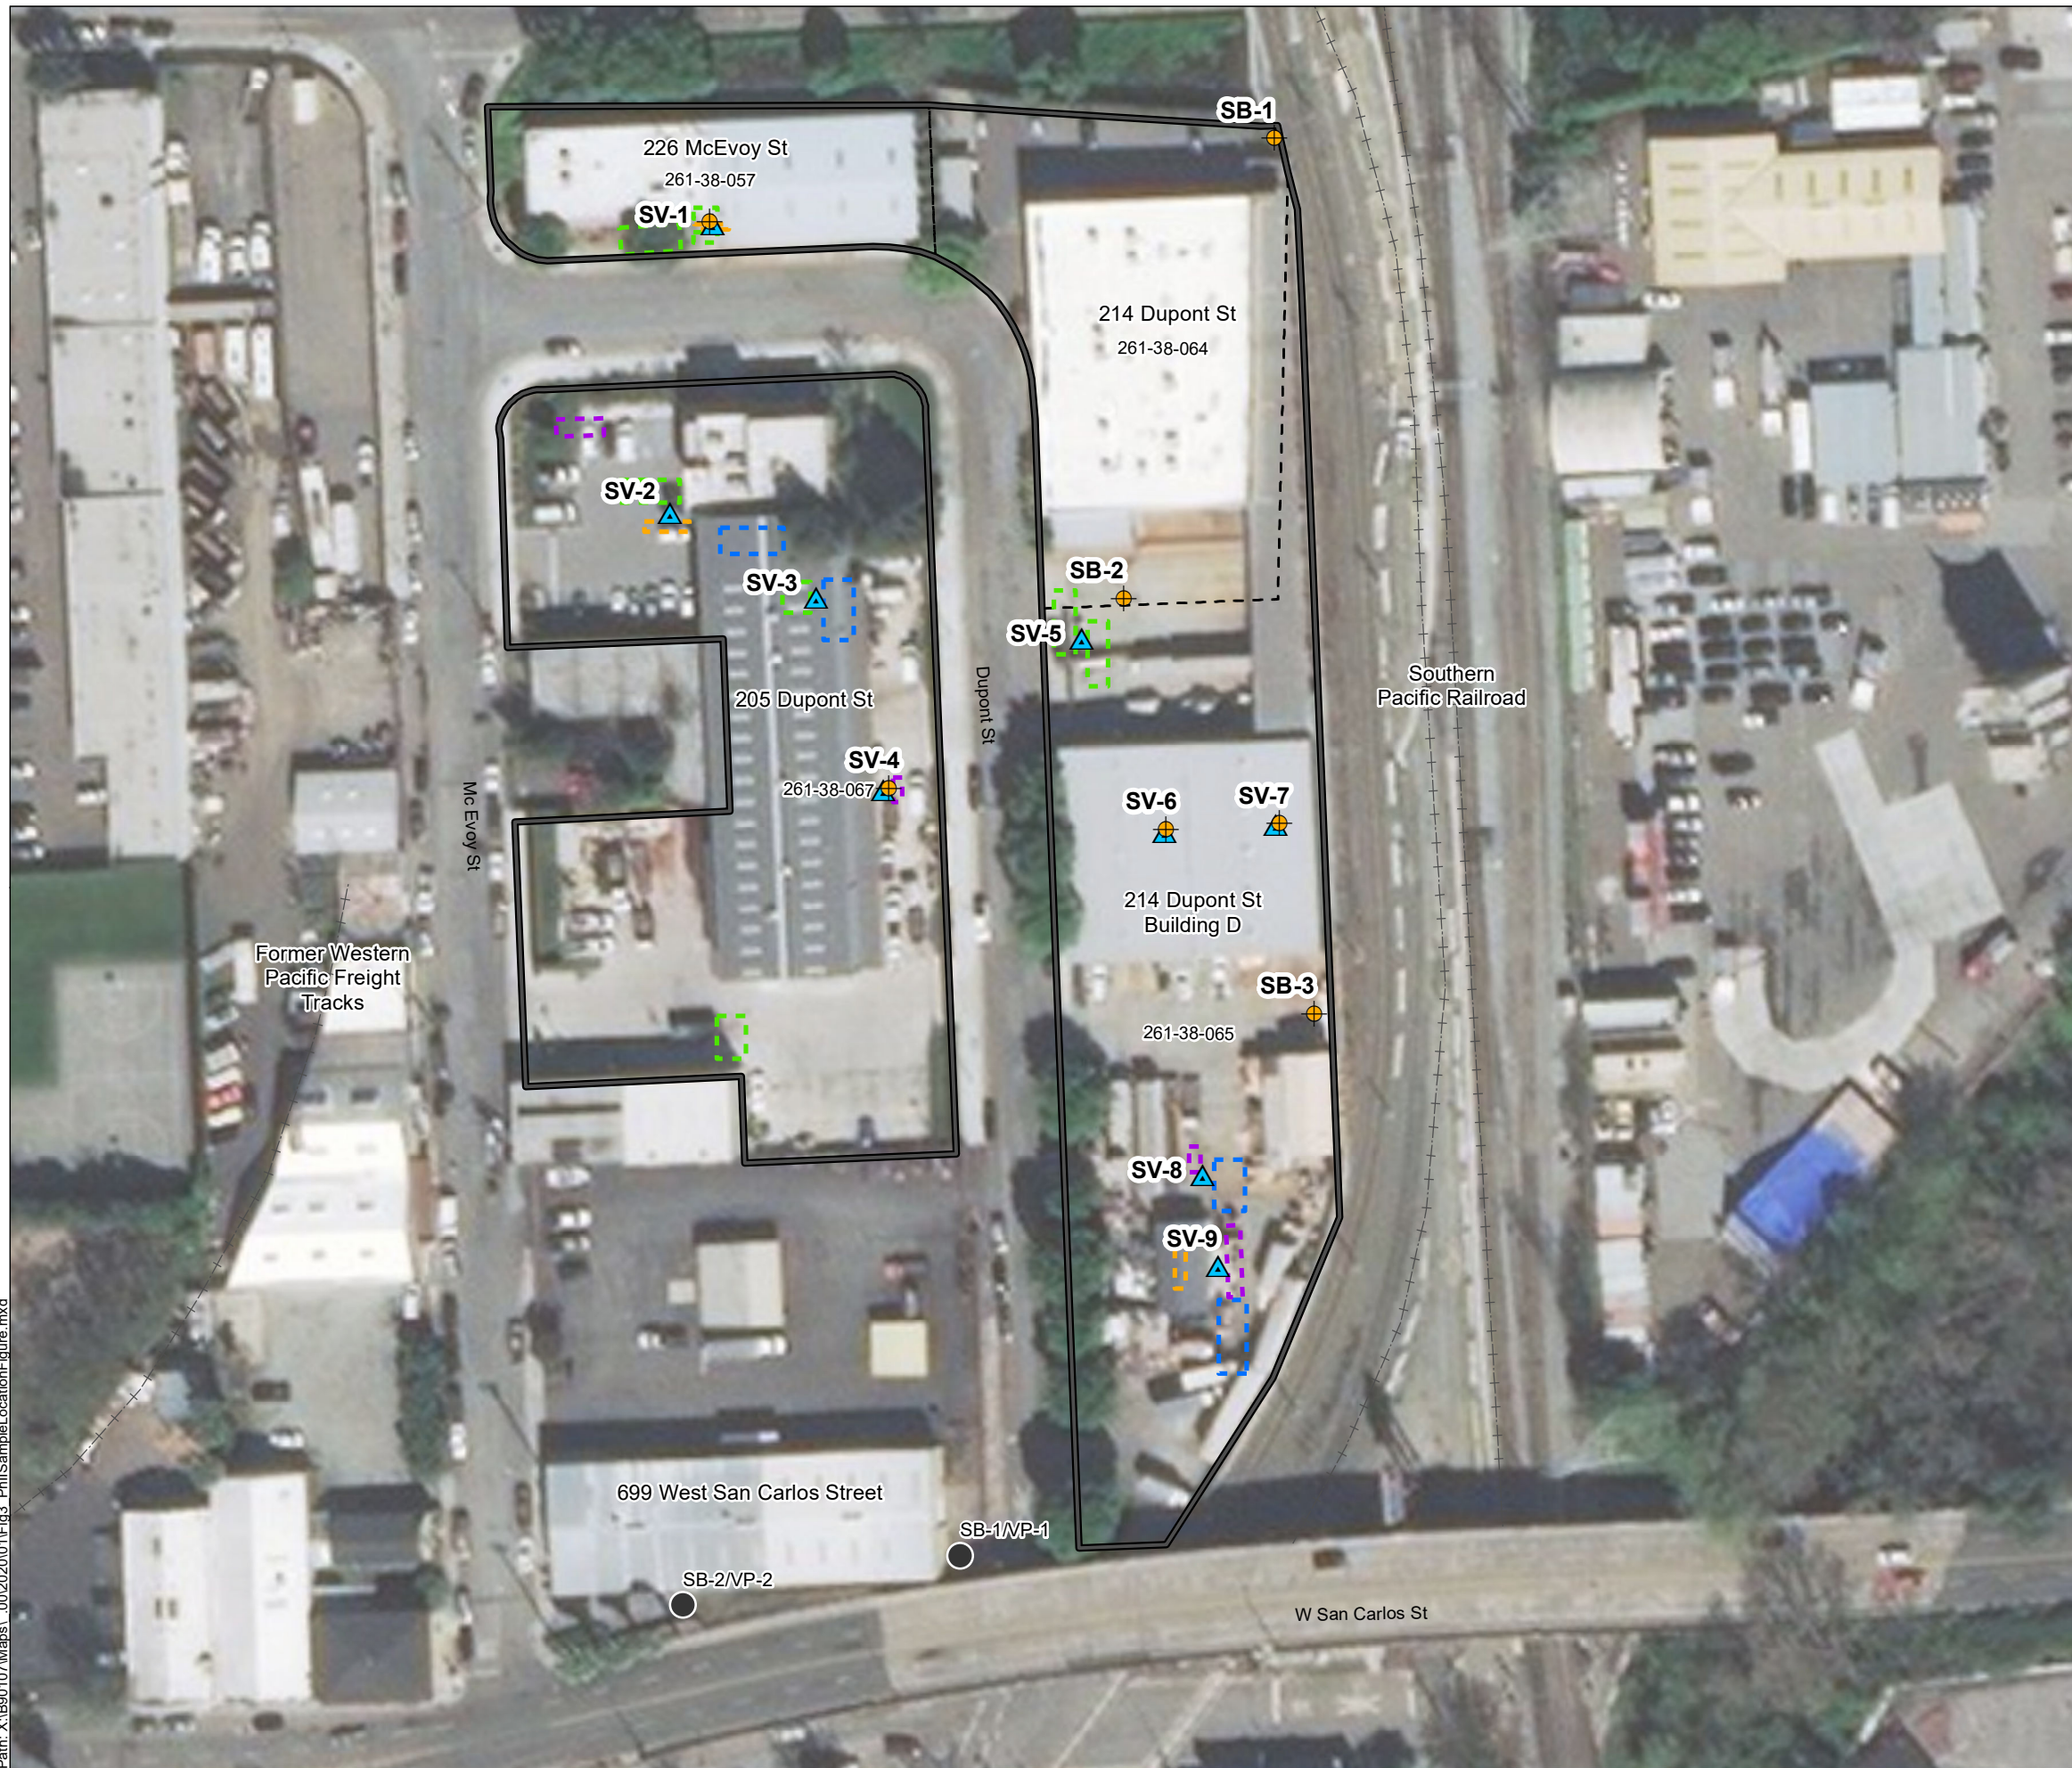
Figure 1

- Collected soil samples from boreholes at the following locations (see Figure 3):
 - Near the existing railroad track adjacent to the Subject Property (SB-1 and SB-3);
 - Near a drain with observed staining at 214 Dupont Street (SB-2);
 - Near the former USTs at 226 McEvoy Street (SV-1);
 - At a location with elevated organic vapor readings (SV-6);
 - At a location with observed debris in the fill soil (SV-7); and,
 - Near the existing oil-water separator at 205 Dupont Street (SV-4).

- Collected samples of soil vapor from nine five-foot soil vapor probes (“SVPs”, see Figure 3) installed:
 - Near the former USTs at 226 McEvoy Street (SV-1);
 - Near the former UST and steam cleaning area at 205 Dupont Street (SV-2);
 - Near the former UST and AST at 205 Dupont Street (SV-3);
 - Near the existing oil-water separator at 205 Dupont Street (SV-4);
 - Near the two former 10,000-gallon USTs at 214 Dupont Street (SV-5);
 - Near the approximate middle of each warehouse building footprint at 214 D Dupont Street with cracks and staining (SV-6 and SV-7); and,
 - Near the existing oil-water separator features at 214 D Dupont Street (SV-8 and SV-9).
