TYPE OF SERVICES	Phase I Environmental Site Assessment
LOCATION	Camden Avenue and Malpas Drive (APN 567-26-014) San Jose, California
CLIENT	DAL Properties, LLC
PROJECT NUMBER	336-10-1
DATE	June 5, 2020

Phase I Environmental Site Assessment
Camden Avenue and Malpas Drive
(APN 567-26-014)
San Jose, California

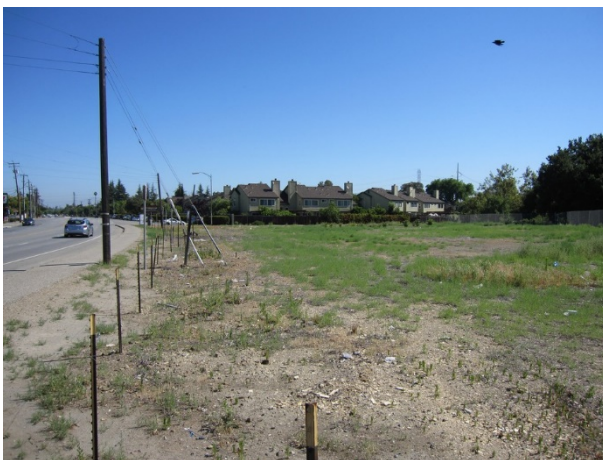
At the time of our visit, the Site was observed to consist of an undeveloped lot covered by low grass and weeds. Small piles (a few cubic yards) of mulch and gravel were observed to have been placed on the southern portion of the Site. No hazardous materials or evidence of prior development were observed.

Photograph 1. View of the Site looking north along Camden Avenue.

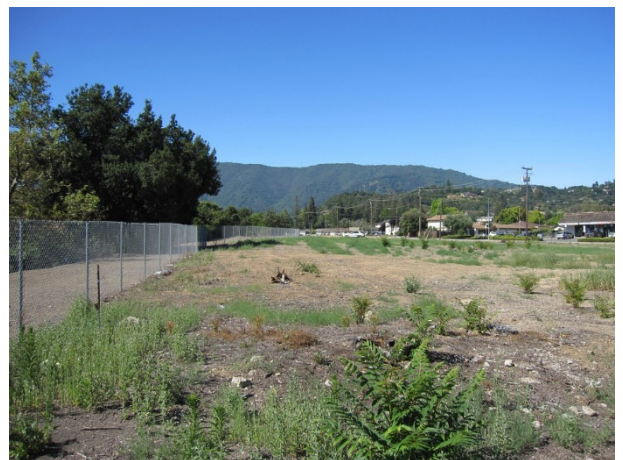
Photograph 2. View of the Site looking south.
