Appendix C  
**Cultural Resources Technical  
Memo**

# memorandum

subject DRAFT Cultural Resources Memorandum for San José Municipal Water New Offices Project ,  
3025 Tuers Road, San José

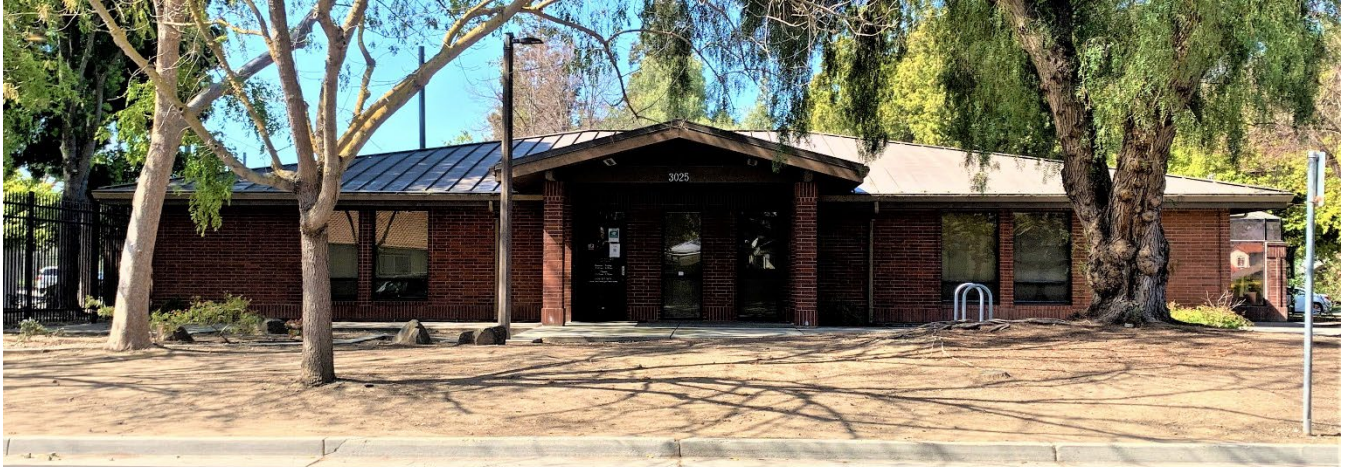
**Figure 4**  
Administration Building, Primary (Northeast) Façade, View Facing Southwest

The primary (northeast) façade faces Tuers Road (**Figure 4**). The primary entrance is located near the center of the façade, which is marked by a gabled porch supported by brick-clad columns. The entrance is composed of a single, glazed door and two door-height windows. The gabled porch is flanked by two pairs of windows.

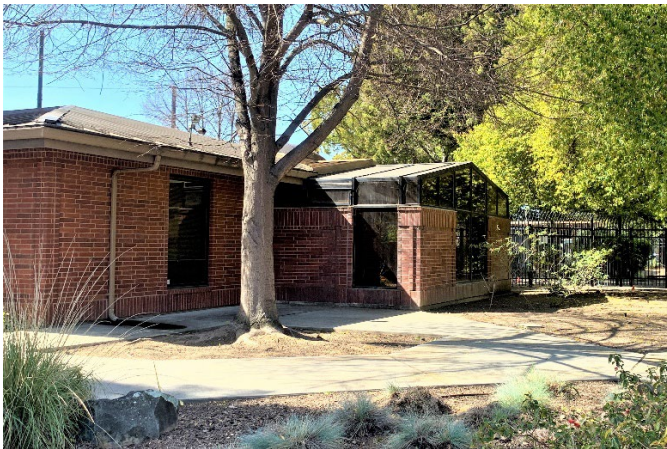
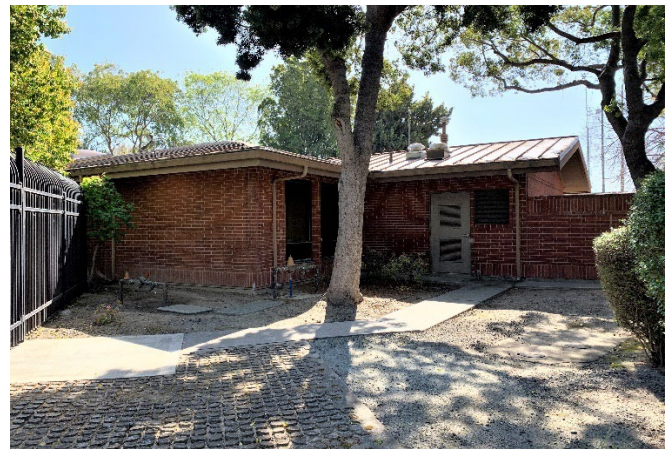
**Figure 5**  
Administration Building, Secondary (Northwest) Façade, East Half (Left) and West Half (Right)

The secondary (northwest) façade faces Loupe Avenue (**Figure 5**).<sup>1</sup> Near the center of the façade is a gabled projection that contains an employee dining area and features aluminum-sash windows and clerestory windows and is capped by a greenhouse-type glass roof. To the east of this feature is one two-part aluminum-sash window. The west half of the façade is located behind a metal perimeter fence and features one louvered, metal door and a separate louvered, metal panel.

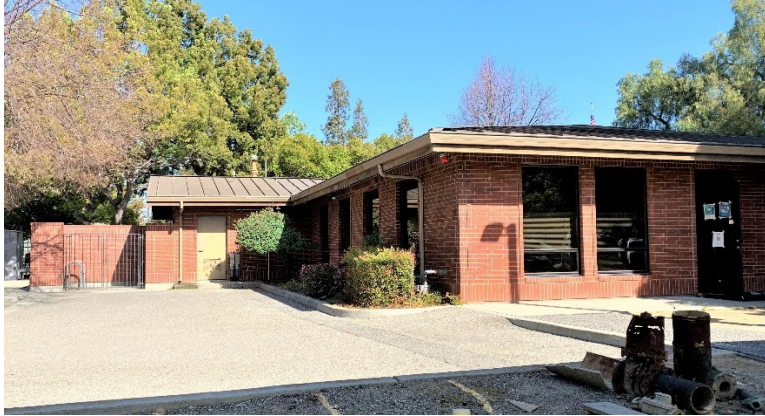
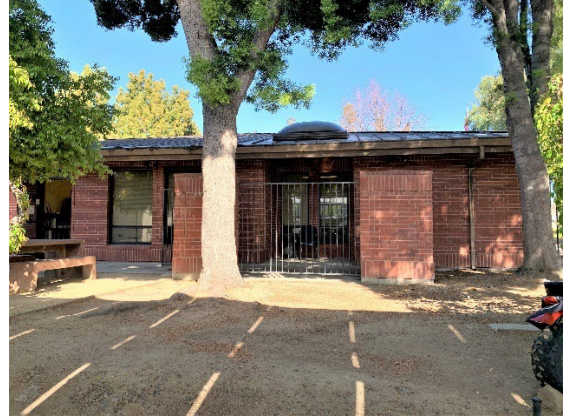
**Figure 6**  
Administration Building, Side (Southeast) Façade, West Half (Left) and East Half (Right)

The side (southeast) façade faces an employee parking lot on the interior of the facility (**Figure 6**). This façade features one glazed door flanked by two pairs of windows and a small, paved patio enclosed by brick piers and metal fencing. The west end of the façade is set back and features a louvered, metal door.

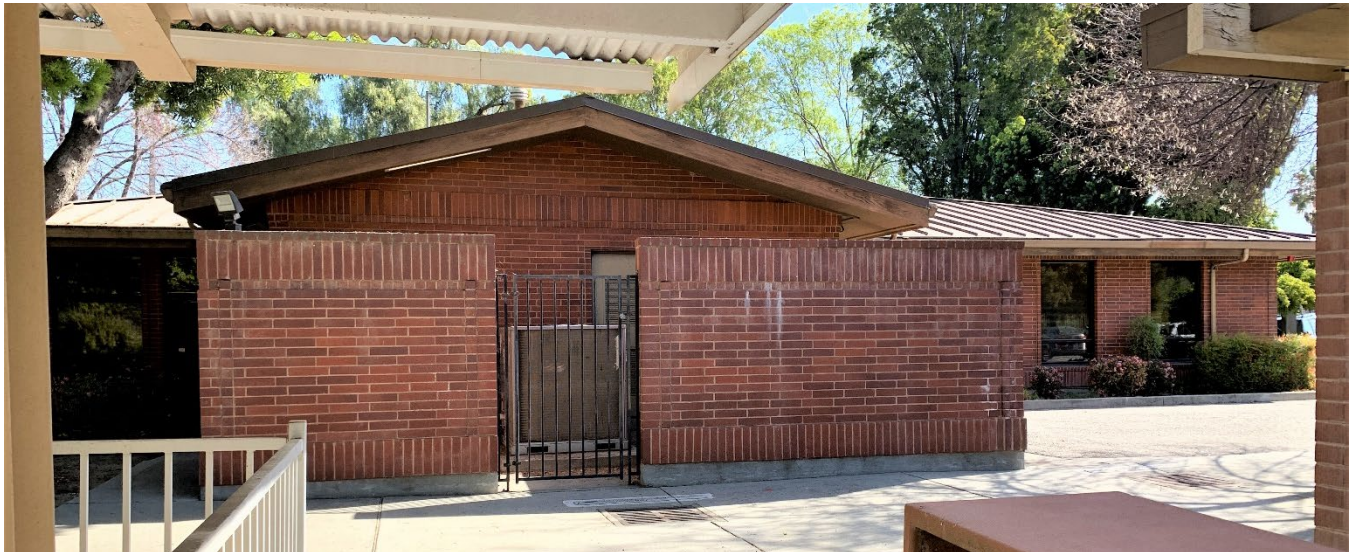
**Figure 7**  
Administration Building, Rear (Southwest) Façade, View Facing East

The rear (southwest) façade faces the generator building and a covered picnic area (**Figure 7**). Near the center of the façade is a gabled projection that contains mechanical and electrical rooms; it features one louvered, metal door and projecting brick walls with a metal security gate. The gabled projection is flanked by two pairs of windows.

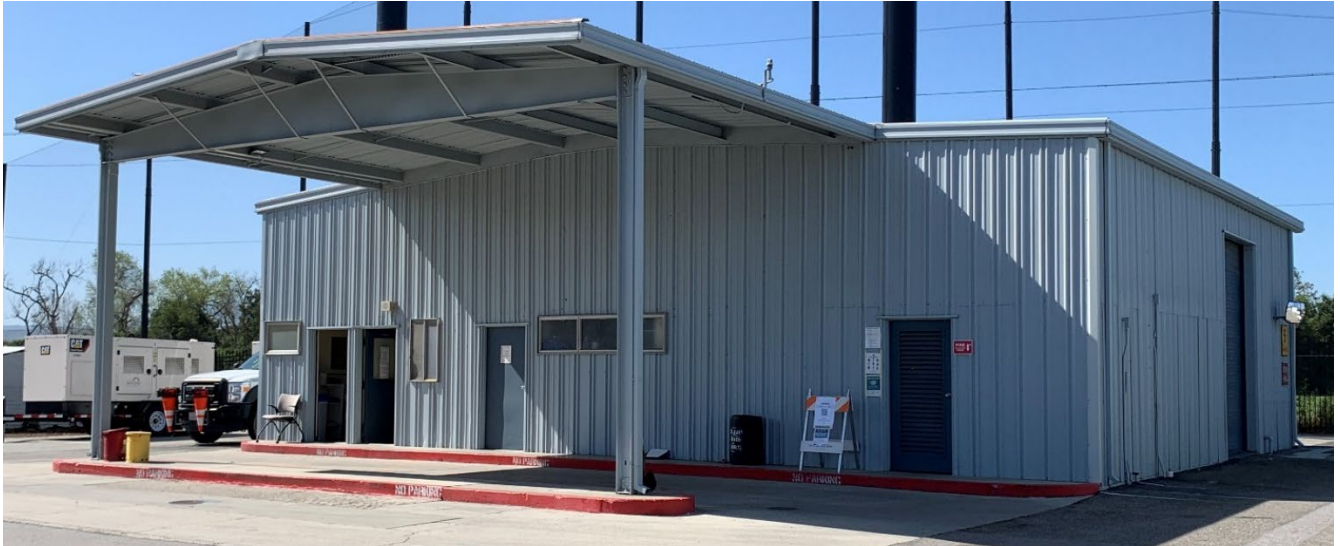
**Figure 8**  
Building A, Primary (Northeast) Façade, View Facing South

Building A was constructed ca. 1968-80. It is a prefabricated, metal-frame building with a T-shaped footprint that is clad in ribbed, metal siding and capped by a gabled roof covered with metal roofing (**Figure 8**). The primary (northeast) façade faces Tuers Road and features a covered driveway supported by metal columns. The façade also features four metal pedestrian doors and sliding, aluminum-sash windows.

The northwest and southeast façades feature metal, roll-up, vehicular doors. The southwest façade features one single and one pair of louvered, metal doors.

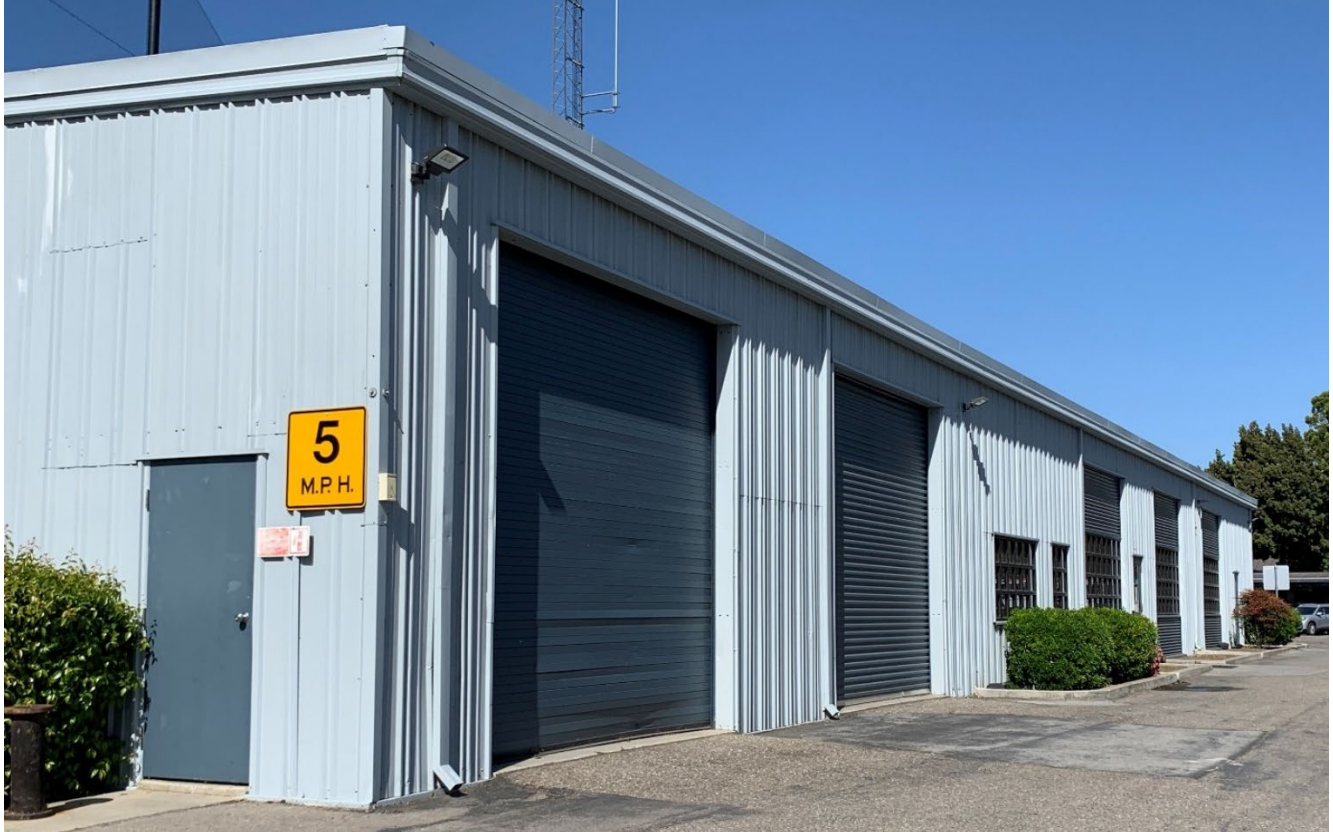
**Figure 9**  
Building B, Primary (Northeast) Façade, View Facing Northwest

Building B was constructed ca. 1968-80. It is a prefabricated, metal-frame building with a rectangular footprint that is clad in ribbed, metal siding and capped by a gabled roof covered with metal roofing (**Figure 9**). The primary (northeast) façade faces Tuers Road and features two single, glazed doors; five multi-lite, aluminum-sash windows; and two metal, roll-up, vehicular doors. Three of the windows are located in large openings that have been partially filled in with metal siding.

The northwest and southeast façades each feature one flush, metal door. The southwest façade features several glazed and flush metal doors; multi-lite, aluminum-sash windows, and louvered, metal panels.

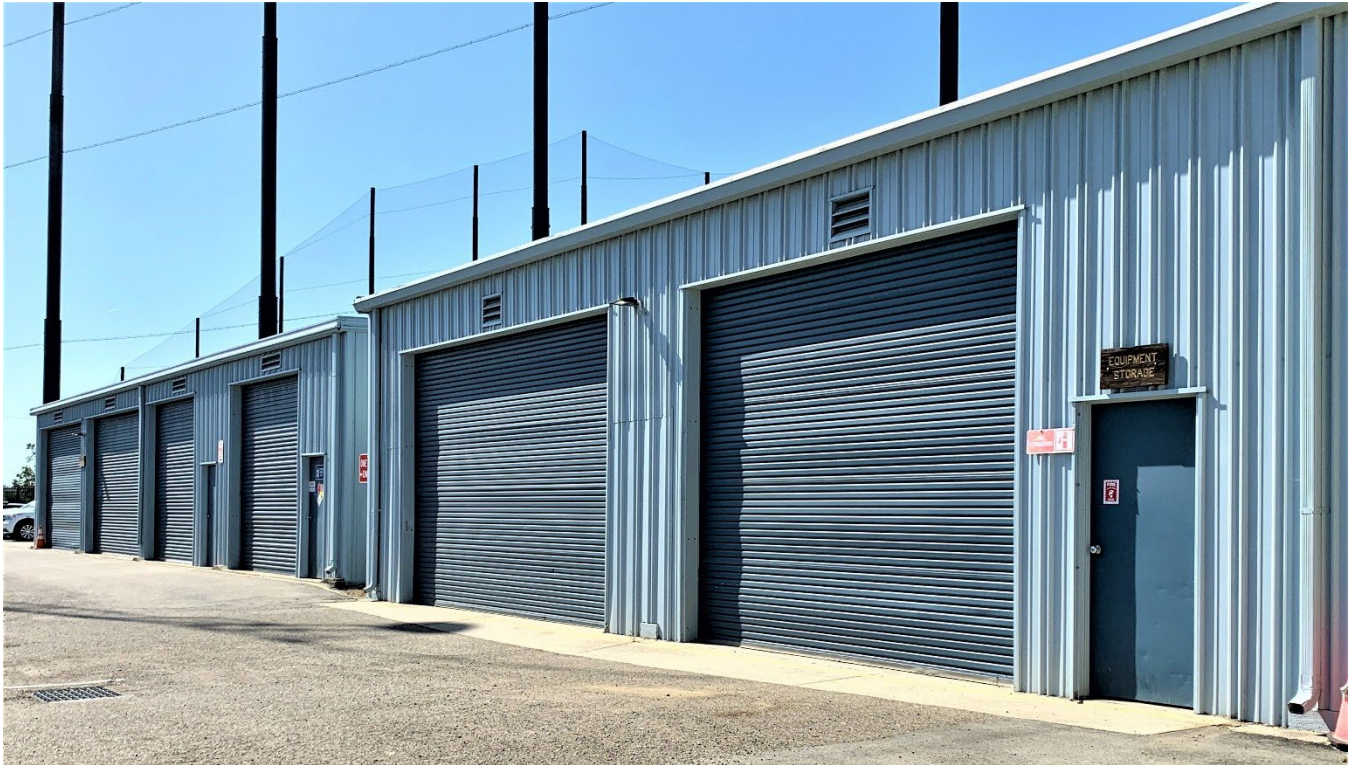
**Figure 10**  
Buildings C (Left) and D (Right), Primary (Northeast) Façades, View Facing South

Buildings C and D were constructed ca. 1968-80. They are nearly identical, prefabricated, metal-frame buildings with rectangular footprints that are clad in ribbed, metal siding and capped by gabled roofs covered with metal roofing (**Figure 10**). The primary (northeast) façades face Building B. Building C features two flush metal doors and three metal, roll-up, vehicular doors. Building D features one flush metal door and two roll-up doors.

There is no fenestration on the northwest, southwest, or southeast façades.

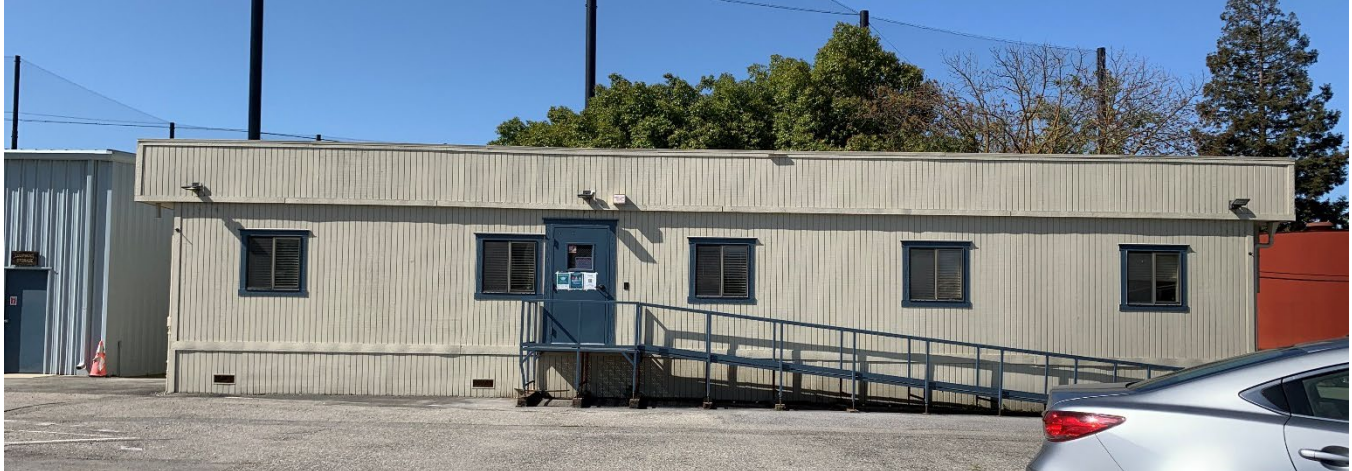
**Figure 11**  
Building E, Primary (Northeast) Façade, View Facing Southwest

Building E was constructed ca. 1968-80. It is a prefabricated building with a rectangular footprint that is clad in plywood siding and capped by a flat roof (roofing material unknown) (**Figure 11**). The primary (northeast) façade faces an employee parking lot on the interior of the facility. It features a partially glazed, metal door that is accessed by a metal-frame ramp and five sliding, aluminum-sash windows. Above the door and windows, the façade projects slightly.

The southeast façade features three sliding, aluminum-sash windows. The southwest façade features a flush, metal door that is accessed by metal stairs, a pair of flush doors, and two sliding, aluminum-sash windows. The northwest façade does not feature any fenestration.

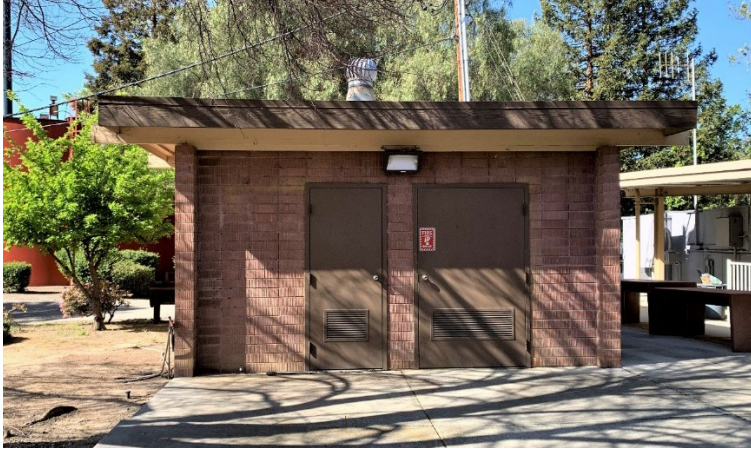
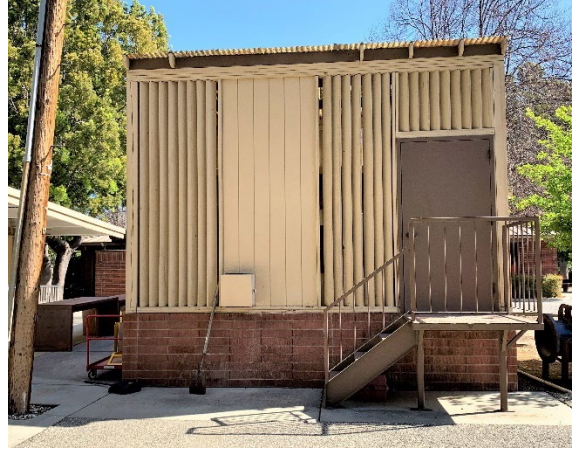
**Figure 12**  
Generator Building, Northeast (Left) and Southwest (Right) Façades

The generator building is a one-story, split-level building that features a rectangular footprint and is capped by a series of flat roofs with wood fascia boards and exposed beams. The original portion of the building (which measures approximately 16' x 16' in area) was constructed ca. 1968-80, is clad in textured brick laid in a stack bond, has a lower profile, and the roofing material of its overhanging roof is unknown. A later addition (which measures approximately 16' x 8' in area) was constructed at an unknown date after 1980 and is clad in brick at the base and vertical wood siding and louvered, wood slats above. The addition has a taller profile, and its roof is covered with some type of corrugated roofing. The building can be accessed from the northeast and southwest façades, neither of which are marked with signage indicating which one is the primary entrance.

The northeast façade faces the administration building and features two louvered, metal doors at grade, one of which is wider than the other (**Figure 12**). The exterior corners of the façade feature shallow, brick projections. The southwest façade features a flush, metal door that is accessed by metal stairs (Figure 9).

There is no fenestration on the northwest or southeast façades.

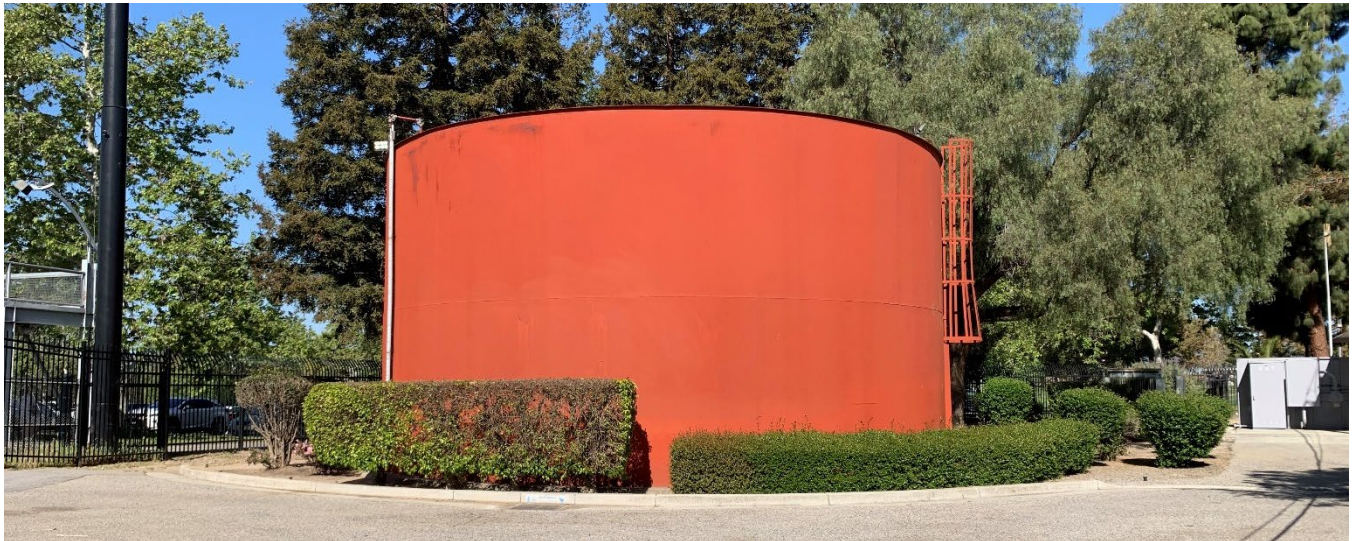
**Figure 13**  
Water Tank, View Facing West

The cylindrical water tank was constructed ca. 1968-76. The structure is clad in smooth, metal panels and is capped with a flat cover (**Figure 13**). The tank measures approximately 21 feet tall and 40 feet in diameter. A metal ladder is located at the north end of the tank. Shrubs are planted around the perimeter of the tank.
