EVERGREEN • EAST HILLS VISION STRATEGY

EIR APPENDIX L

**PHASE I & II
ENVIRONMENTAL SITE ASSESSMENT
ARCADIA PROPERTY
SAN JOSE, CA 95122**

July 7, 2005
File No. 56815/ENV

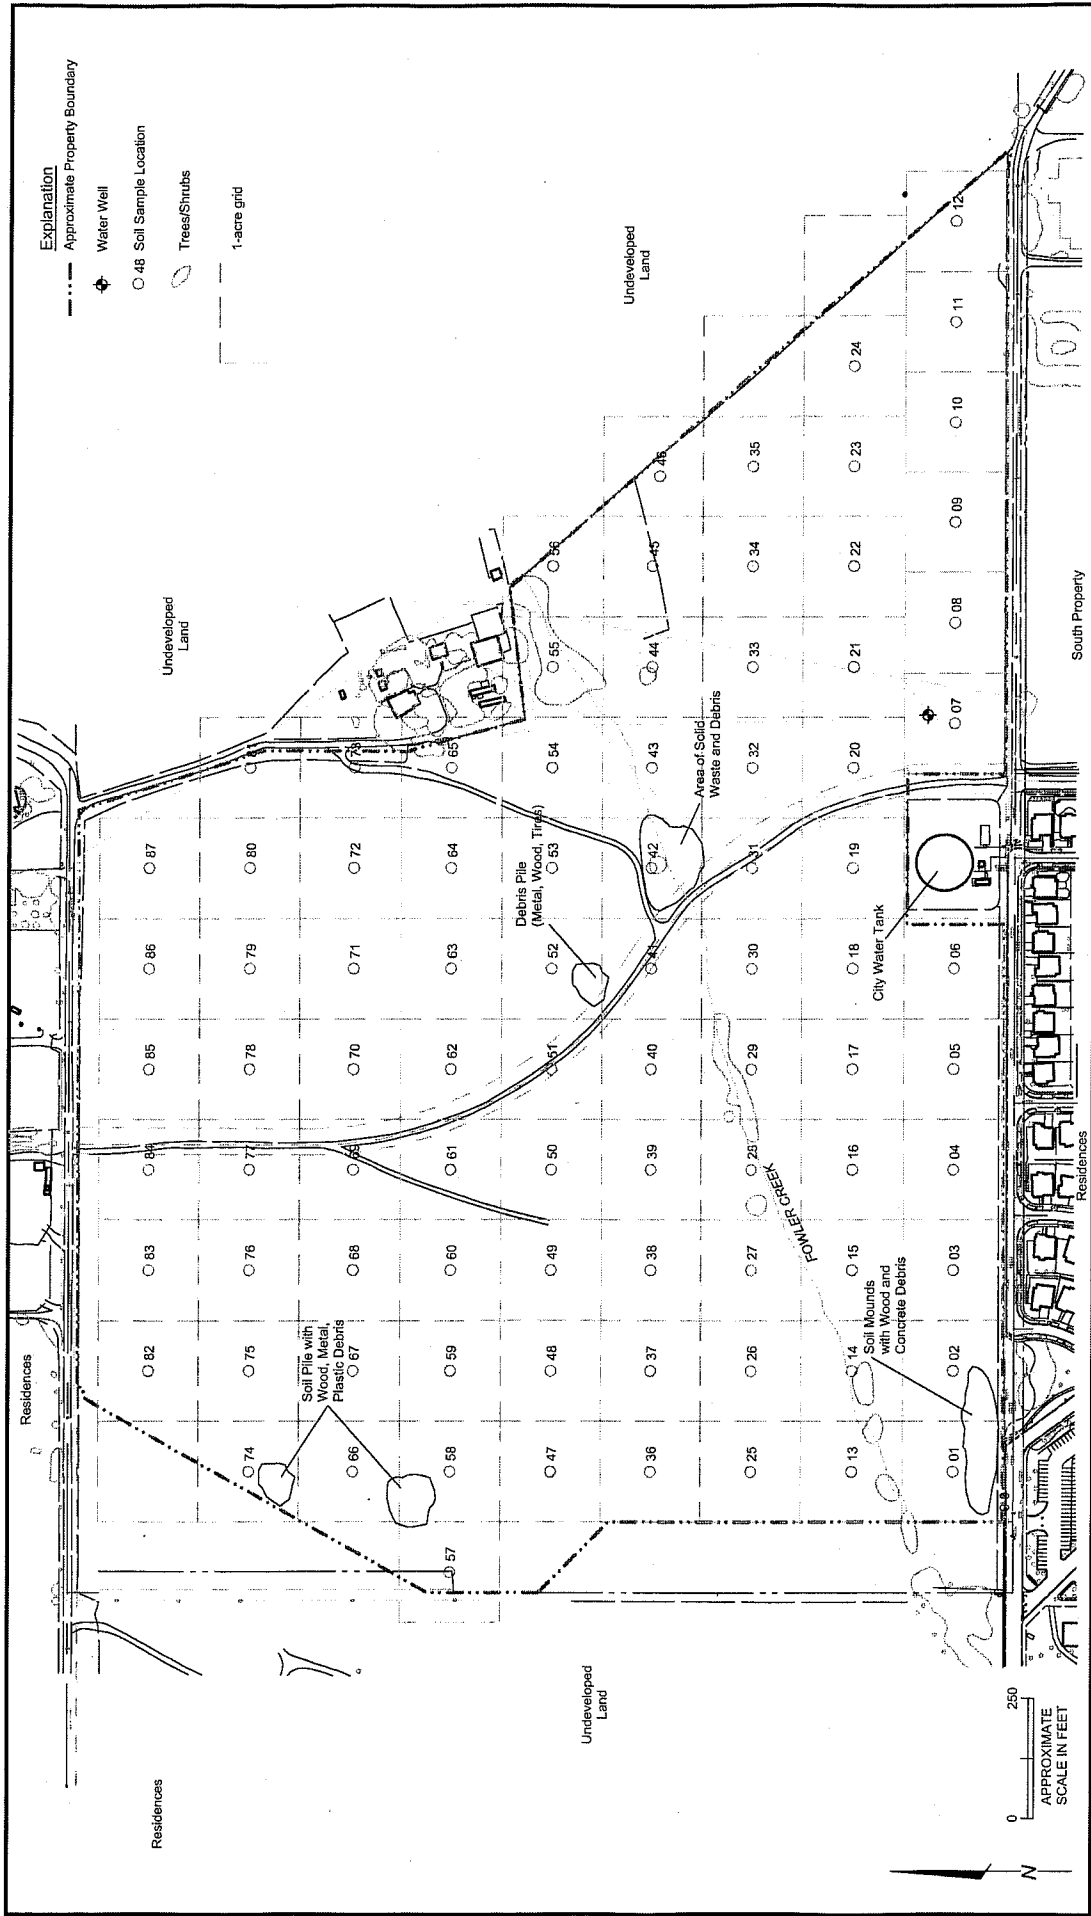
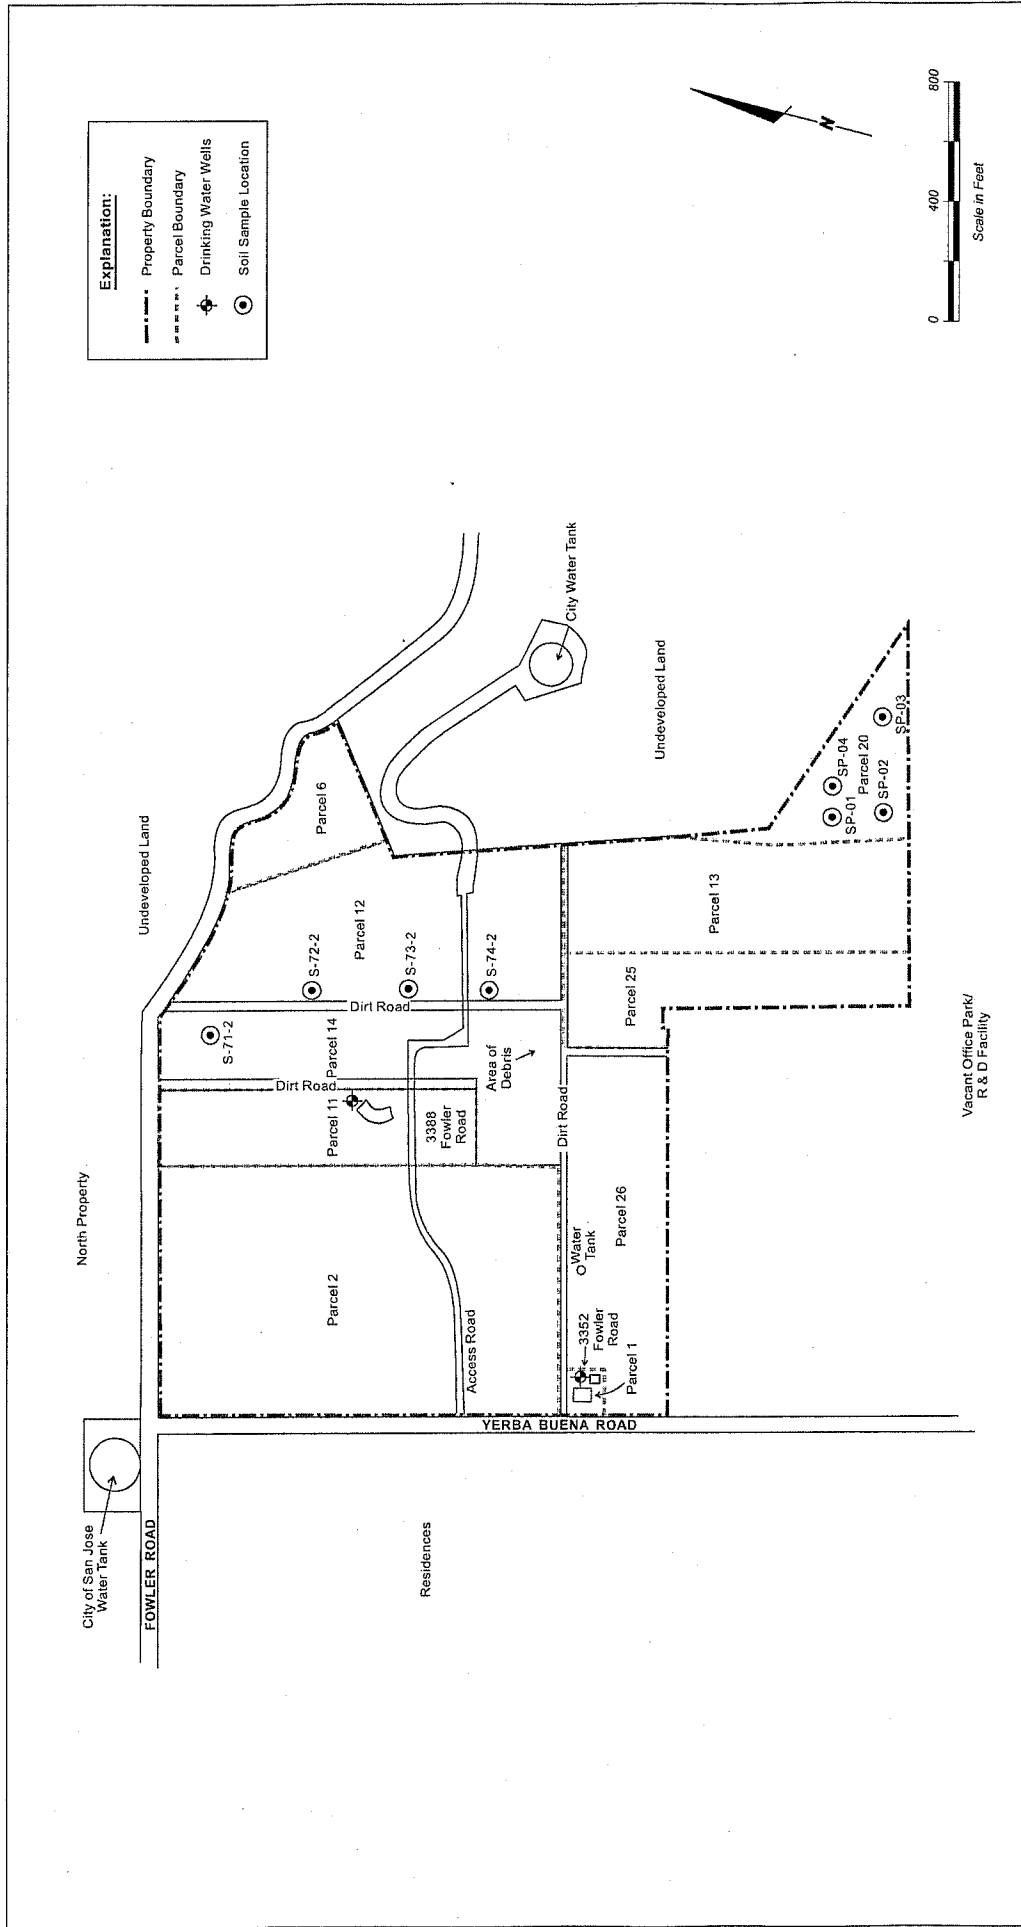
PLATE
4

There are two occupied residences present on the South property, one on APN 660-33-001 (3352 Fowler Road) and one on APN 660-33-011 (3388 Fowler Road). Each of these residences has a domestic water well that are assumed to be operational (Plate 4). In addition to these two wells, three other wells are present on the South Property as follows: (1) an apparent operational water well used for watering livestock located in the northeast portion of the South property (APN 660-33-012); (2) a non-operational well at the northwest portion of the South property (APN 660-33-002); and (3) a non-operational well at the central portion of the South property (APN 660-33-014). A corral area for managing livestock is present in the northeast portion of the South property (APN 660-33-012).

For the South property, PES collected samples at a depth of 2 feet bgs at the approximate location of S-71, S-72, S-73, and S-74 (from ICES, 1997 map locations). These four samples, designated S-71-2 through S-74-2, were analyzed for organochlorine pesticides using U.S. EPA Test Method 8081A. PES also collected four samples at 0.5 to 1 foot bgs from the approximately 4-acre parcel (APN# 660-33-20) on the South property. These four samples, designated SP-01 through SP-04, were analyzed for organochlorine pesticides using U.S. EPA Test Method 8081A, arsenic and lead using U.S. EPA Test Method 6010B, and mercury using U.S. EPA Test Method 7471A. The sample collection locations for the South property are shown on Plate 4.

Site Plan and Sample Locations
 Fowler Road Properties
 South Property
 San Jose, California

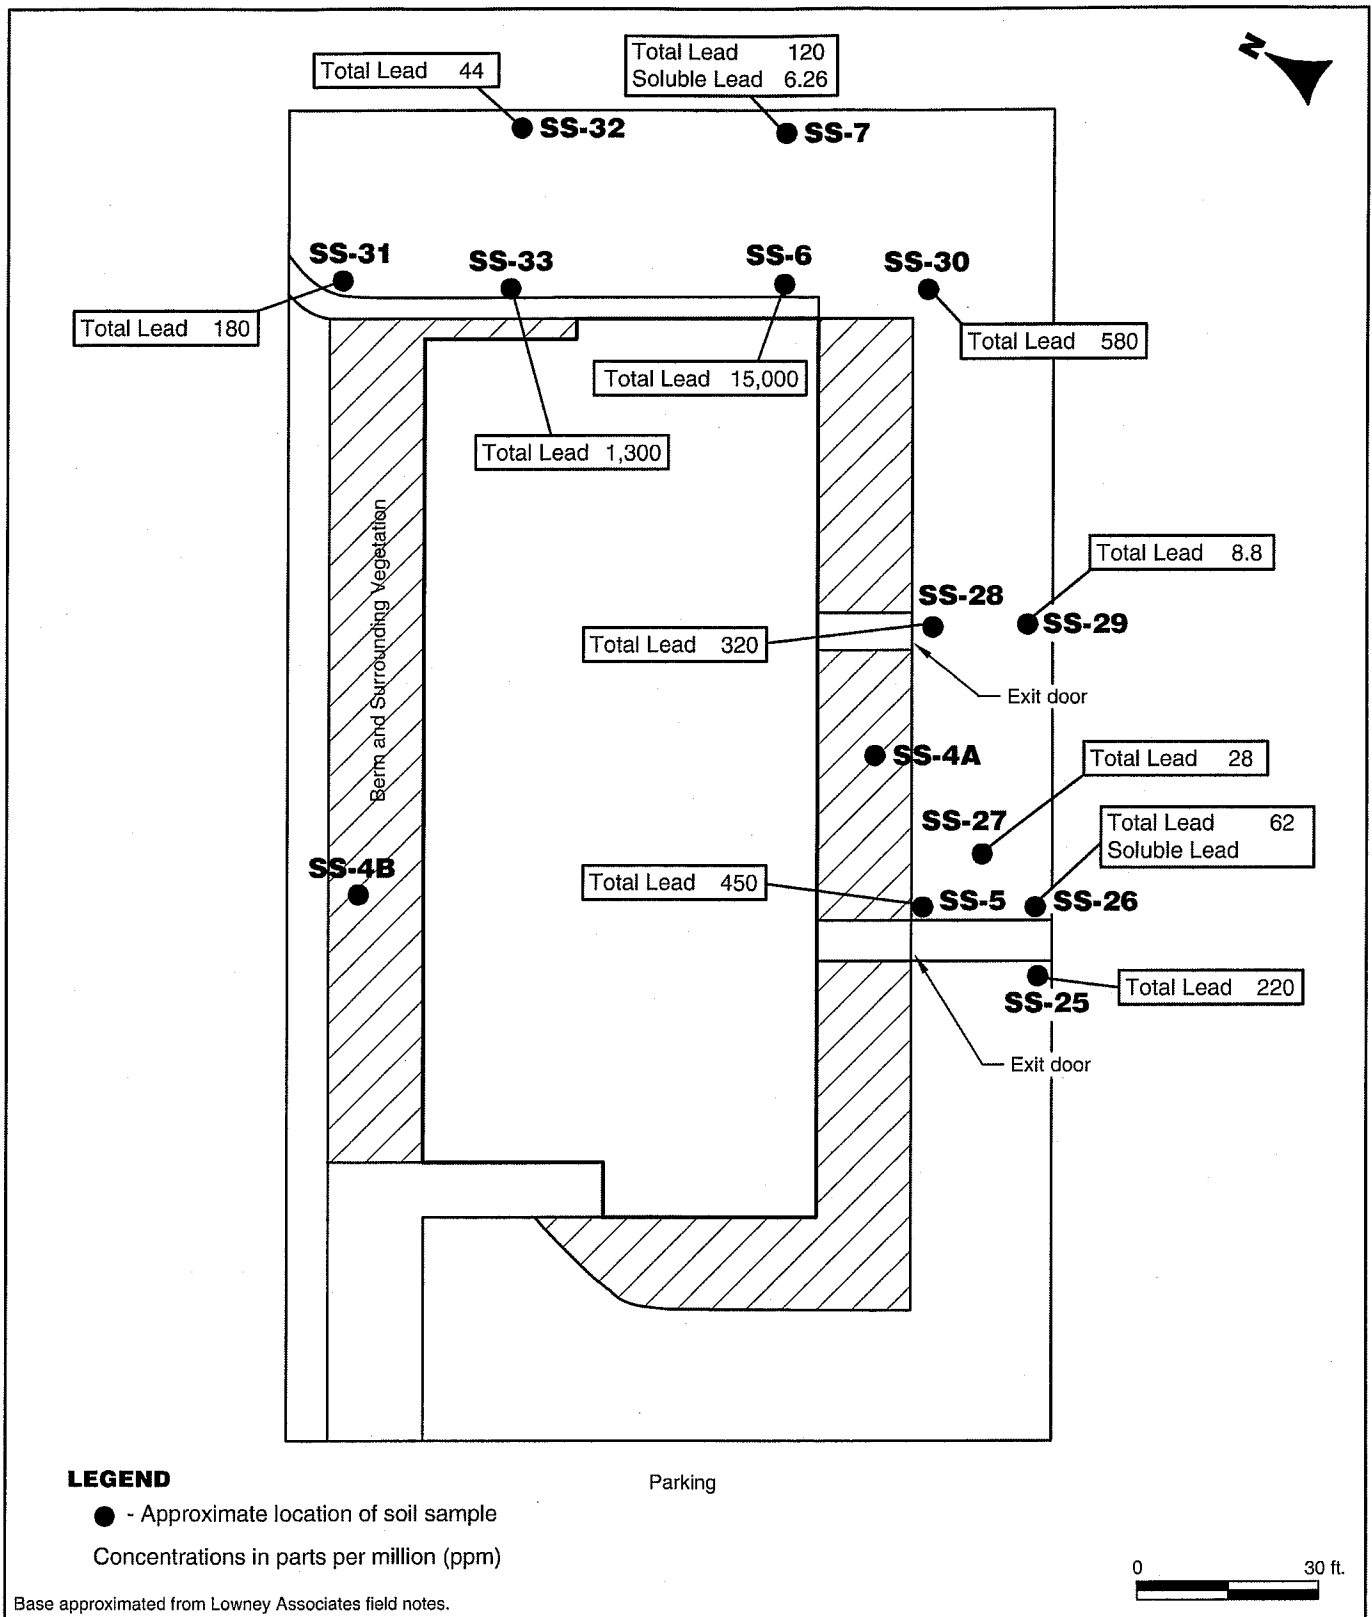
FIGURE 4 — FIRING RANGE RESULTS

Elevated concentrations of lead were detected at several locations ranging from 120 ppm up to 15,000 ppm. One sample with elevated lead was collected from the former farm building area, and the remaining samples were collected from the firing range building. Elevated lead was found to be associated with the exhaust fans and exit doors at the firing range, as shown on Figure 4. Lead concentrations appear to decrease with distances from these areas. These concentrations with the exception of SS-7 (120 ppm) are above the CHHSL of 150 ppm for residential uses. One sample exceeded the commercial/industrial CHHSL of 3,500 ppm. Two of these samples have concentrations over 1,000 ppm, which exceeds the hazardous waste threshold. Three samples were analyzed for soluble lead concentrations (Table 4). Samples SS-7 and SS-26 were above the threshold concentration for soluble lead and would be considered hazardous waste if excavated and disposed.

FIRING RANGE RESULTS **EVERGREEN COMMUNITY COLLEGE** San Jose, California
