**Tree Inventory, Assessment,
And
Protection**

**201 Delmas Avenue
San Jose, CA 95110**

**September 3, 2015
Revised
January 14, 2016
Revised
April 15, 2016**

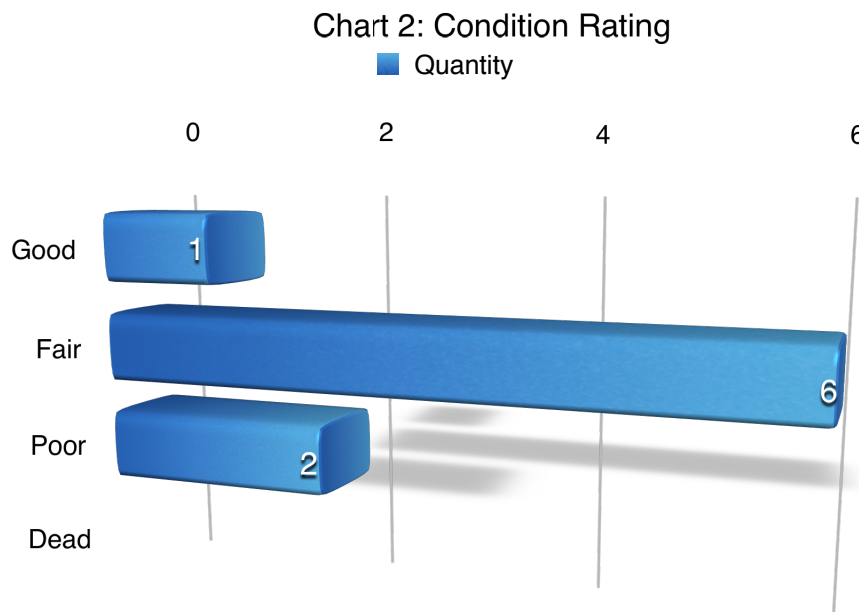
Most of the trees are in fair condition with some problems. The Canary Island pine has codominant stems originating about 25 feet up the tree and the incense cedar has a lean and is crowded by the coast live oak. The coast live oak is the only tree I considered to be in good condition with normal foliar color, size and density. Structurally the coast live oak has two defects or conditions that could be problematic which are codominant stems and a corrected lean but overall this tree is in good shape. The coast redwood and the Peruvian pepper are both in poor condition with defects and conditions that cannot be mitigated.

The chart below list the condition ratings and the relative quantity of each category (Chart 2).

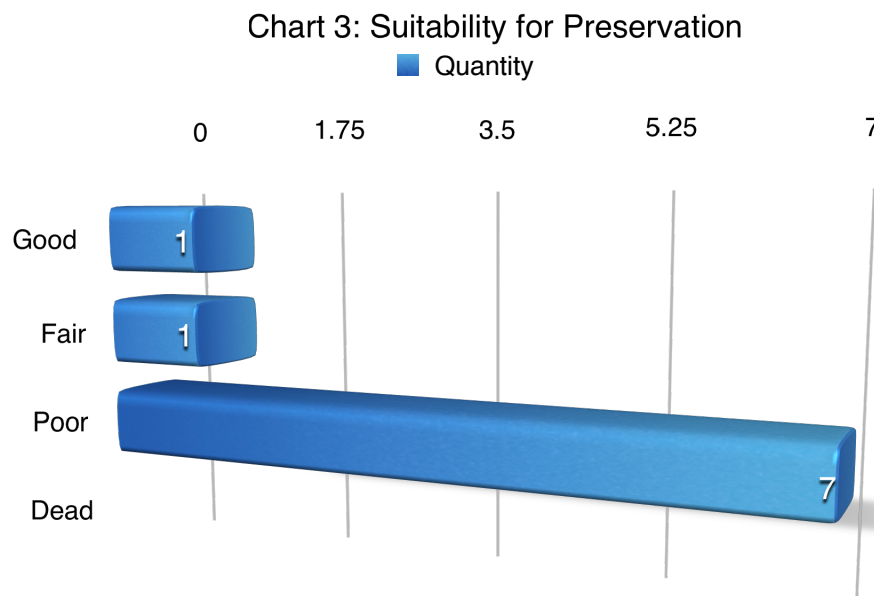
All the trees have poor suitability for preservation with the exception of the coast live oak and the Canary Island pine. The pepper and coast redwood are failing while the tree of heaven are an invasive plant not suitable to retain. I considered the coast live oak to be the best tree suited for retention with good suitability and the Canary Island pine is a large tree that would require some mitigation to help reduce the risk of codominant stem failure. The Canary Island pine has fair suitability for preservation.

The chart below list the condition ratings and the relative quantity of each category (Chart 3).

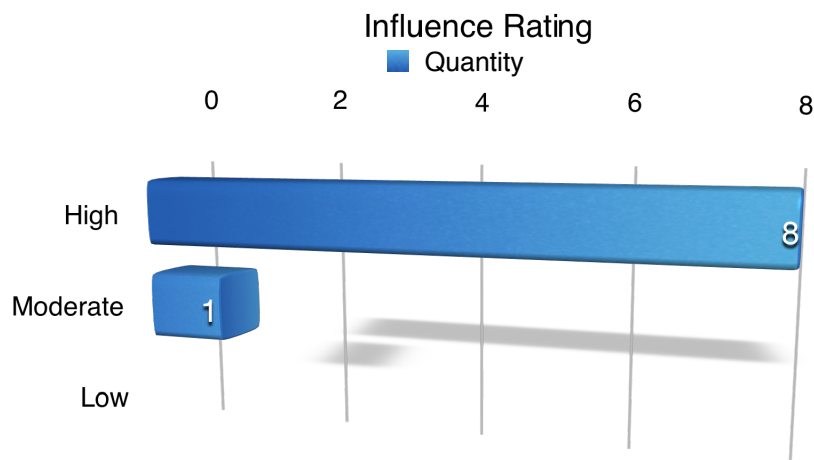
There has been discussion of soil remediation under the coast live oak to remove toxic elements that may be present. The removal of soil may negatively impact the tree depending on how the process is performed.

The chart below lists the trees and the development influence rating (Chart 4).

In the event that soil remediation needs to take place under the coast live oak the process selected for the type of remediation should not damage or destroy tree roots. Mechanical removal of soils would need to be done with a hydrovac or similar type machinery to remove the soil from the site. Soil remediation techniques vary greatly depending on what needs to be cleaned or removed.

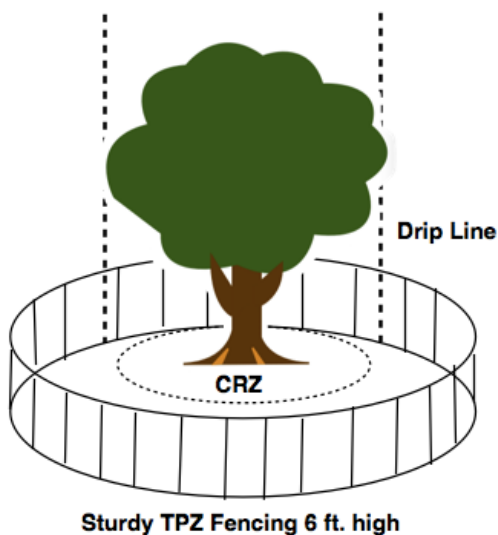
Figure 1: Tree protection distances

The tree protection zone (TPZ) is the defined area in which certain activities are prohibited to minimize potential injury to the tree. The TPZ can be determined by a formula based on species tolerance, tree age, and diameter at breast height (DBH) (Matheny, N. and Clark, J. 1998) or as the drip line in some instances. The tree protection zones for this project will likely include a combination of measures (Figure 1). With the understanding the coast live oak will be the only tree preserved using the tolerance, age, and diameter formula the results are as follows: mature in age, has good tolerance for disturbance, trunk diameter at breast height of 52 inches, tree protection radius of 39 feet (.75 feet per inch trunk diameter).

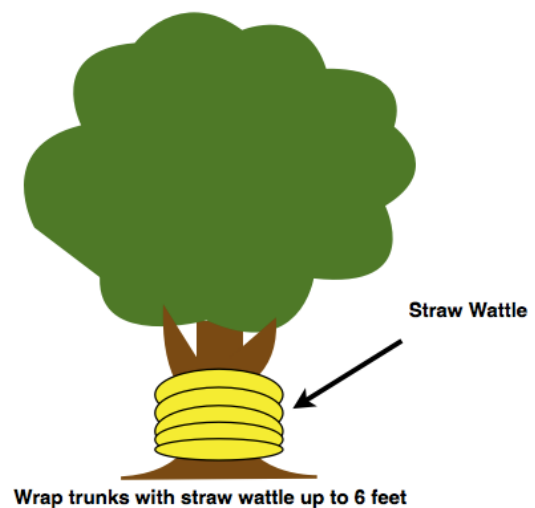
Figure 2: Trunk protection with straw wattle

Preventing mechanical damage to the main stems from equipment or hand tools can be accomplished by wrapping the main stem with straw wattle (Figure 2). The wattle will create a porous barrier around the trunk and prevent damage to the bark and vascular tissues underneath. Trees that are to be moderately affected by the project without adequate fence protection should be wrapped in wattle. The coast live oak will require wattle once landscape under the tree is to be performed.

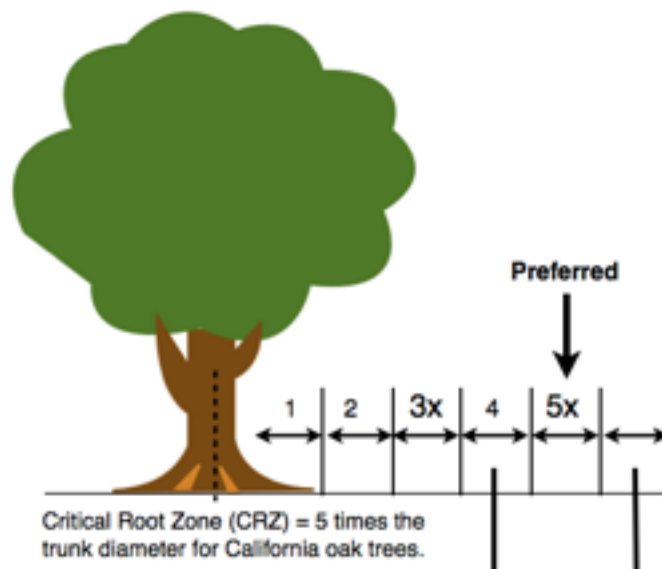
The recommended maximum encroachment distance into the root zone of oaks on one side is five times the trunk diameter (Coate, B.)(Costello, L., Hagan, B., Jones, K. 2011)(Figure 3). For the coast live oak the maximum recommended encroachment distance on one side would be between 13 to 22 feet, however no trenching should occur within 22 feet of the trunk.

Figure 3: The image above depicts the preferred Critical Root Zone distance for oaks.

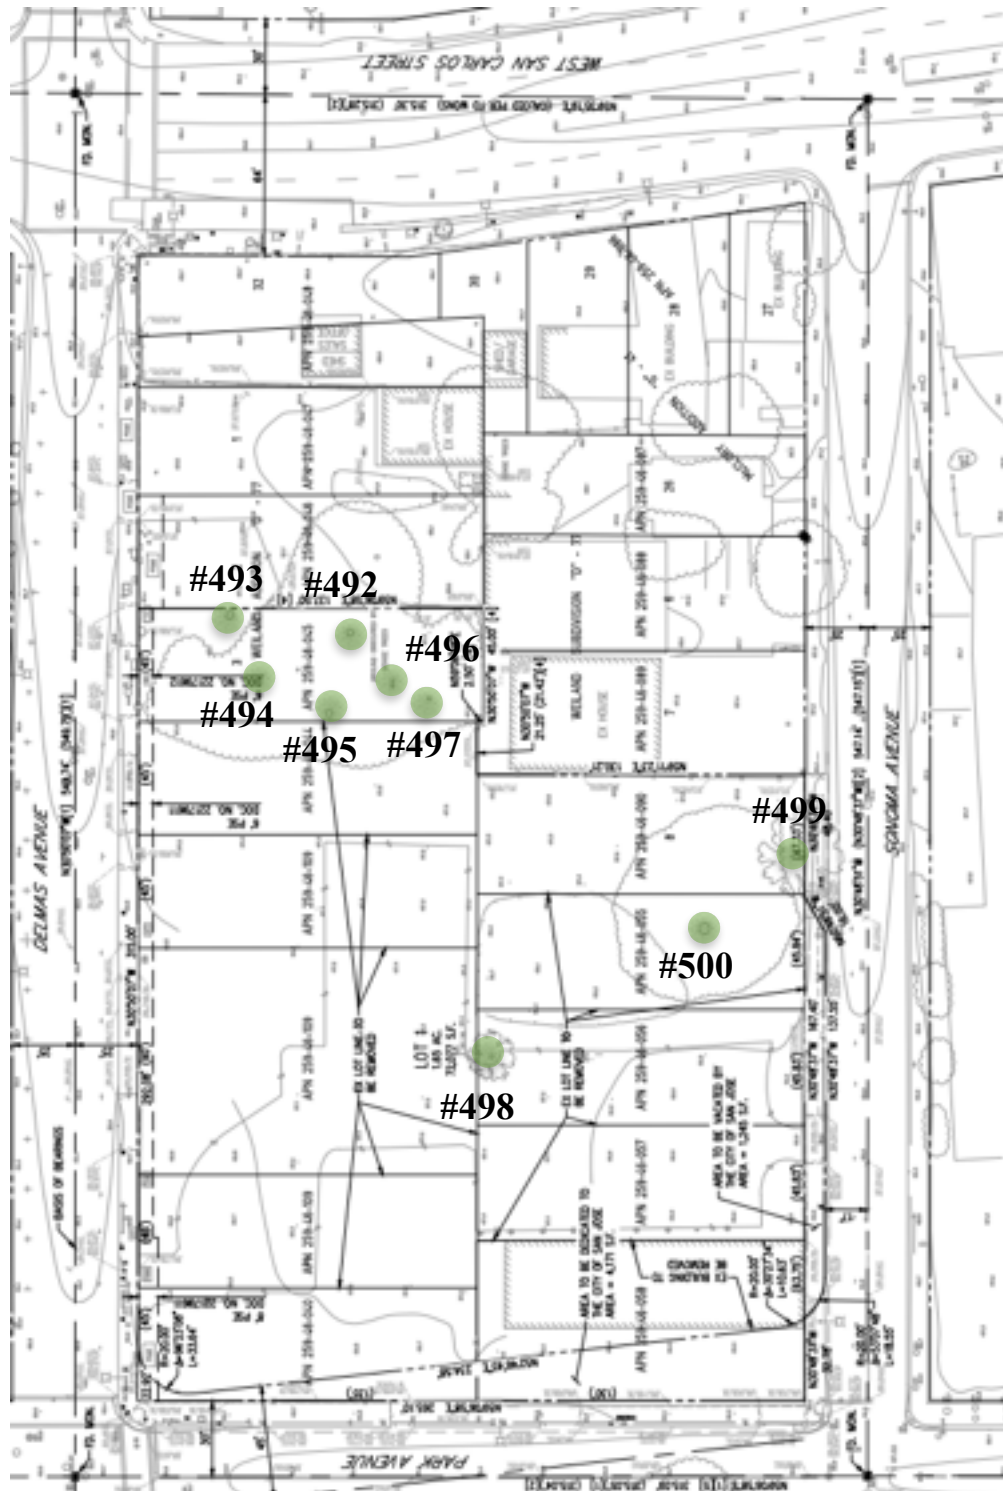
Appendix A: Tree Inventory Map

Tree numbers and approximate locations labeled 492 to 500.
