San José-Santa Clara
Regional Wastewater Facility
Reporting Period June 1 – October 31, 2018

Pond A18

2018 Annual Self-Monitoring Report

Order No. R2-2005-0003

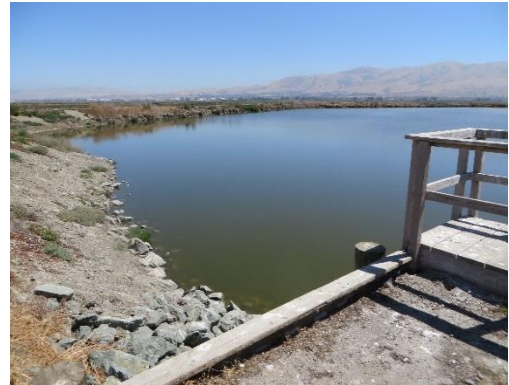
*Figure 9. Pond A18 water color observations.
Opaque brownish-green waters, 13 June 2018*

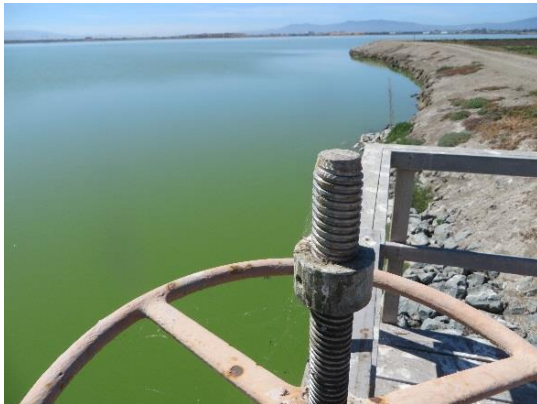
*Figure 8. Pond A18 water color observations.
High primary productivity waters- 10 July 2018*

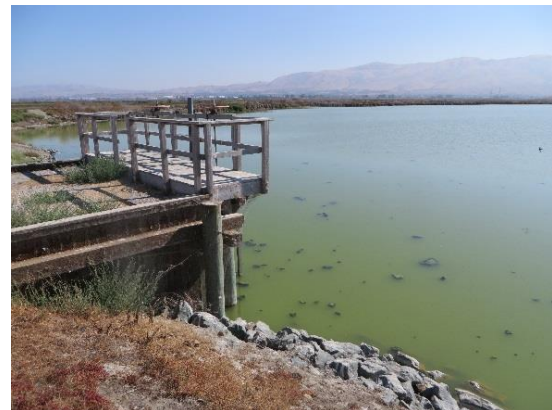
Pond water color and clarity at the beginning of the 2018 monitoring season was similar to the previous year, likely due to the same southern intake configuration. This flow orientation allows for higher nitrogen concentrations in the water entering the pond due to the southern structure's proximity to the Facility final effluent discharge point. Pond water in early June was an opaque brownish-green (Figure 7) which brightened to a vibrant green by mid-July (Figure 8), indicating higher concentration of phytoplankton. Secchi values diminished gradually during this time (Table 7), and chlorophyll samples collected in June-July measured approximately 50-65% of those collected in 2017. With the exception of weeks 4 and 5 (June 26- July 10), the pond's weekly 10th percentile DO concentration fell below the 3.3 mg/L threshold throughout June and July. Filamentous algae sparsely populated the pond's margins throughout the majority of the monitoring season, while floating clumps of benthic algae released from the substrate were observed on the pond's surface briefly in late July (Figure 9).

*Figure 7. Pond A18 water color observations.
Floating clumps of benthic algae, 26 July 2018*

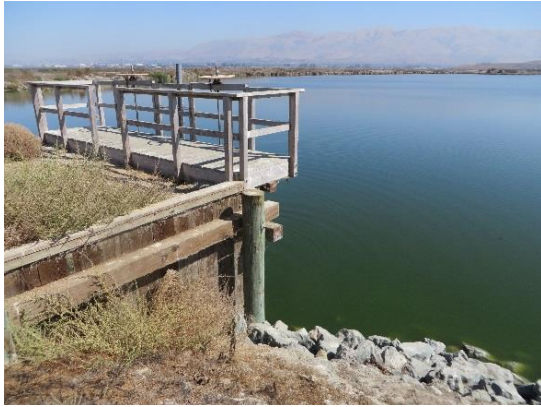
Figure 11. Pond A18 water color observations. Deeper green waters, 28 August 2018

The pond's water color darkened to deeper shades of green in August (Figure 10) while secchi measurements dipped, likely due to shifts in phytoplankton species composition. Chlorophyll values decreased considerably in September and remained low through the remainder of the season, indicating diminishing concentration of phytoplankton. Pond water became increasingly turbid (Figure 11) as secchi measurements crept upwards into October.

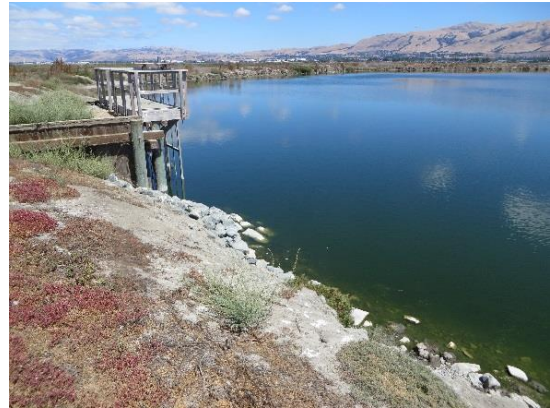
Figure 10. Pond A18 water color observations. Murkier waters, 25 September 2018

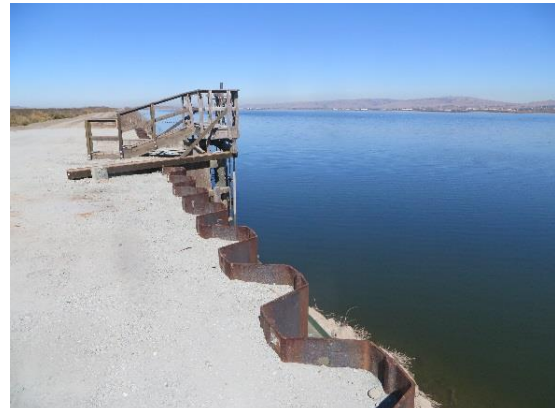
On October 9, 2018, the pond's flow regime was reversed, with inflow through the northern hydraulic structure and discharge from the southern structure, and water color shifted to greenish-brown through the end of October (Figure 12).

Figure 12. Pond A18 water color observations. Greenish-brown waters after flow regime reversal, 16 October 2018
