Appendix B: Updated Tree Assessment and Arborist Tree Report

295 E. Virginia Street

Updated Tree Assessment

ARBORIST TREE REPORT

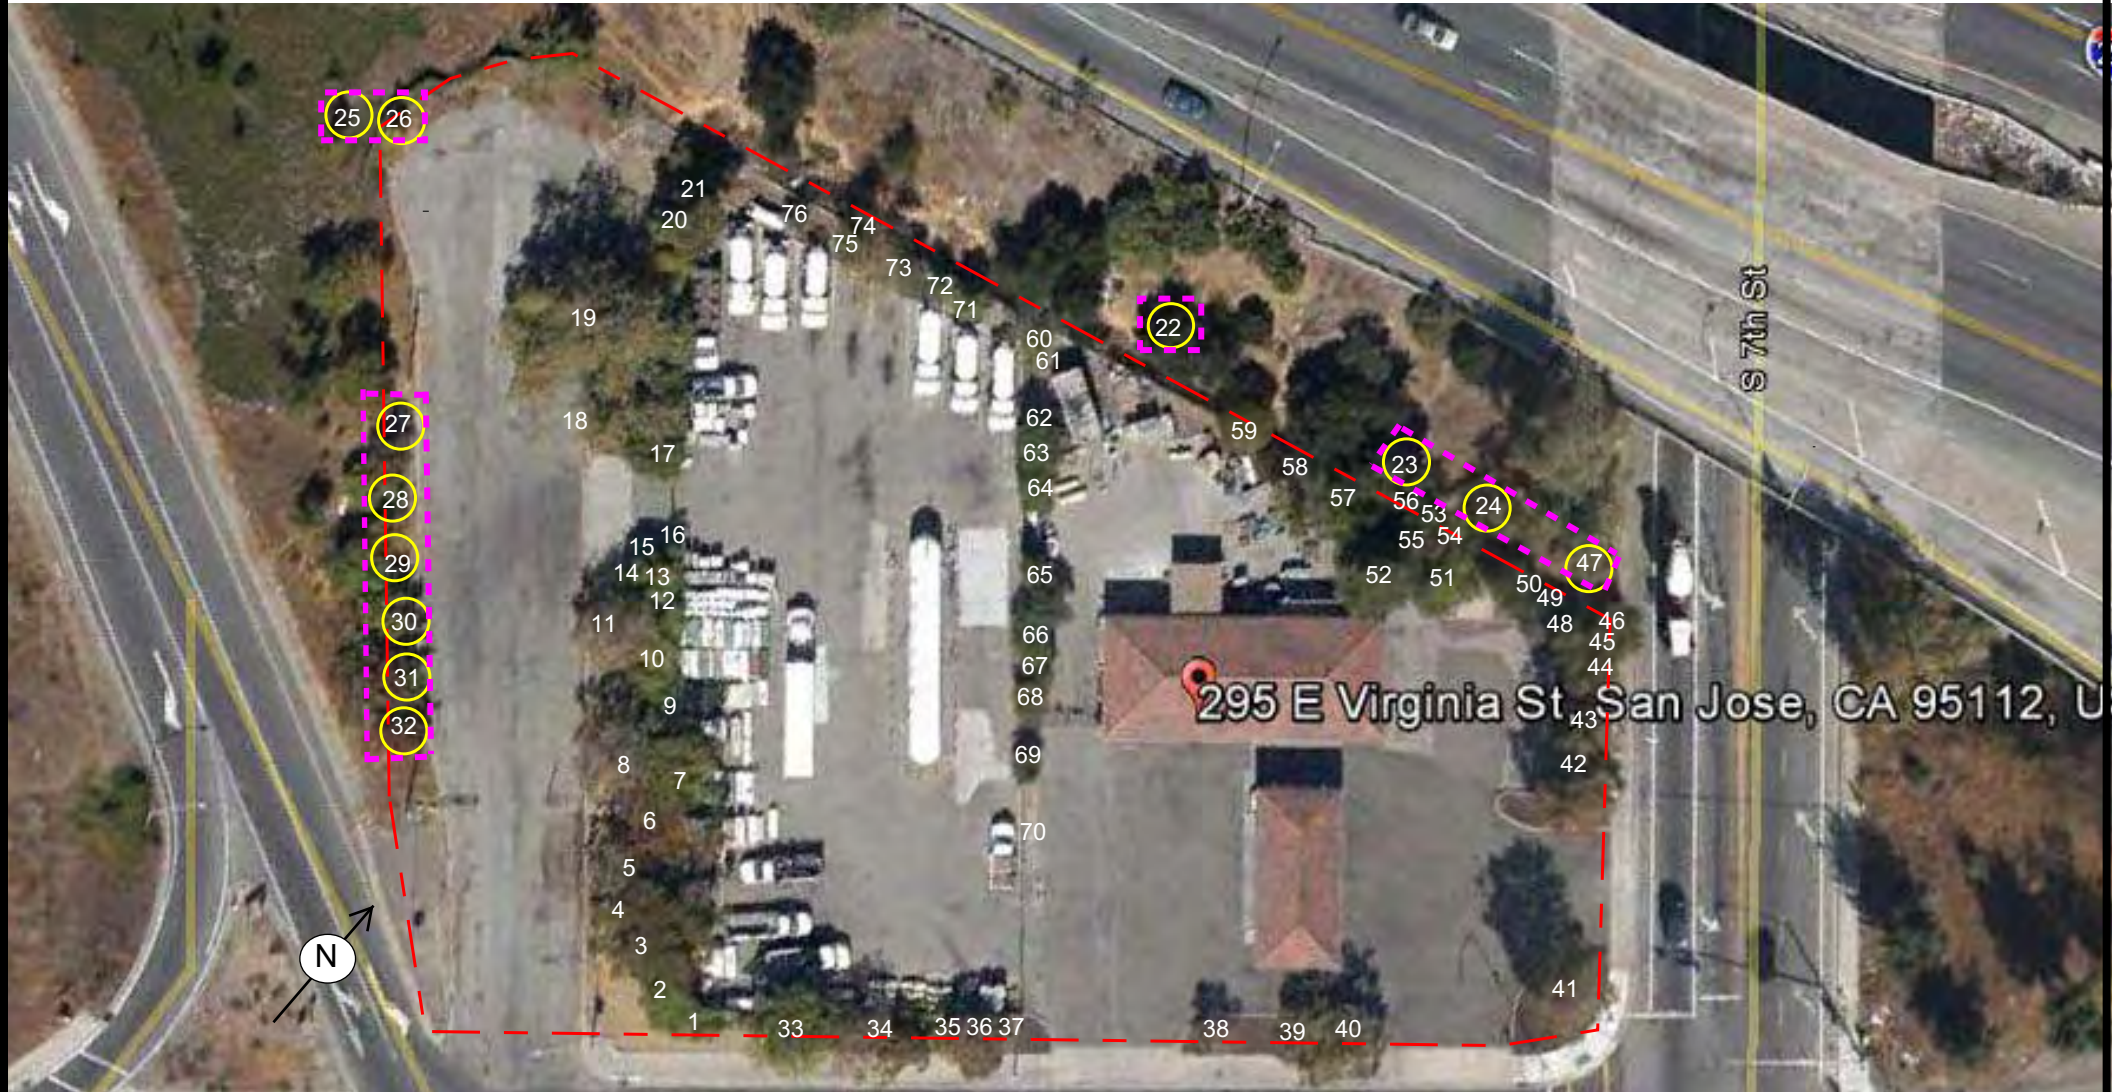
Appendix 3
Preliminary Tree Location Map
295 East Virginia Street
 San Jose, California

- MAP IS NOT SCALED
- TREE LOCATIONS WERE APPROXIMATED
- OFF-SITE TREES APPROXIMATELY 10 FEET OUTSIDE OF EXISTING FENCE WERE ASSESSED.
- AERIAL PHOTO BY GOOGLE EARTH
