June 16, 2020
Revised July 14, 2020

Knox-Goodrich Building
34-36 S. First Street
San Jose, California

PRESERVATION PLAN

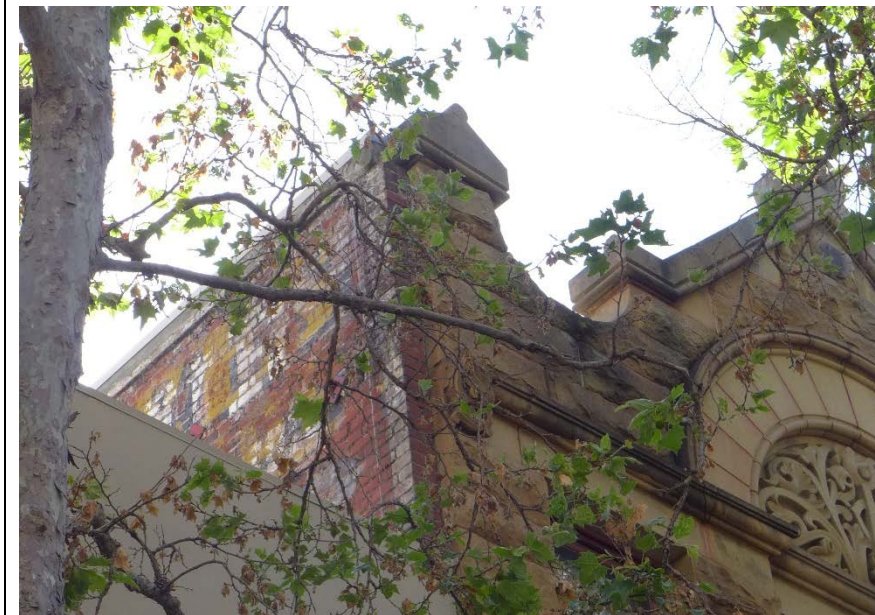
24. Reference photograph. Ghost sign on the west side of the structure, viewed from the public right of way (South First Street).

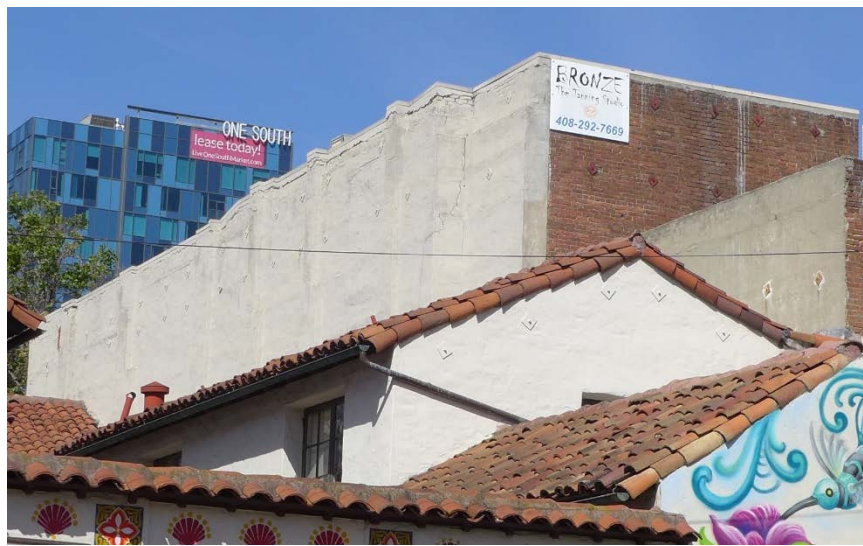
26. Reference photograph. The east façade of the building, viewed from the northern parking lot at the rear of the structure.

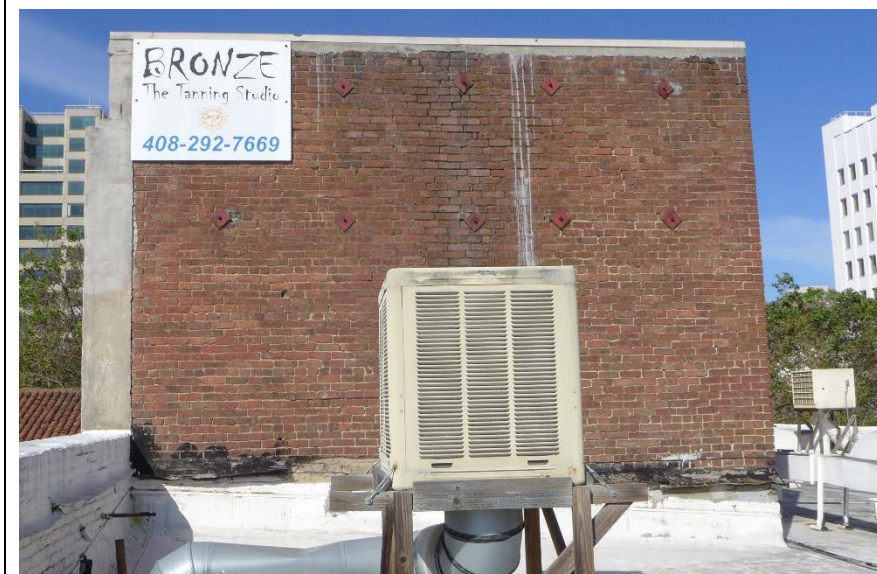
28. Reference photograph of the north side of the building, viewed from the roof of the Lido Building. Only the upper portion of the exterior wall is visible.

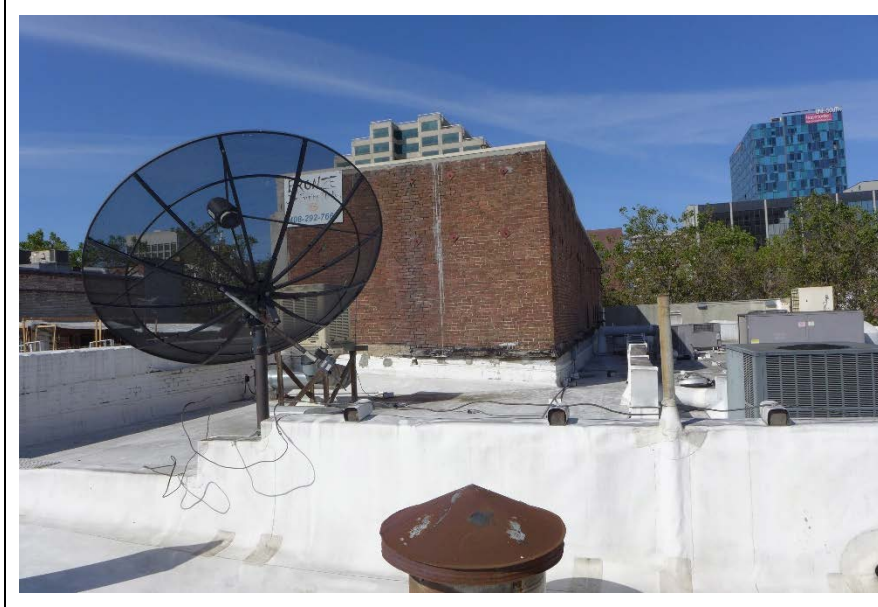
30. Reference photograph. View of the north and west walls of the Knox-Goodrich Building from the roof of the Lido Building.

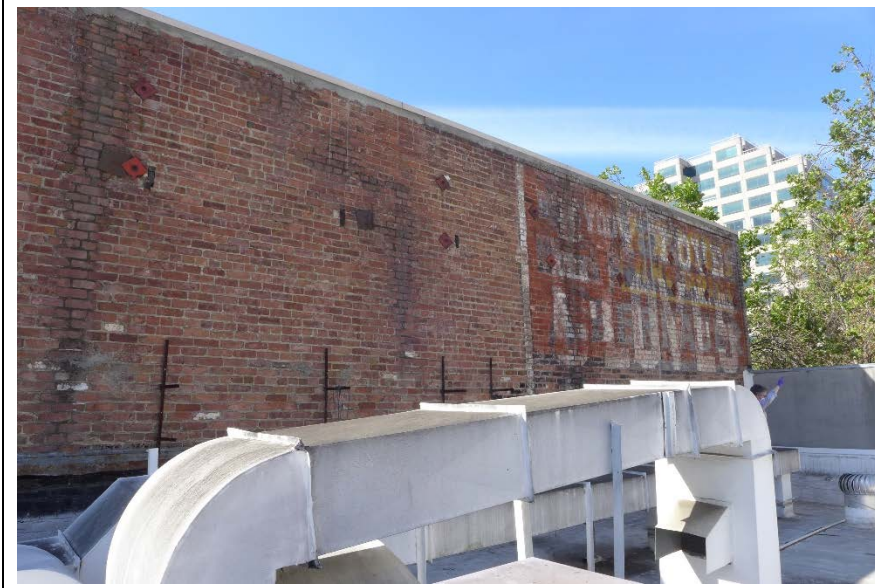
33. Reference photograph. View of the west wall, looking at the southern end with the ghost sign.

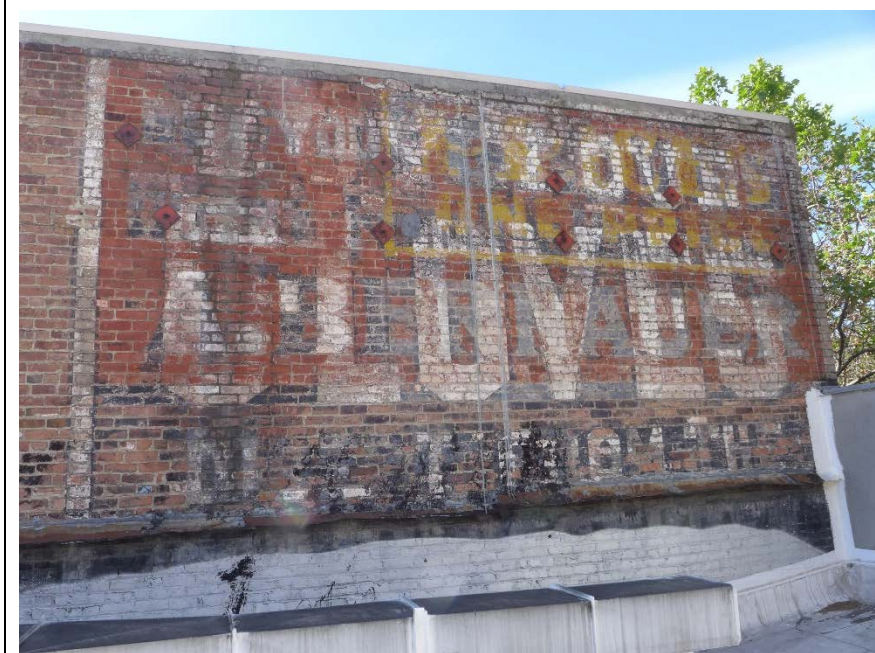
35. Reference photograph.

The ghost sign at the south end of the west wall. Several signs have been painted on top of one another, so it is difficult to tell what any one sign says. However, "GLOVES" can easily be identified, as well as "A. BERNAUER". These both make sense as the building was home to a glove manufacturer Alexander Bernauer. The rest of the various signs are illegible.

The sign should be photographed with digital photos prior to any demolition work. The construction of the adjacent building and required seismic joint will have a limited impact on the ghost sign. While the ghost sign will be enclosed in the seismic gap between the two buildings, it will remain mostly untouched because of the gap. There will be anchors at select intervals installed at one location as well as sealant. The proposed work is all reversible with minimal damage to the sign.

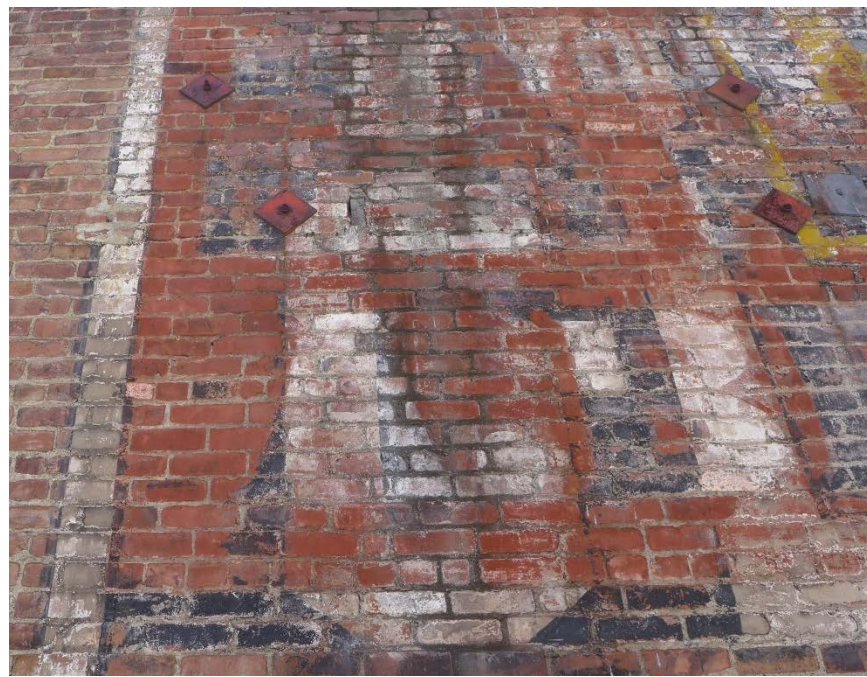
36. Close up of a portion of the sign.
