Appendix E3  
**Historic Resources Relocation  
Studies**

**Project:** San Jose, CA  
Site Selection Criteria for Relocation of Identified Historic Resources

RE: Downtown West Mixed Use Plan - 40 South Montgomery - Kearny  
Pattern Works Move Feasibility

RE: Downtown West Mixed Use Plan - Historic Resource Move  
Feasibility

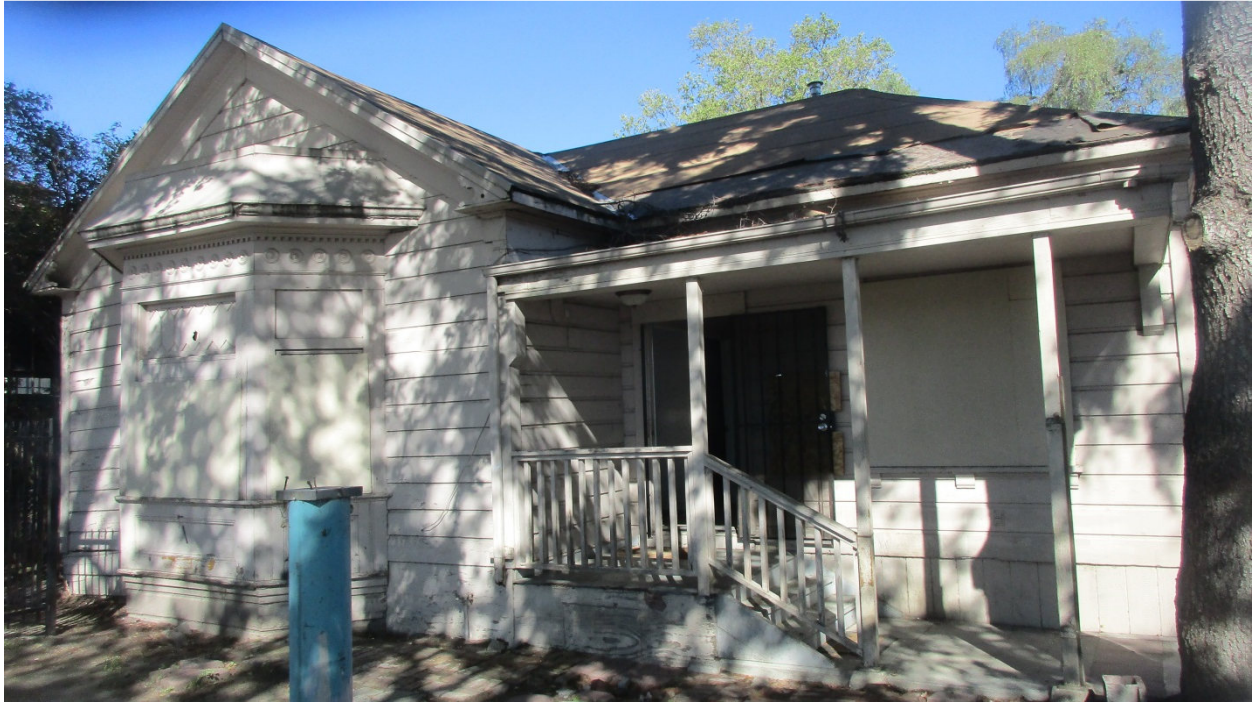
567 West Julian Figure 2

The Historic Resources at West Julian Street are all wood framed structures with crawl spaces under them and are in varying degrees of poor condition. The interiors have been modernized in a cheap fashion into multiple units and will require complete gutting. The majority of interior historic fabric is missing. Two of the houses have non-historic appendages which should be removed. Certainly Lead paint and likely asbestos are present. These houses can be moved by a traditional house mover on standard equipment. The widest house is at 559 W. Julian Street (See Figure 4) at 45'. Depending on the receiver site location, it is possible that the roof structures may need to be removed to reduce the cost of moving utility lines or to make it under

- a. Abate hazardous materials notably lead paint
- b. Remove non-historic appendages
- c. Gut interiors
- d. Remove or support porches
- e. Remove bulkhead siding
- f. Demolish any brick flues or chimneys
- g. Install shoring, cribbing, and raise
- h. Coordinate with utility companies, DOT, and Public Works
- i. Install dollies and transport to receiver site

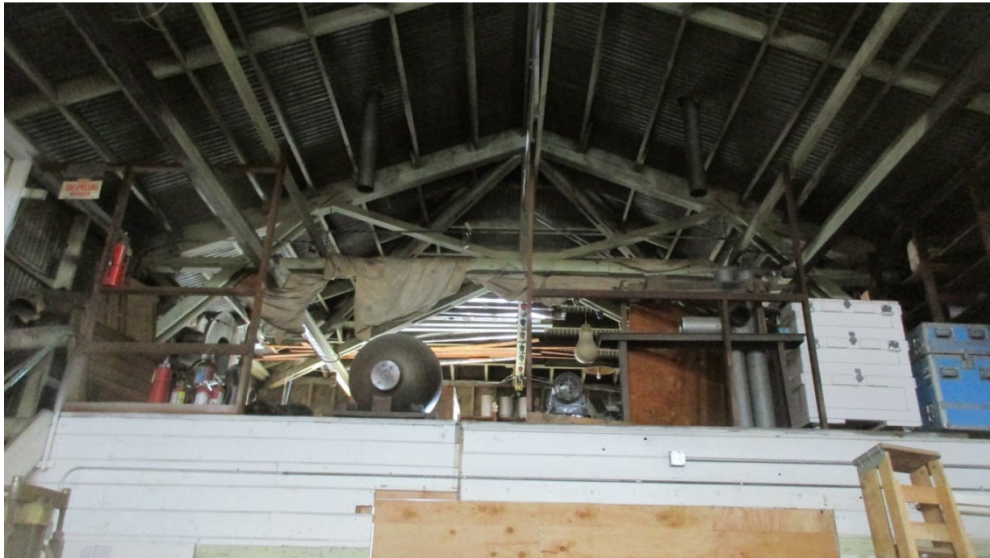
343 North Montgomery Figure 3

The 343 North Montgomery Street building is 31' Wide, 20'6" Tall and 206' in length. The structure is clad with tin siding and tin roofing. The façade is plaster as shown above. There is an interior office with a storage mezzanine on top of it. (See Figure 3) The building's Warehouse portion of the structure is constructed of wood posts and trusses on the eastern side then the framing switches to steel trusses with overhead crane rails attached on each end running the length of the building. (See Figures 3,4,6) There is a circa 1949 non-historic addition planted on the north side of the structure which should be removed as it does not fit architecturally and will complicate a move. The building is in fair condition although the tin on the roof is rusted (See Figure 2) however the façade and offices are in good condition. If one were to contemplate moving the structure the likely scenario would be to disconnect the office mezzanine area to the nearest truss and move that portion as a separate section and then brace all posts down to the concrete
