## Arborist Report

# Tree A of Initial Study Fig 15

Address: 484, 488 E Saint John Street and 93,95, 97 N. 11th Street  
San Jose, CA. 95112

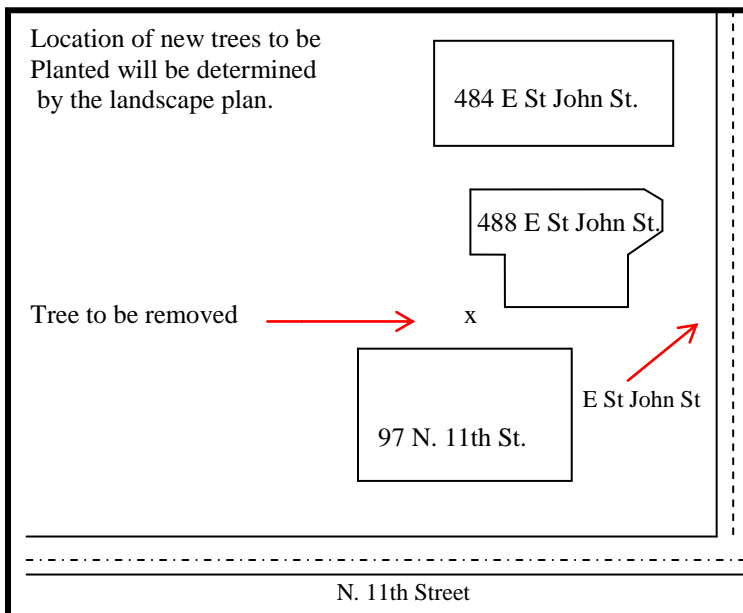
I found the tree with several natural defects and irreversible damage, severely topped, poor structure, unbalanced, poor branch taper and weak attachments. These conditions are less than ideal for a mature tree.

The current condition of the tree and the proximity from the tree to the house increases the risk for a potential failure, posing a very significant hazard to the existing structures and the public.

Failure potential: low medium **high** severe

Tree part most likely to fail: branches

Hazard abatement: remove tree, replace with one  
15 gallon European Hornbeam

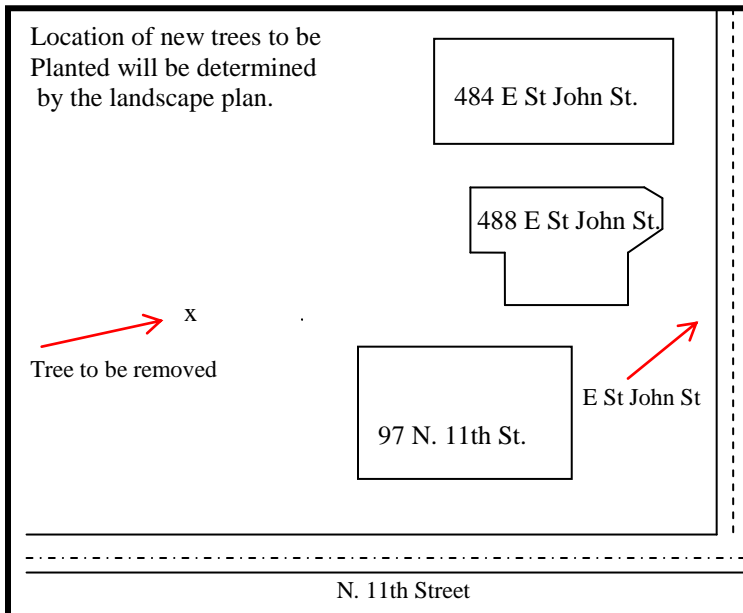
Non native tree, is very well known for spreading and becoming a common invasive plant in urban, agricultural and forested areas. This species is currently listed as an unsuitable tree by the city of San Jose.  
The location where the tree is growing strongly indicates that it was a seed carried by wild life or dispersed by the wind.  
I found the tree with several natural defects, poor structure, unbalanced, large branches over the roof areas, leaning towards the neighbors structures and weak attachments. These conditions are less than ideal for a mature tree.  
A better selection of new trees with an improved planting process will provide a better result in the future.  
The current condition of the tree and the proximity from the tree to the structures, increases the risk for a potential failure, posing a very significant hazard to the existing structures and the public.

Failure potential: low medium **high** severe  
Tree part most likely to fail: branches  
Hazard abatement: remove tree, replace with one 15 gallon Chitalpa tashkentensis

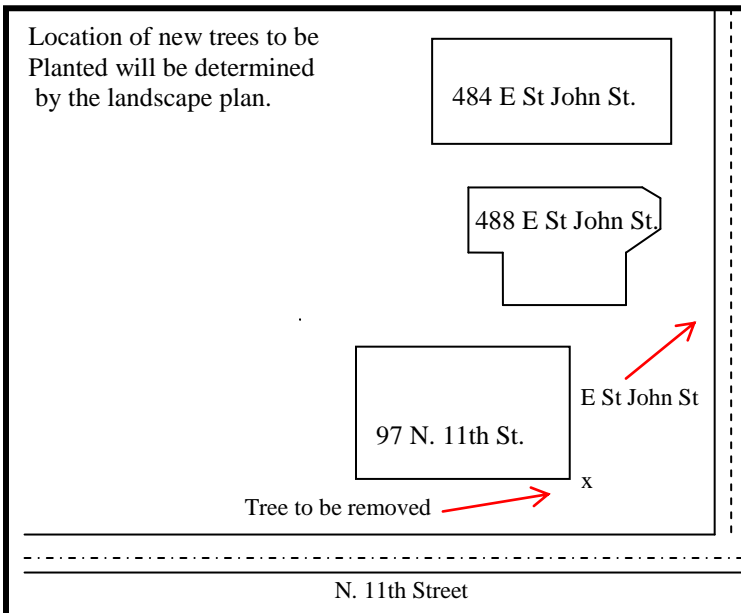
Non native tree, is very well known for spreading and becoming a common invasive plant in urban, agricultural and forested areas. This species is currently listed as an unsuitable tree by the city of San Jose.  
The location where the tree is growing strongly indicates that it was a seed carried by wild life or dispersed by the wind.  
I found the tree with several natural defects, poor structure, unbalance, poor branch taper, large branches over the roof area and weak attachments. These conditions are less than ideal for a mature tree.  
A better selection of new trees with an improved planting process will provide a better result in the future.  
The current condition of the tree and the proximity from the tree to the house increases the risk for a potential failure, posing a very significant hazard to the existing structures and the public.

Failure potential: low medium **high** severe  
Tree part most likely to fail: branches  
Hazard abatement: remove tree, replace with one 15 gallon European Hornbeam

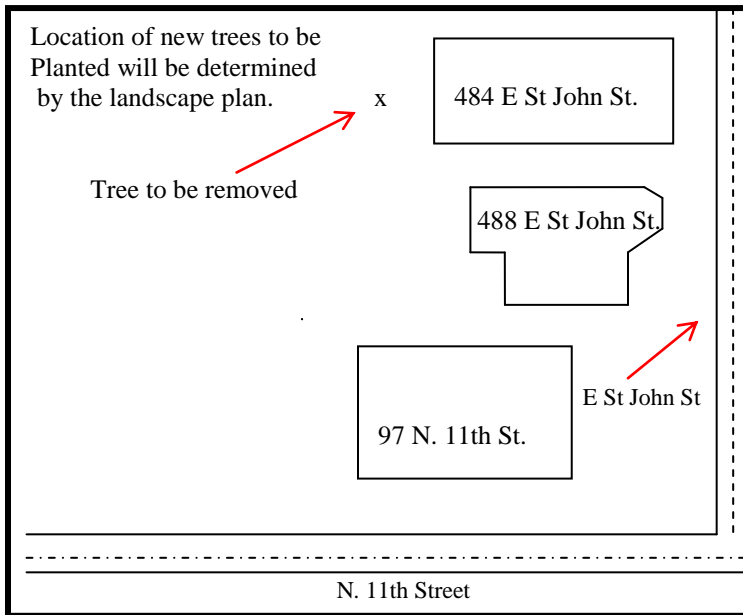
I found the tree under stress with very poor crown ratio and a excessive amount of dead and dying fronds.

The current condition of the tree and the proximity from the tree to the house increases the risk for a potential failure, posing a very significant hazard to the existing structures and the public.

Failure potential: low **medium** high severe

Tree part most likely to fail: fronds

Hazard abatement: remove tree, replace with one  
15 gallon European Hornbeam

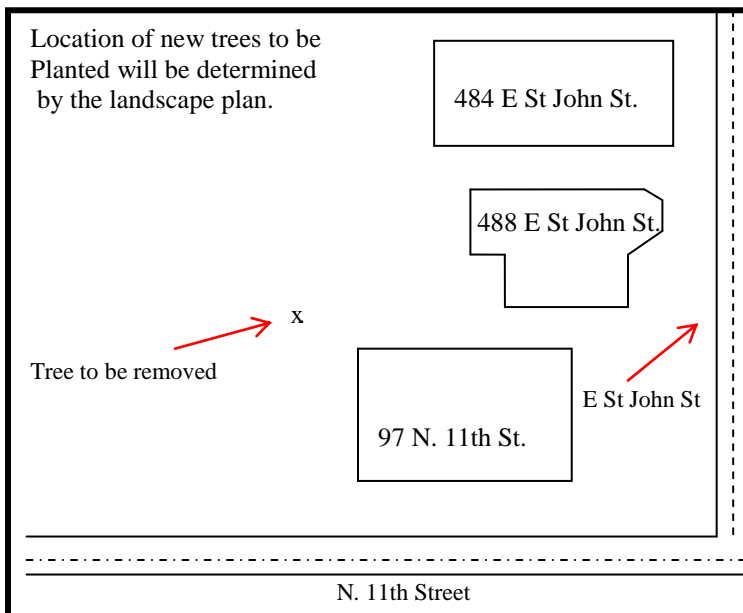
I found the tree with several natural defects, poor structure, unbalanced and weak attachments. These conditions are less than ideal for a mature tree.

The current condition of the tree and the proximity from the tree to the structure, increases the risk for a potential failure, posing a very significant hazard to the existing structures and the public.

Failure potential: low medium **high** severe

Tree part most likely to fail: branches

Hazard abatement: remove tree, replace with one 15 gallon Chitalpa tashkentensis

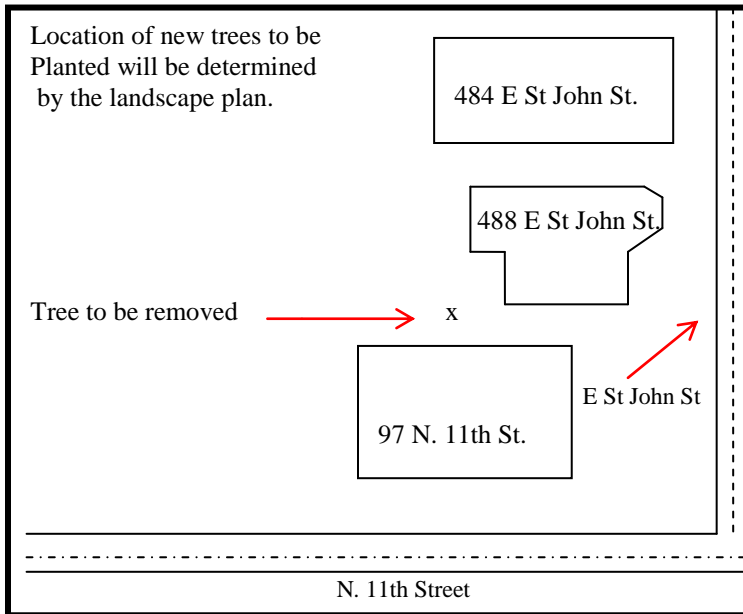
A better selection of new trees with an improved planting process will provide a better result in the future. The current condition of the tree and the proximity from the tree to the house increases the risk for a potential failure, posing a very significant hazard to the existing structures and the public.

Failure potential: low medium high **severe**

Tree part most likely to fail: branches, whole tree

Hazard abatement: remove tree, replace with one 15 gallon European Hornbeam

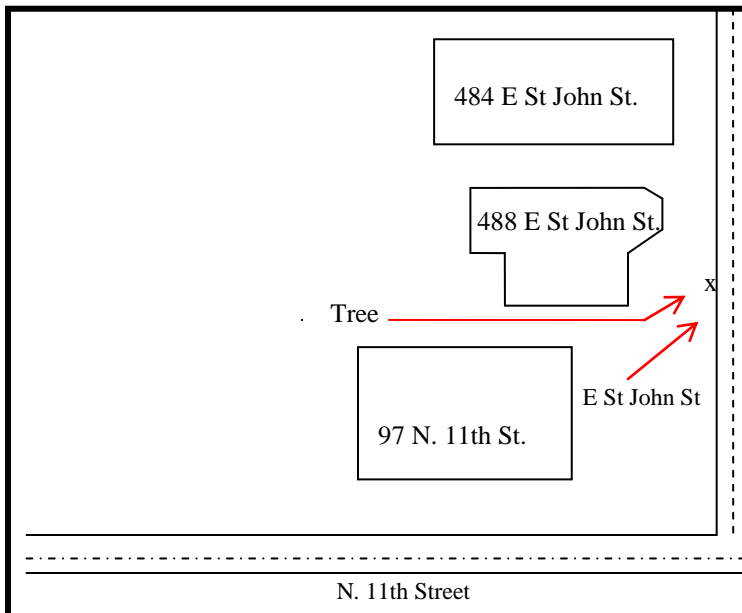
The overall condition of the tree is good, the foliage looks normal, healthy trunk taper and excellent crown ratio.

Failure potential: **low** medium high severe

Hazard Abatement: Thin the crown by selective removal of branches to increase light and air penetration, raise low branches, remove dead and dying branches.

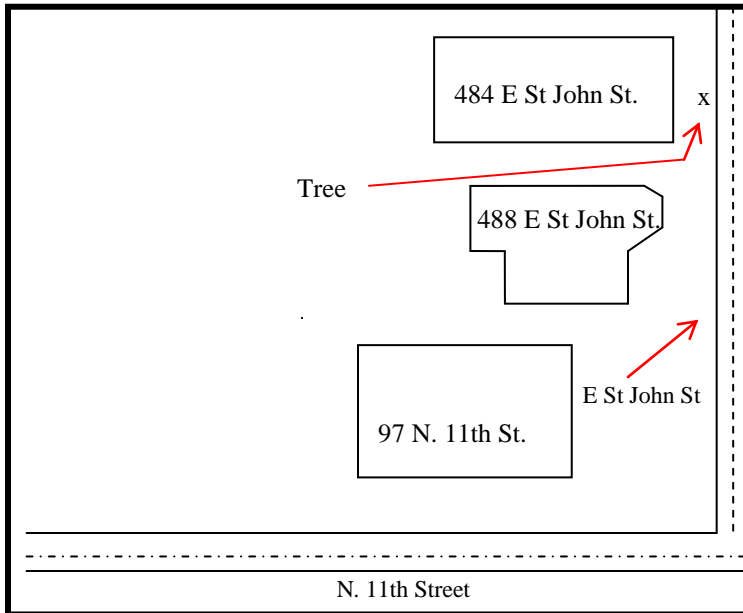
Flowering tree drought tolerant , its native habitat are the desert lands of Texas, California and Mexico.  
 The tree is growing next to a utility pole in the parking strip.  
 The overall condition of the tree is normal, but the tree should be trimmed to correct some natural defects.  
 The selection for the species in this location is appropriate, the compact shape and general appearance makes this tree a good selection for a street tree in specific areas.

Failure potential: **low** medium high severe

Tree part most likely to fail:  
Hazard abatement: Thin the crown of the tree by selective removal of branches to increase light and air penetration, raise low branches, remove dead and dying branches.

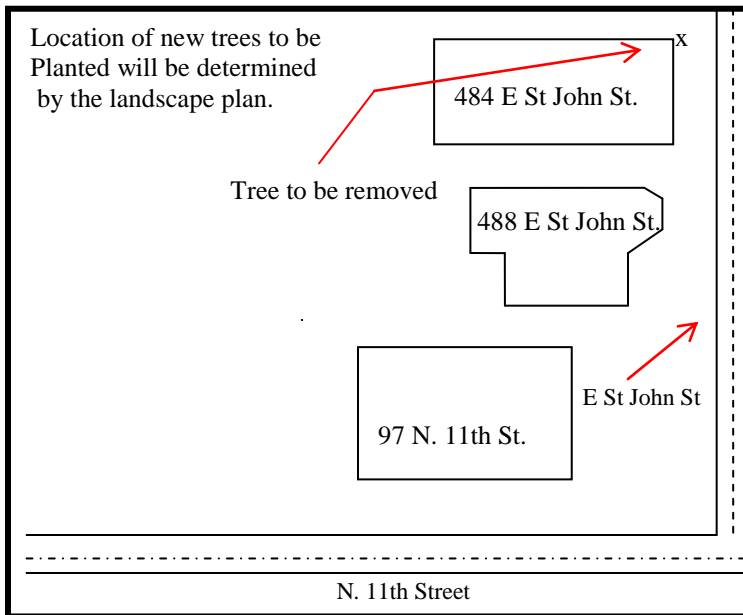
The tree is currently very unhealthy and dying, I found the tree with very poor structure, low crown ratio, topped, trunk decay and with a deformed shape.

The current condition of the tree and the proximity from the tree to the house increases the risk for a potential failure, posing a very significant hazard to the existing structures and the public.

Failure potential: low **medium** high severe

Tree part most likely to fail: fronds

Hazard abatement: remove tree, replace with one 15 gallon Magnolia grandiflora 'Little Gem'

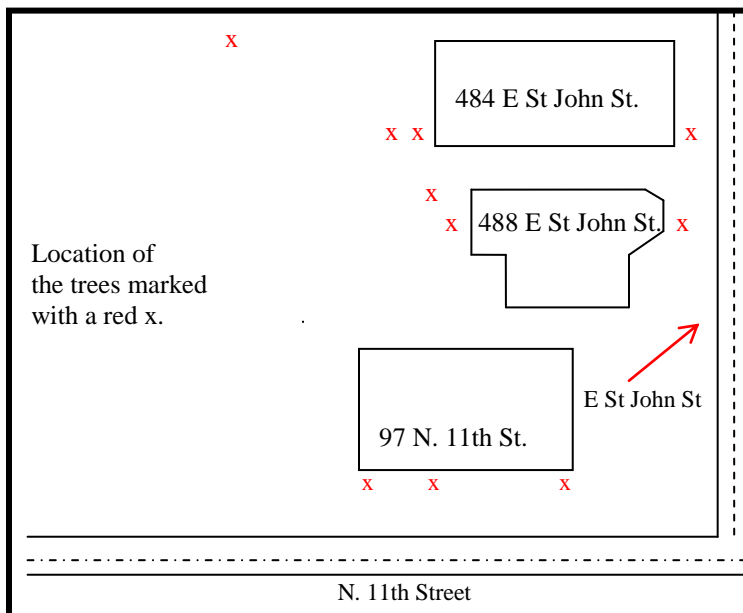
Very young non-native fruit tree.

Only 1 out of 10 trees is native to the area.

Hazard abatement: Remove all 10 trees and shrubs.
