1655 Berryessa Road Project

Arborist Report

Project #4248-01

October 29, 2018

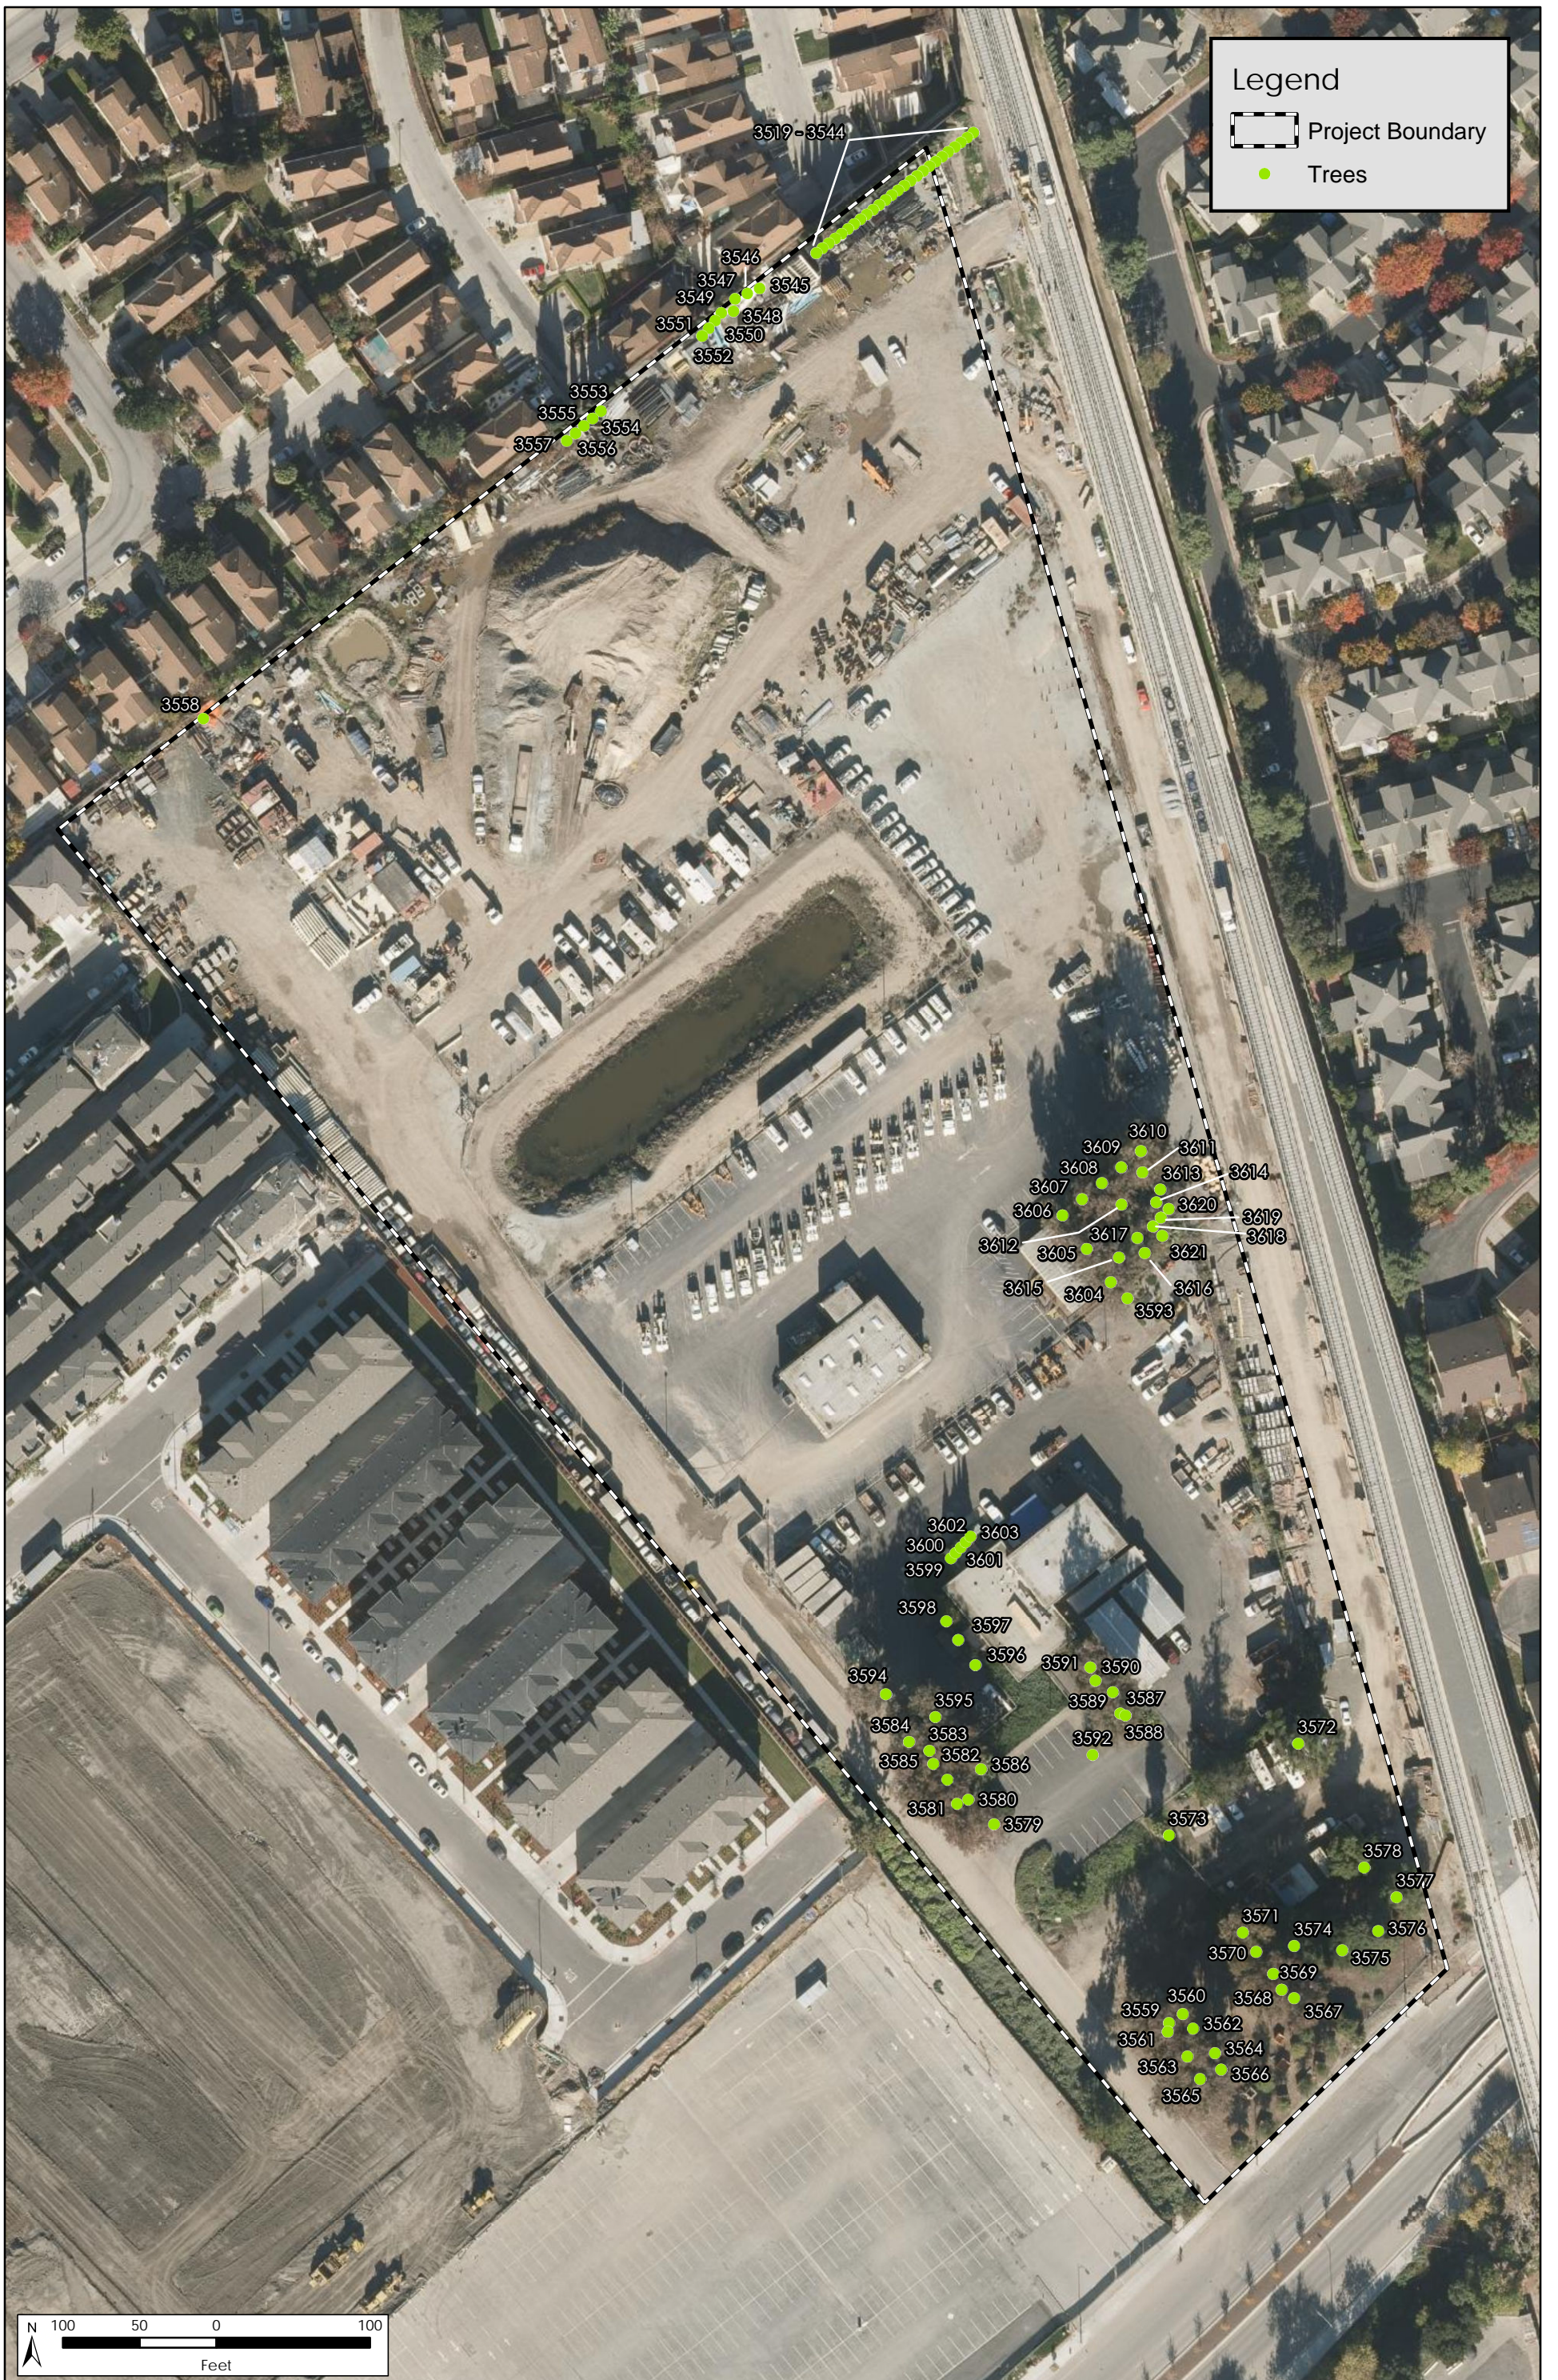
We identified 103 trees on the site (Figure 1). Descriptions of each tree including DBH, tree health and structural scores, and whether or not each tree is ordinance-sized are provided in Appendix C. Table 3 provides a summary of the 103 trees that were assessed, which represent 10 species. Of the 103 trees located on the site, 47 (46%) met the City's criteria for ordinance-size trees (see Section 3.4 below). The most common species on the site were Italian cypress (44%) and red ironbark (41%).
