Preliminary Arborist Report

**420 S. 2nd Street
San Jose, CA 95113**

May 26, 2021

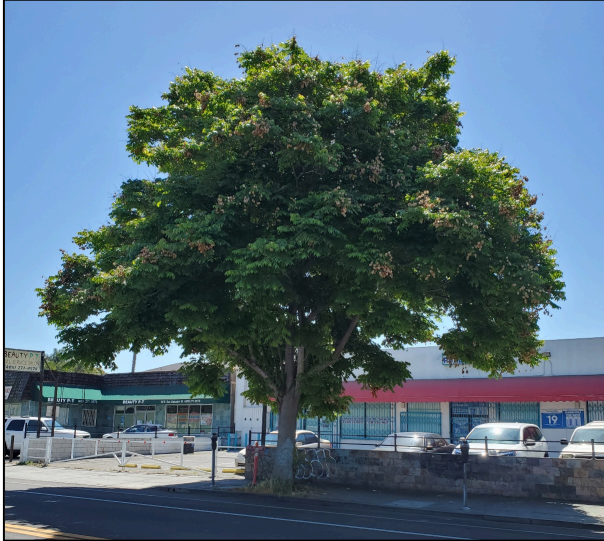
Chinese pistache #183 was a street tree planted in a concrete cutout along San Salvador Ave (Photo 2). It was in fair condition and was 11” in diameter. It had numerous basal sprouts and minor mechanical damage, but a dense, healthy crown.

Photo 2 (below): Chinese pistache #183 was a street tree planted along San Salvador Ave.
