Arborist Report

Tamien Station
San Jose, CA

February 1, 2019

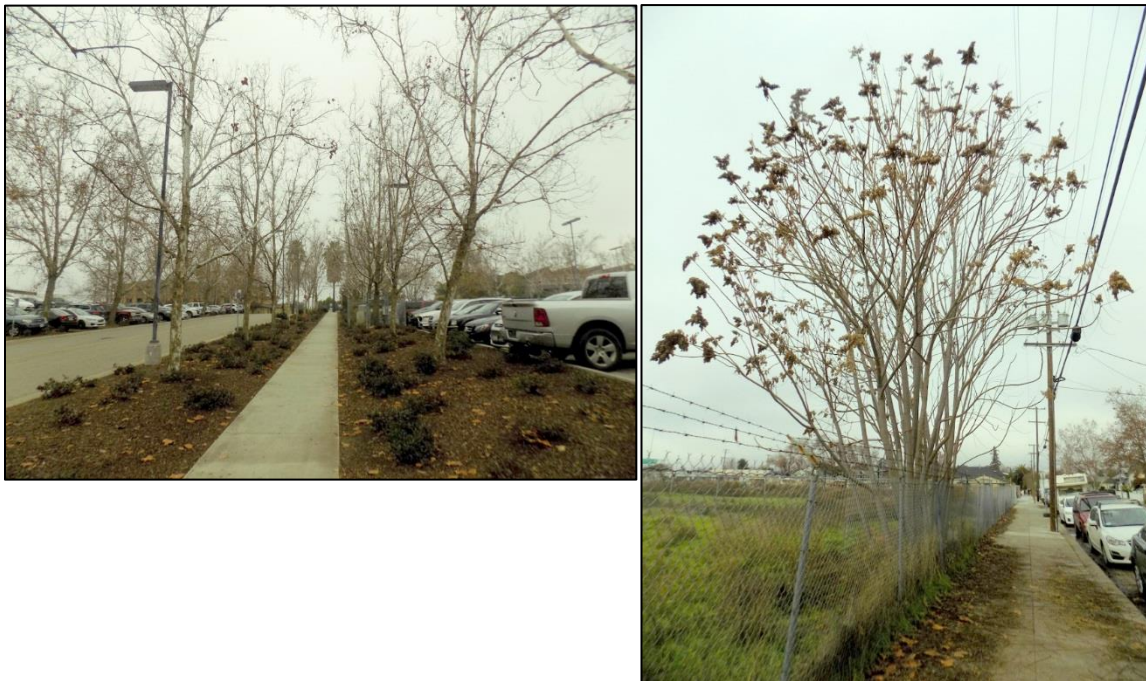
The second most common species assessed was London plane (54 trees, 34% of the population). The London planes primarily lined the street and main access to the parking lot. These trees were in fair condition (29 trees) with 22 trees in good condition and three trees in poor condition. The London planes ranged from young (2" diameter) to semi-mature (20" diameter) with an average diameter of 12". The street trees had been pruned heavily to provide clearance for utilities (Photo 2). The London planes in the entranceway had been planted closely together and were competing for growing space (Photo 3).

Nine trees-of-heaven volunteers were growing in the vacant lot and off-site (Photo 4). Tree #1 was a large multi-stemmed tree (Photo 4).

Photo 3 (lower left): The London planes lining the pathway to the station were densely planted and competing for space.

Photo 4 (lower right): Several multi-stemmed tree-of-heavens were growing on the vacant portion of the site.
