FEASIBILITY LEVEL GEOTECHNICAL ENGINEERING AND GEOLOGIC HAZARDS STUDY

Good Samaritan Hospital Entitlements
2425 Samaritan Drive
San Jose, California 95124

October 17, 2022

GEO-ENGINEERING SOLUTIONS, INC.
2570 San Ramon Valley Boulevard, Suite A102
San Ramon, California 94583
Project No. 133-1442

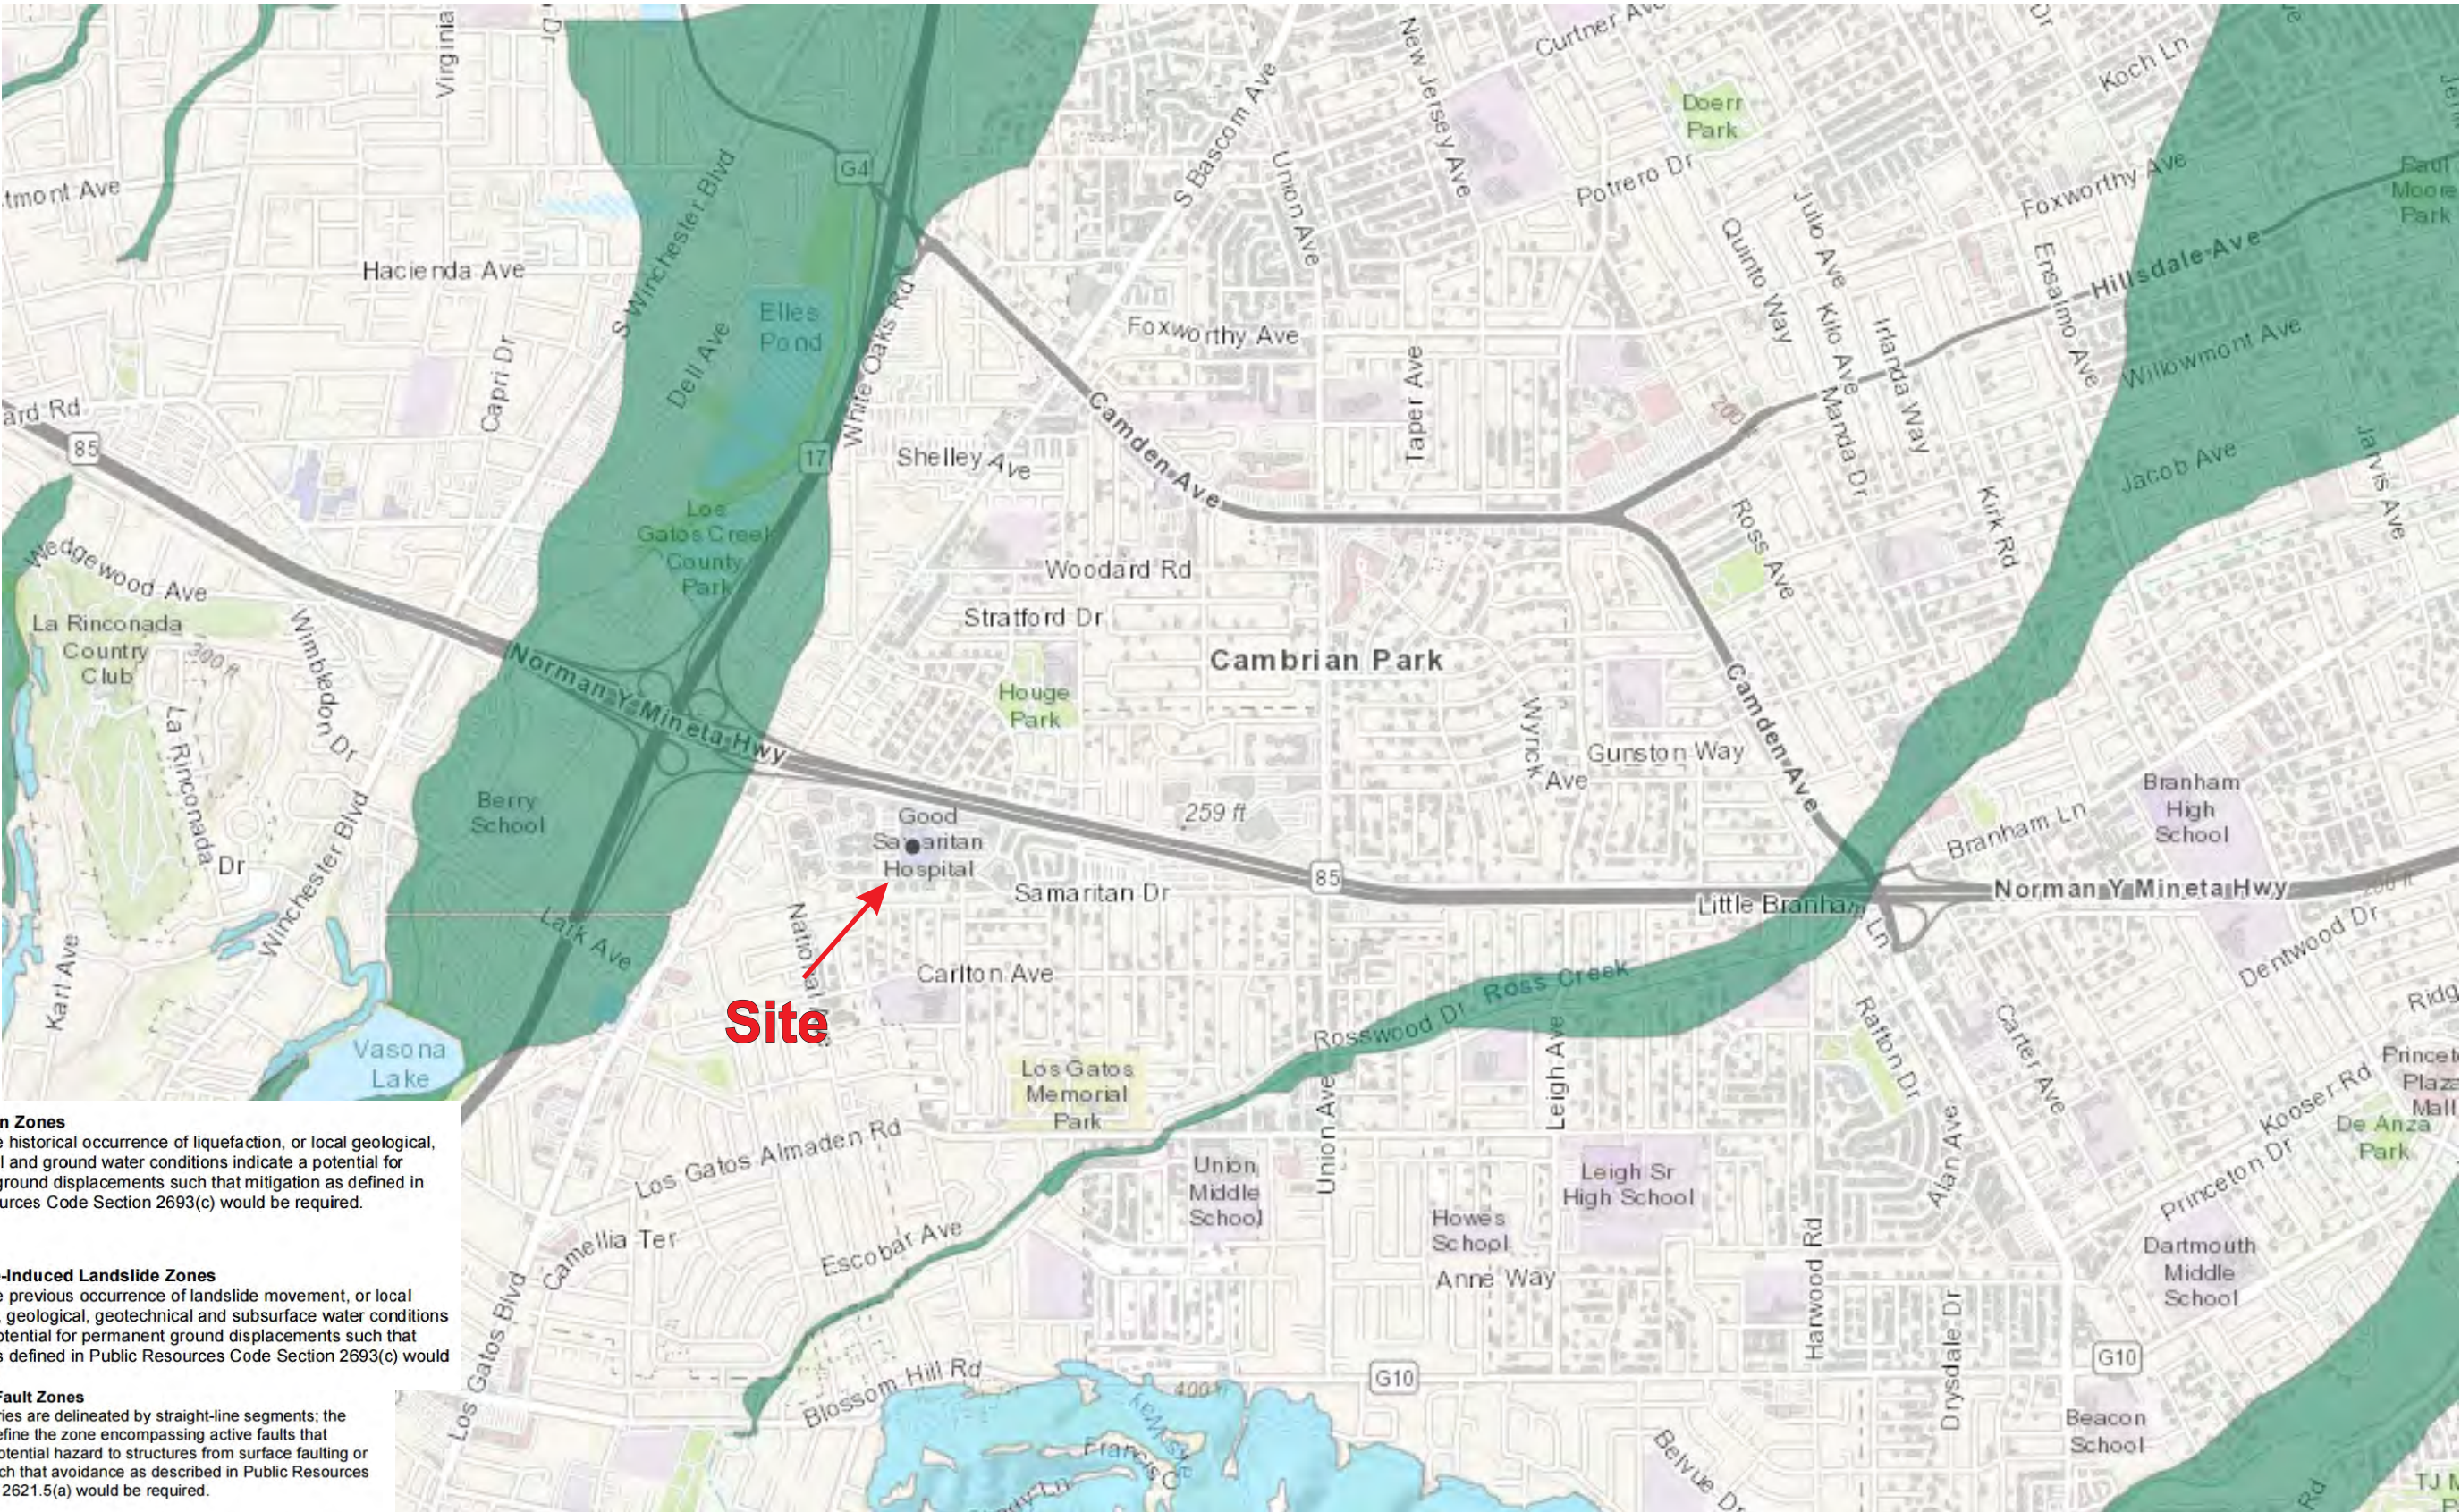
Figure 5

Active Fault Traces
Faults considered to have been active during Holocene time and to have potential for surface rupture: Solid Line in Black or Red where Accurately Located; Long Dash in Black or Solid Line in Purple where Approximately Located; Short Dash in Black or Solid Line in Orange where Inferred; Dotted Line in Black or Solid Line in Rose where Concealed; Query (?) indicates additional uncertainty. Evidence of historic offset indicated by year of earthquake-associated event or C for displacement caused by fault creep.
