**GEOLOGIC AND GEOTECHNICAL STUDY  
PROPOSED COMMERCIAL RE-DEVELOPMENT**

**DURDEN CONSTRUCTION, INC  
1096 LINCOLN AVENUE  
SAN JOSE, CALIFORNIA**

**17 February 2016**  
Document Id. 15164C-01R1

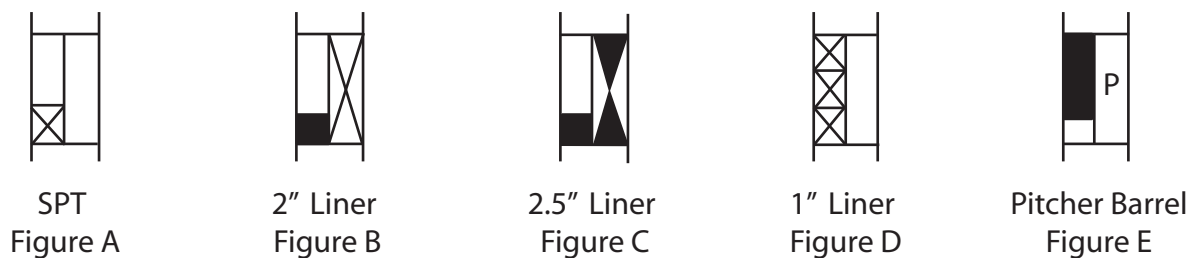
= Undisturbed Sample
  = Disturbed Sample

Where obtained, the shear strength of the soil samples is shown on the boring logs in far right-hand column.
