Date: August 28, 2015
Project No.: 535-1-3
Prepared For: Mr. Ed Abelite
CANYON CREEK PLAZA, LP
5601 Silver Creek Valley Road
San Jose, California 95136
Re: Geotechnical and Geologic Hazards Report Update
Canyon Creek Plaza
5601 – 5667 Silver Creek Valley Road
San Jose, California

Re: Geologic Hazards Evaluation
Canyon Creek Plaza
5601 to 5667 Silver Creek Valley Road
San Jose, California

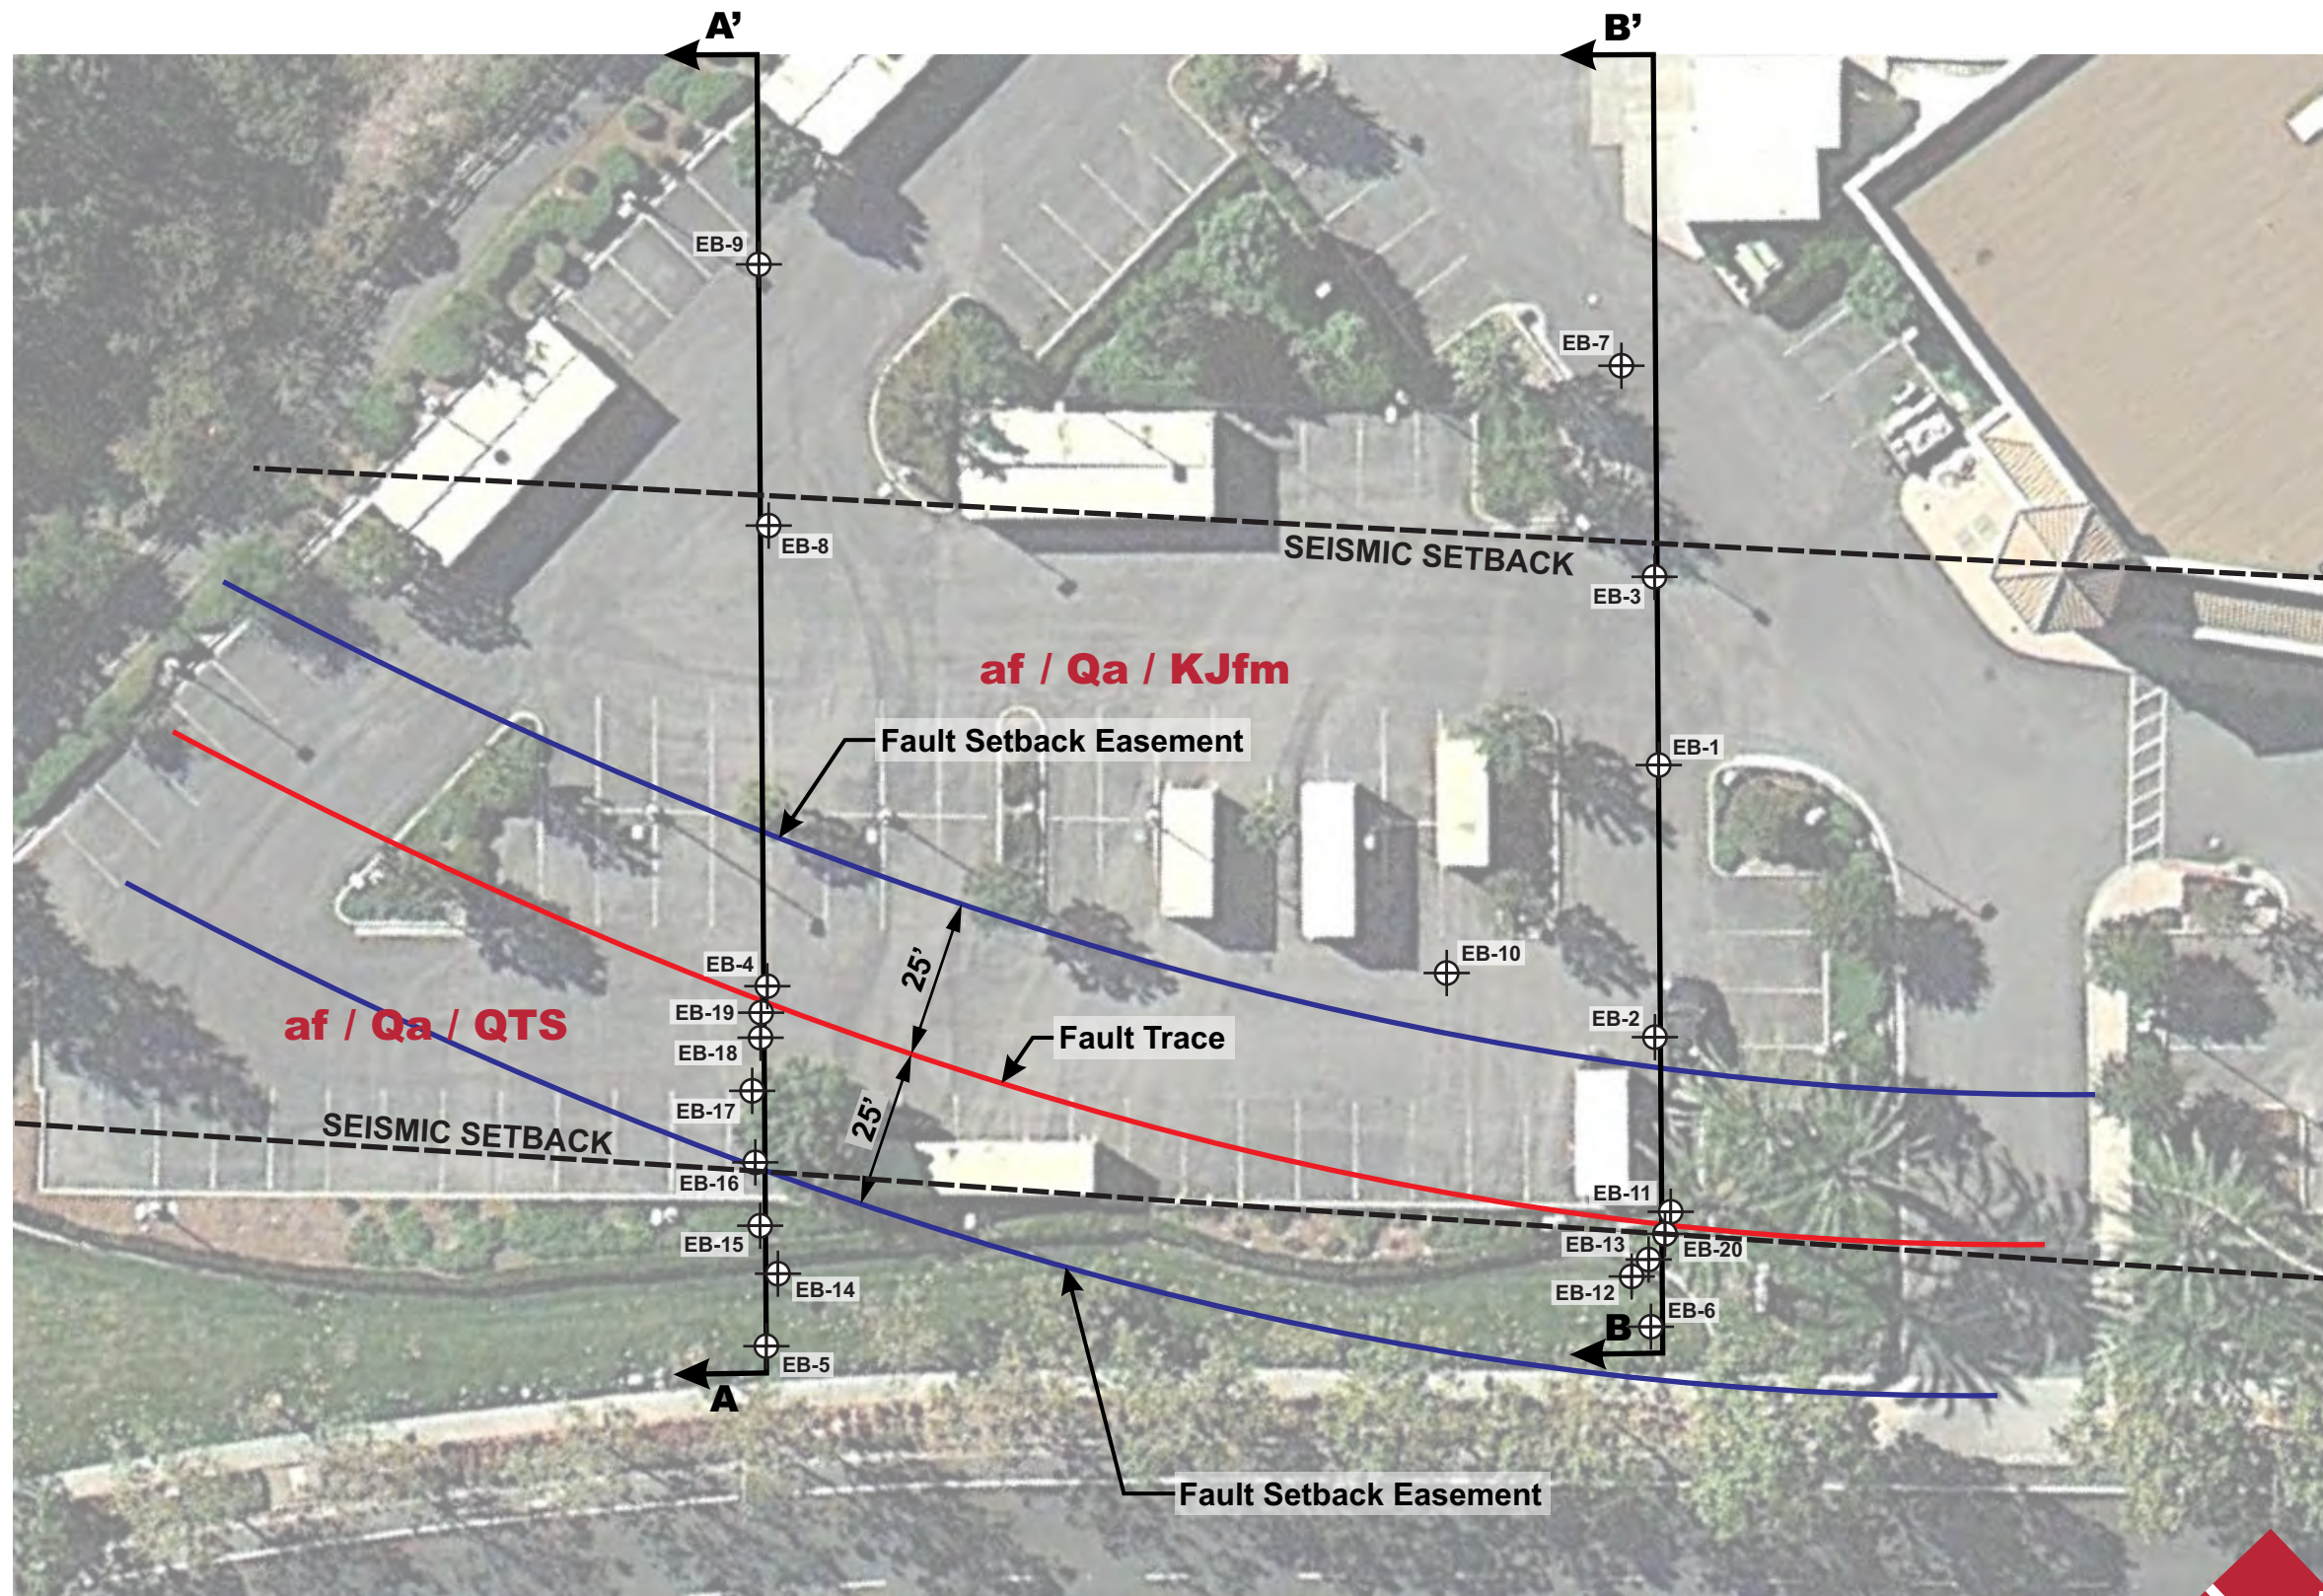
Site Plan
Canyon Creek Plaza
5601 Silver Creek Valley Road
San Jose, CA

Approximate location of exploratory boring
	Approximate surface trace of Silver Creek Fault
	Approximate fault setback - 25 feet from surface trace
	Approximate seismic setback lines (Terrasearch, 1988)
	Approximate location of geologic cross section

Base by Google Earth, dated 10/31/2011

Attachments: Figure 1 – Site Plan
Figure 2 – Geologic Cross-Section A-A'
Figure 3 – Geologic Cross-Section B-B'
Borings EB-1 through EB-20

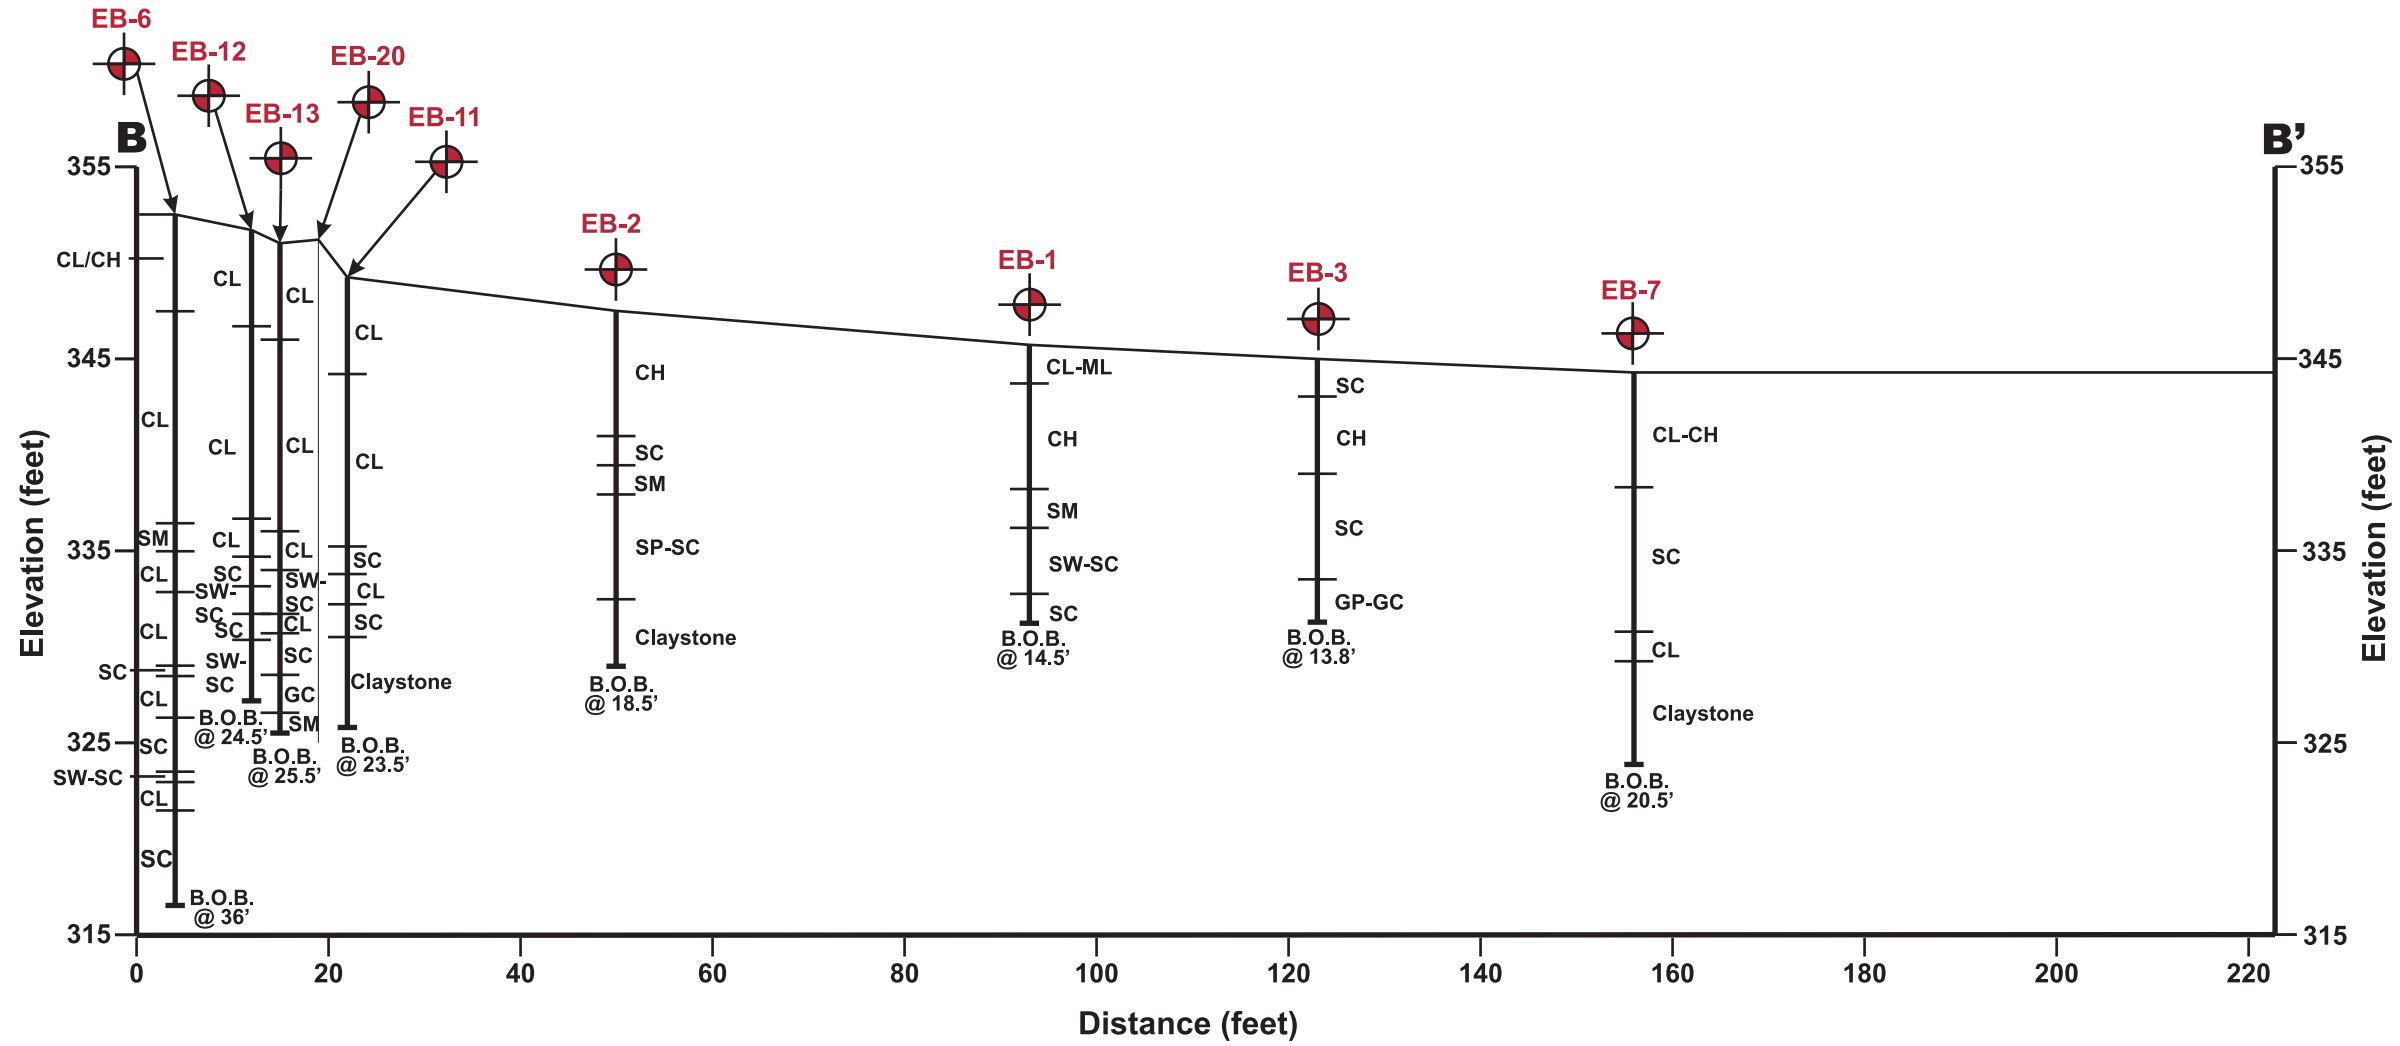
Project Number 535-1-2	Figure Number Figure 5	Date July 2014	Drawn By RRN
<p>Geologic Cross Section B-B'</p> <p>Canyon Creek Plaza 5601 Silver Creek Valley Road San Jose, CA</p>

- CL Lean Clay or sandy clay
- CH Fat Clay
- CL-CH Lean Clay with Fat Clay
- CL-ML Lean Clay or Sandy Clay with Silt
- SC Clayey Sand
- SM Silty Sand
- SW-SC Well-Graded Sand with Clayey Sand
- SP-SC Poorly Graded Sand with Clayey Sand
- GC Clayey Gravel with Sand
- GP-GC Poorly Graded Gravel with Clay and Sand
- Claystone Franciscan Complex
-

Logs of Borings EB-1 through EB-20 are included in Appendix A, and our interpretation of subsurface geologic conditions is depicted on our Geologic Cross Sections A-A’ and B-B’ (Figures 4 and 5).

DPW Comment #13: “The location of the SCF is not evident in Geologic Cross Sections A-A' or B-B', Figures 4 and 5. Supplemental cross sections showing the CEG SCF, the TI (1988)/KI(1989) SCF location, groundwater levels, soil stratigraphic lines, overlying alluvium/colluvium deposits, the buried bedrock surface, offsets in the bedrock surface and juxtaposition of differing bedrock formations should be presented.”

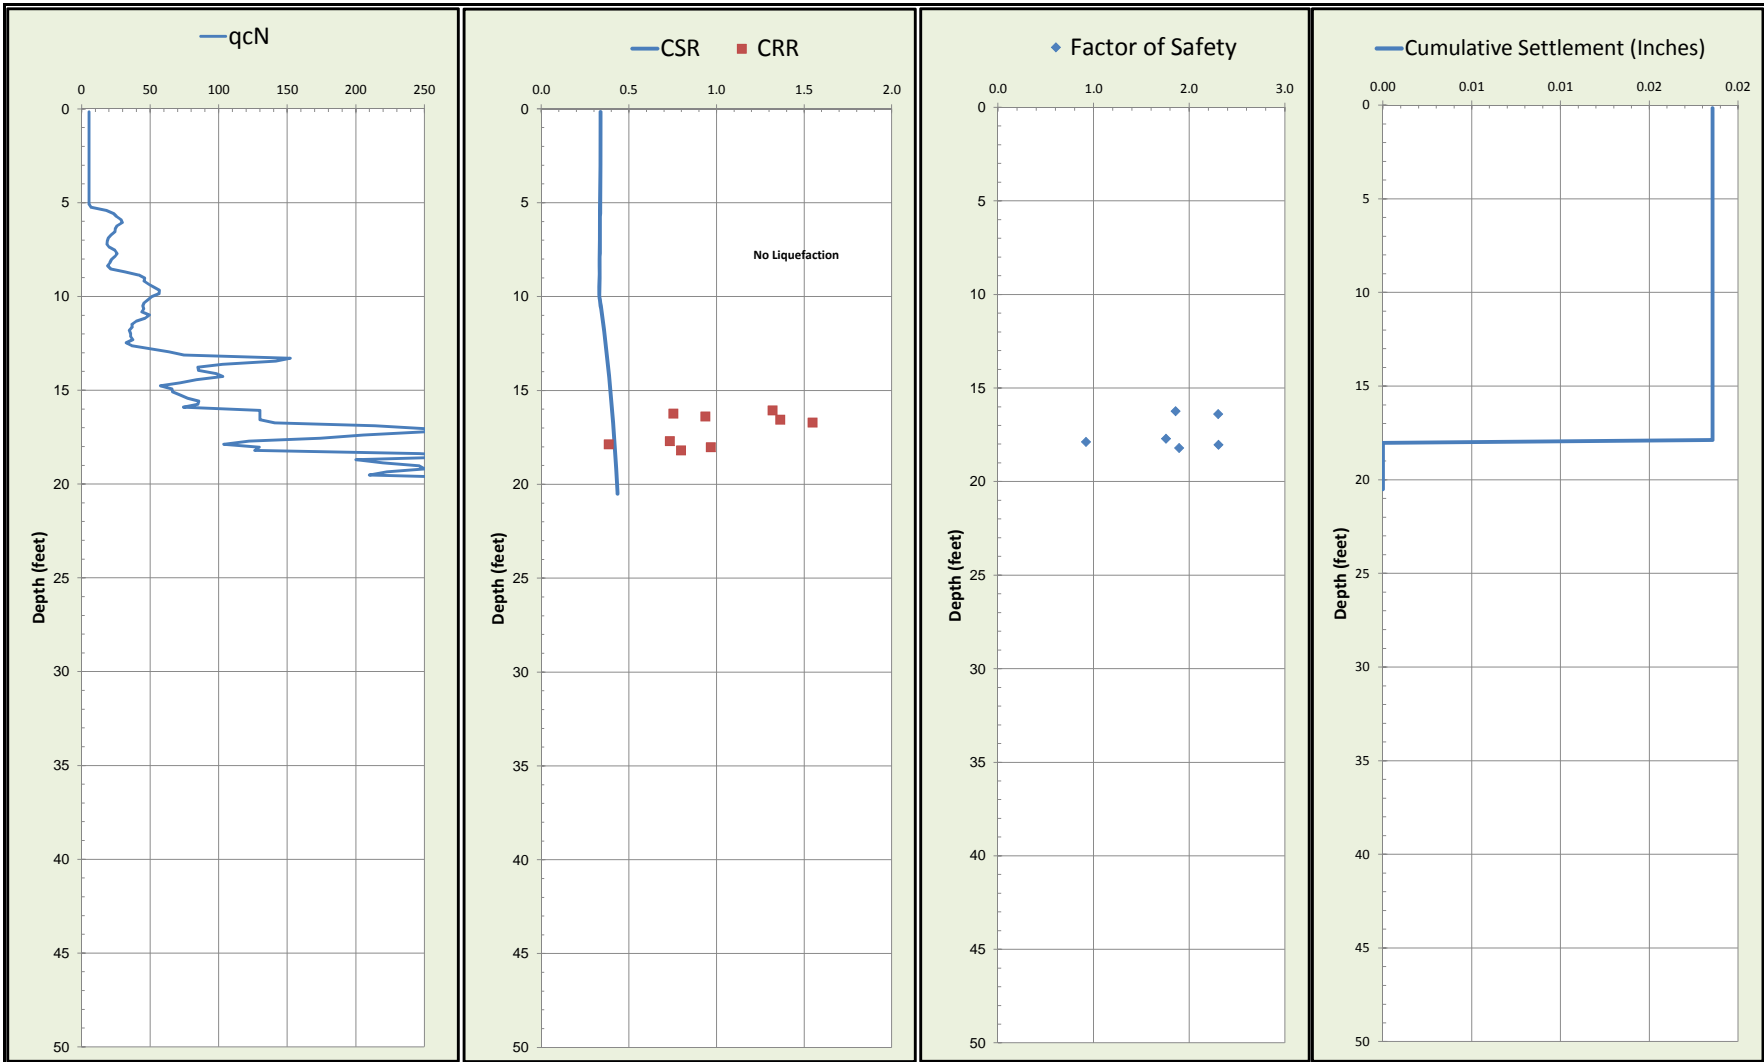
Project Number	535-1-2	
Figure Number	Figure 6A	
7/10/2014	CPT No. 1

Liquefaction Analysis Summary

The soils encountered in our borings were generally very stiff fine-grained soils and dense to very dense sands. We performed a liquefaction “triggering” analysis for the CPT data for each of the sand layers following the procedures described in Idriss and Boulanger (2008) and CGS Special Publication 117A guidelines (CGS, 2008) for quantitative analysis. All layers had factors of safety greater than or equal to 1.3, which is generally considered to be non-liquefiable. Figures 6A and 6B present the results graphically. In our opinion, the potential for liquefaction to impact site developments should be considered low.

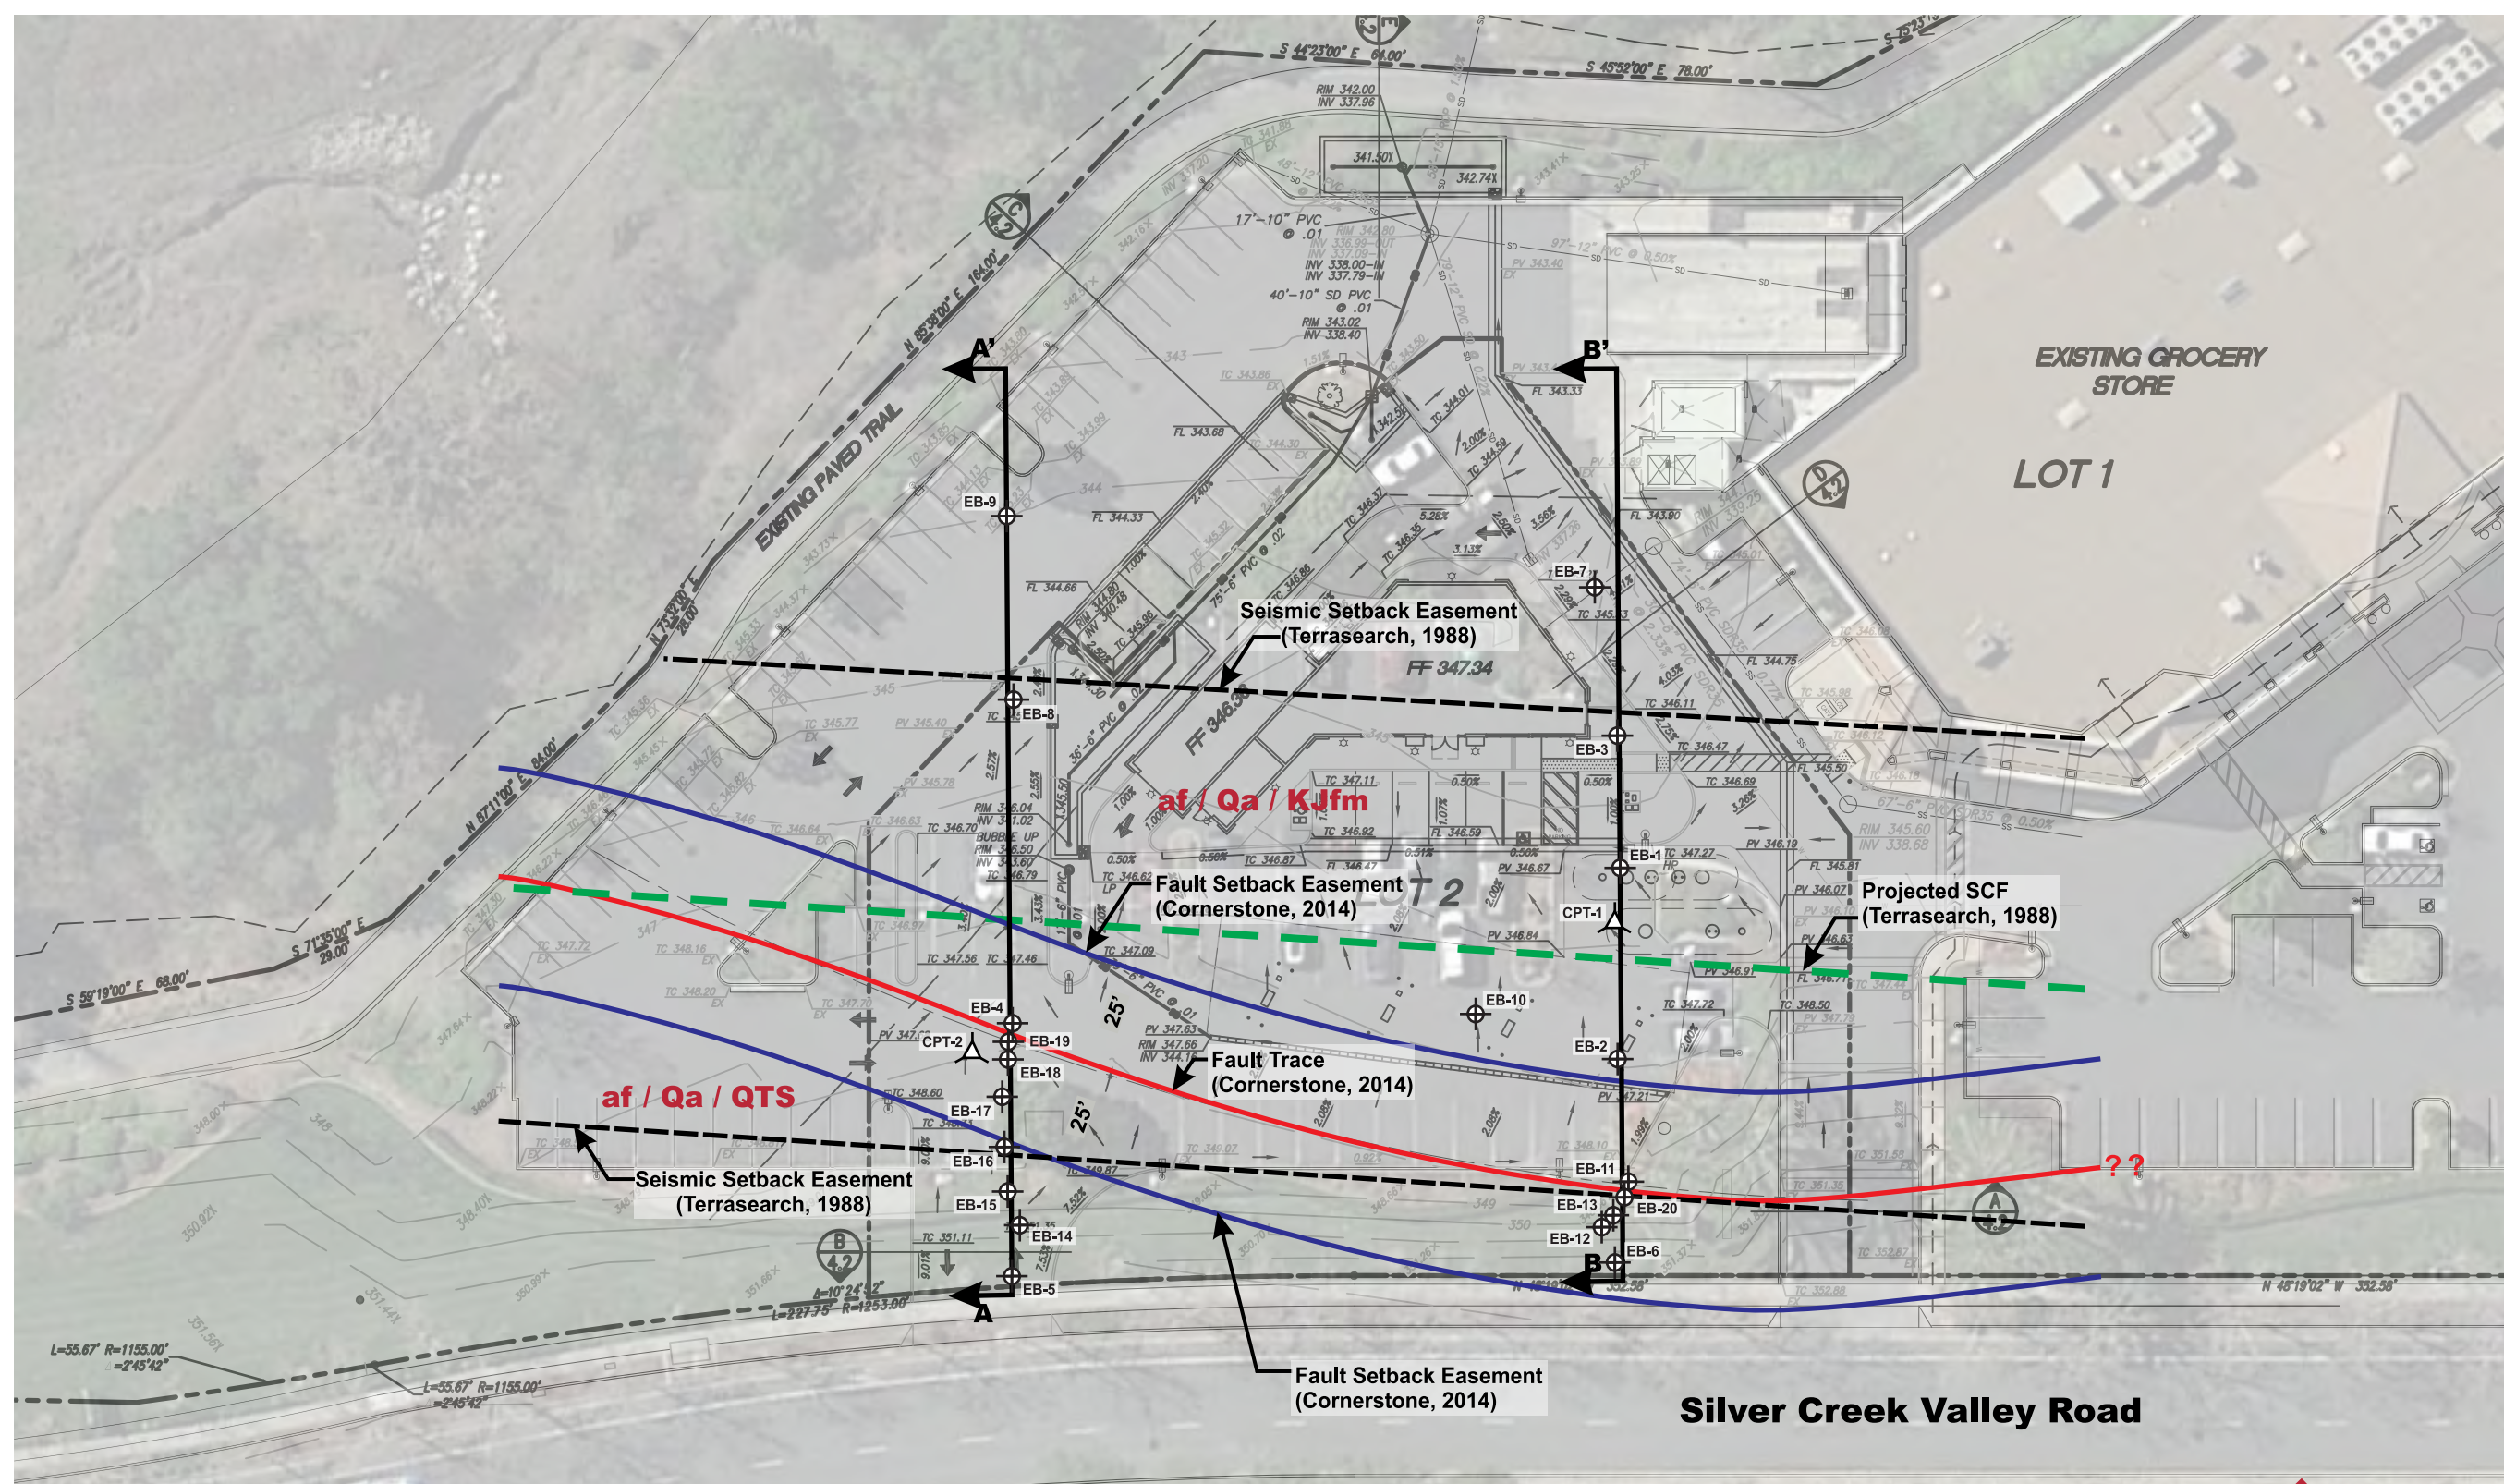
Site Plan
Canyon Creek Plaza
5601 Silver Creek Valley Road
San Jose, CA

Approximate location of exploratory boring
	Approximate location of cone penetration test
	Approximate surface trace of Silver Creek Fault (This study)
	Approximate building exclusion zone (This study)
	Approximate seismic easement (Terrasearch, 1988)
	Approximate location of geologic cross section

Base by Google Earth, dated 2/23/2014
 Overlay by Charles W. Davidson Co., "Conceptual Grading and Drainage Plan - Sh. 4.1," dated 6/2/2014

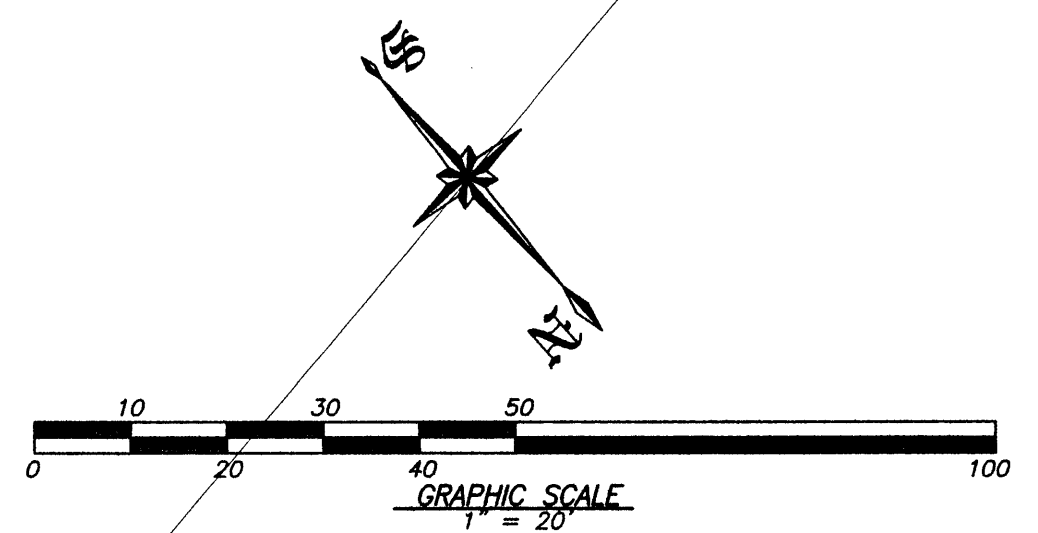
CANYON CREEK PLAZA

EXISTING	PROPOSED	DESCRIPTION
	---	PROPERTY LINE
	---	CENTERLINE
	---	WATERSHED AREA
---	---	CONTOUR
---	---	CONCRETE CURB & GUTTER
---	---	DEPRESSED CURB
---	---	RETAINING WALL
---	---	VERTICAL CURB
---	---	V-64 CHRISTY DRAIN
---	---	STANDARD HOODED INLET
---	---	POSITIVE RELEASE
---	---	FLOW ARROW
FF 161.00		FINISHED FLOOR ELEVATION
PAD 180.00		PAD ELEVATION
TC 180.00		TOP OF CURB ELEVATION
FL 180.00		FLOW LINE ELEVATION
X160.00		GRADE
S=0.00%		SLOPE
GB		GRADE BREAK
TW		TOP OF WALL
A		SECTION NAME

SILVER CREEK VALLEY ROAD
