**GEOTECHNICAL INVESTIGATION AND
GEOLOGIC HAZARD EVALUATION
Dove Hill Assisted Living Community
4200 Dove Hill Road
San Jose, California**

Prepared For:
**Salvatore Caruso Design Corporation
980 El Camino Real, Suite 200
Santa Clara, California 95050**

Prepared By:
**Langan Treadwell Rollo
4030 Moorpark Avenue, Suite 210
San Jose, California 95117**

**26 May 2015
770619901**

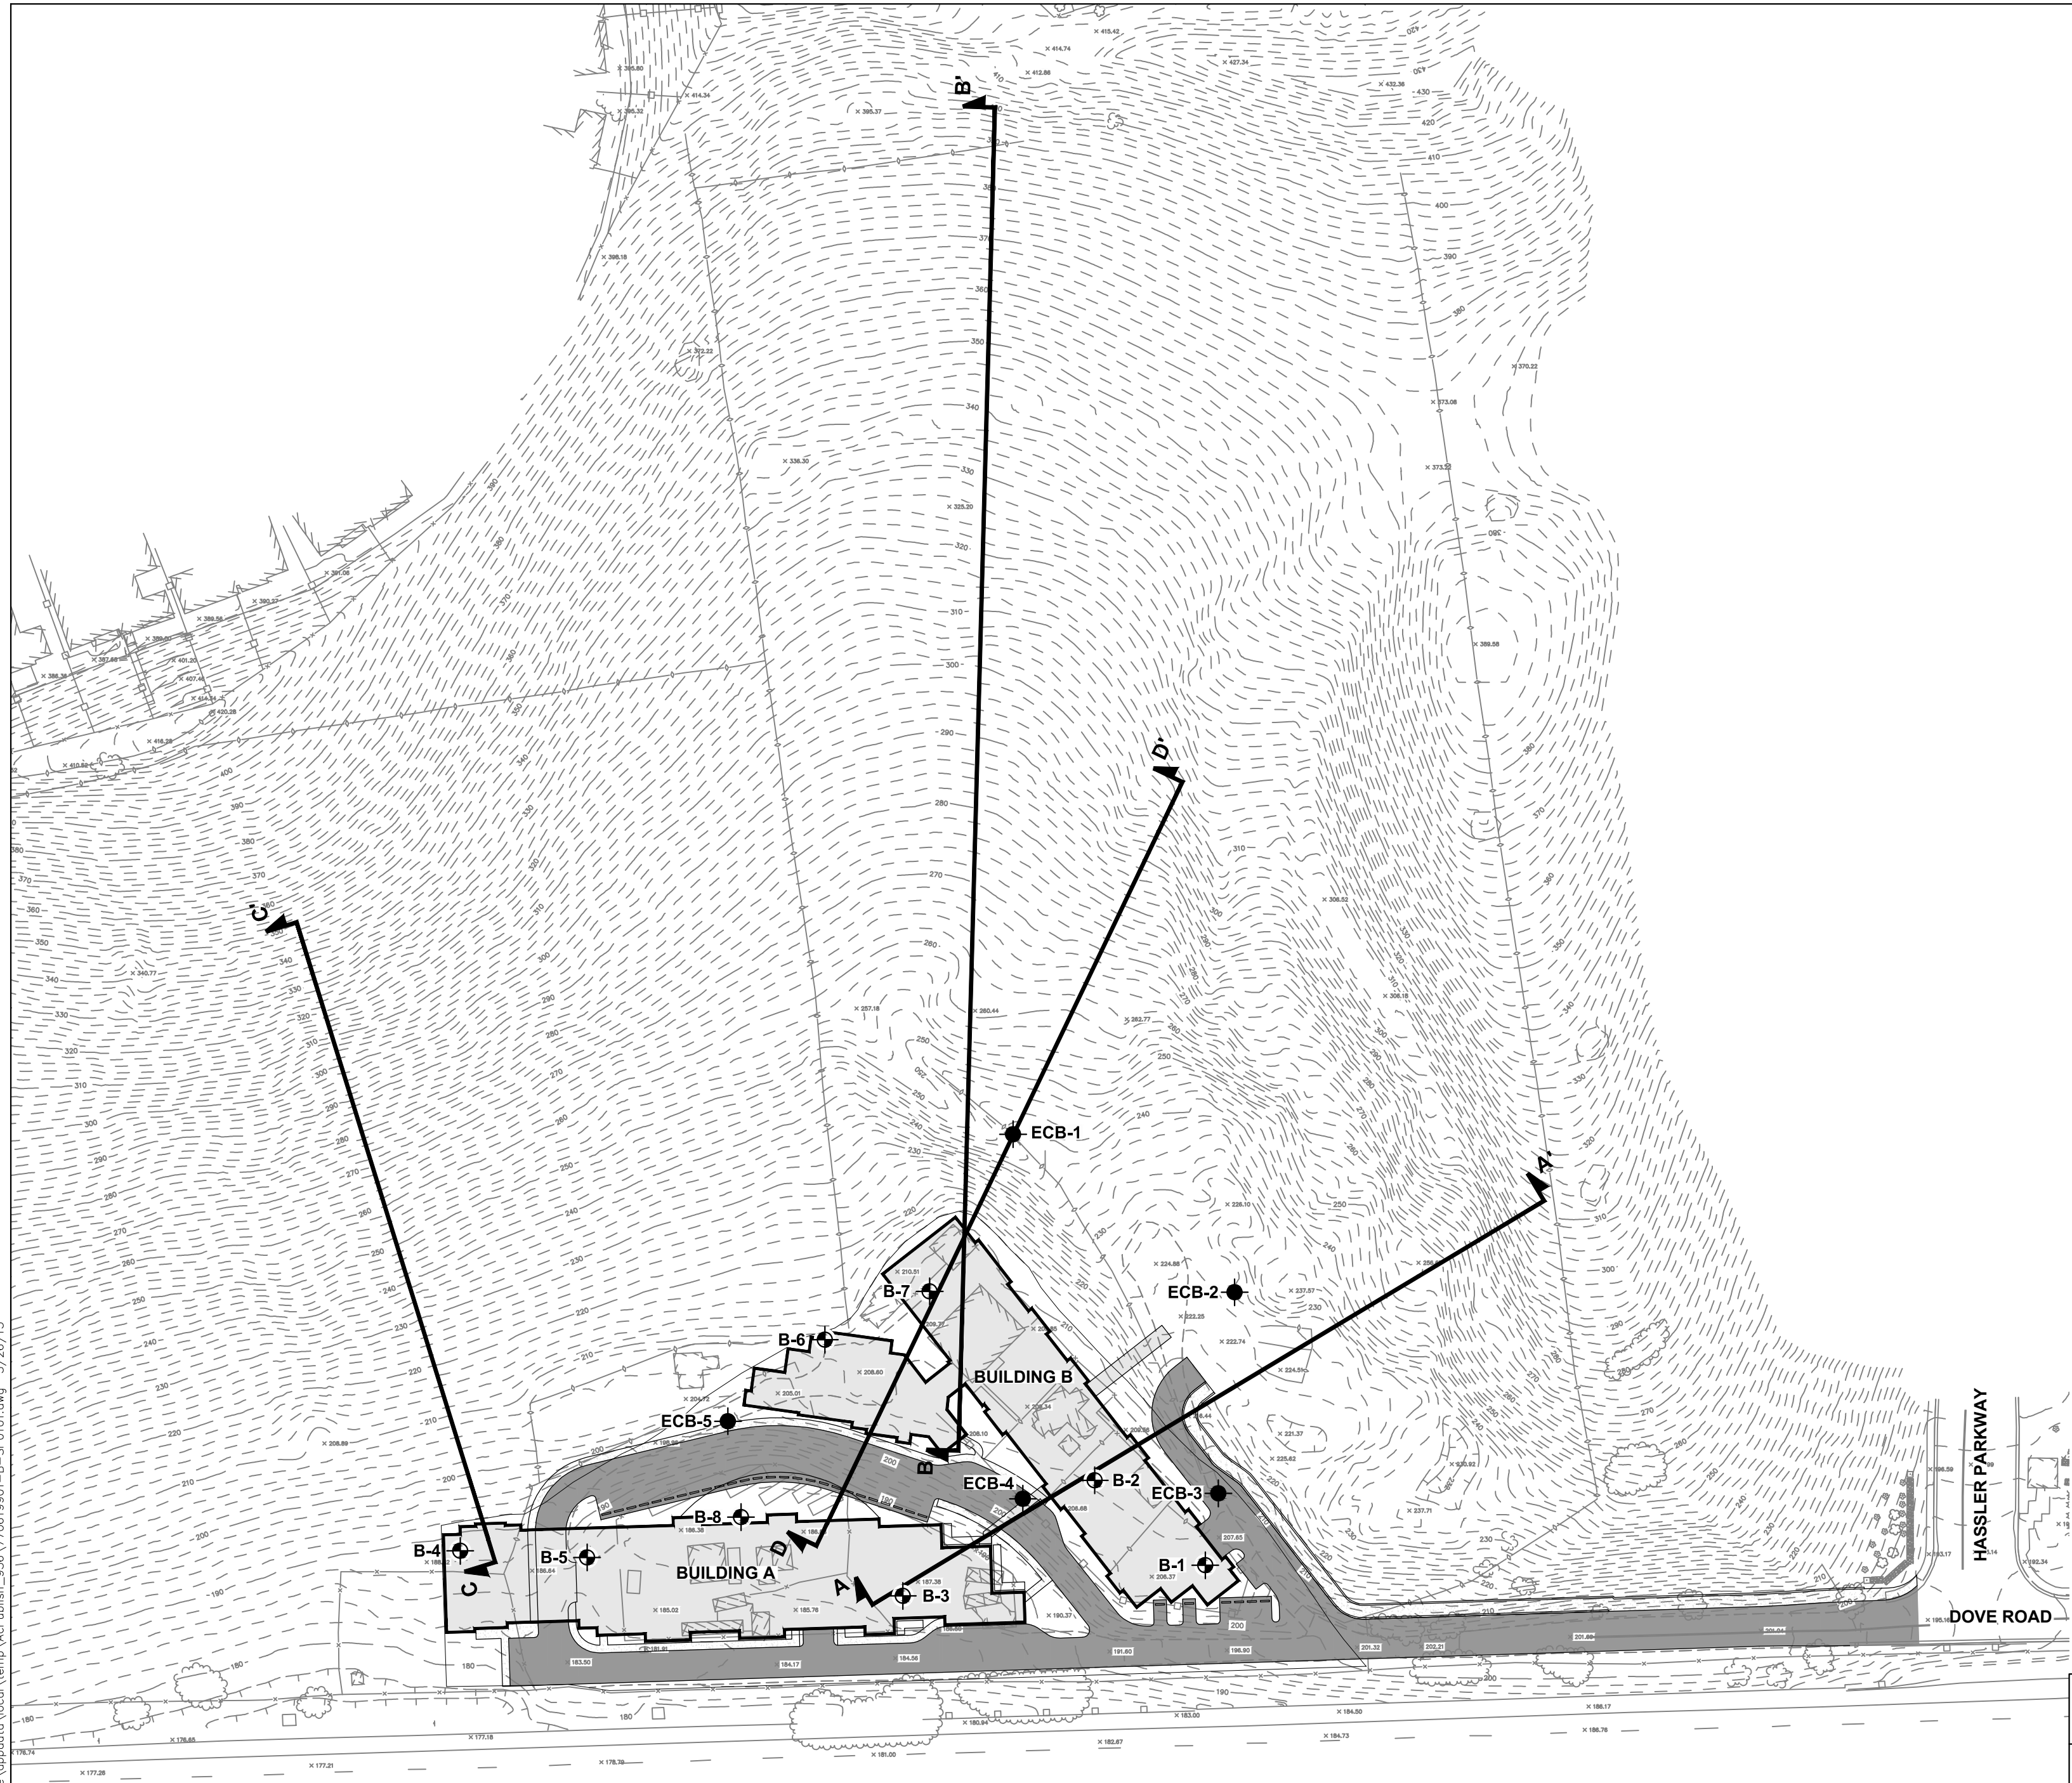
- EXPLANATION**
- B-1 Approximate location of boring by Langan Treadwell Rollo, May 2014
 - ECB-1 Approximate location of boring by E₂C, Inc., August 2008
 - A-A' Idealized subsurface profile location

DOVE HILL ASSISTED LIVING COMMUNITY		
4200 DOVE HILL ROAD		
San Jose, California		
SITE PLAN WITH PROPOSED DEVELOPMENT		
Date 05/26/15	Project No. 770619901	Figure 3
LANGAN TREADWELL ROLLO

For this study, we performed evaluations of the stability of the slopes closest to the proposed buildings. Figures 6 through 9 present idealized subsurface profiles (Section A-A', B-B', C-C' and D-D') of the slopes that we analyzed. The locations of the sections are shown on Figures 2 and 3. The slope stability analyses were performed using the computer program Slope/W (2010), which is a fully integrated slope stability analysis program. Slope/W uses the Morgenstern-Price method to search for the most critical surface and to calculate factor of safety⁸.

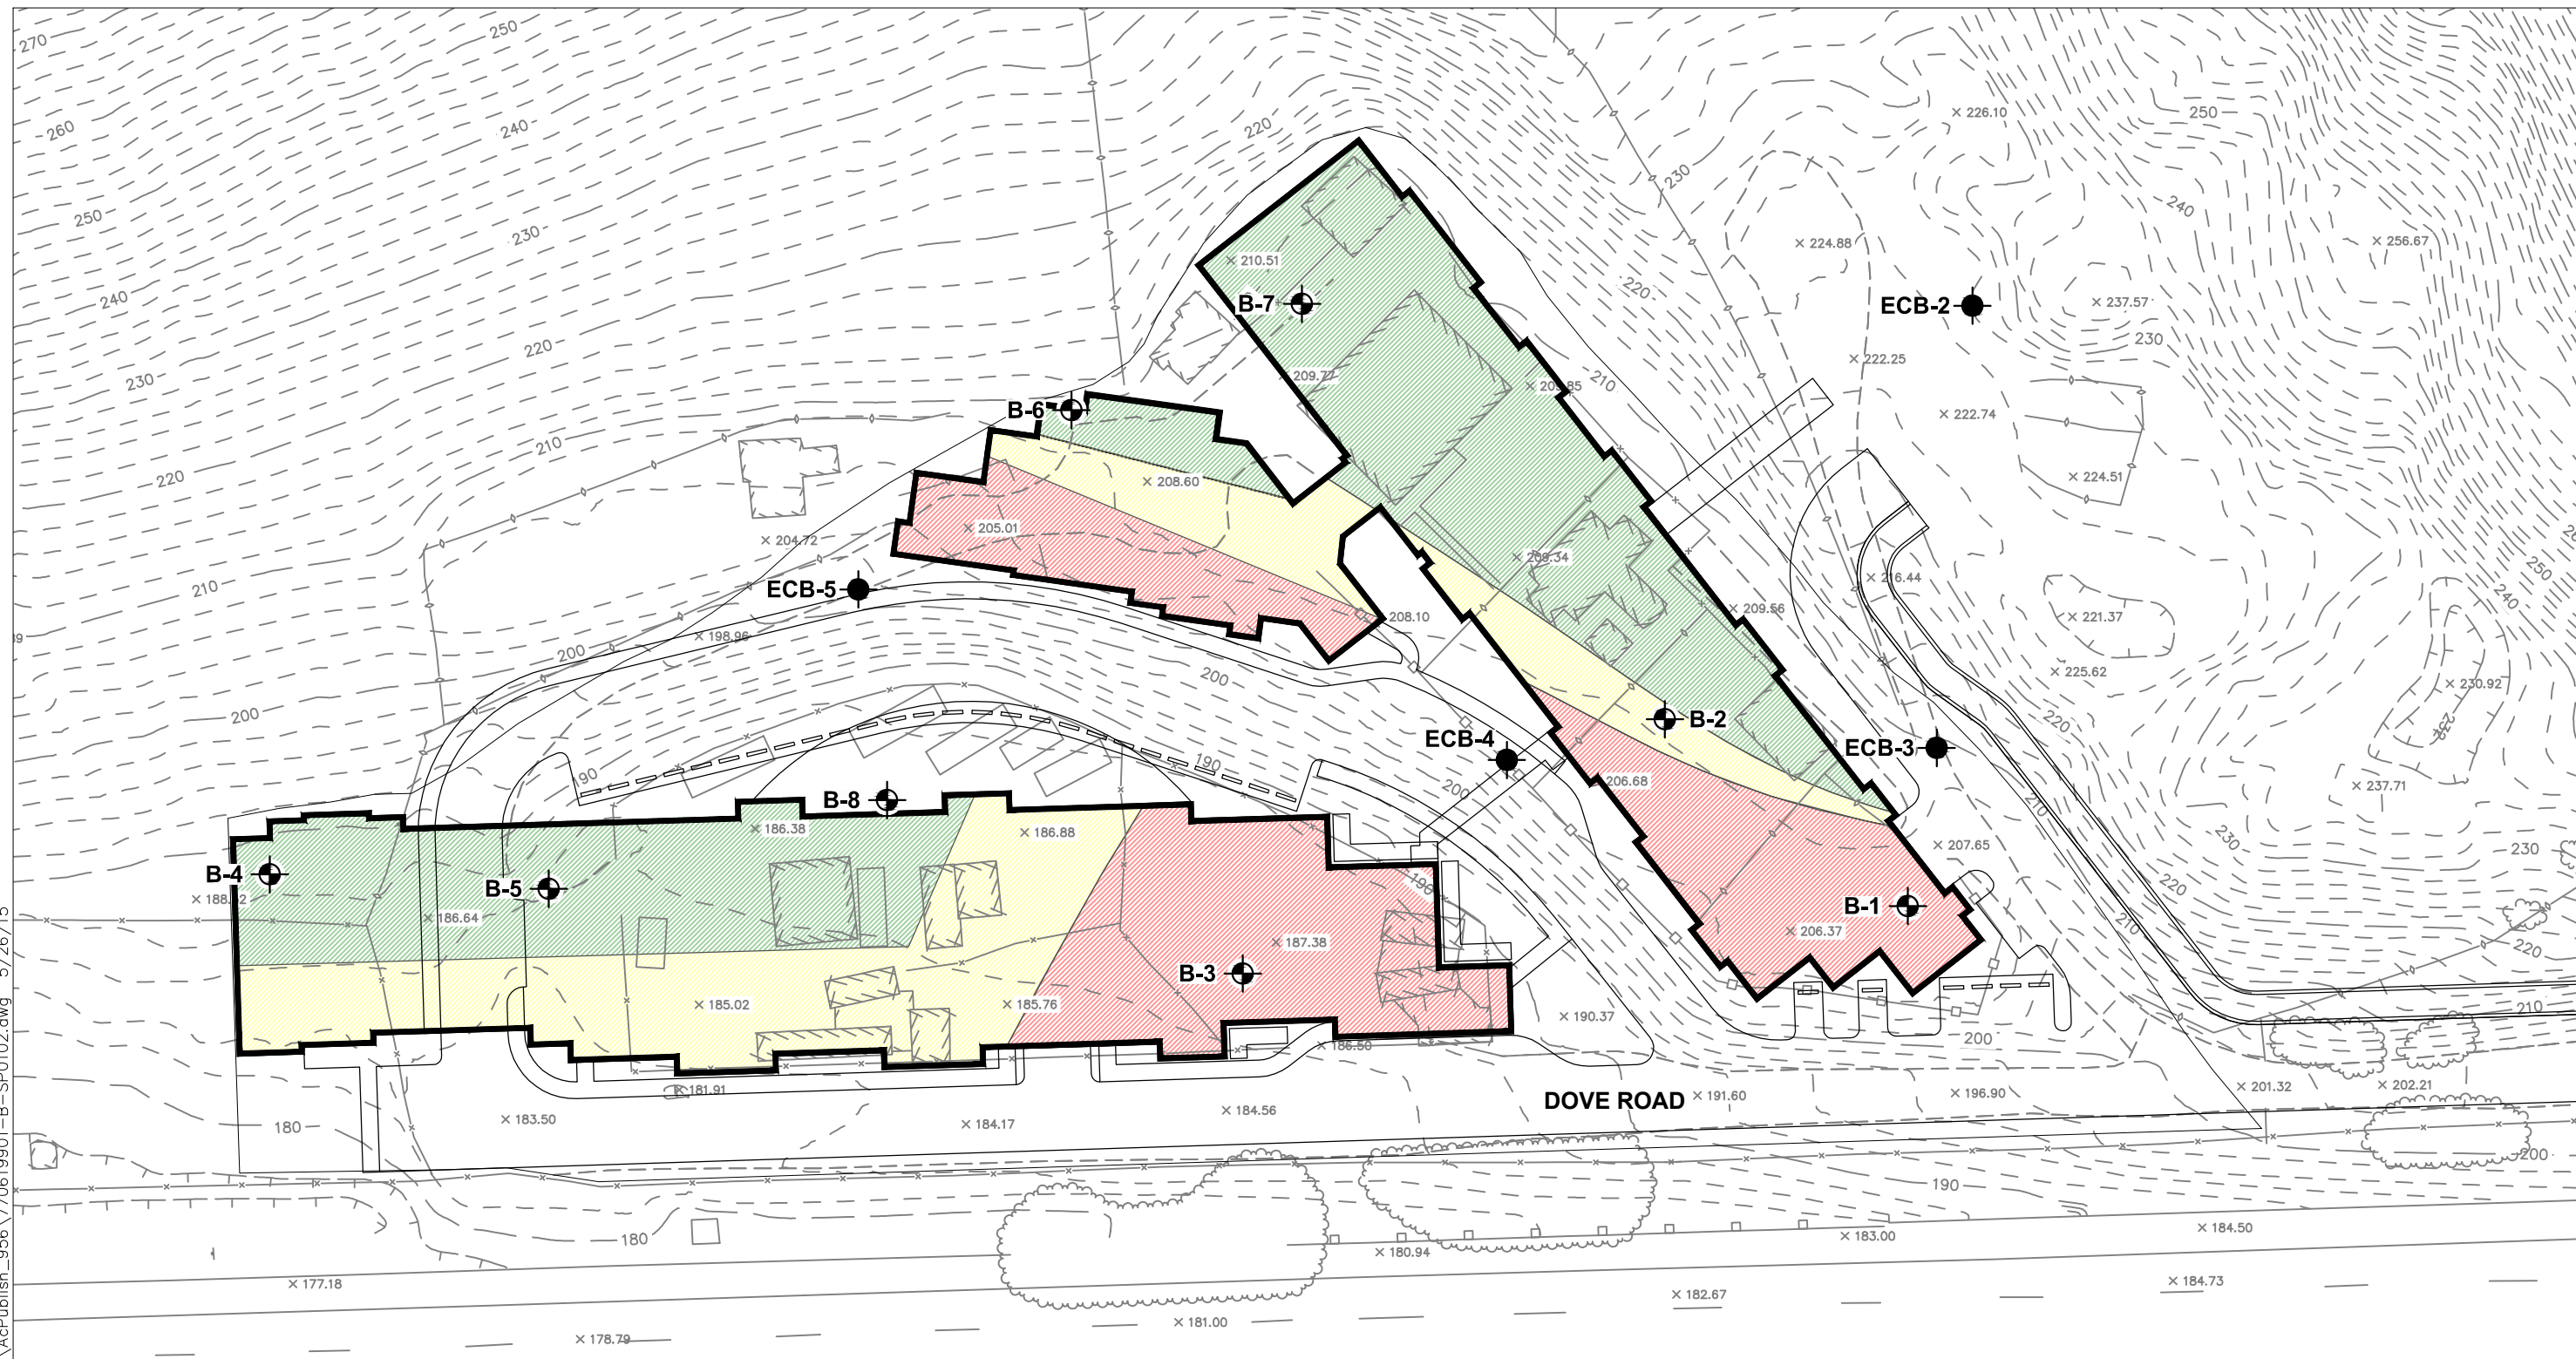
- Approximate location of foundation consisting of footings bearing on rock
- Approximate location of foundation transition zone where drilled piers may be required
- Approximate location of foundation requiring drilled piers

DOVE HILL ASSISTED LIVING COMMUNITY 4200 DOVE HILL ROAD San Jose, California		
APPROXIMATE FOUNDATION ZONE		
Date 05/26/15	Project No. 770619901	Figure 13
LANGAN TREADWELL ROLLO

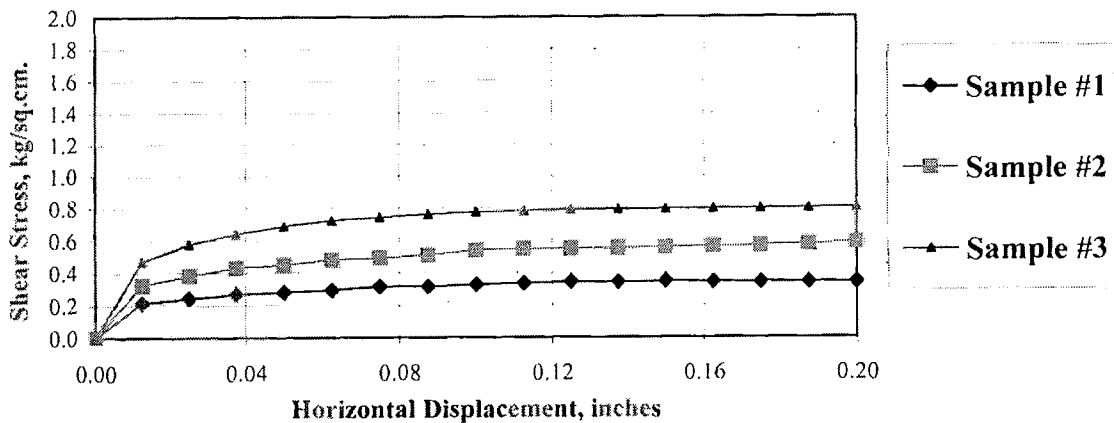
Sample No.	1	2	3	Average
Initial				
Dry Density, pcf	85.7	90.4	92.4	89.5
Moisture Content at Test, %	44.2	39.0	37.5	40.2
Saturation, %	100	100	100	100.0
At Test				
Moisture Content, %	44.2	39.0	37.5	40.2
Saturation, %	125	123	125	124
Normal Stress, kg/cm ²	0.49	0.99	1.48	
Peak Stress, kg/cm ²	0.34	0.59	0.80	
Ultimate Stress, kg/cm ²	0.34	0.59	0.80

SHEAR vs. NORMAL STRESS DIAGRAM

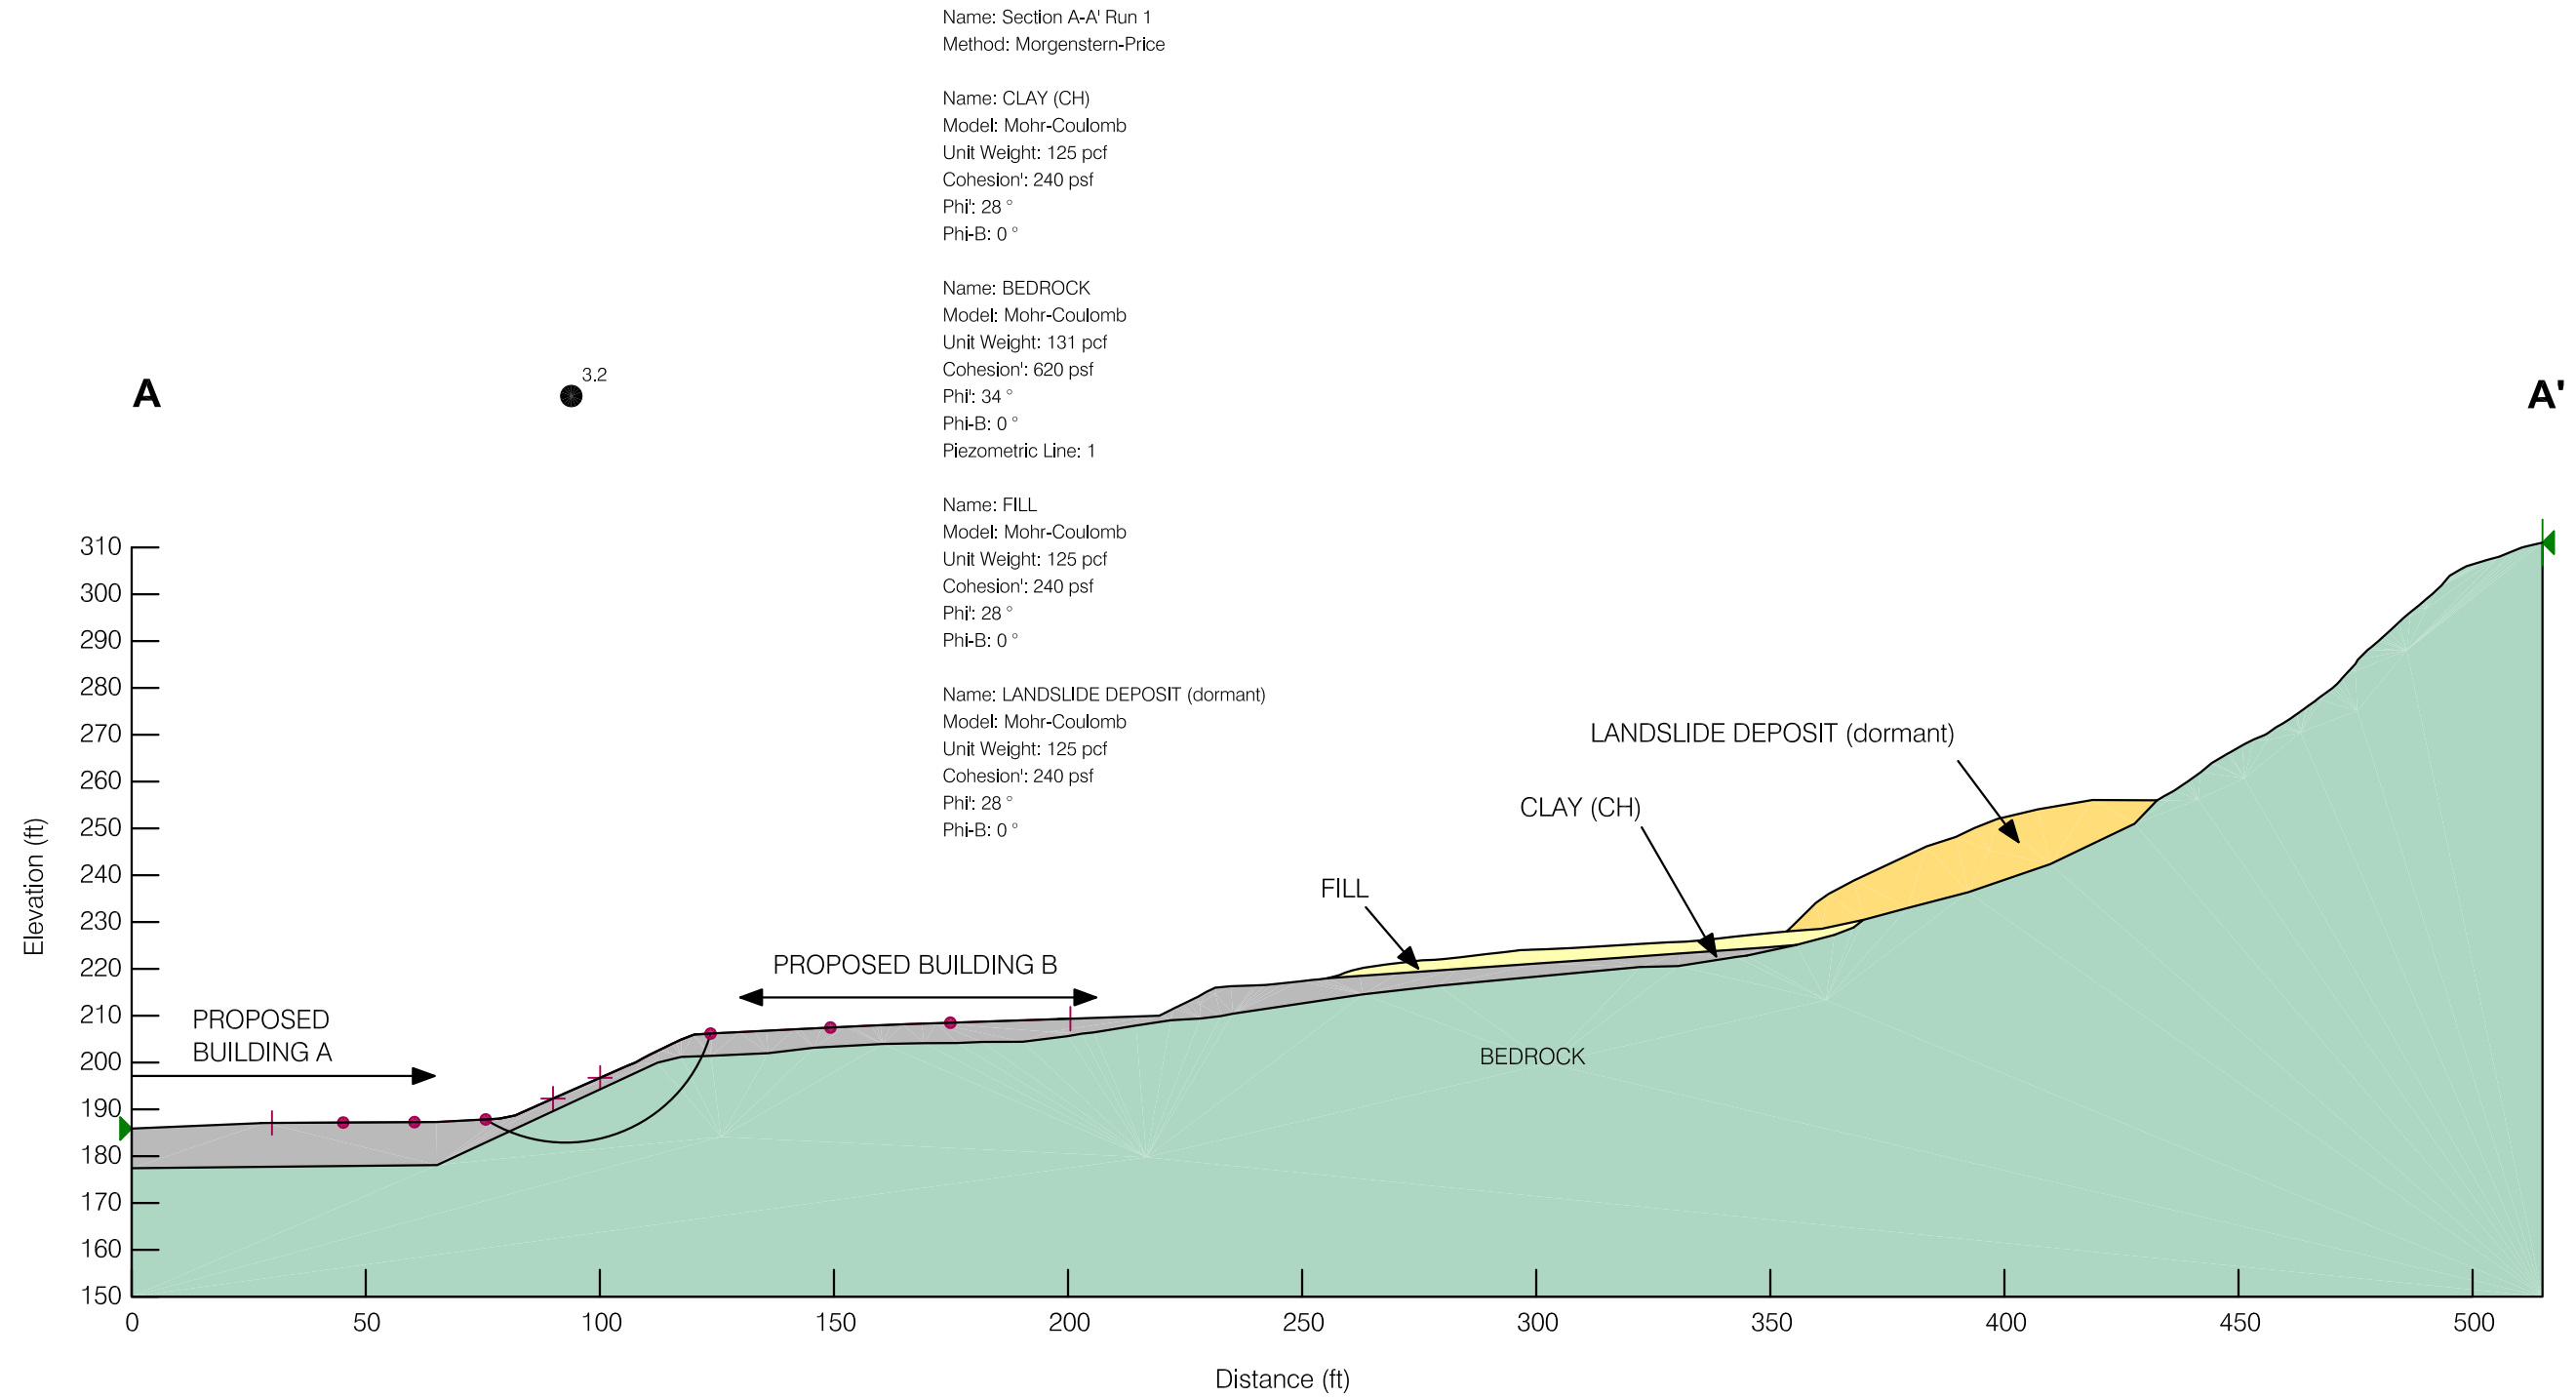
DOVE HILL ASSISTED LIVING COMMUNITY 4200 DOVE HILL ROAD San Jose, California		
SLOPE STABILITY ANALYSIS A-A' EXISTING CONDITIONS - LOWER SLOPE		
Date 05/07/15	Project No. 770619901	Figure F-1
LANGAN TREADWELL ROLLO

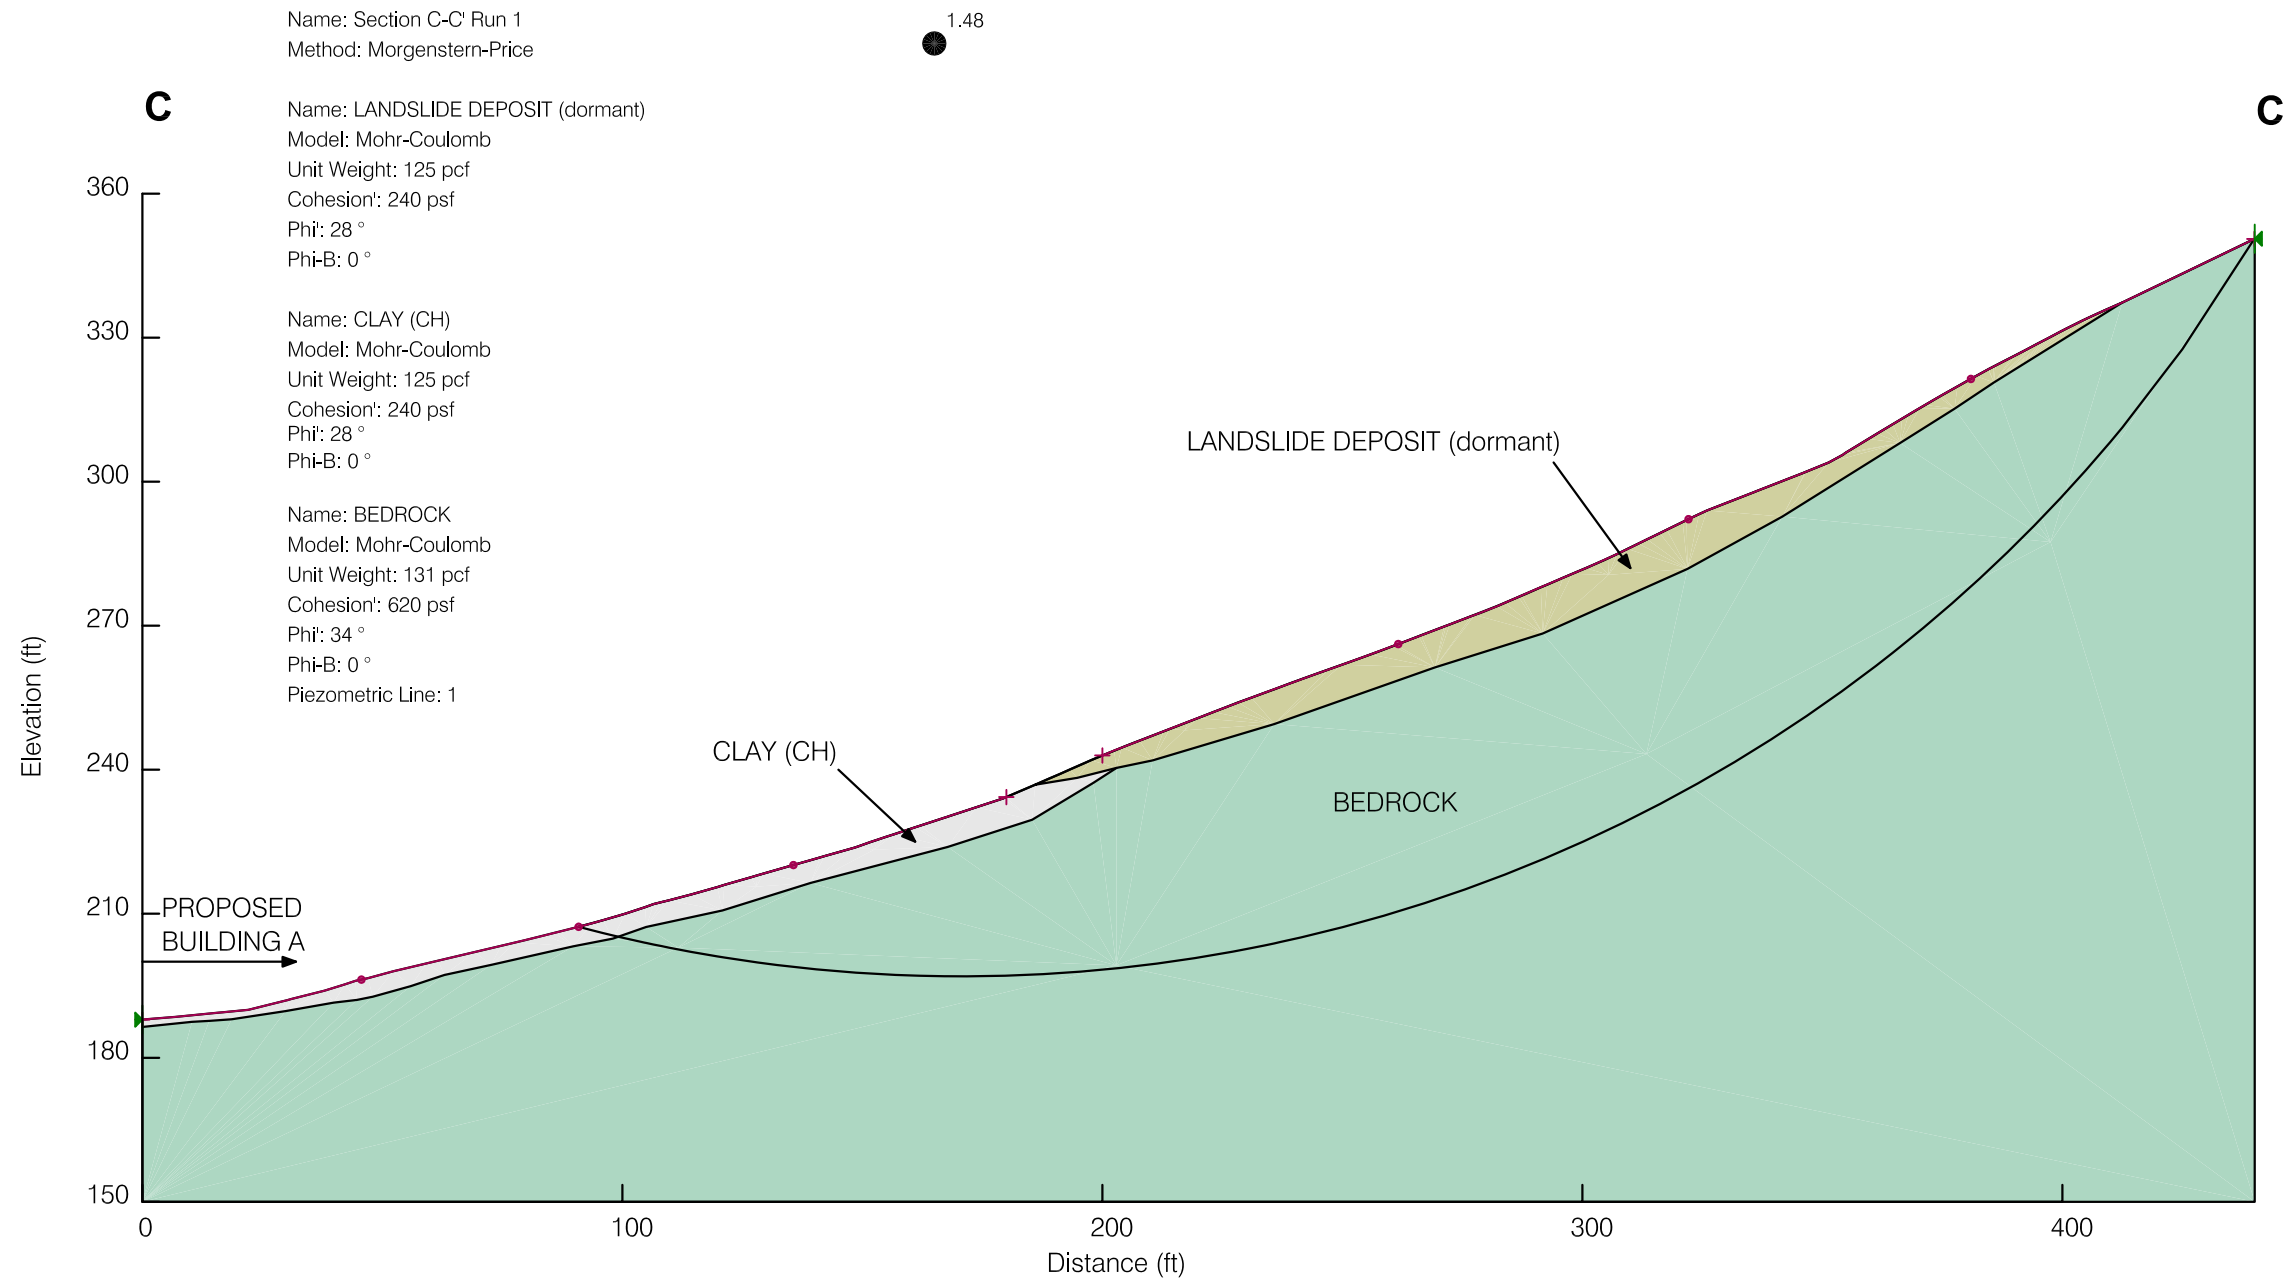
DOVE HILL ASSISTED LIVING COMMUNITY 4200 DOVE HILL ROAD San Jose, California		
SLOPE STABILITY ANALYSIS C-C' EXISTING CONDITIONS		
Date 05/07/15	Project No. 770619901	Figure F-5
LANGAN TREADWELL ROLLO

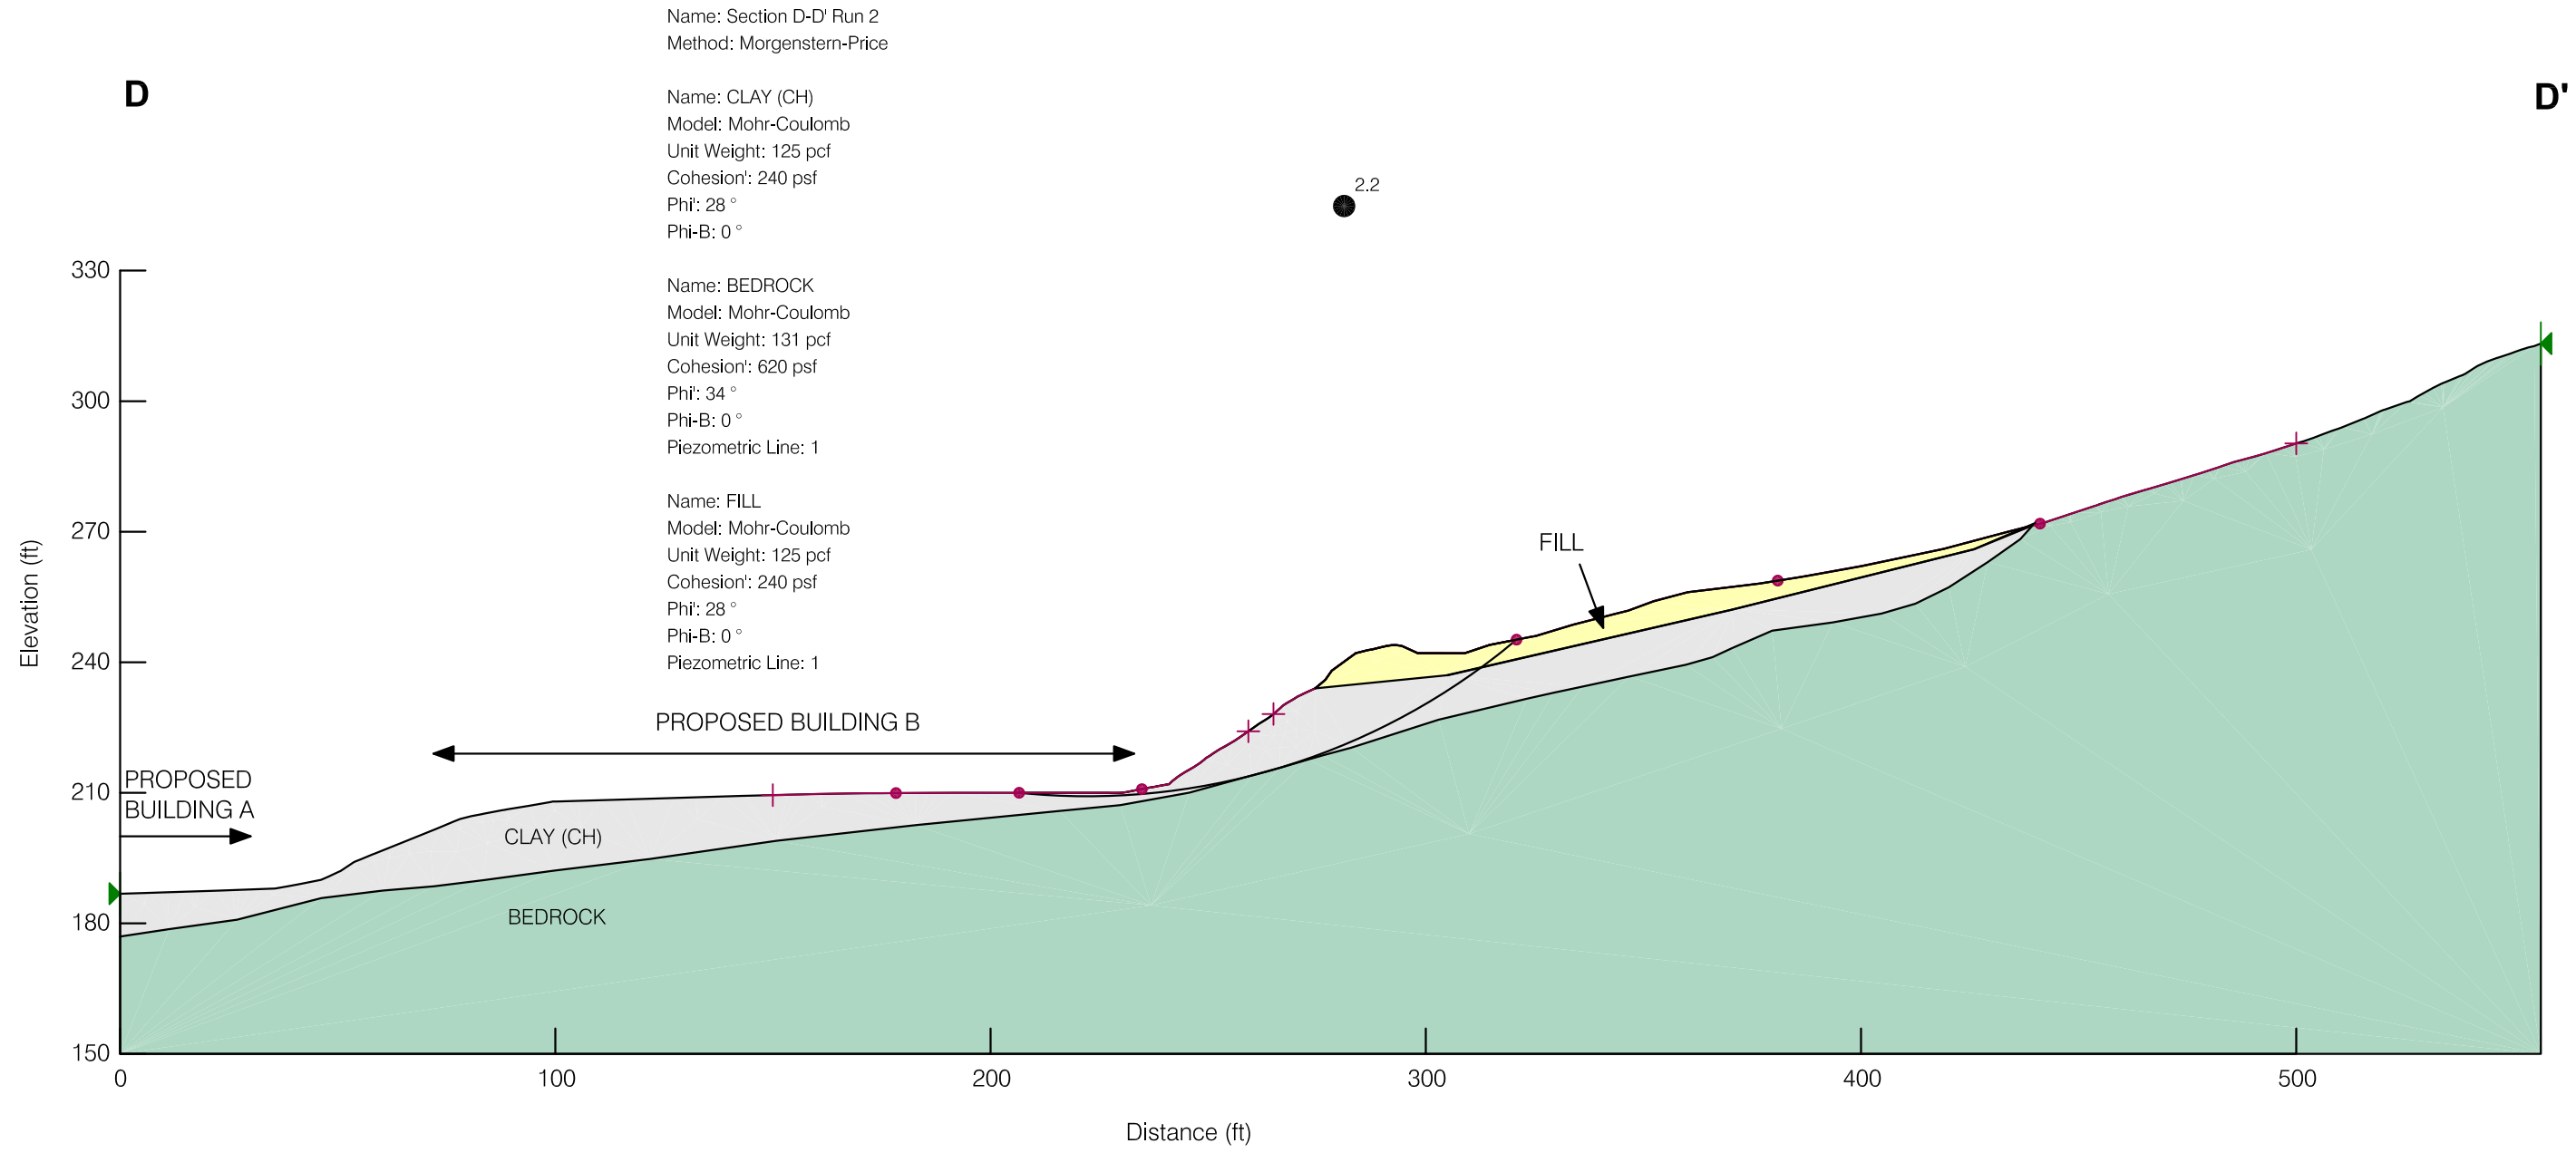
DOVE HILL ASSISTED LIVING COMMUNITY 4200 DOVE HILL ROAD San Jose, California		
SLOPE STABILITY ANALYSIS D-D' EXISTING CONDITIONS - UPPER SLOPE		
Date 05/07/15	Project No. 770619901	Figure F-7
LANGAN TREADWELL ROLLO

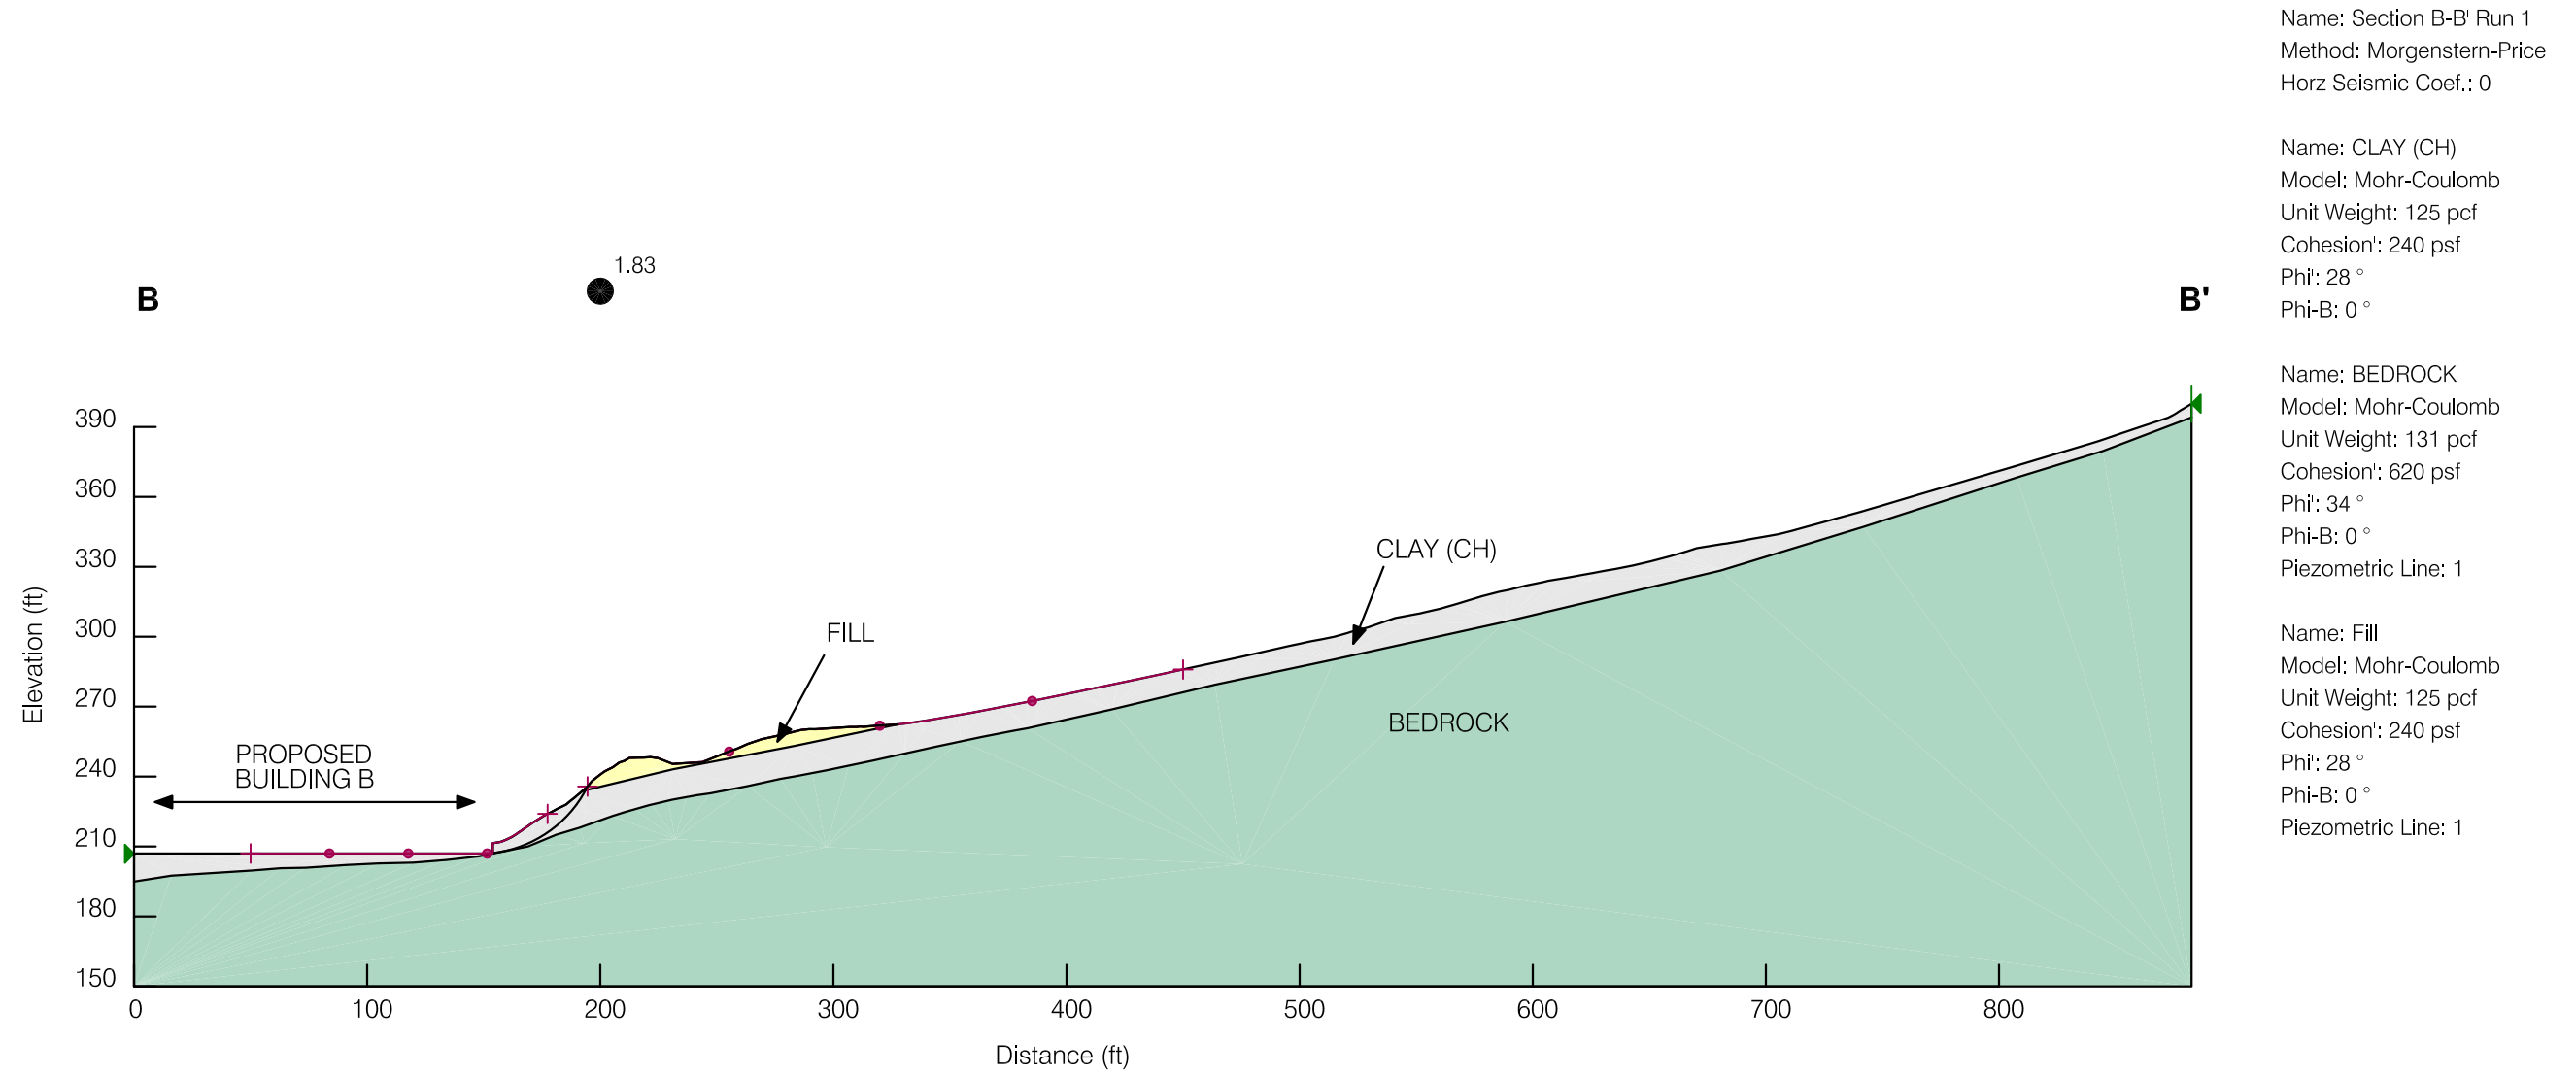
DOVE HILL ASSISTED LIVING COMMUNITY 4200 DOVE HILL ROAD San Jose, California		
SLOPE STABILITY ANALYSIS B-B' POST-GRADING		
Date 05/07/15	Project No. 770619901	Figure F-10
LANGAN TREADWELL ROLLO
