**Re: Response to Preliminary Geologic/Seismic Hazard Review and
Supplemental Geologic Investigation
Proposed Senior Housing Facility
4200 Dove Hill Road
San Jose, California
Langan Project No.: 770619902**

This letter presents our response to review comments by the San Jose Department of Public Works (SJDPW) dated 25 September 2015 regarding our Geotechnical Investigation and Geologic Hazard Evaluation report dated 30 June 2015 for the proposed senior Housing Facility project at 4200 Dove Hill Road in San Jose, California. SJDPW had several comments (designated 1 through 13 in their review letter) regarding geologic/seismic hazards evaluation and mitigation at the site; a copy of the review letter is included in Appendix D. The project will consist of two new buildings, designated as Buildings A and B; both buildings are proposed to be four stories above a podium level as shown on Figure 1.

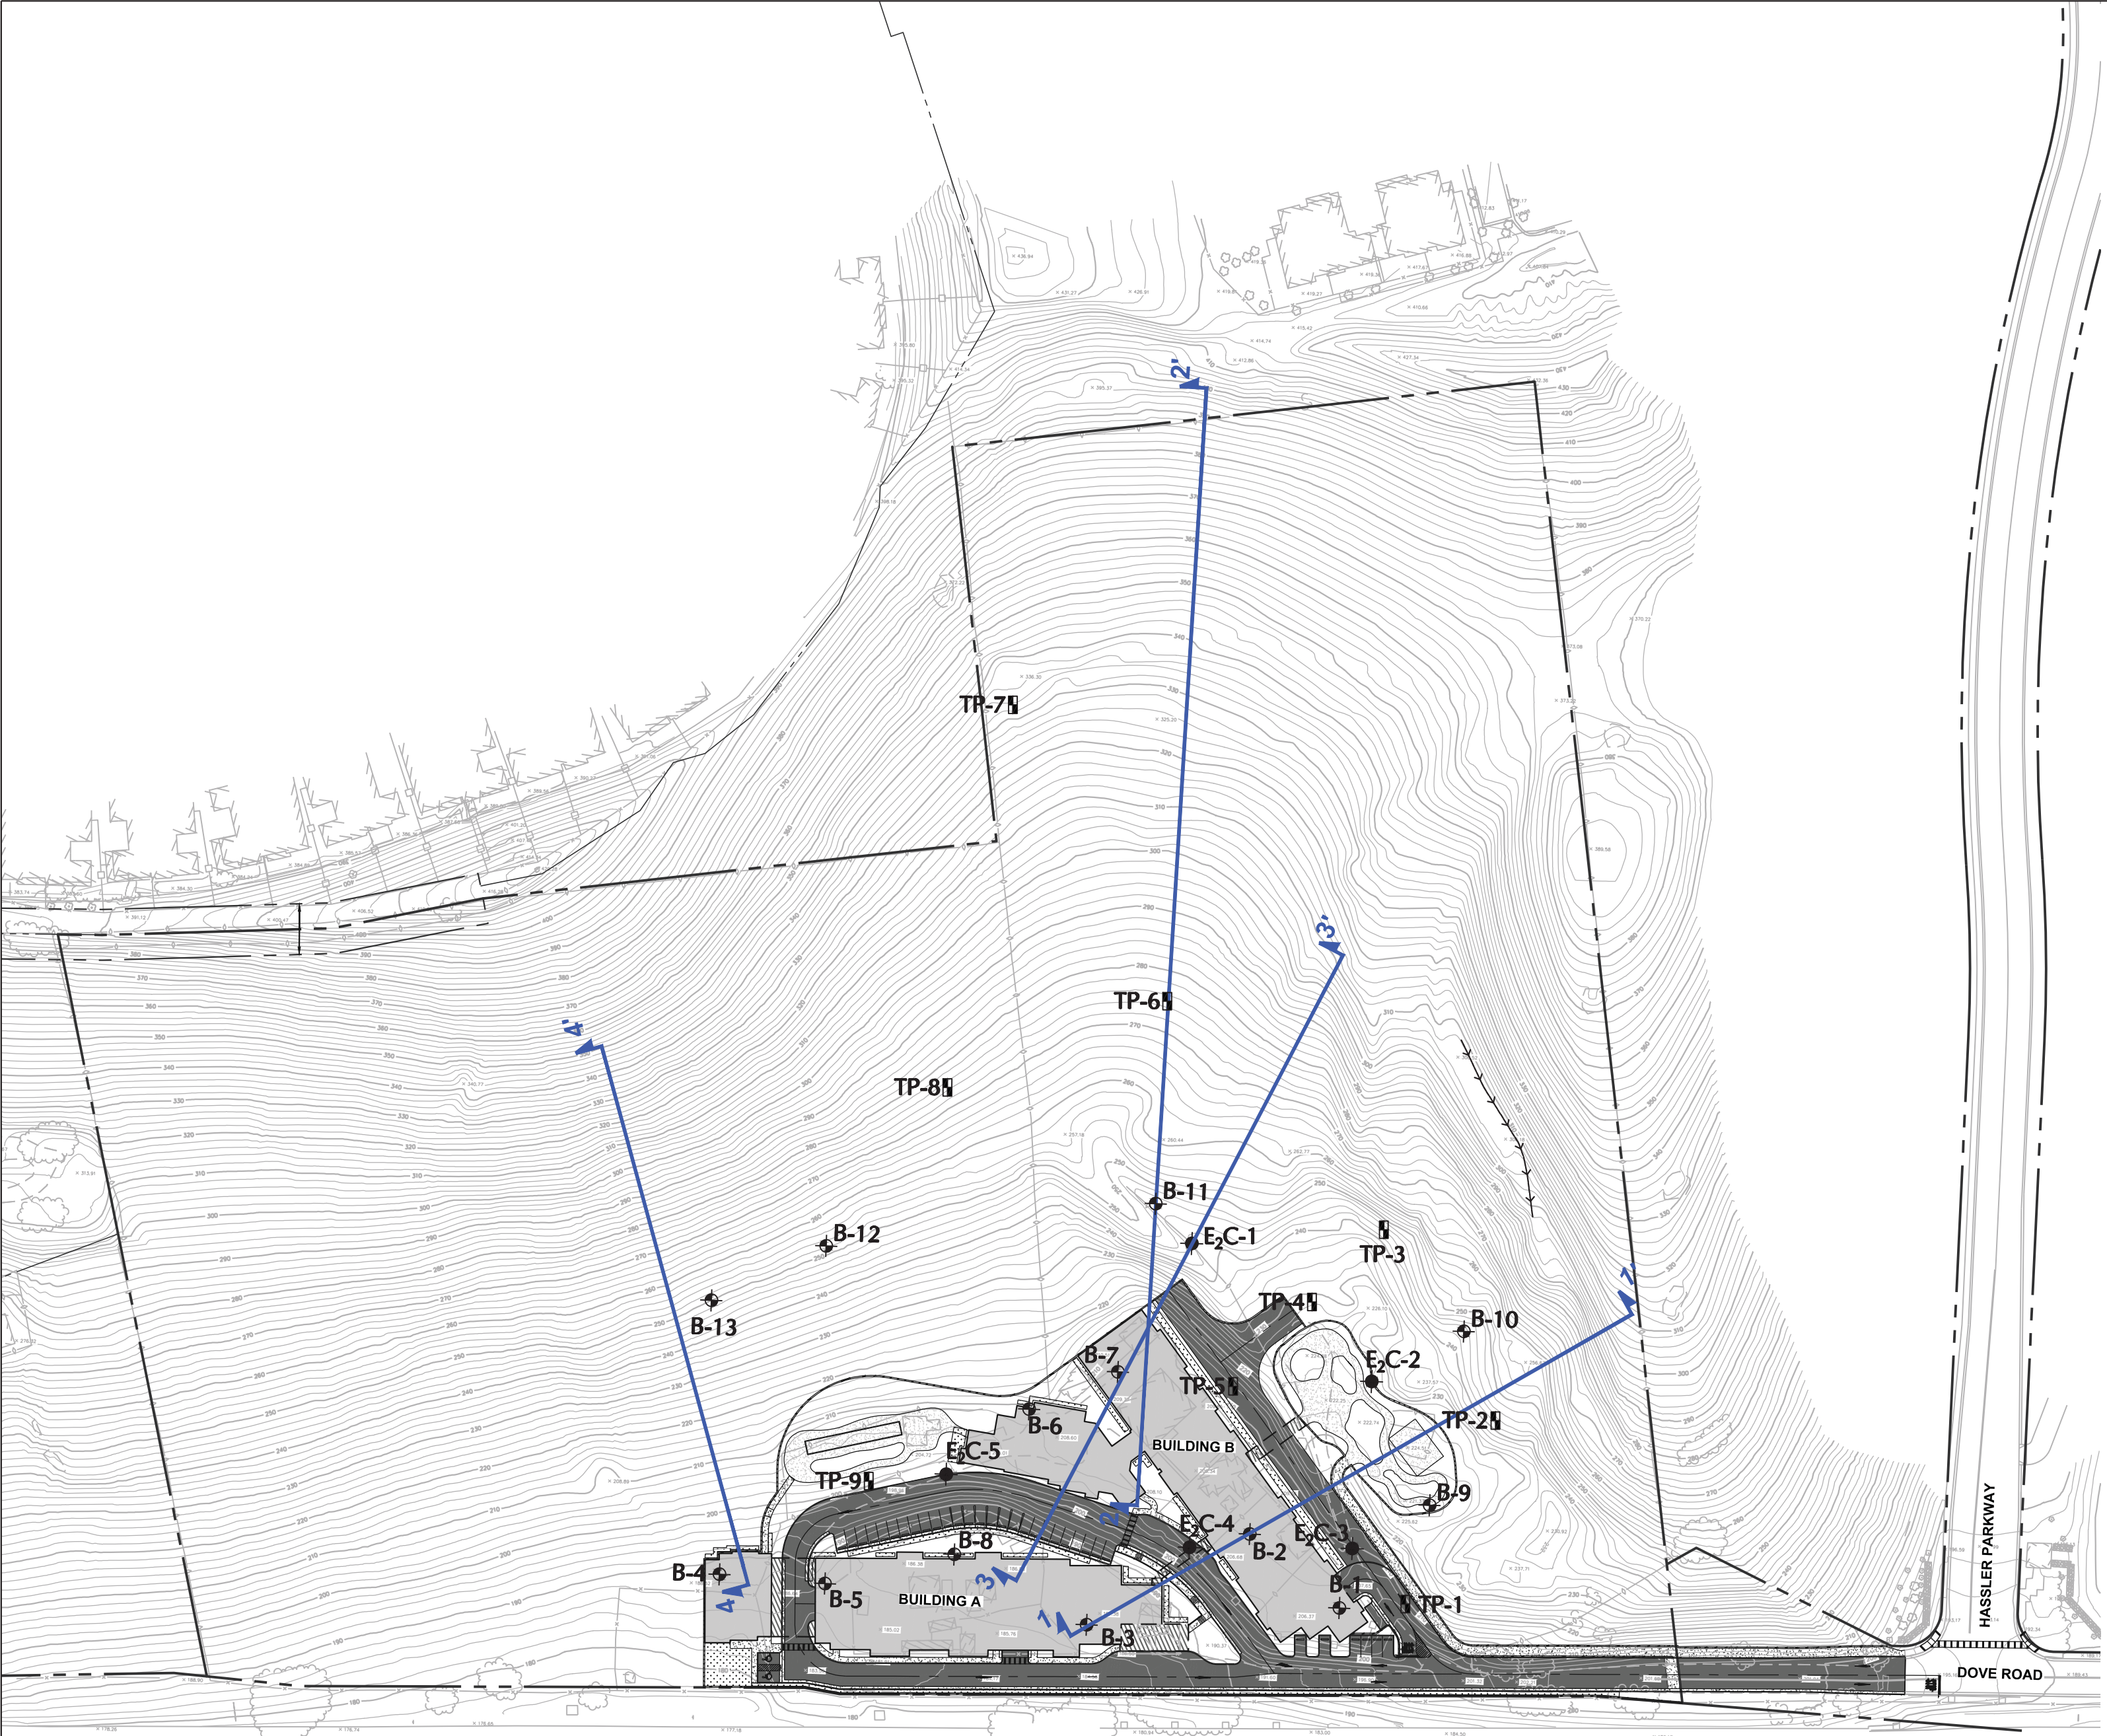
Date 02/24/16	Project No. 770619902	Figure 1
---------------	-----------------------	----------

SITE PLAN WITH PROPOSED DEVELOPMENT

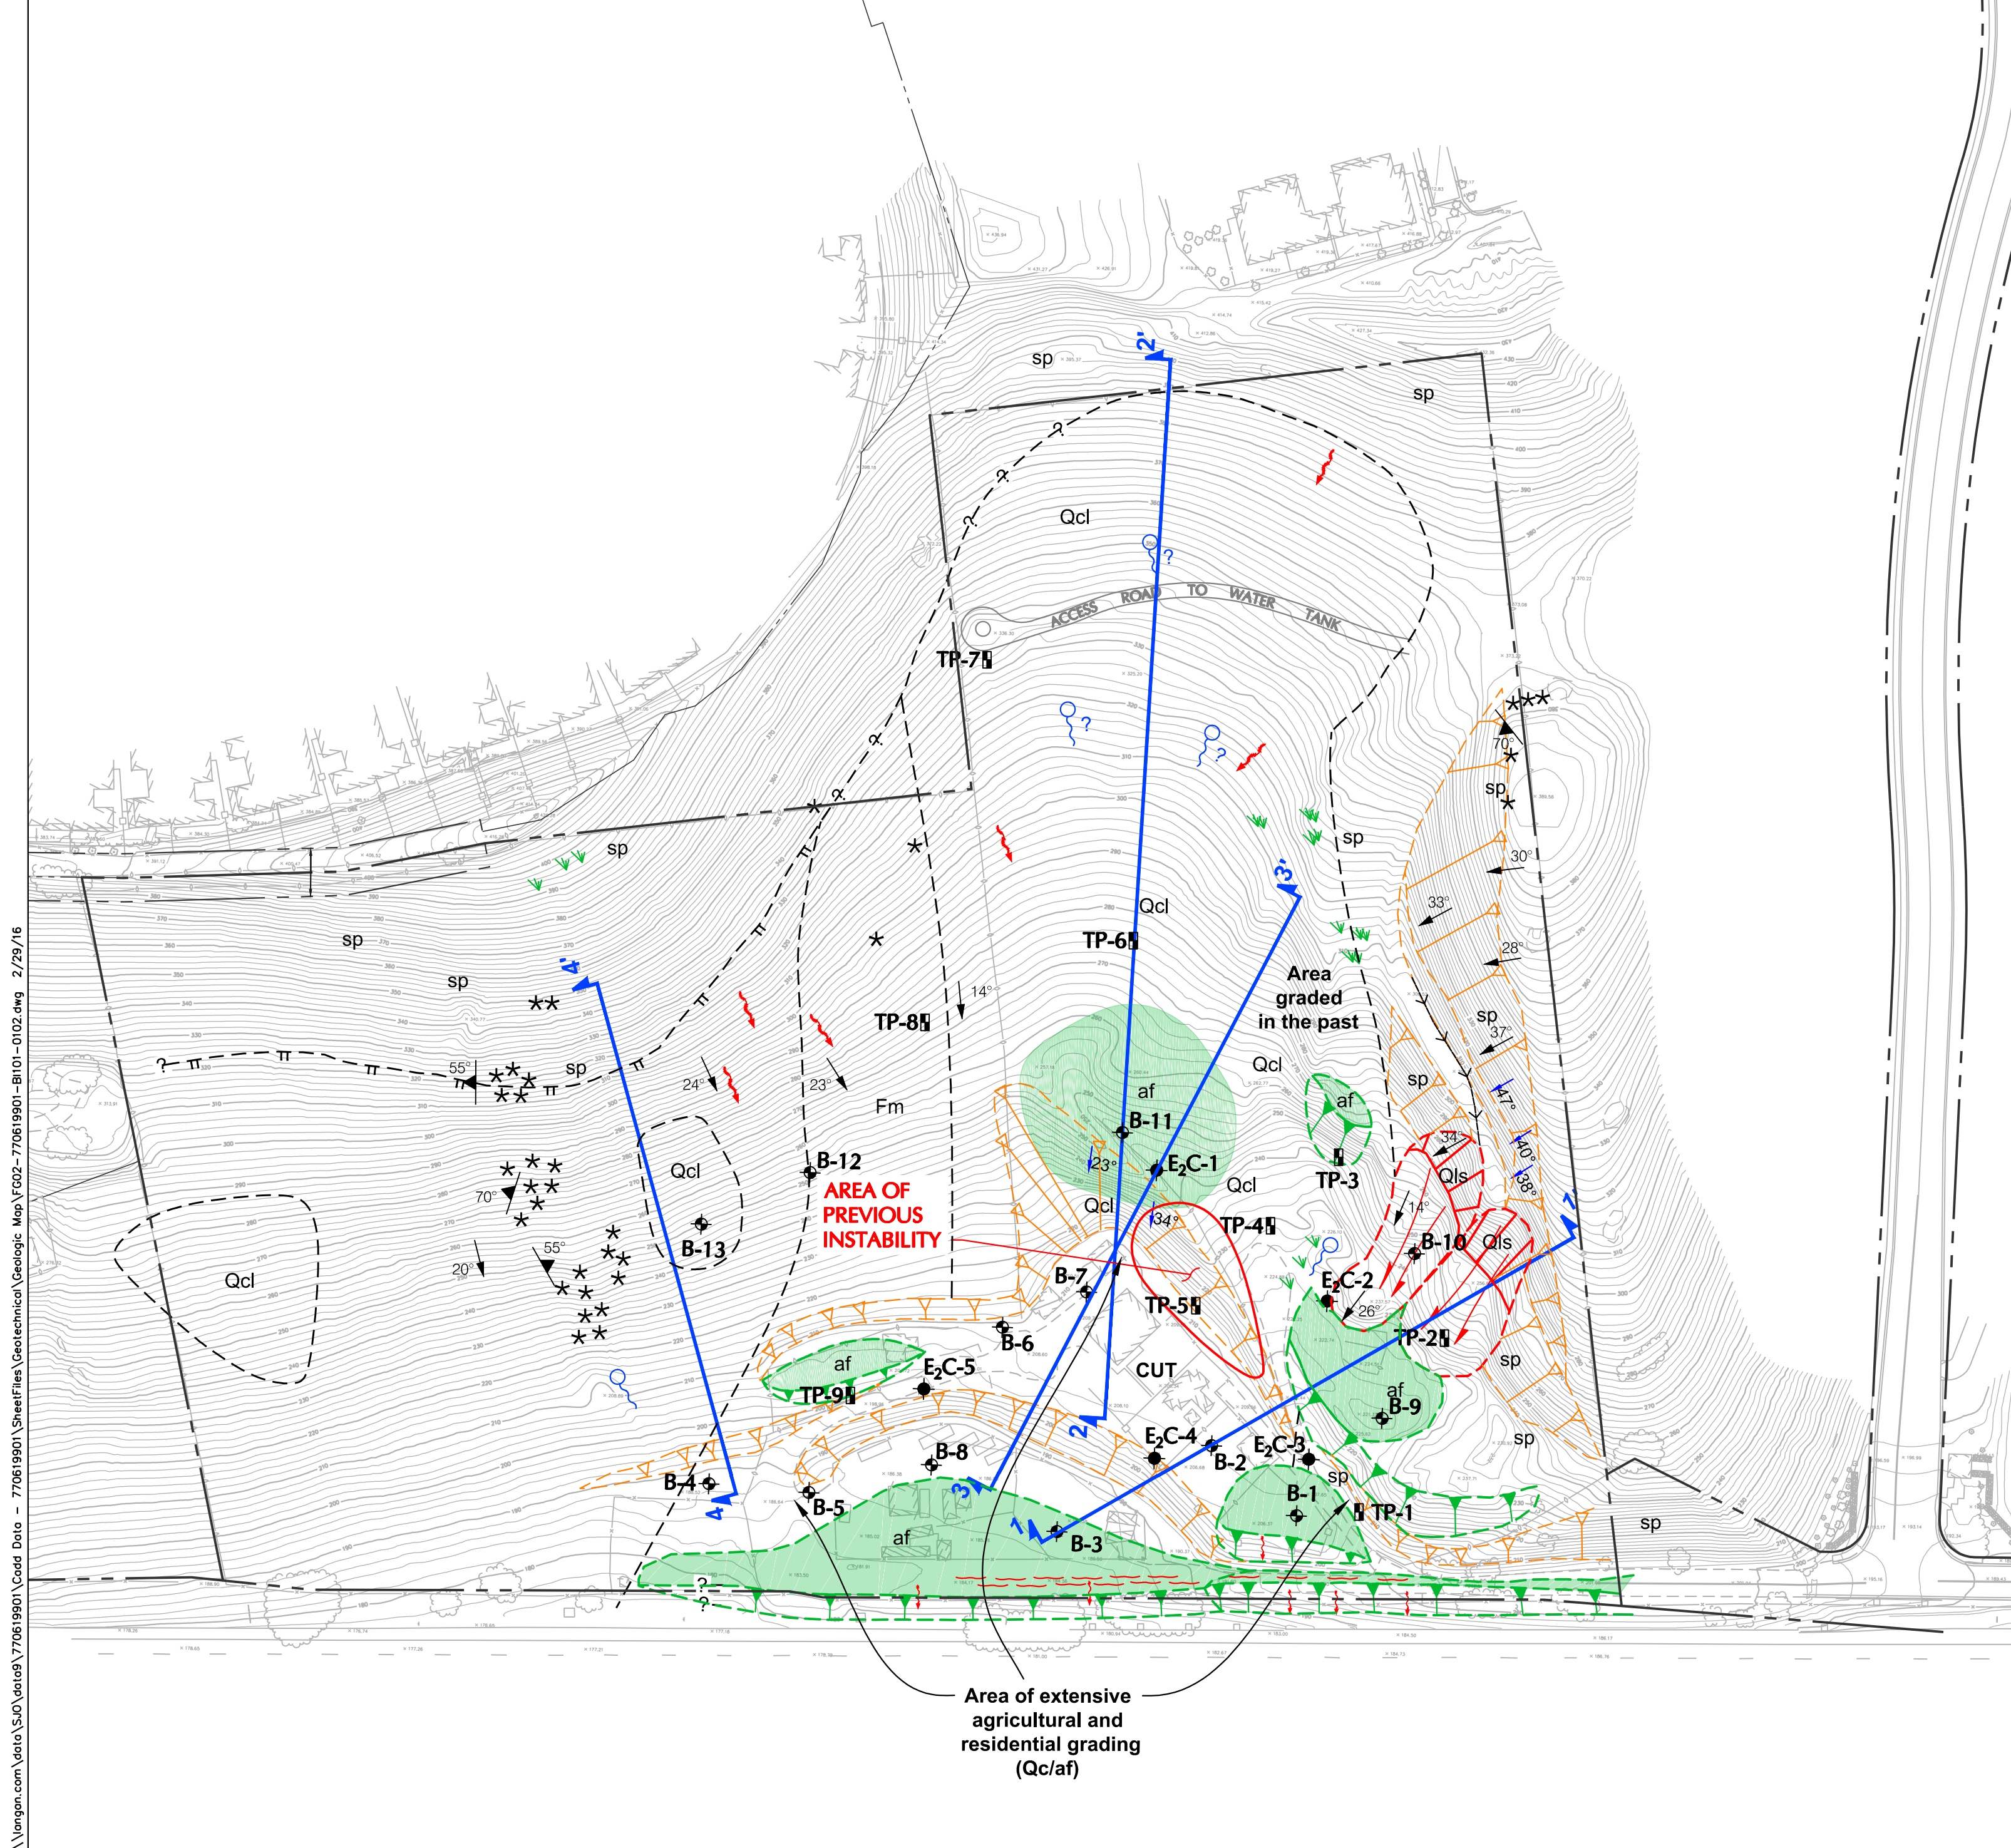
Date 02/24/16 | Project No. 770619902 | Figure 2

Notes:
 1. Site conditions are those observed during reconnaissance mapping on - and - and may have since changed.
 2. Mapping performed using standard tape/pace and compass methods.
 3. Cross sections shown on Figure 6.

To address the comments by the SJDPW, we completed a supplemental geologic investigation by exploring the site with 9 test pits, 5 additional borings and additional geologic mapping conducted from 7 through 8 December 2015. Our updated engineering geologic map and 'idealized' subsurface profiles reflect data collected during this supplemental investigation (Figures 2 and 3). Our investigation included logging and sampling the subsurface conditions encountered from the geotechnical borings and test pits. Logs of the borings, designated as B-9 through B-13, and test pits, designated as TP-1 through TP-9, are attached in Appendix A with lab test results presented in Appendix B. The approximate locations of all of the borings and test pits are shown on Figure 2.

As discussed in comment 1, two landslides were identified and investigated on the southern portion of the site (Figure 2). Boring 10 and Test Pit 2 characterized the landslide materials. The proximity of the two landslides to each other indicates a similar failure trigger. Aerial photo reconnaissance, geomorphology, and subsurface investigation all indicate the southern steep hillslope was quarried and graded to incorporate several access roads. The upper access road demarcates the headscarp region of both landslides. Slope gradients upslope of the headscarps range from 47° to 37°, while gradients to the east range from 26° to 33°. Therefore, it appears the over-excavation of the quarry face in the region of landslides coupled with concentrated runoff from the access road were the primary triggers for these slope failures. See Figure 3 for the southern landslide deposits thickness and geometry.

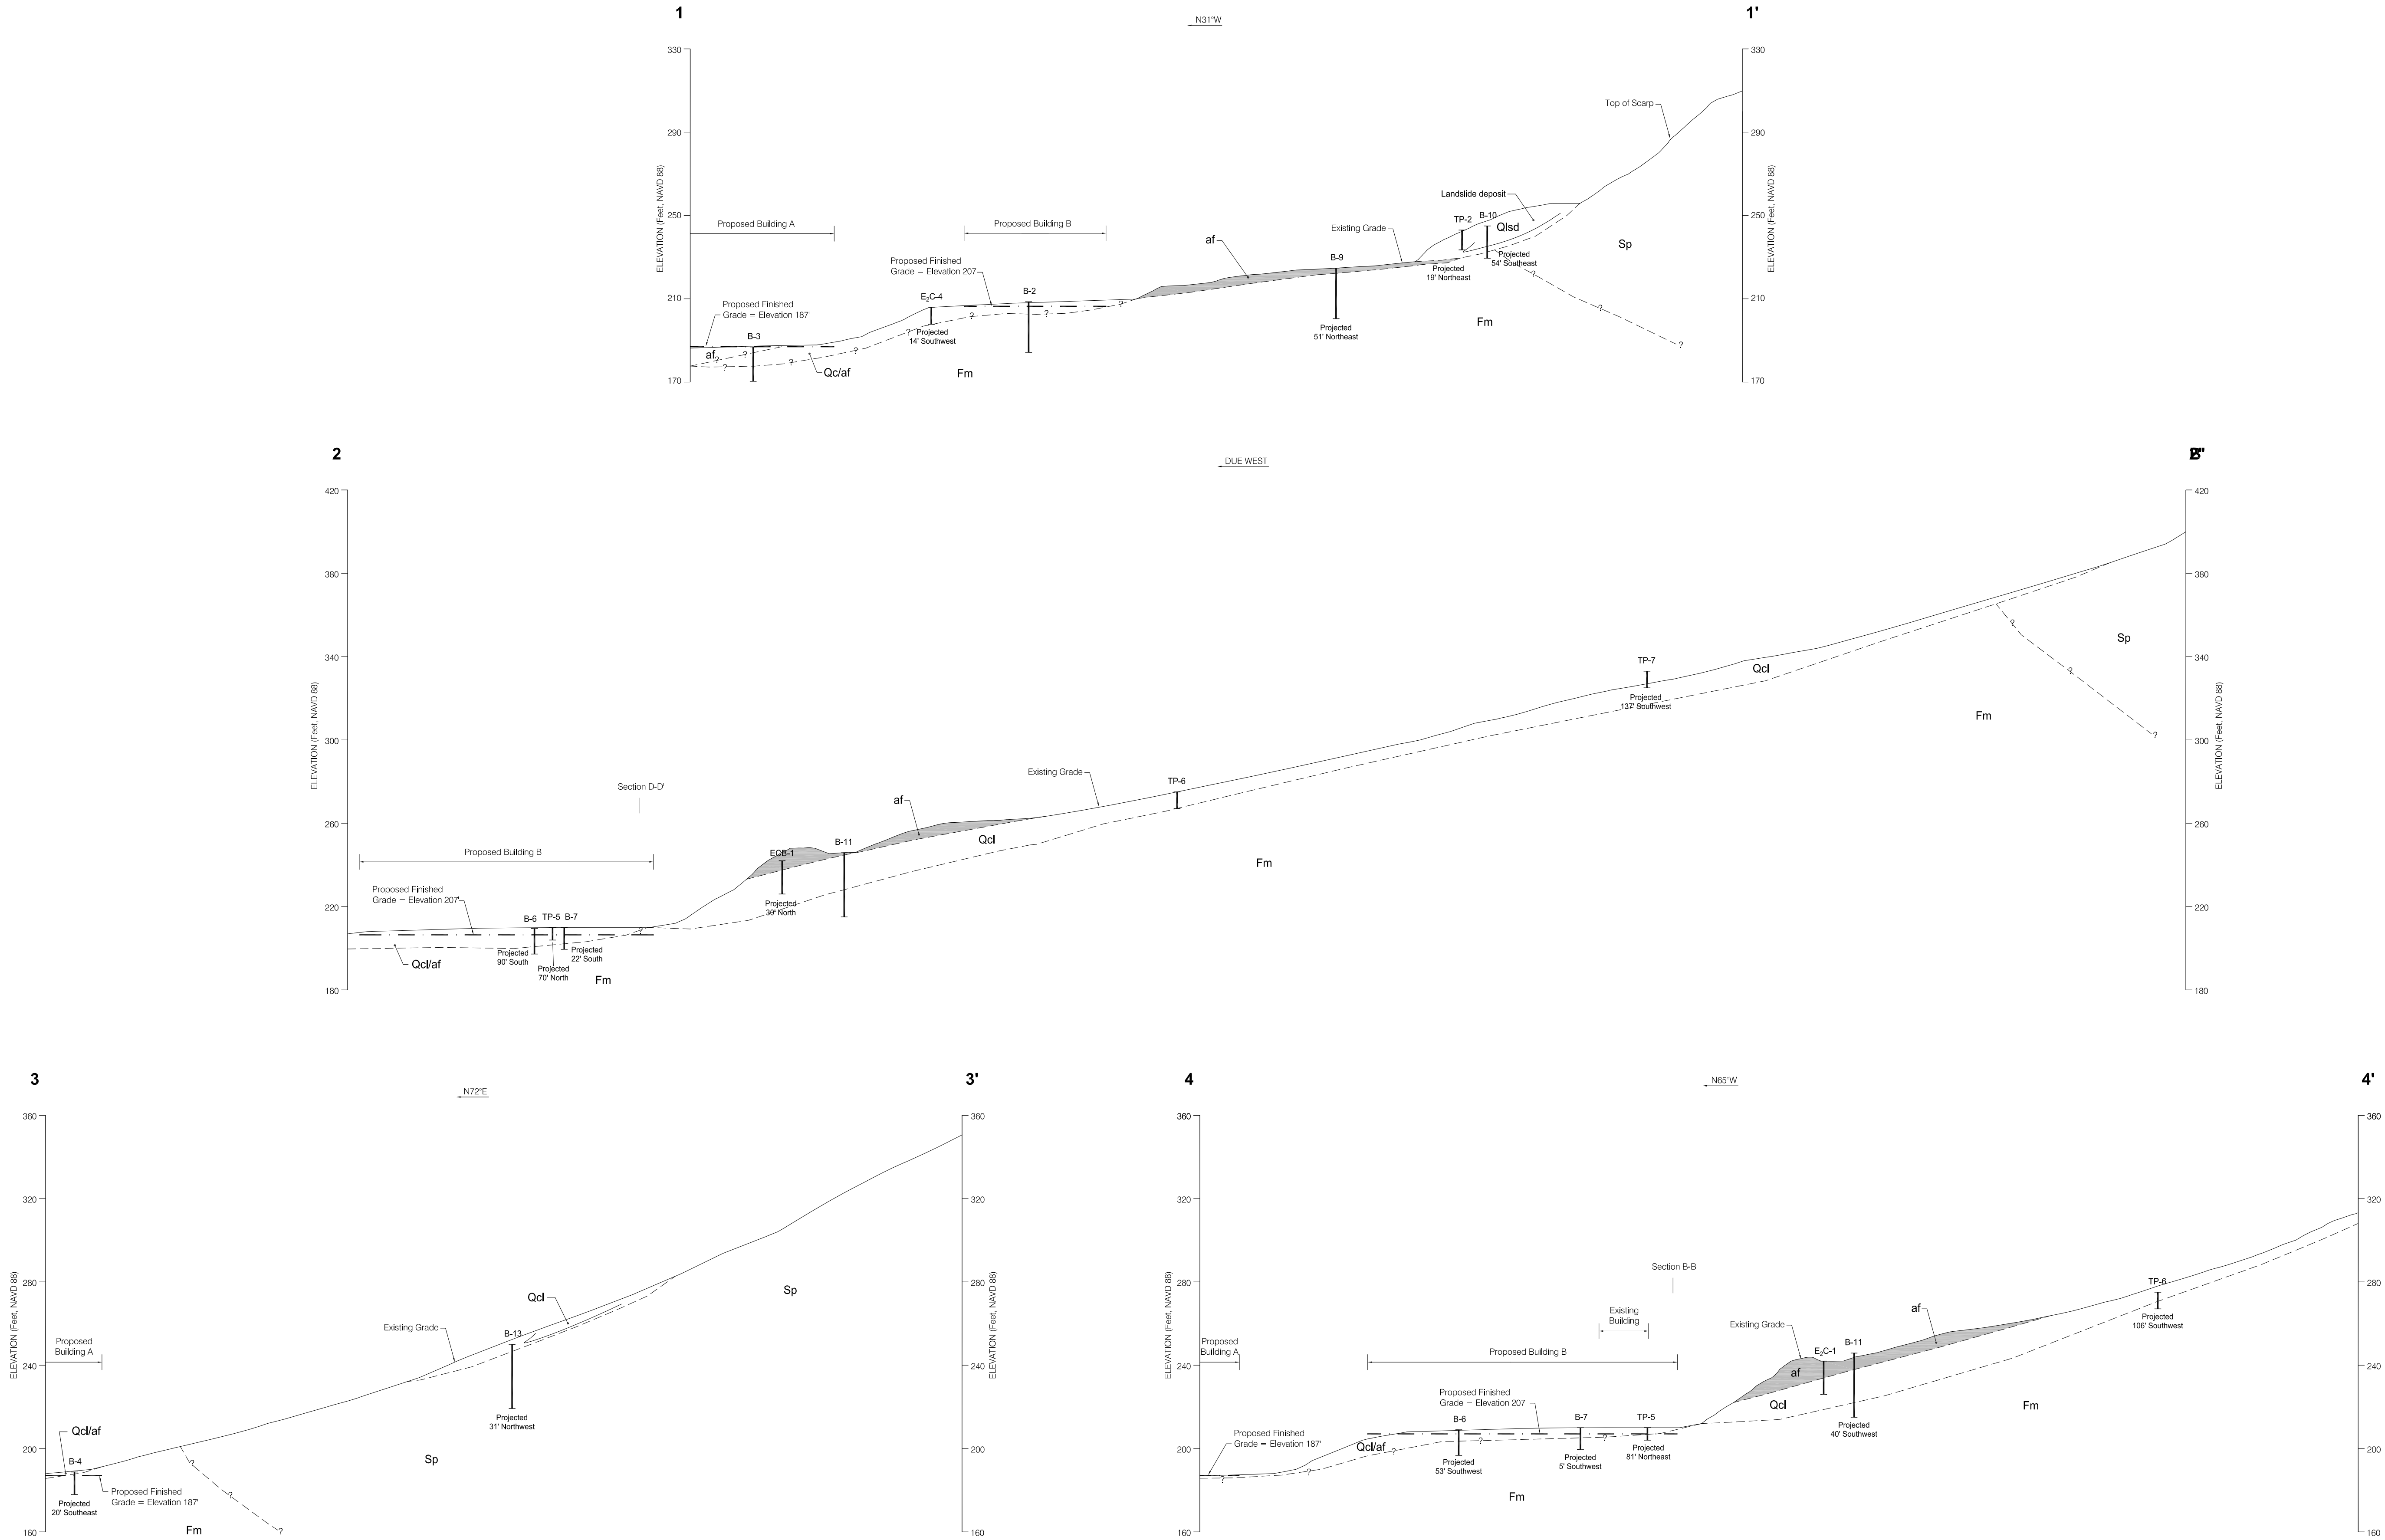
Notes:
 1. The above profiles represents a generalized subsurface cross section interpreted from widely spaced borings. Earth materials may vary in type, strength, and other important properties between points of exploration.
 2. See figure 2 for explanation.

IDEALIZED SUBSURFACE PROFILES
1-1', 2-2', 3-3', AND 4-4'

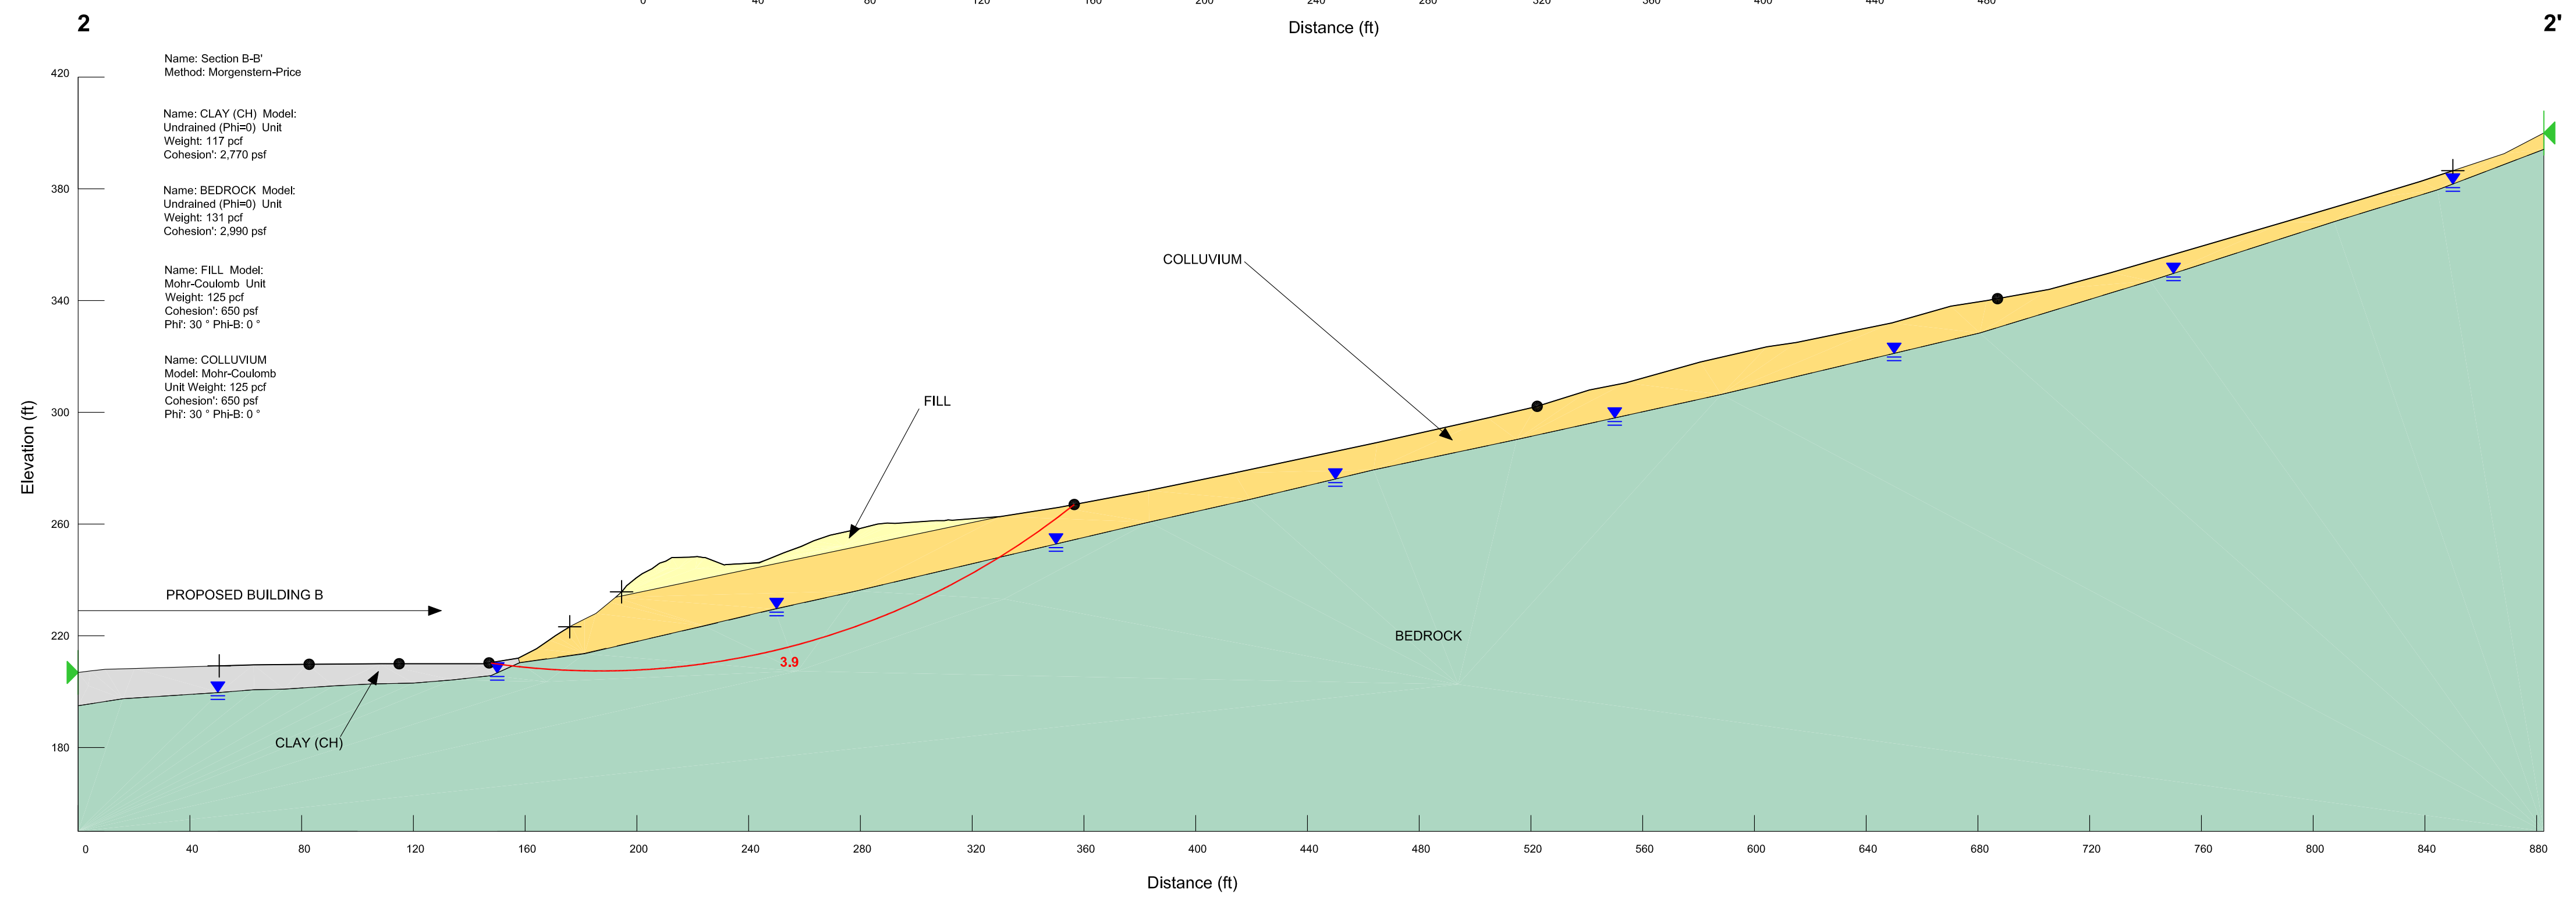
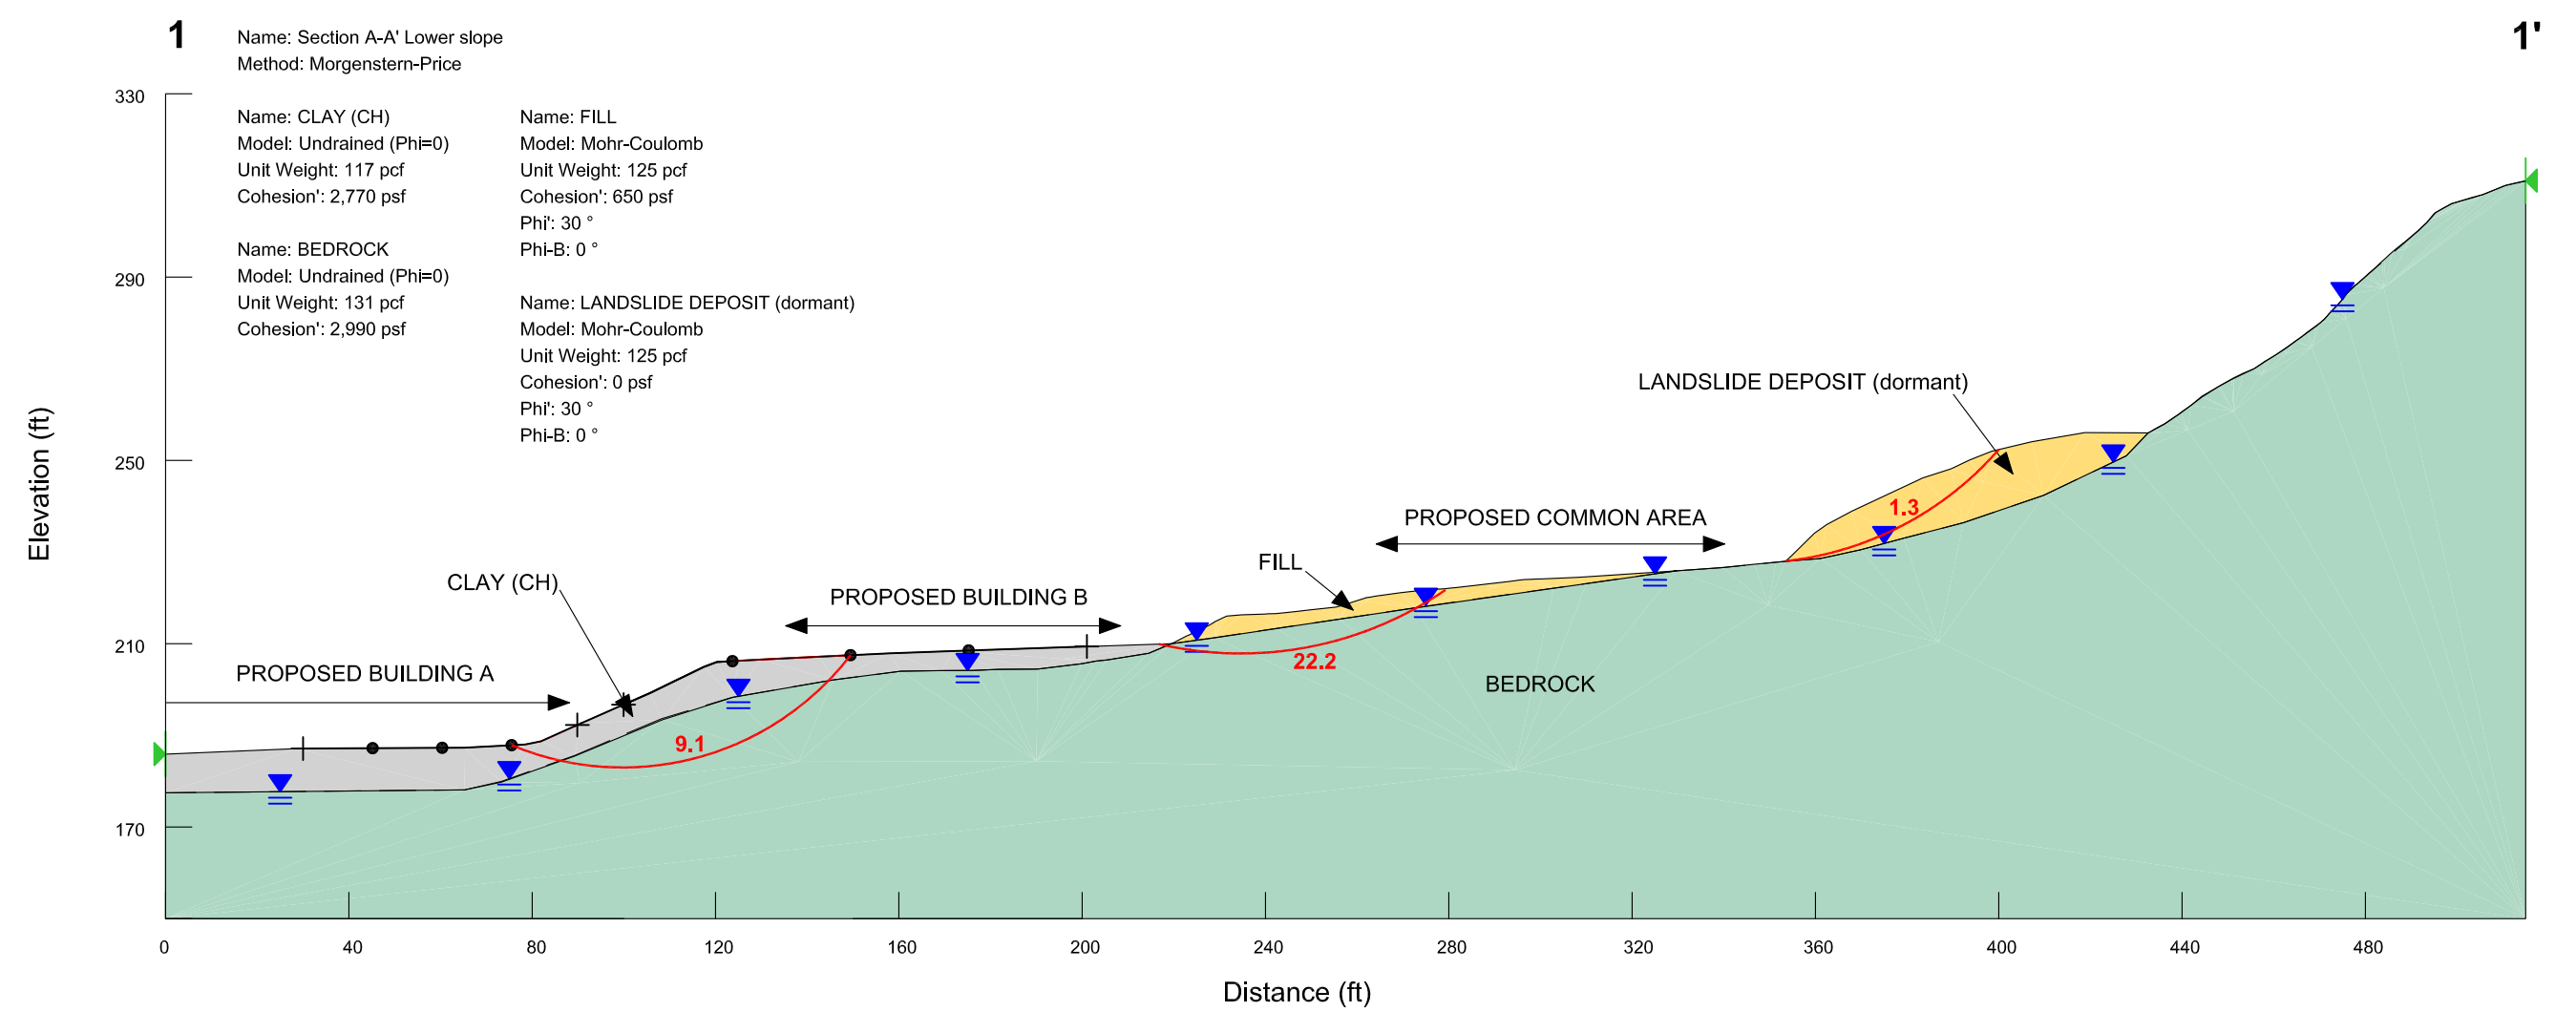
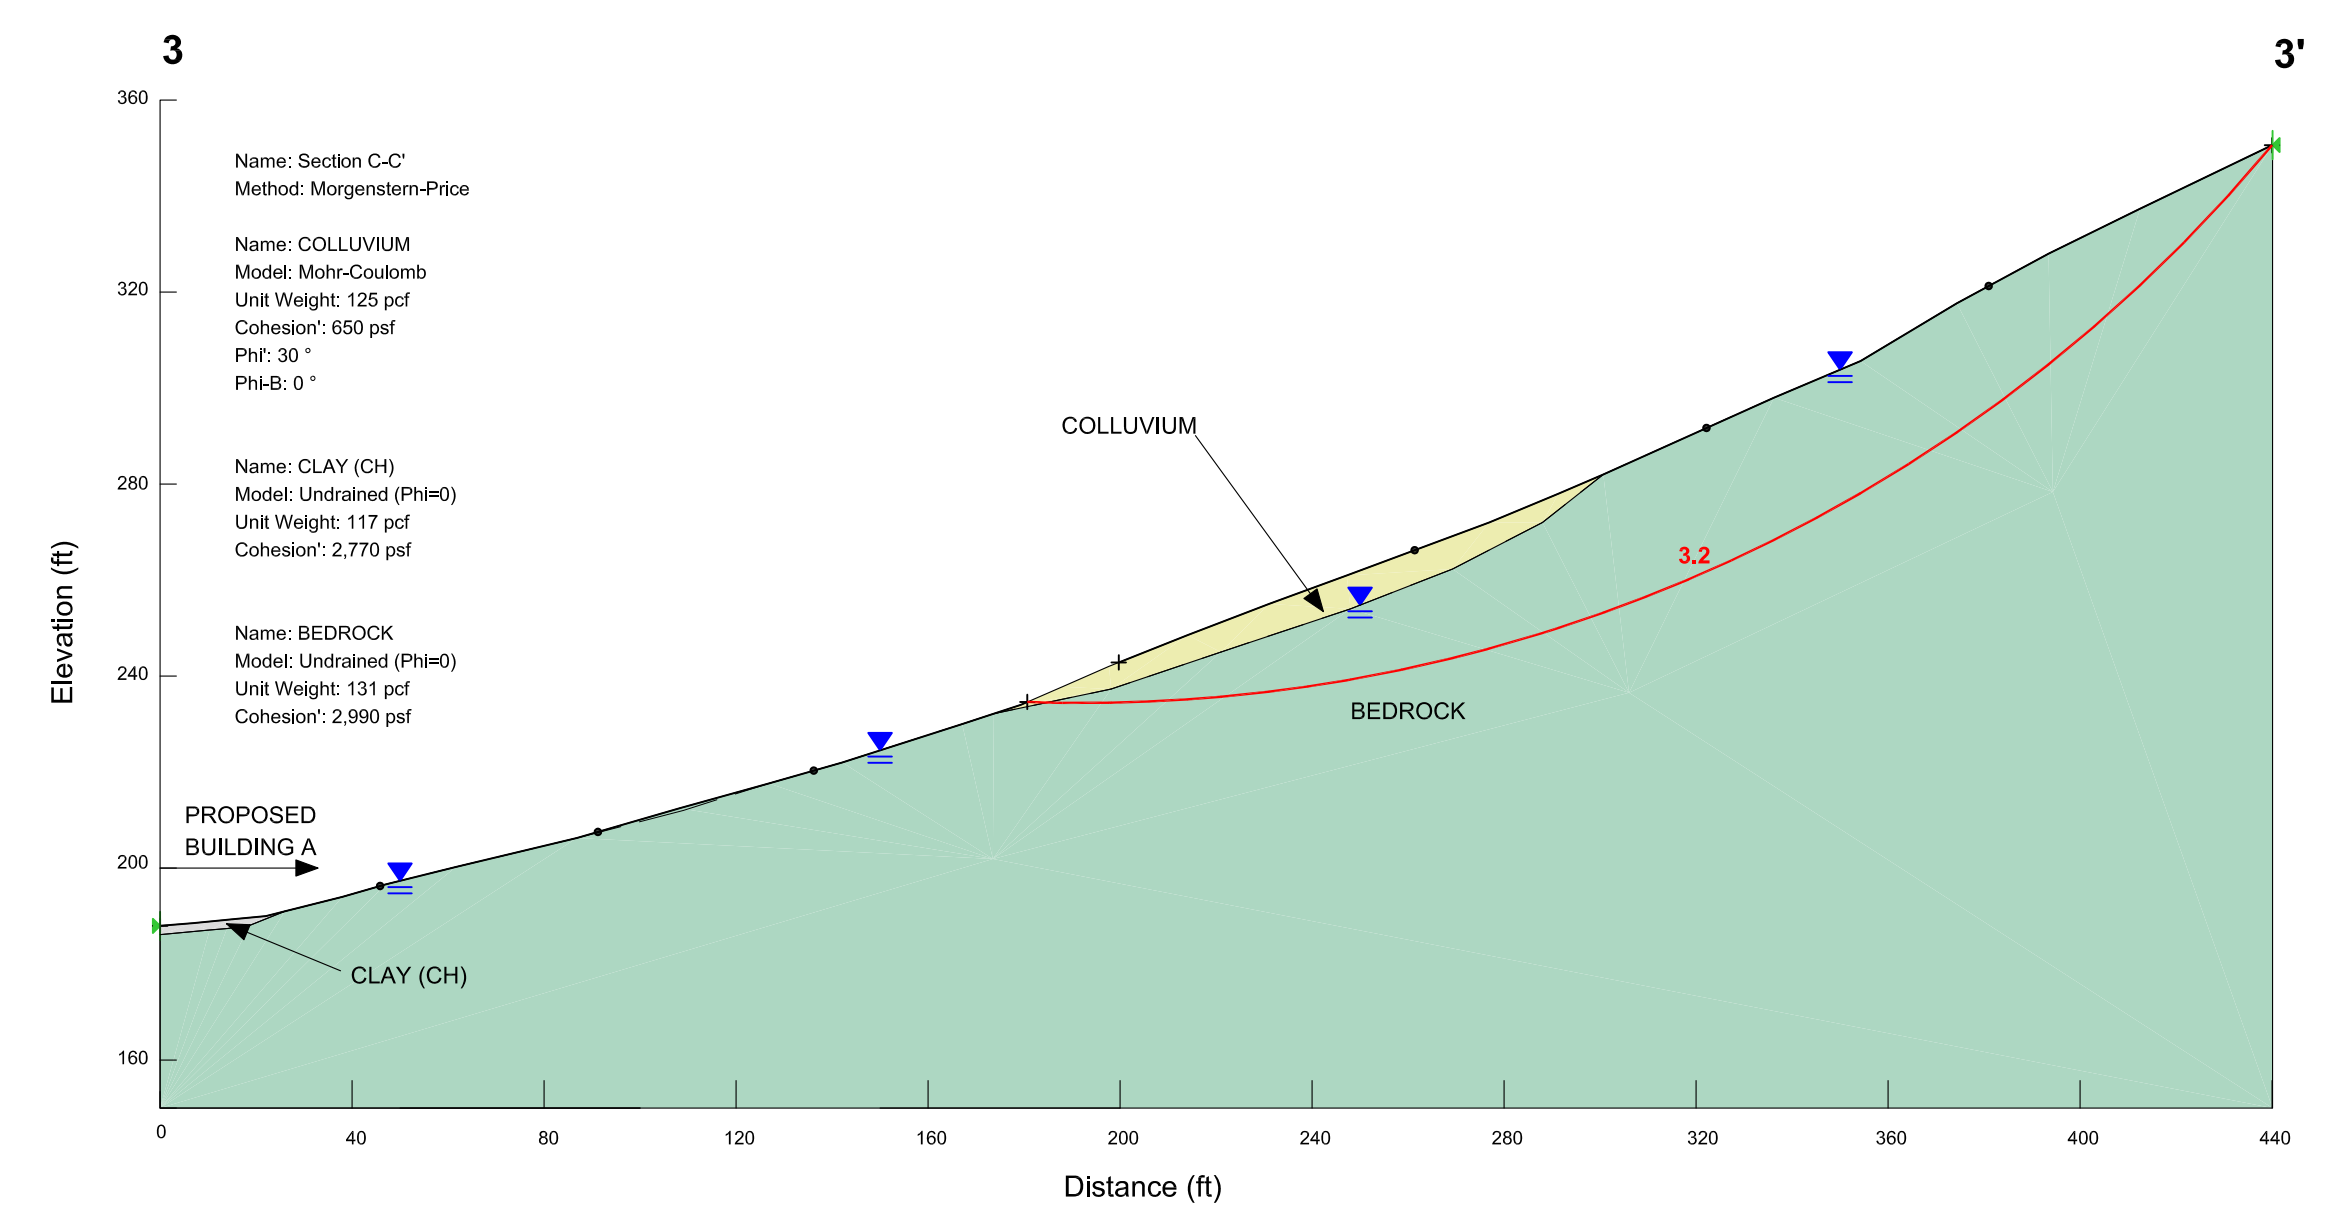
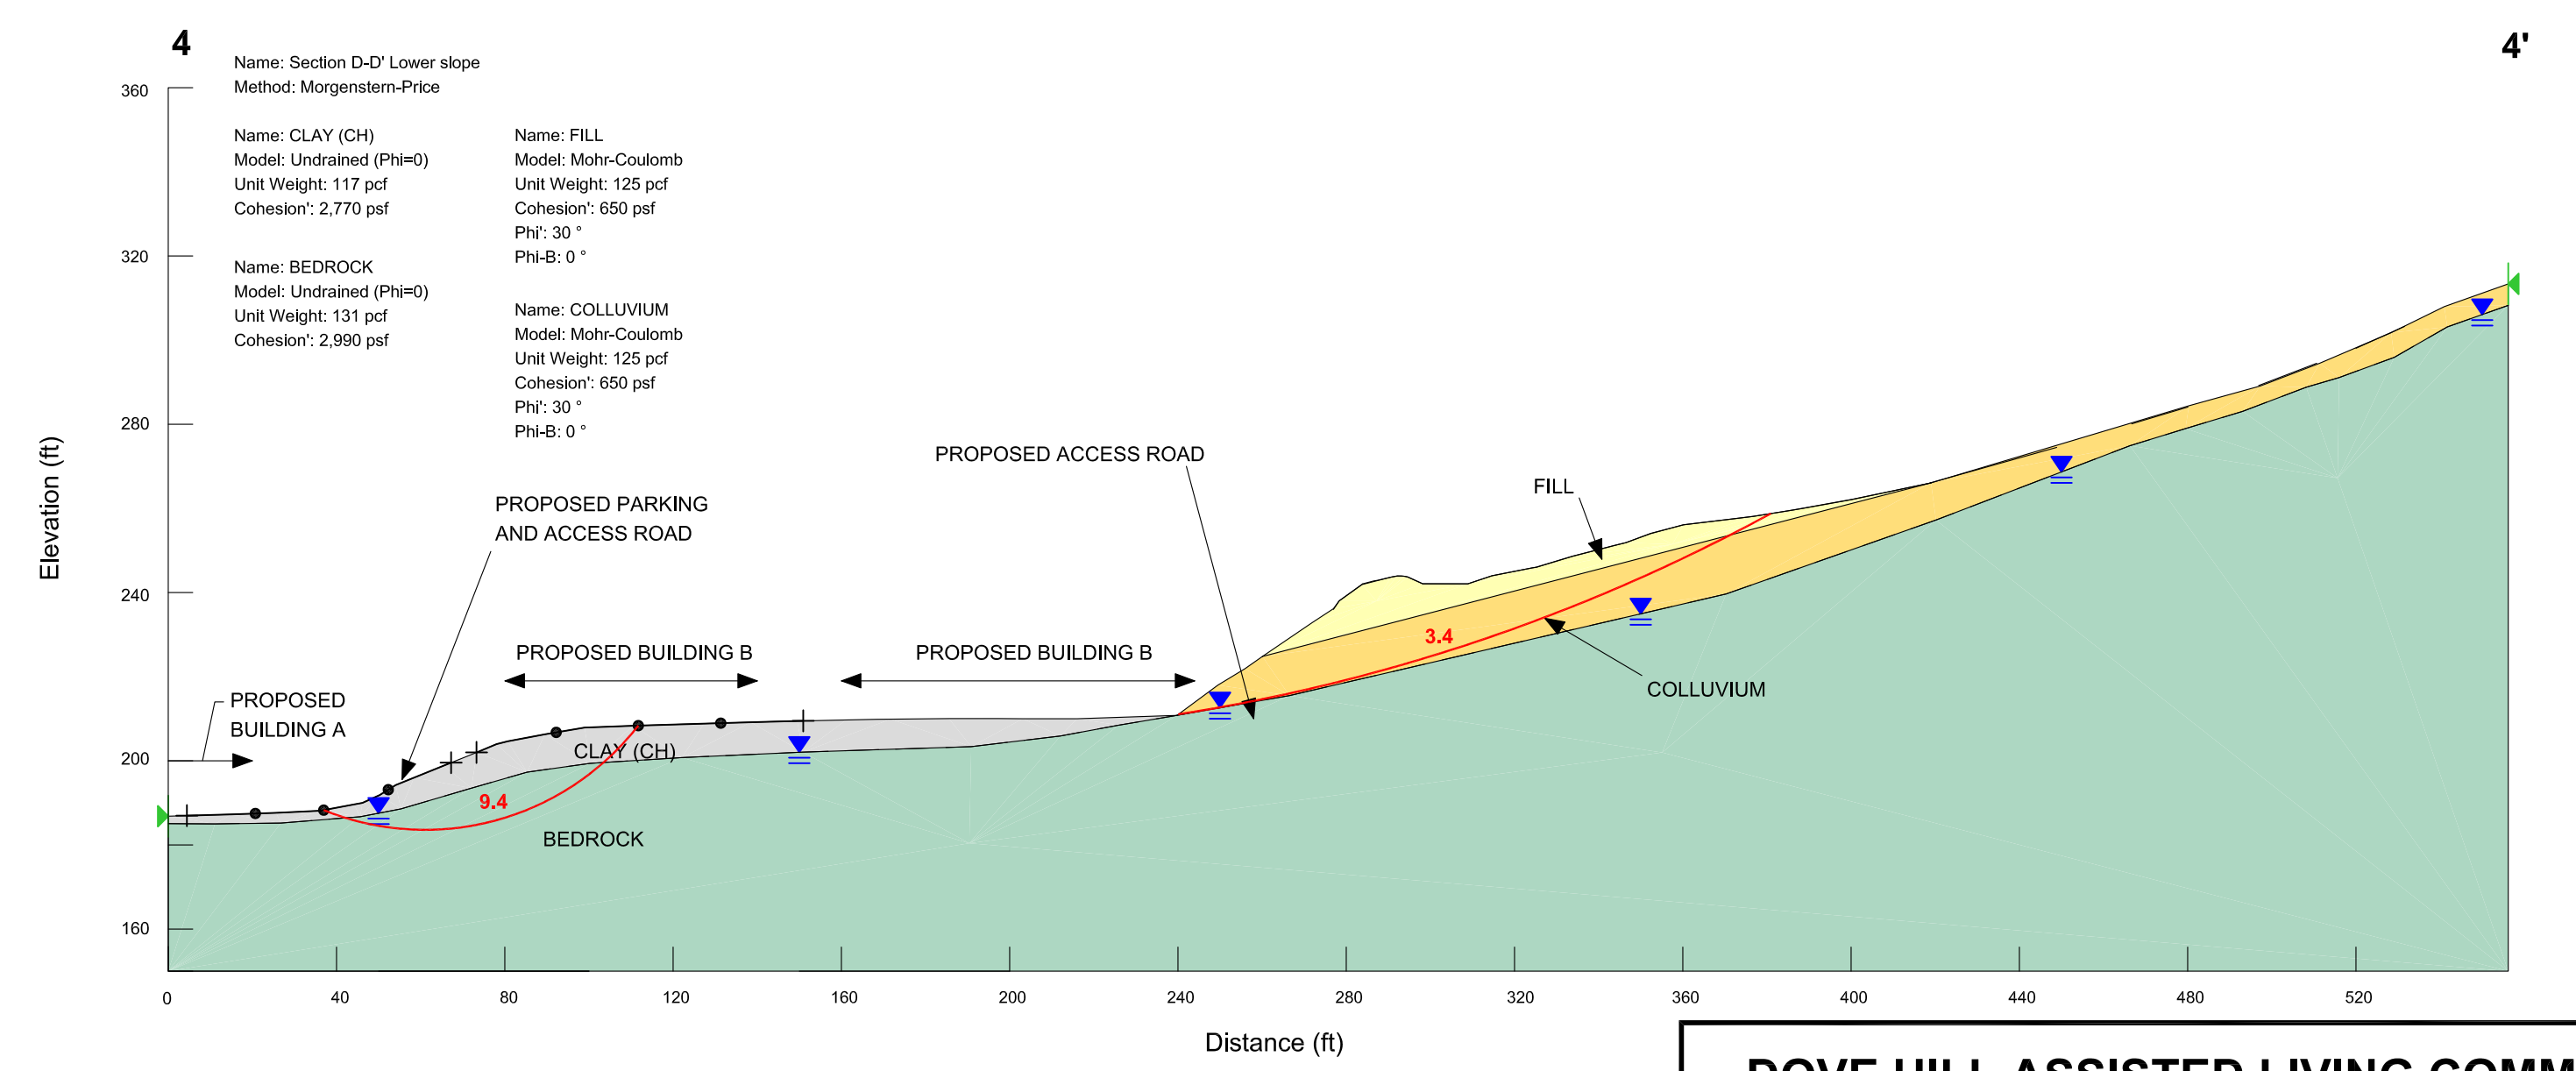
Date	02/26/16	Project No.	770619902	Figure	4
------	----------	-------------	-----------	--------	---

DOVE HILL ASSISTED LIVING COMMUNITY
4200 DOVE HILL ROAD
 San Jose, California
SLOPE STABILITY ANALYSIS
IDEALIZED SUBSURFACE PROFILES
1-1', 2-2', 3-3', AND 4-4'
EXISTING CONDITIONS

We have analyzed the slope stability on the site using the newly acquired data. In our initial evaluation we conservatively modeled the groundwater along the surface of the bedrock, however we did not portray this on our figures. The location of the critical slope failure surfaces and the location of the modeled groundwater surface for each of the profiles evaluated are provided on Figures 4 (current conditions) and 5 (proposed grading)/.

The results of our analyses indicate most of the existing slopes are stable or may exhibit negligible permanent slope displacements upslope of the proposed improvements during a major earthquake. However, the landslide deposits above proposed Building B could exhibit significant permanent slope displacements, if not removed and regraded, as previously discussed. The results of our slope stability analyses and seismic slope displacements are summarized in Table 2, below for existing conditions. We used the same methodology to evaluate slope stability and potential slope deformations during a seismic event as discussed in our previous geotechnical report. The location of the critical slope failure surfaces for each of the profiles evaluated showing existing conditions are provided on Figure 4.

See response to comments 1 and 4 for additional details concerning the supplemental subsurface exploration, groundwater conditions, and results of the slope stability analyses. The location of the critical slope failure surfaces and the location of the modeled groundwater surface for section 3-3' are provided Figures 4 and 5.
