**Re: Response to Preliminary Geologic/Seismic Hazard Review and
Supplemental Geologic Investigation
Proposed Senior Housing Facility
4200 Dove Hill Road
San Jose, California
Langan Project No.: 770619902**

This letter presents our response to review comments by the San Jose Department of Public Works (SJDPW) dated 25 September 2015 regarding our Geotechnical Investigation and Geologic Hazard Evaluation report dated 30 June 2015 for the proposed senior Housing Facility project at 4200 Dove Hill Road in San Jose, California. SJDPW had several comments (designated 1 through 13 in their review letter) regarding geologic/seismic hazards evaluation and mitigation at the site; a copy of the review letter is included in Appendix D. The project will consist of two new buildings, designated as Buildings A and B; both buildings are proposed to be four stories above a podium level as shown on Figure 1.

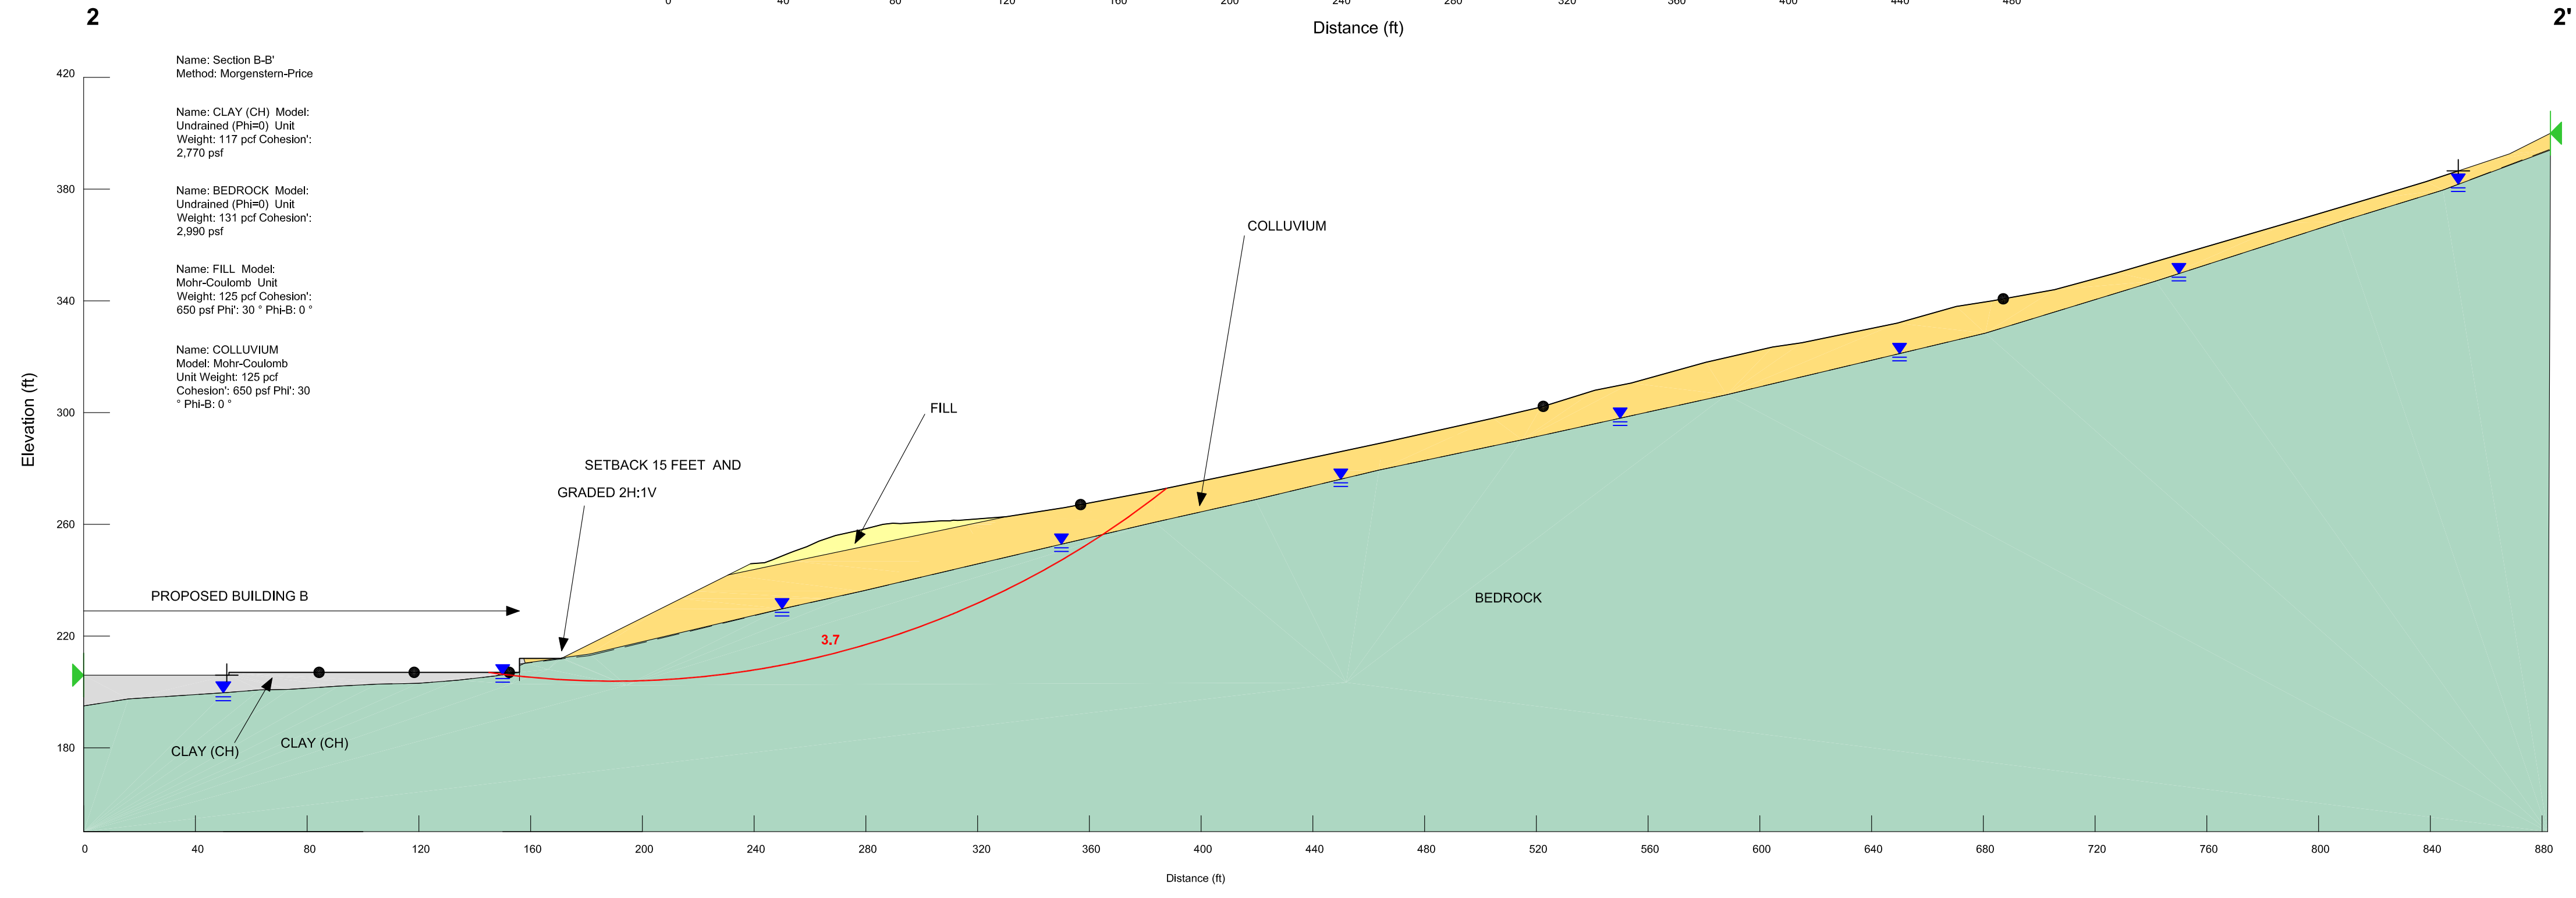
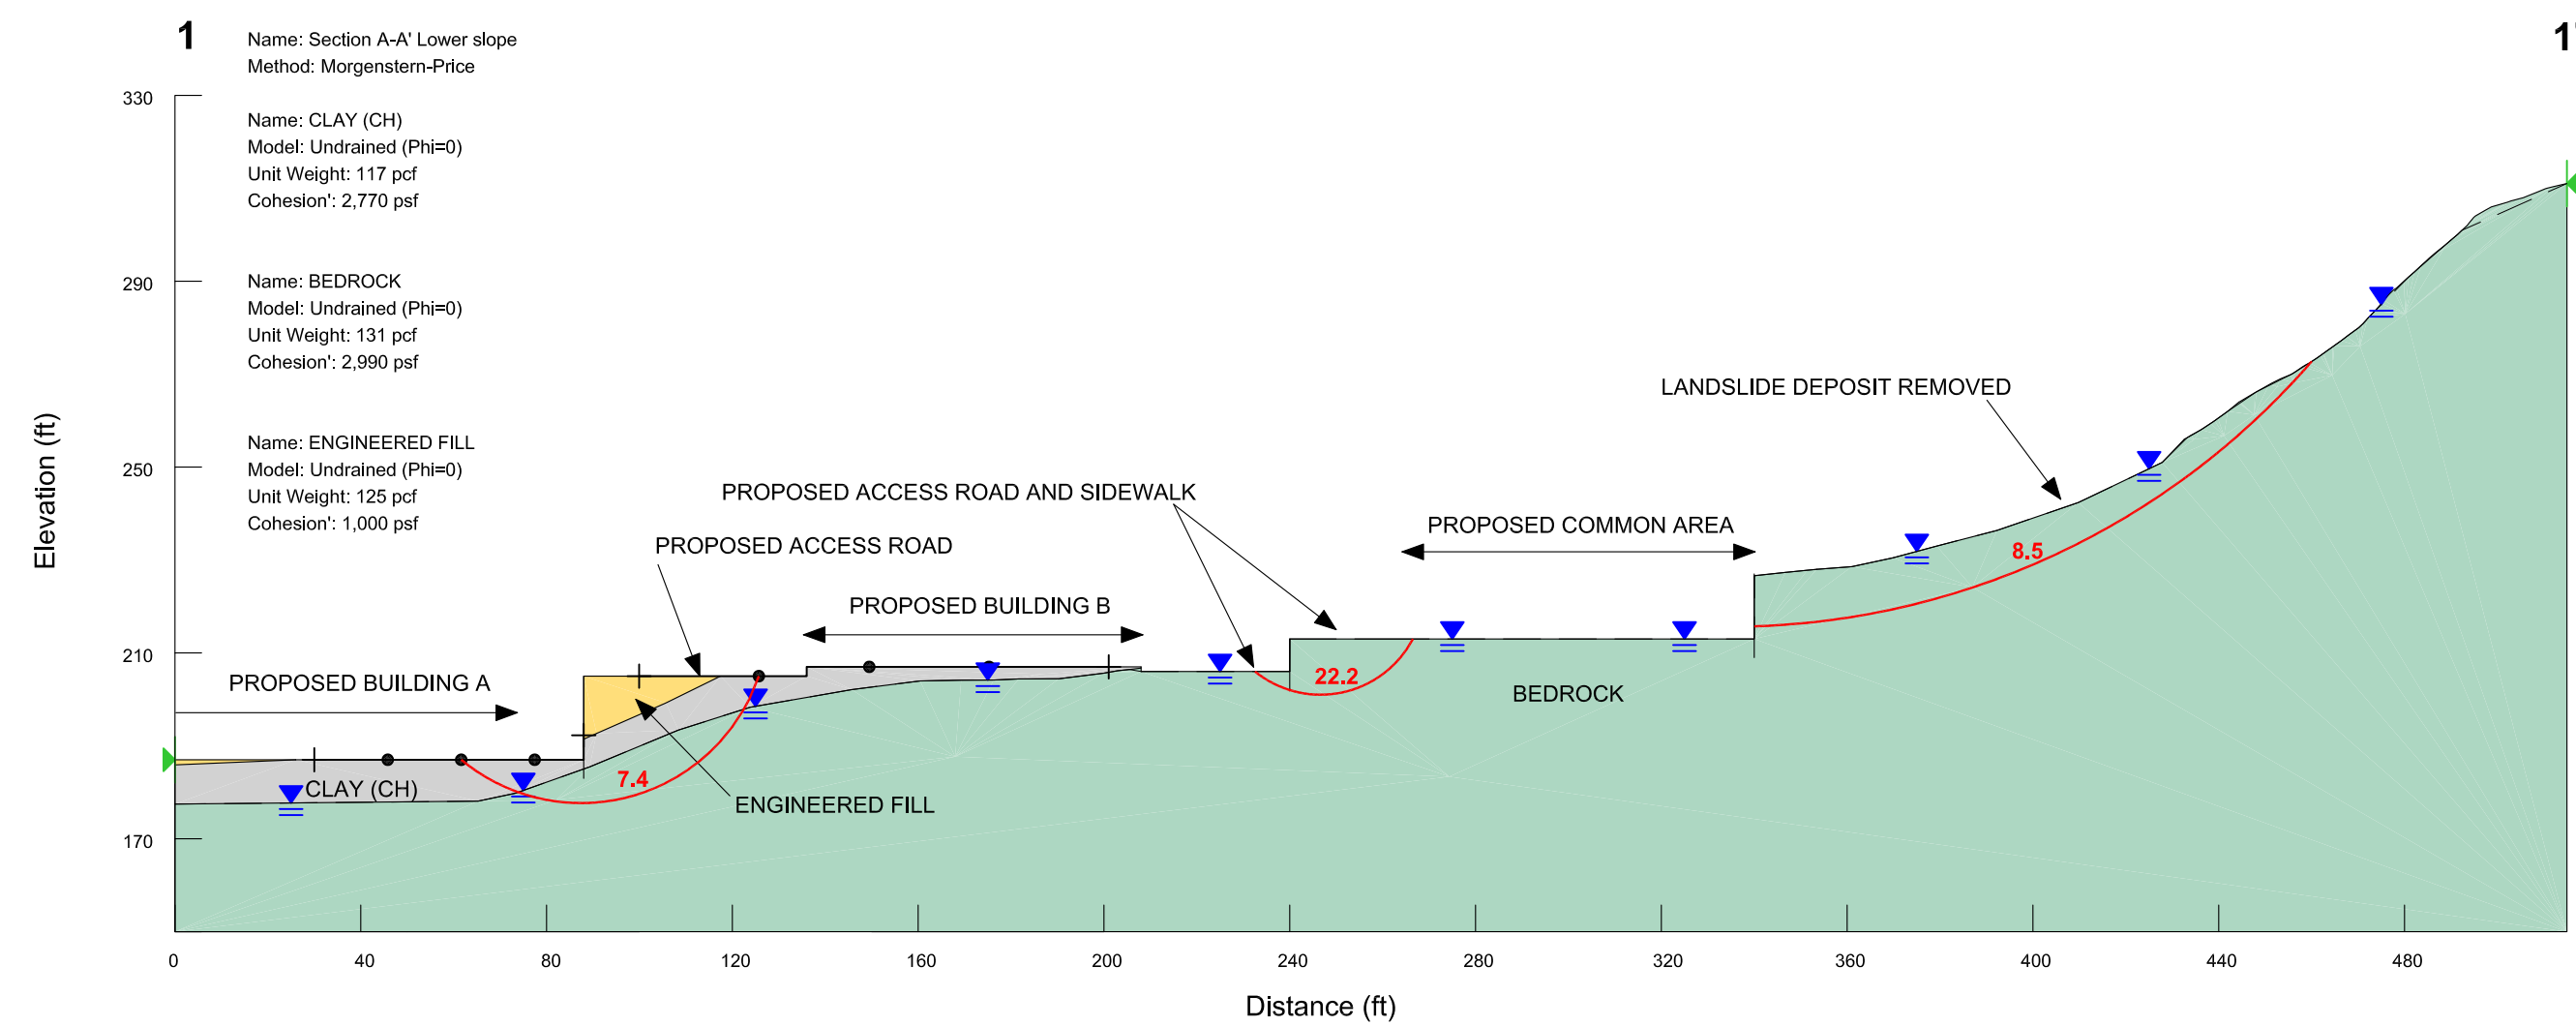
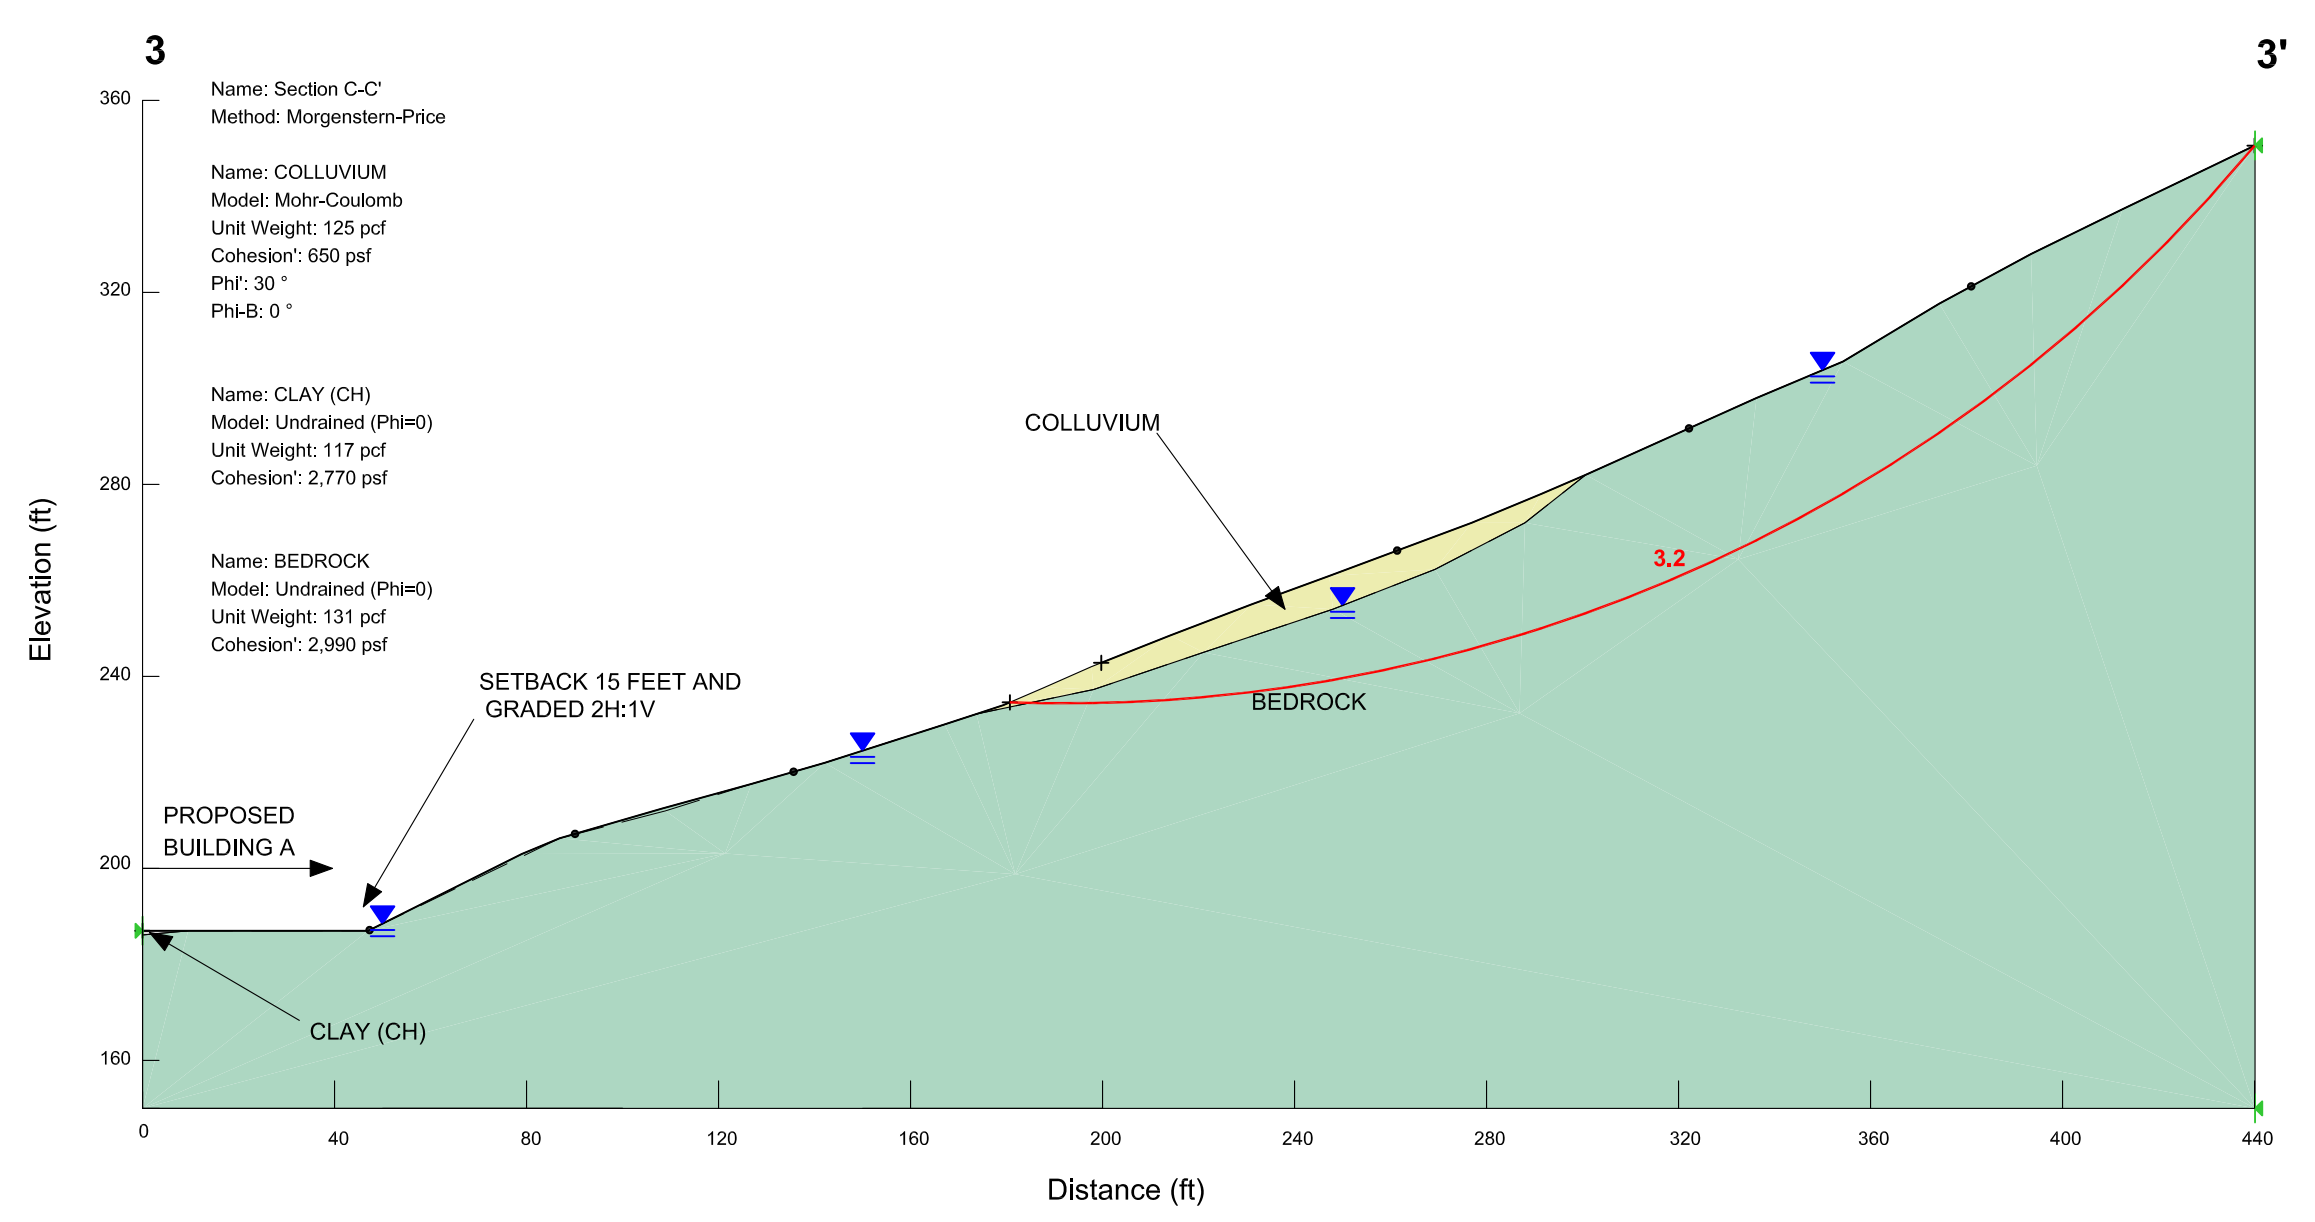
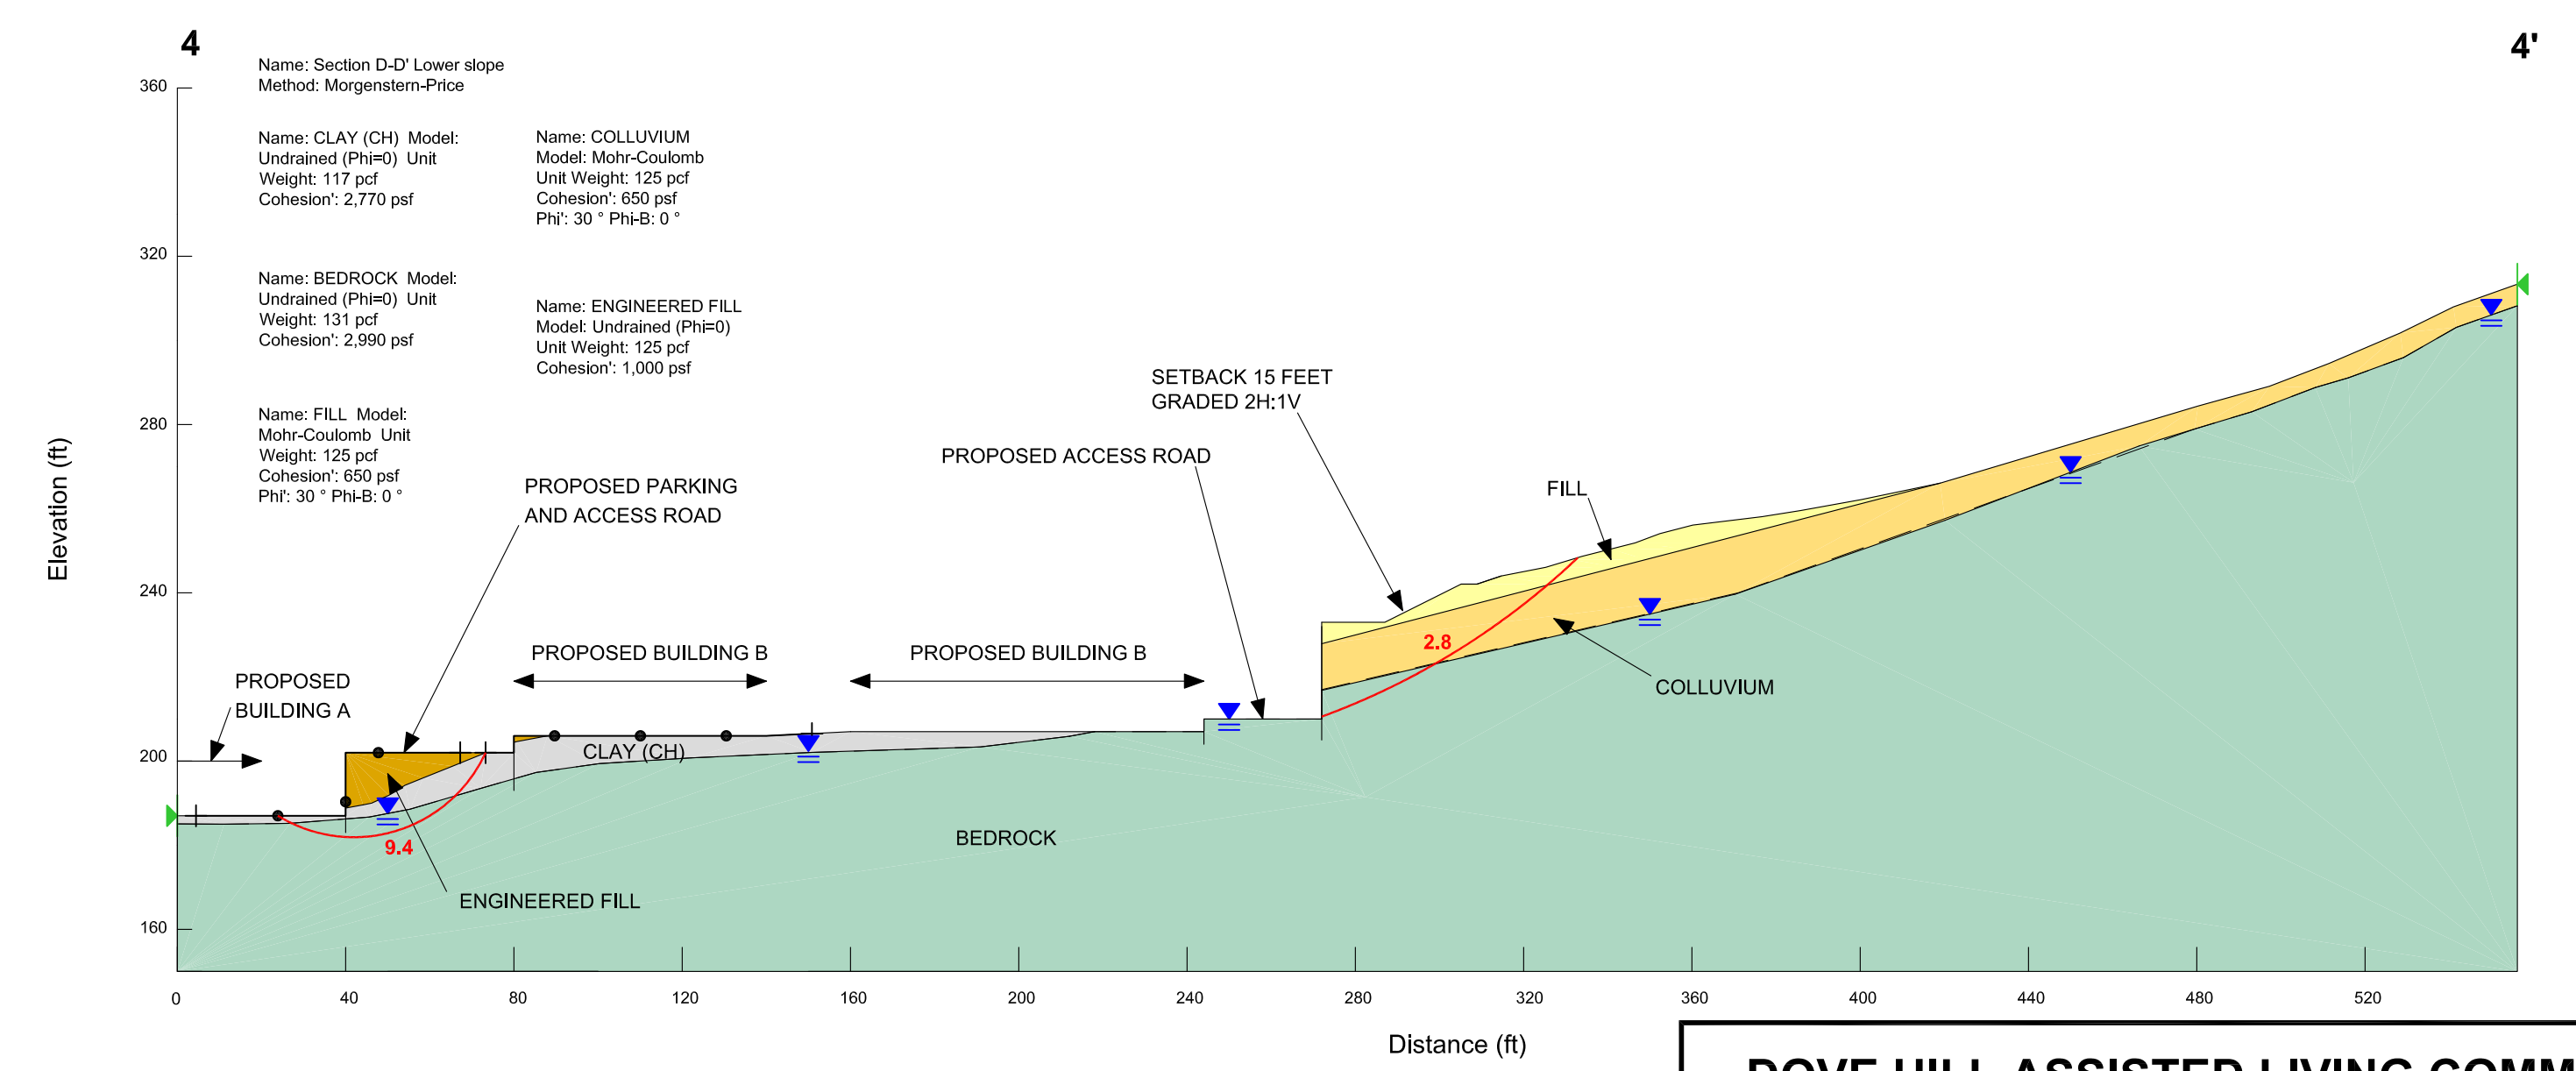
Date 02/26/16 Project No. 770619902 Figure 5

DOVE HILL ASSISTED LIVING COMMUNITY
4200 DOVE HILL ROAD
 San Jose, California
SLOPE STABILITY ANALYSIS
IDEALIZED SUBSURFACE PROFILES
1-1', 2-2', 3-3', AND 4-4'
POST GRADING

We have analyzed the slope stability on the site using the newly acquired data. In our initial evaluation we conservatively modeled the groundwater along the surface of the bedrock, however we did not portray this on our figures. The location of the critical slope failure surfaces and the location of the modeled groundwater surface for each of the profiles evaluated are provided on Figures 4 (current conditions) and 5 (proposed grading)/.

of our slope stability analyses and seismic slope displacements, which include the proposed grading, are summarized in Table 3. The location of the critical slope failure surfaces for each of the profiles evaluated are provided on Figure 5.

See response to comments 1 and 4 for additional details concerning the supplemental subsurface exploration, groundwater conditions, and results of the slope stability analyses. The location of the critical slope failure surfaces and the location of the modeled groundwater surface for section 3-3' are provided Figures 4 and 5.

The grading plans have been updated and are presented on the figures presented in Appendix C. In our initial evaluation we modeled the slopes under the existing and post-grading conditions both statically and seismically; however, since the engineering properties and grades have changed, we reassessed the slope analysis as suggested in previous comments. The location of the critical slope failure surfaces for each of the profiles evaluated are provided on Figure 5.

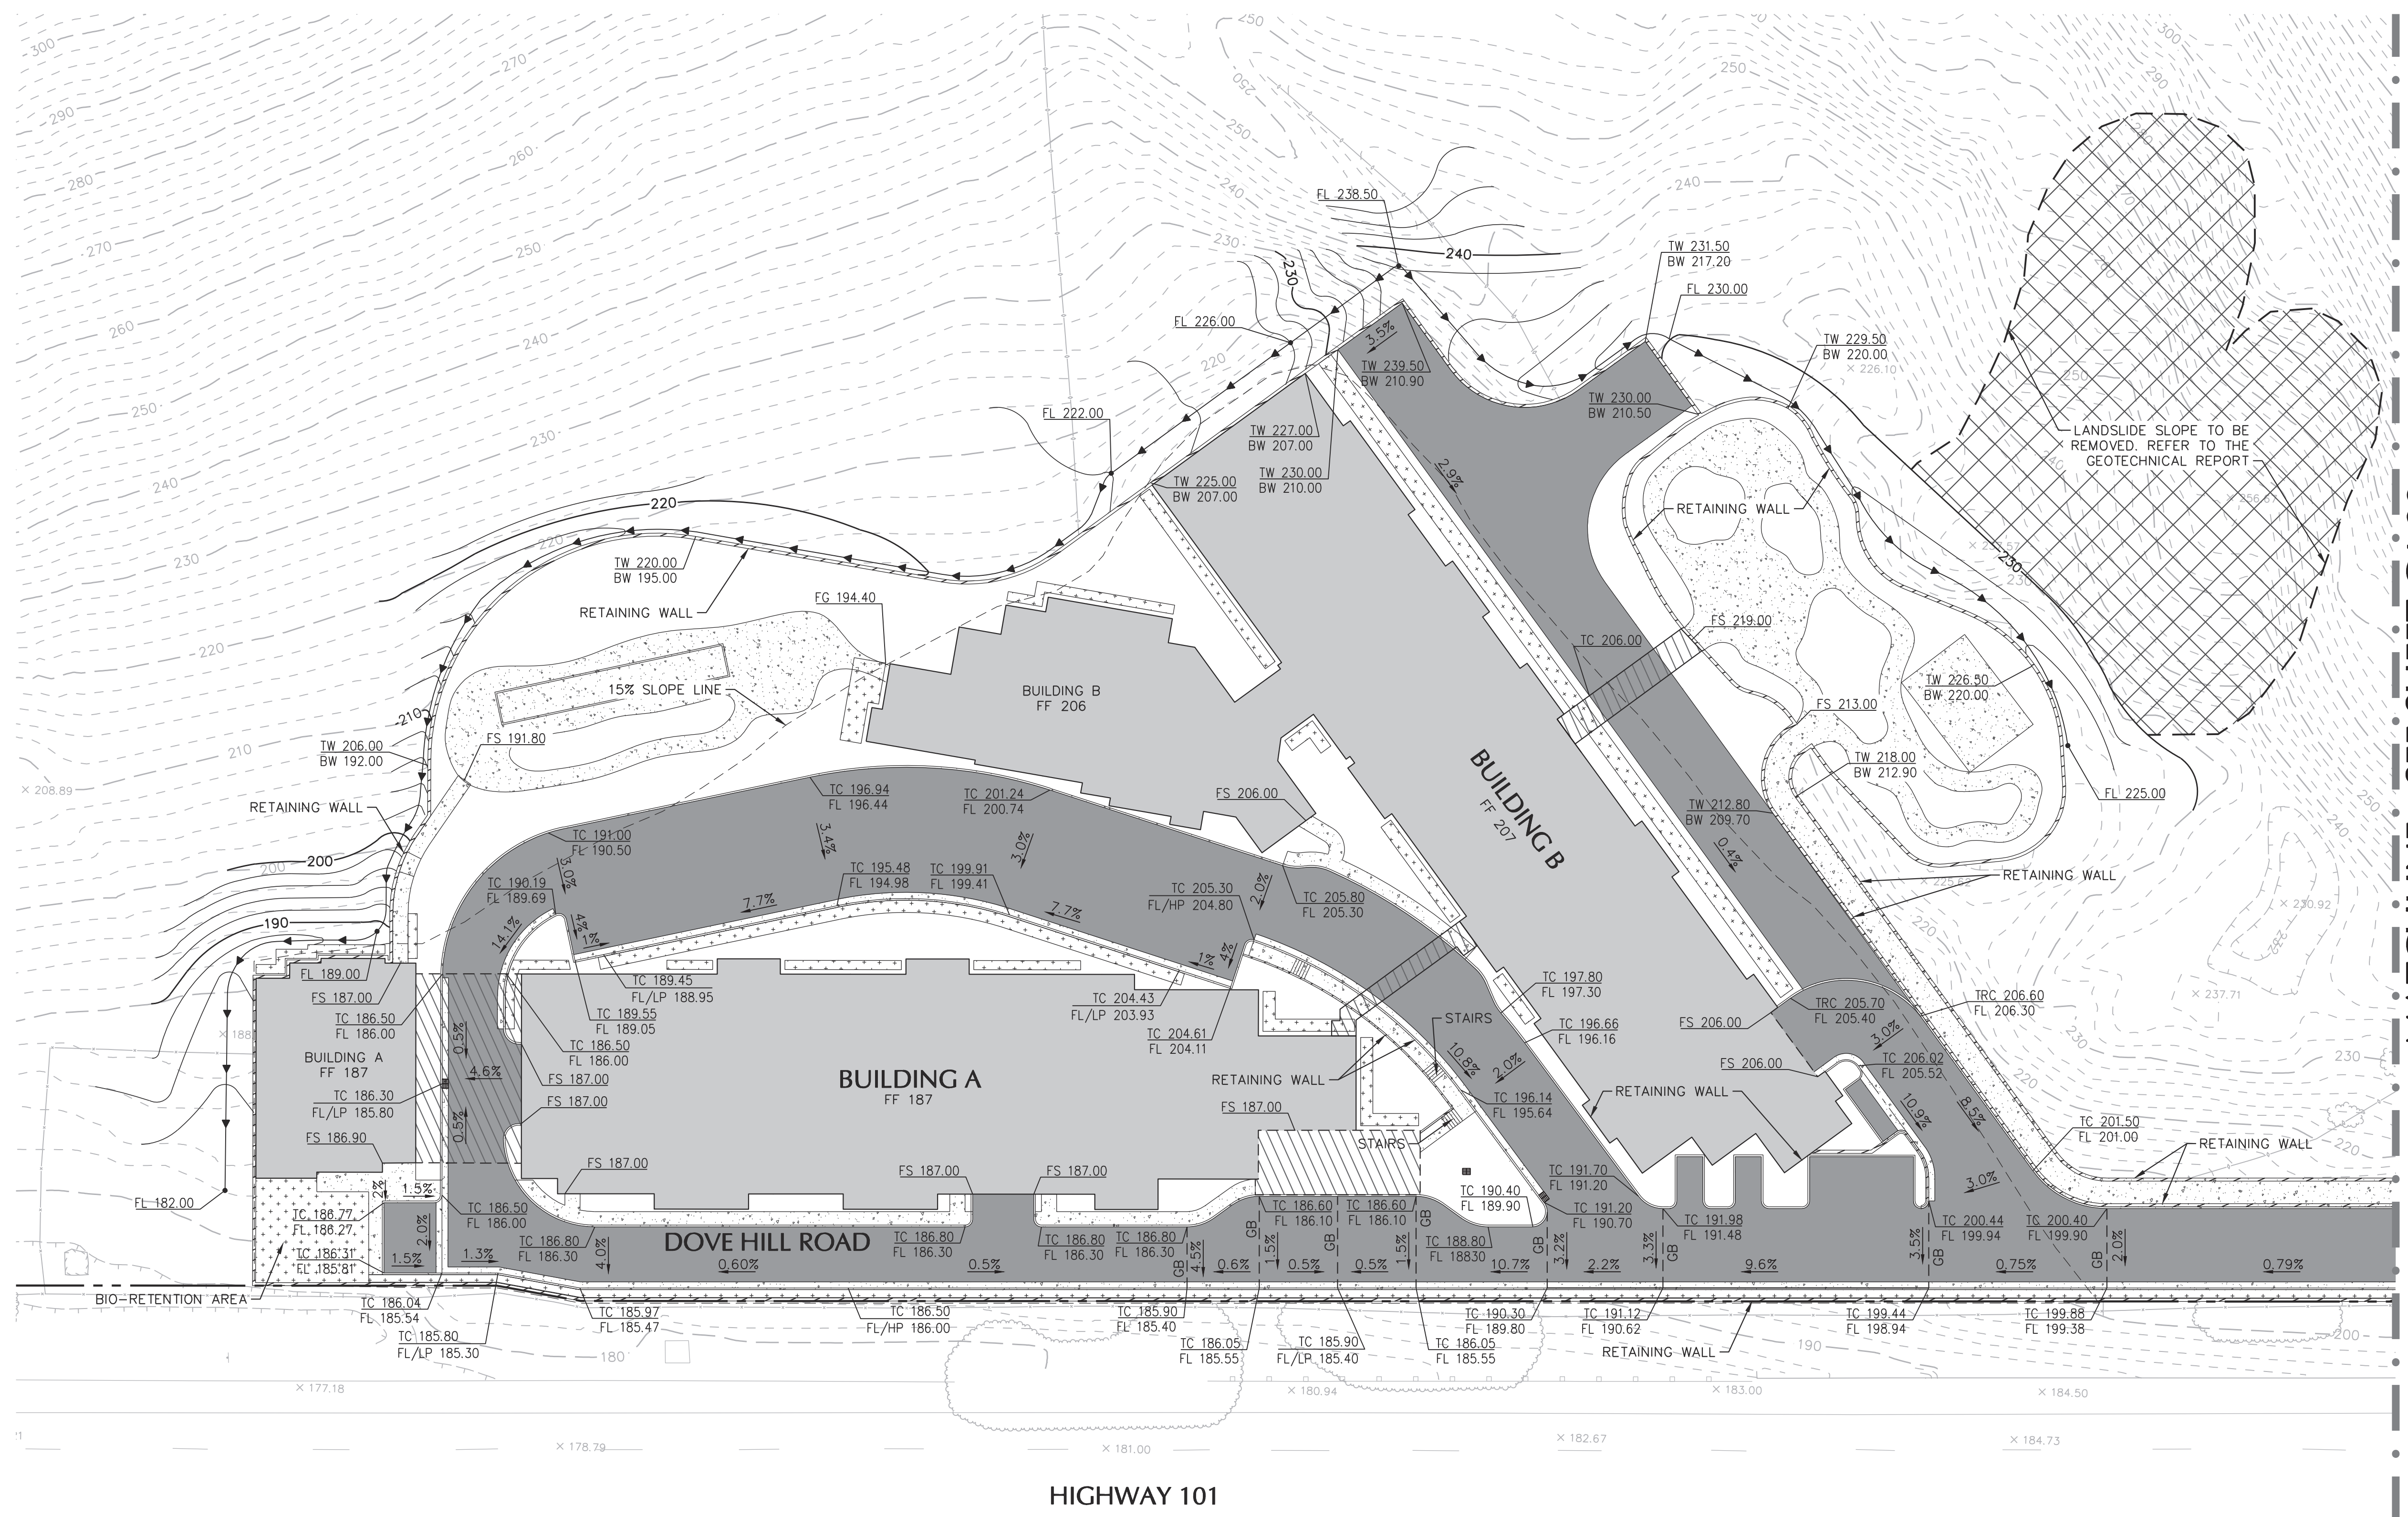
Drawing Title
GRADING PLAN

MATCHLINE - SEE SHEET C4.02

Project No. 770619901	Drawing No. C4.01
Date 2/26/2016	
Scale 1" = 30'	
Drawn By DKS	Checked By DJH
Submission Date X	Sheet 5 of 12
