TREE PROTECTION LEGEND

TREE LOCATION MAP

TREE INVENTORY

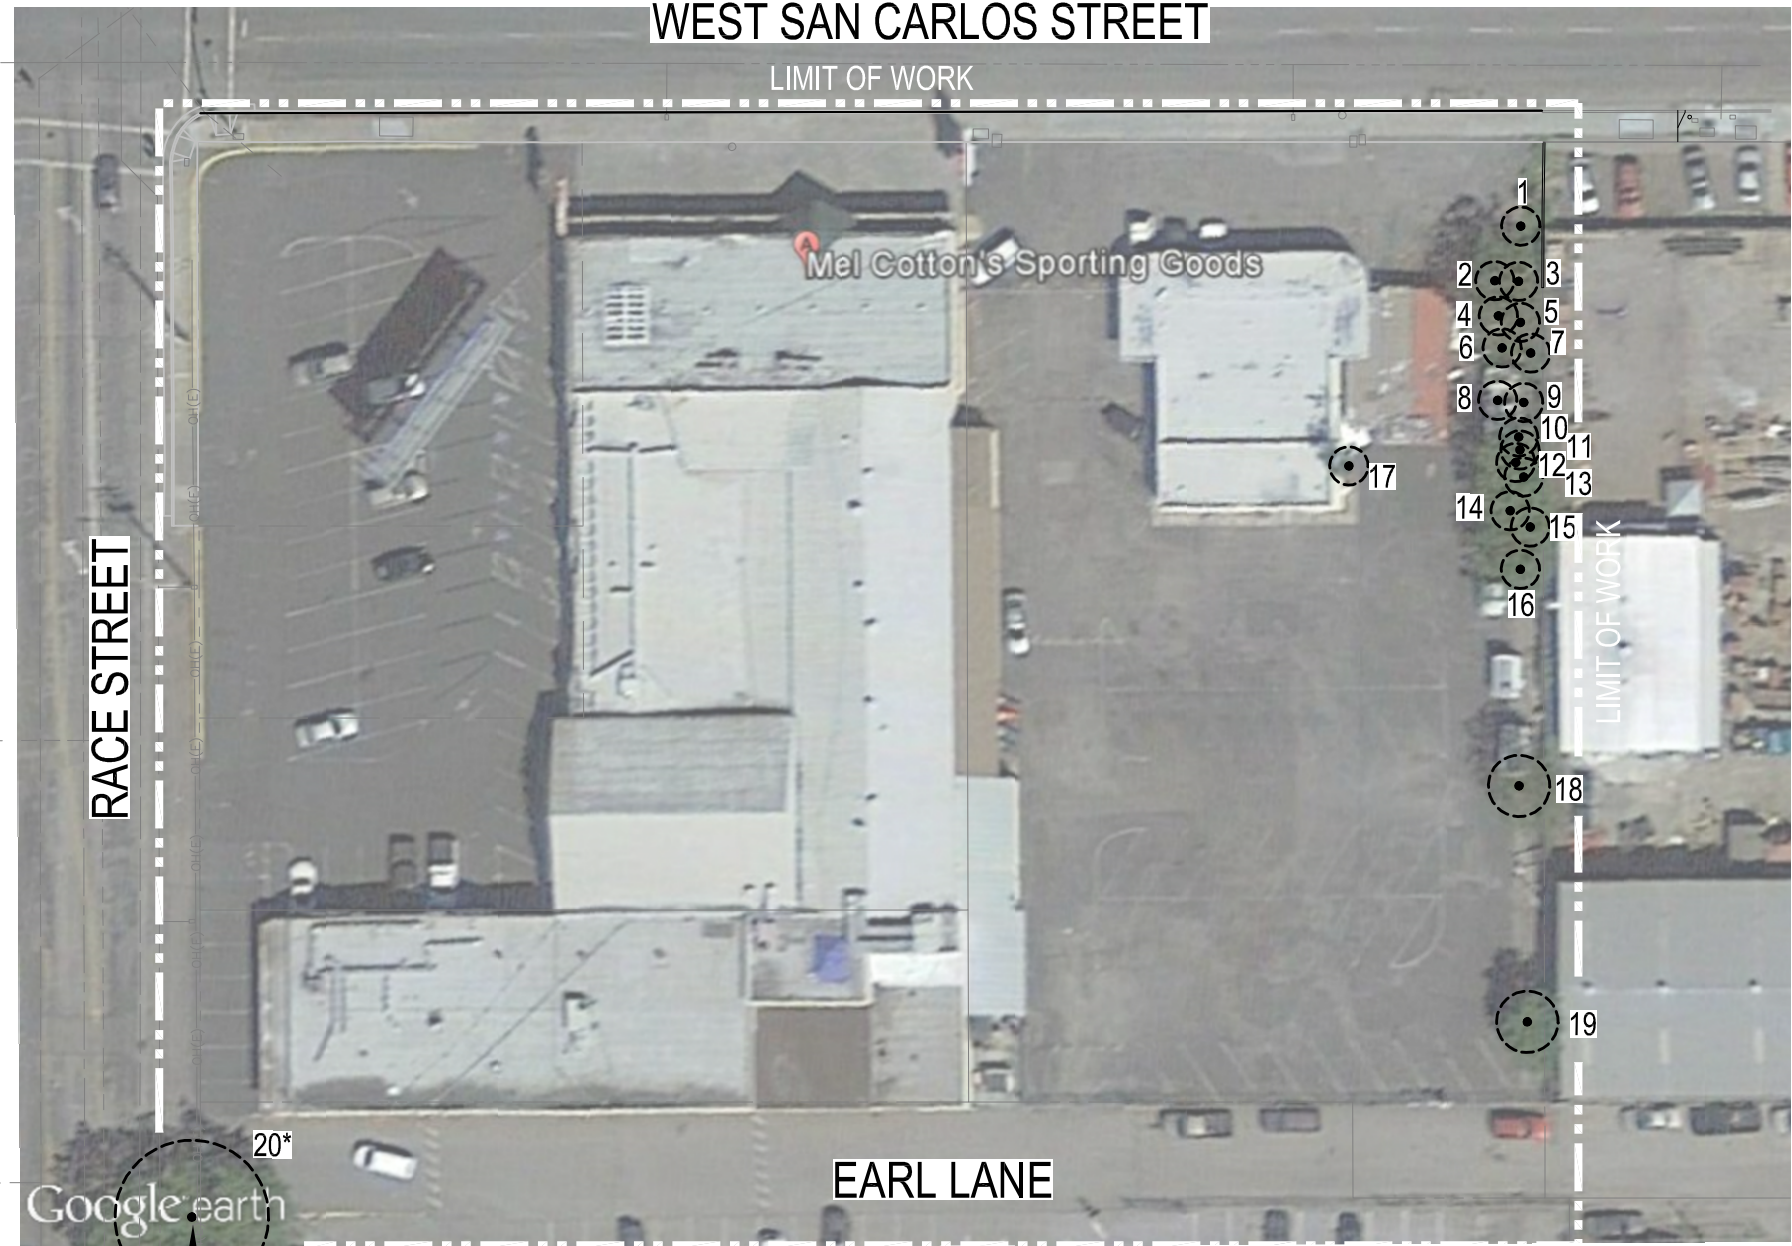
20*

OFF-SITE TREE

TOTAL TREES TO REMAIN	0
TOTAL TREES TO BE RELOCATED	0
TOTAL ON-SITE TREES TO BE REMOVED/MITIGATED (TREES 1-19)	19
TOTAL ON-SITE TREES TO BE REMOVED/MITIGATED (TREE 20)	<u>+ 1</u>
TOTAL EXISTING TREES IMPACTED BY PROJECT	20

TREE #	BOTANICAL NAME	COMMON NAME	MS DBH	TOTAL DBH	CIRCUMFERENCE	ORDINANCE TREE	LOCATION	NATIVE	HEALTH	PRESERVATION SUITABILITY	NOTES	DISPOSITION
1	Alianthus altissima	Tree of Heaven	3.5"x5, 3.1"x7, 1"	49.2	154	YES	Eastern property line	No	2	Poor	volunteer-invasive species	Remove
2	Alianthus altissima	Tree of Heaven	-	4.0	13		Eastern property line	No	2	Poor	volunteer-invasive species	Remove
3	Alianthus altissima	Tree of Heaven	-	4.0	13		Eastern property line	No	2	Poor	volunteer-invasive species	Remove
4	Alianthus altissima	Tree of Heaven	6"x3, 4	21.0	66	YES	Eastern property line	No	2	Poor	volunteer-invasive species	Remove
5	Alianthus altissima	Tree of Heaven	6"x3, 4	21.0	66	YES	Eastern property line	No	2	Poor	volunteer-invasive species	Remove
6	Alianthus altissima	Tree of Heaven	4, 5	9.0	28		Eastern property line	No	2	Poor	volunteer-invasive species	Remove
7	Alianthus altissima	Tree of Heaven	-	2.0	6		Eastern property line	No	2	Poor	volunteer-invasive species	Remove

TREE #	BOTANICAL NAME	COMMON NAME	MS DBH	TOTAL DBH	CIRCUMFERENCE	ORDINANCE TREE	LOCATION	NATIVE	HEALTH	PRESERVATION SUITABILITY	NOTES	DISPOSITION
19	<i>Alanthus altissima</i>	Tree of Heaven	7, 3, 3, 4	17.0	53		Eastern property line	No	2	Poor	volunteer-invasive species	<i>Remove</i>
20*	<i>Alanthus altissima</i>	<i>Tree of Heaven</i>	-	40.6	127	YES	<i>offsite, under power lines</i>	<i>No</i>	3	<i>Poor</i>	<i>*Off-site tree, In conflict with required driveway</i>	<i>Remove</i>
