**UPDATED GEOLOGIC AND GEOTECHNICAL STUDY
PROPOSED RESIDENTIAL DEVELOPMENT**

**GSCHWEND PROPERTY
APNS 708-21-004 AND -005
SANTA TERESA BOULEVARD
SAN JOSE, CALIFORNIA**

8 January 2016
Document Id. 15077C-01R1

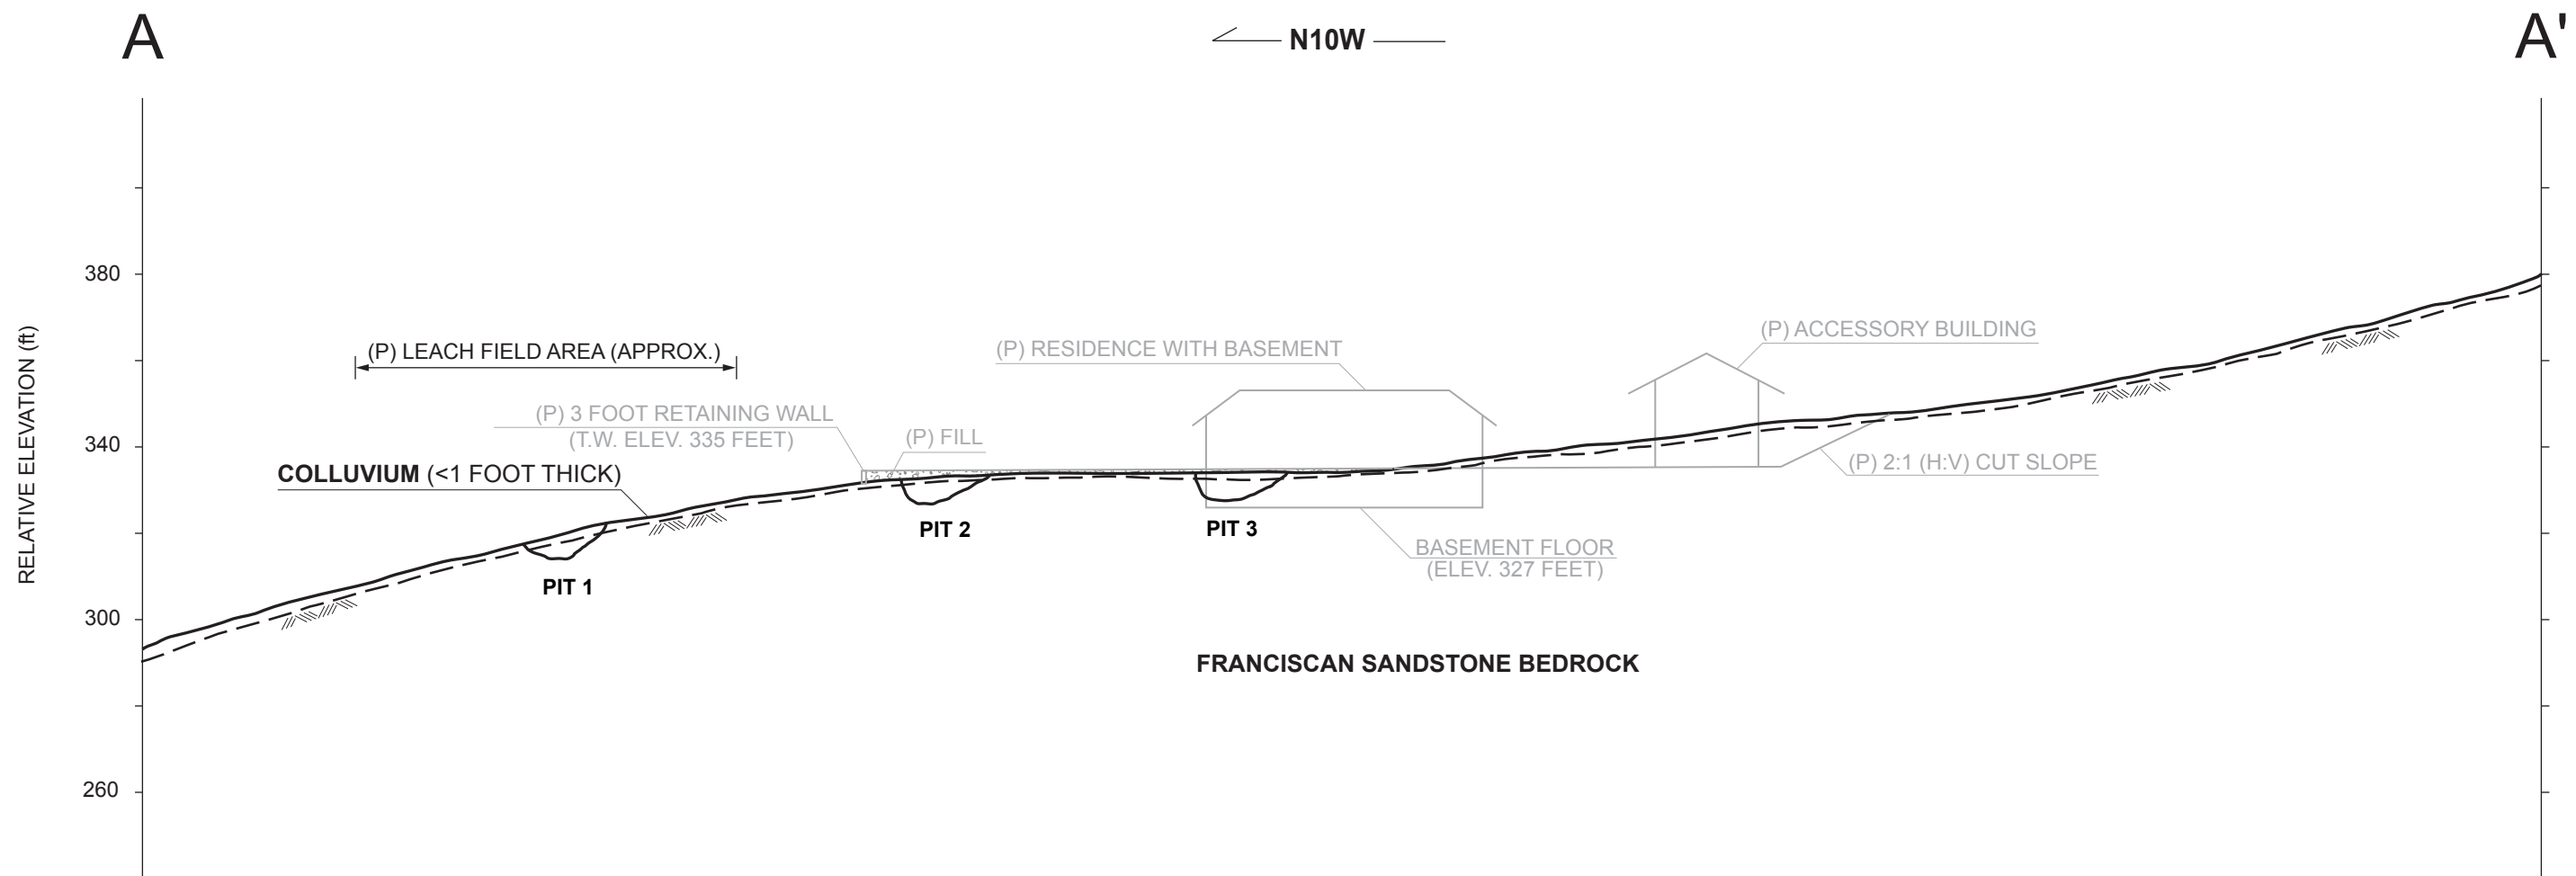
GEOLOGIC CROSS-SECTION A-A'				
UPP GEOTECHNOLOGY a division of C2EARTH, INC.		GSCHWEND PROPERTY APNs 728-21-004 and -005 Santa Teresa Boulevard San Jose, California		
DRAFTED/REVIEWED	SCALE	DOCUMENT ID.	DATE	Figure 6
EB/CH	1" = 40'	15077C-01R1	January 2016

NOTE: This cross-section is a conceptual illustration of general subsurface relationships and should not be used for any other purpose.

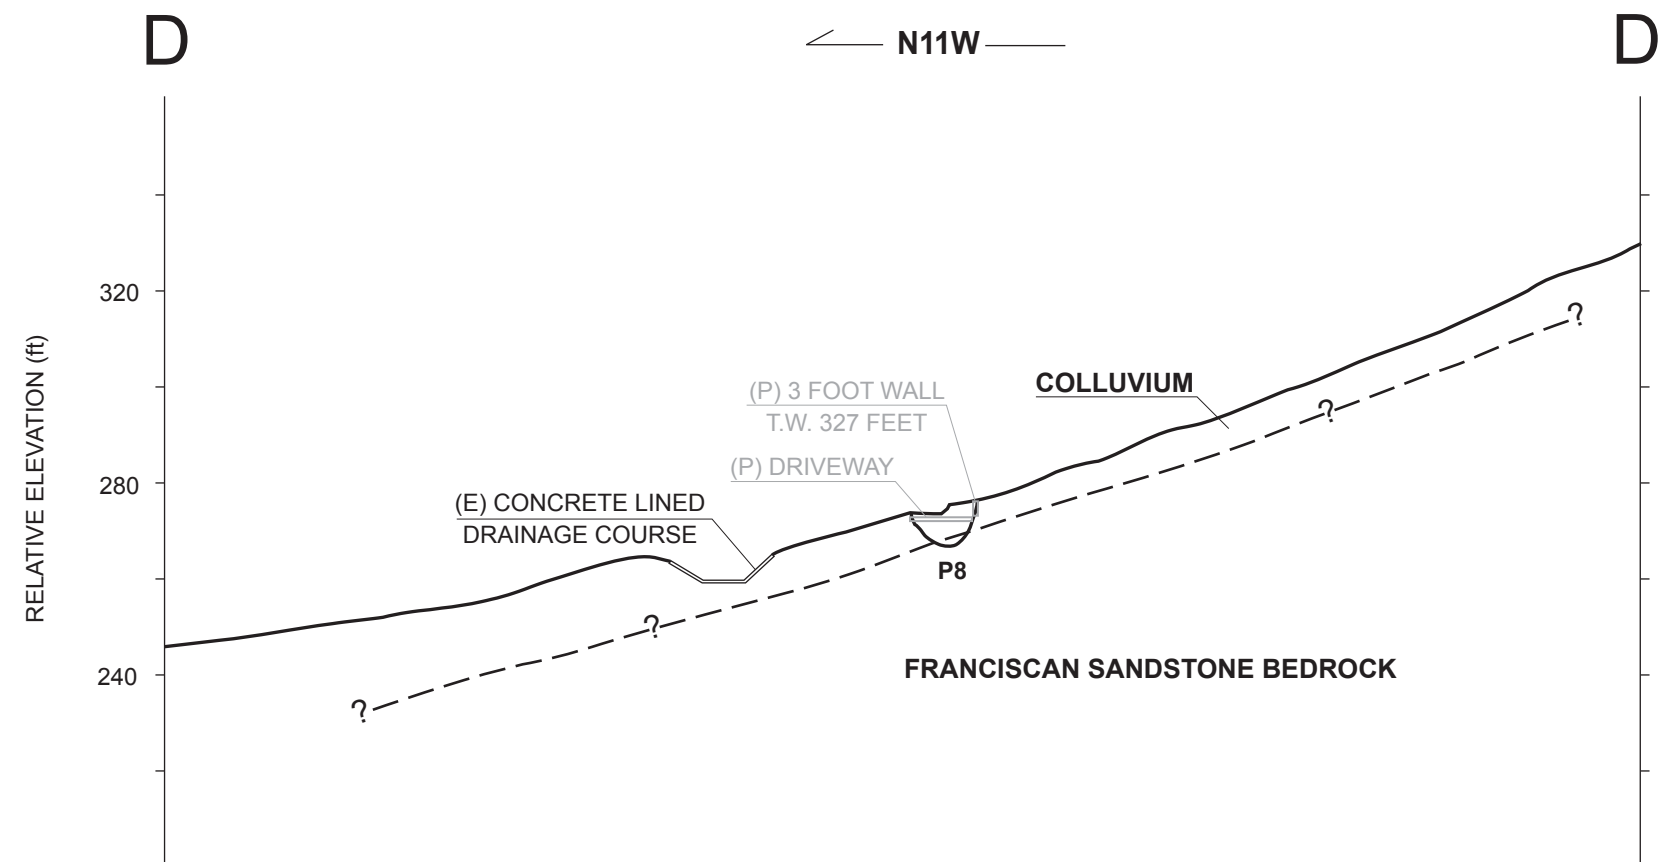
GEOLOGIC CROSS-SECTION D-D'					
UPP GEOTECHNOLOGY a division of C2EARTH, INC.		GSCHWEND PROPERTY APNs 728-21-004 and -005 Santa Teresa Boulevard San Jose, California			
		DRAFTED/REVIEWED	SCALE	DOCUMENT ID.	DATE
EB/CH		1" = 40'	15077C-01R1	January 2016	Figure 9

NOTE: This cross-section is a conceptual illustration of general subsurface relationships and should not be used for any other purpose.

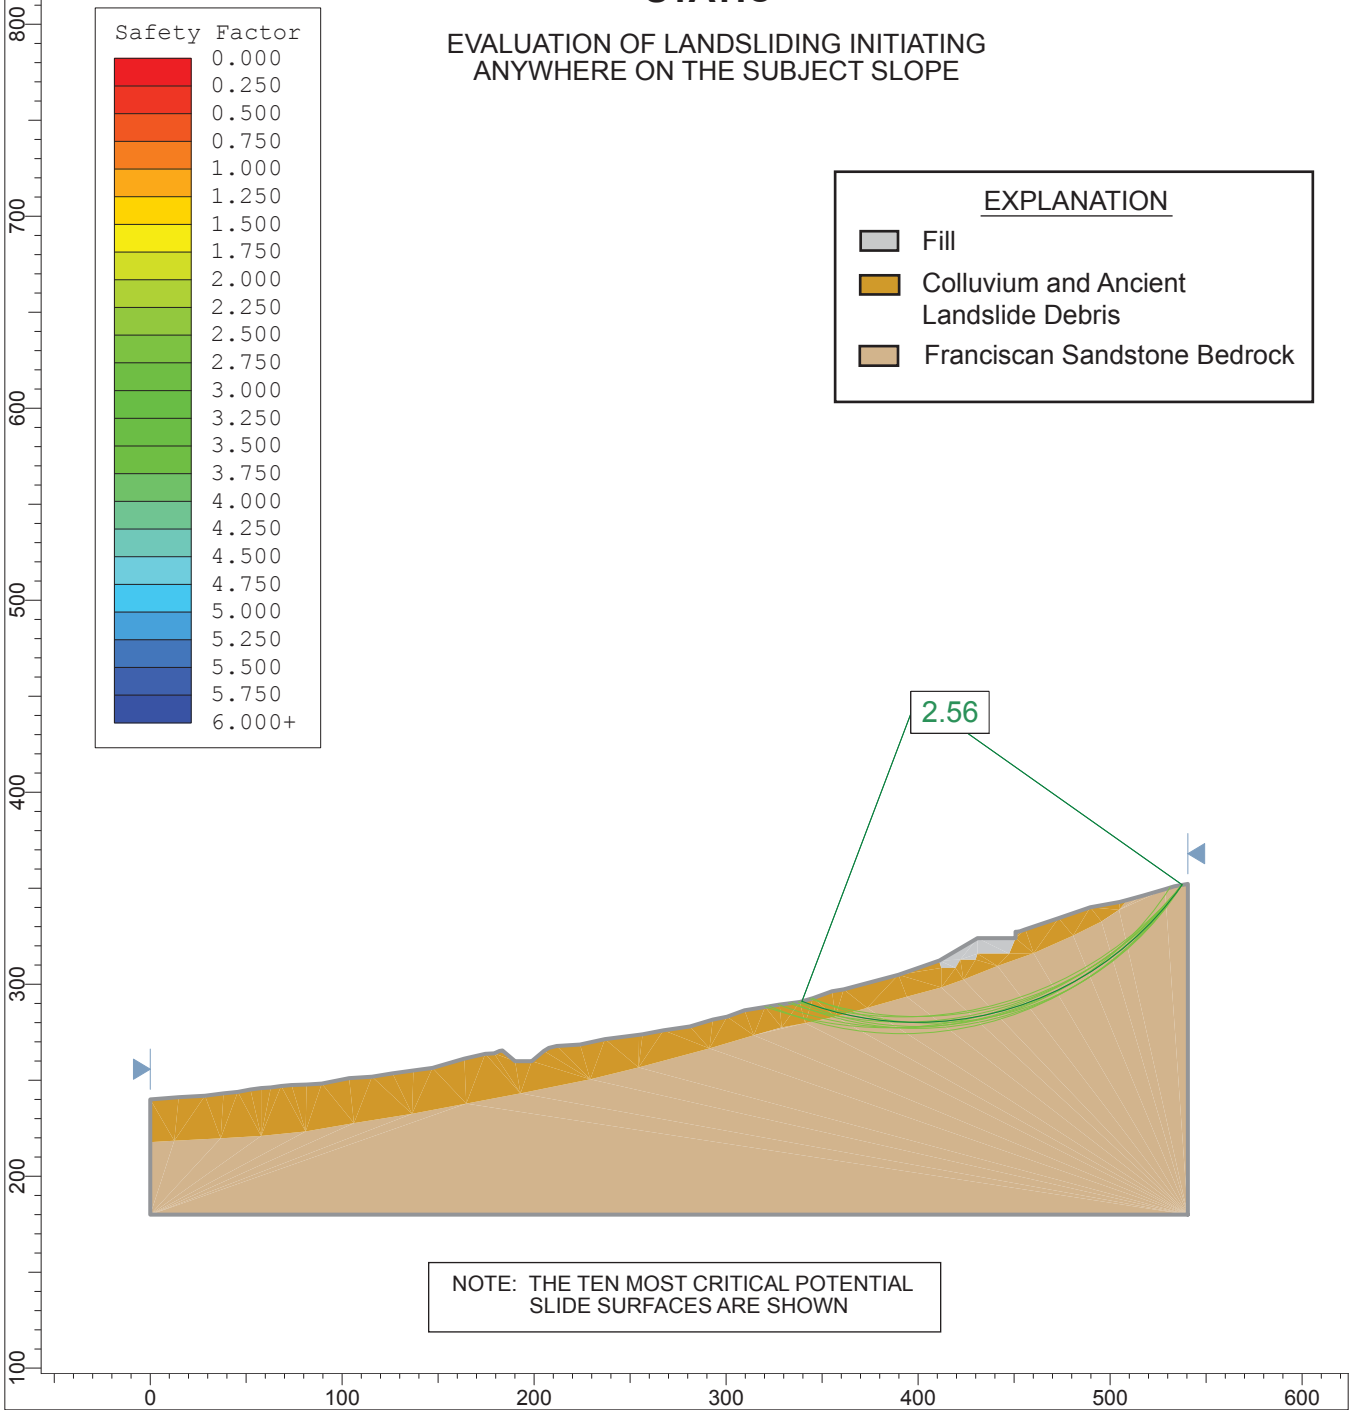
GSCHWEND PROPERTY CROSS-SECTION B-B' STATIC

EVALUATION OF LANDSLIDING INITIATING
ANYWHERE ON THE SUBJECT SLOPE

NOTE: THE TEN MOST CRITICAL POTENTIAL
SLIDE SURFACES ARE SHOWN

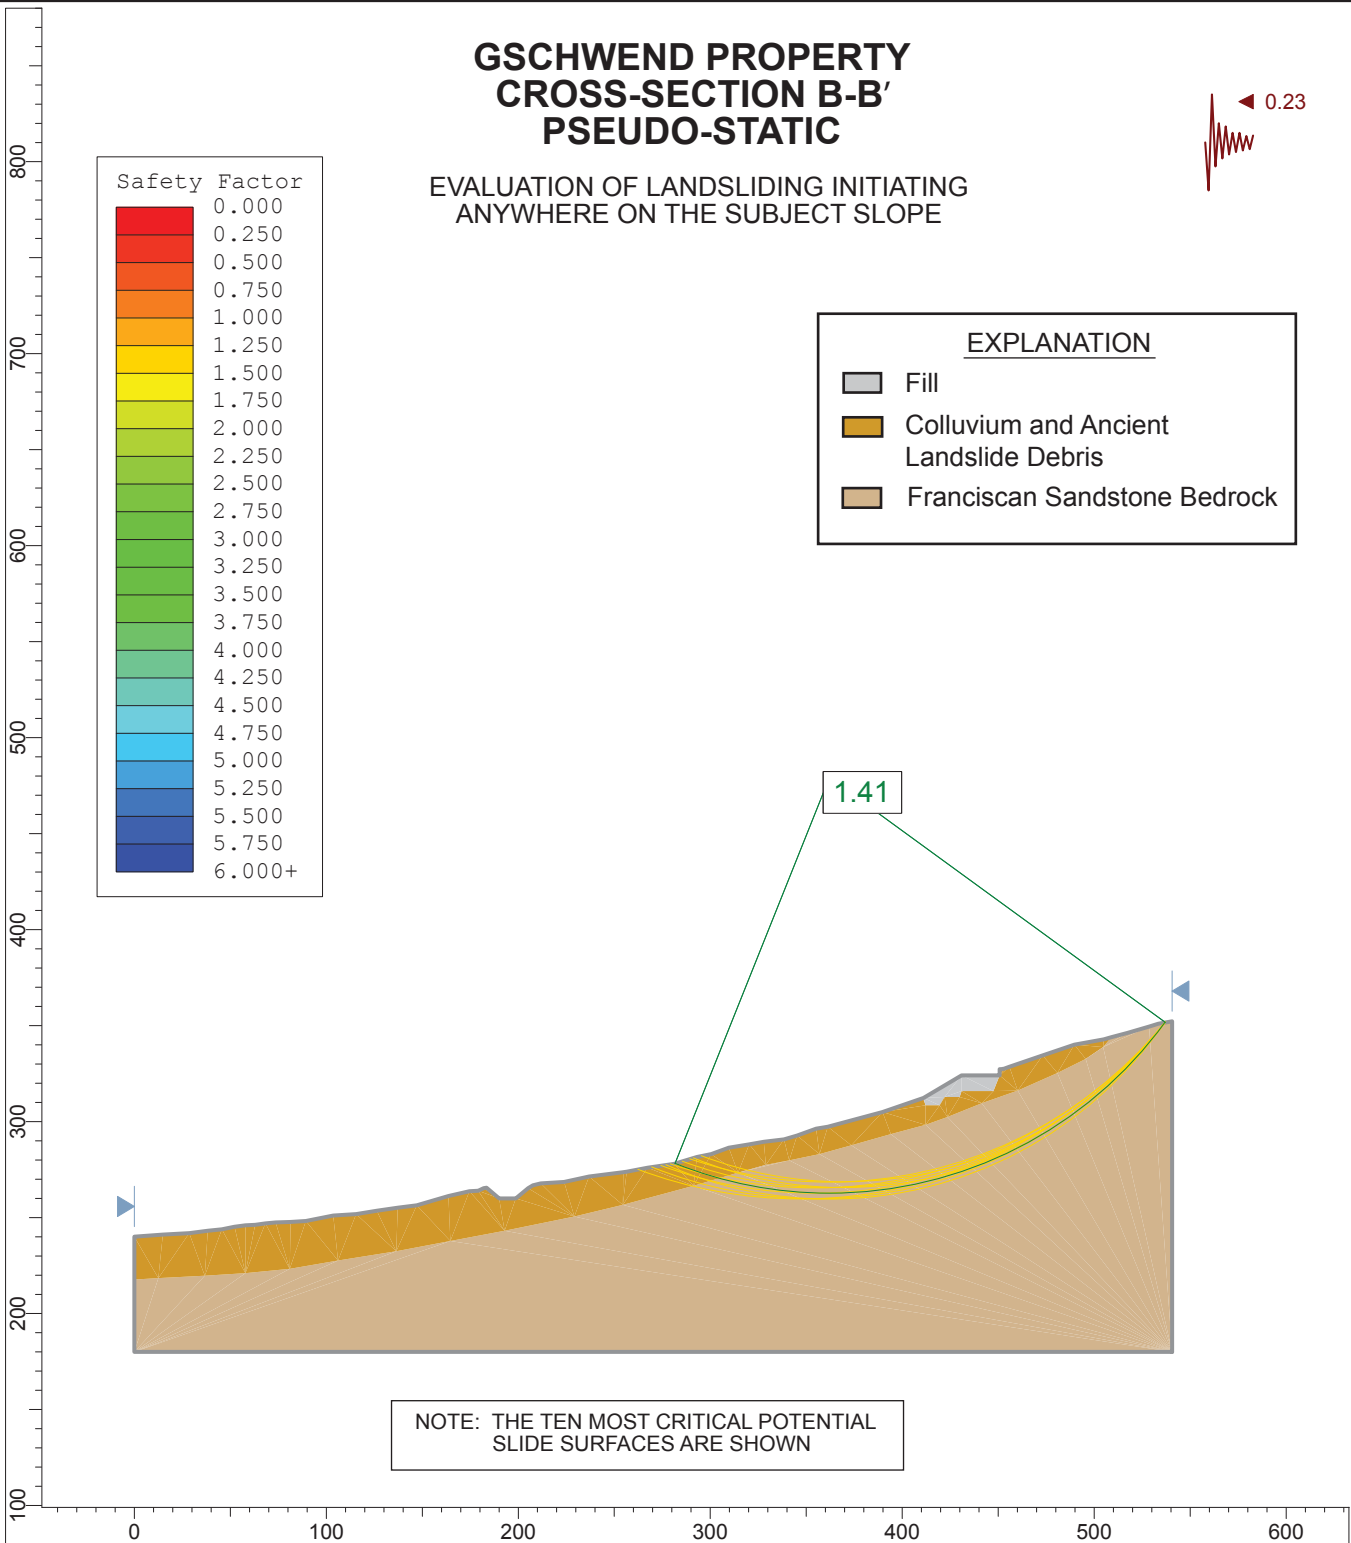
GSCHWEND PROPERTY CROSS-SECTION B-B' PSEUDO-STATIC

EVALUATION OF LANDSLIDING INITIATING
ANYWHERE ON THE SUBJECT SLOPE

EXPLANATION	
	Fill
	Colluvium and Ancient Landslide Debris
	Franciscan Sandstone Bedrock

NOTE: THE TEN MOST CRITICAL POTENTIAL
SLIDE SURFACES ARE SHOWN
