September 2020

MASTER PLAN REPORT

PAYNE AVE PARK

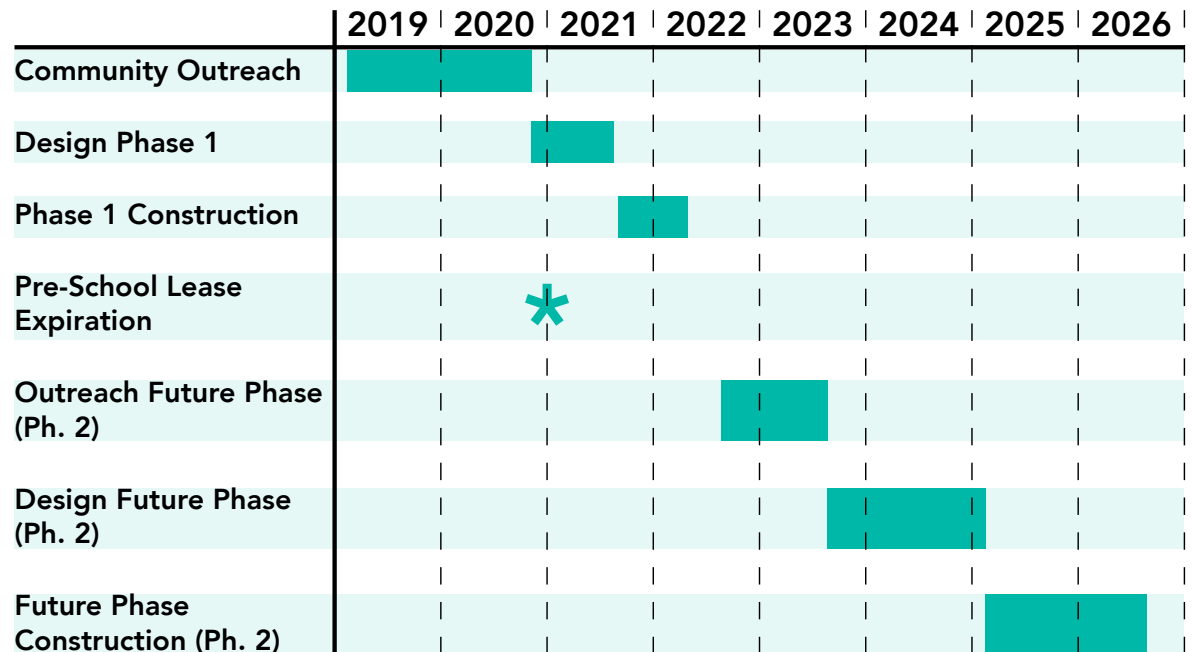
Figure 11. Phasing Schedule

Phase 2

- Build community center
- Complete parking lot

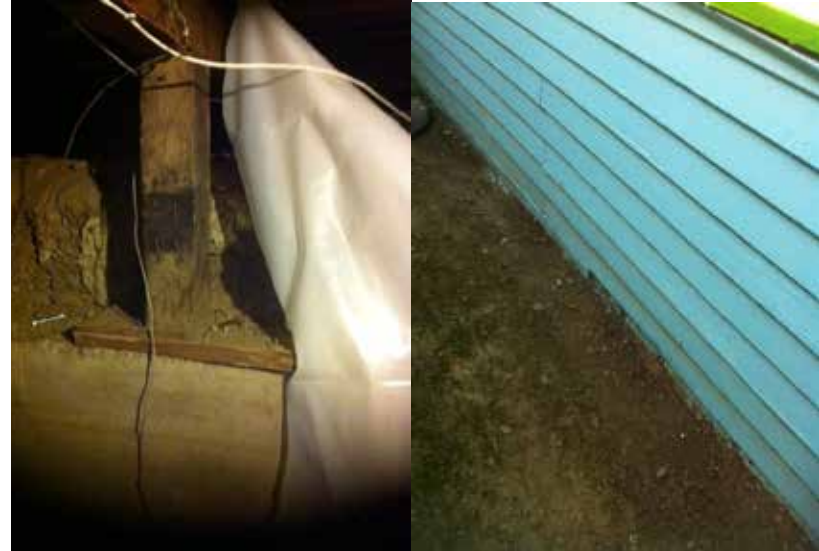
Photos 1 and 2.

In examination of the basement, it appears the structure is not bolted to the foundation, and is therefore subject to being severely damaged in a seismic event and pose a hazard to building occupants. (see photos 1). In addition, the foundation exterior on the east and west sides of the house exhibit evidence of concrete spalling, and possible soil shifting. (see photo 2).The house would need to be bolted to the foundation at a minimum, with possible other foundation work needed. Note that a more thorough foundation inspection would need to be conducted by a structural engineer to verify the visual observations.

The exterior siding of the structure appears to have areas of dry rot, and also comes within 1" of the soil line in places. (see photo 2). Parts of the siding would need to be replaced.

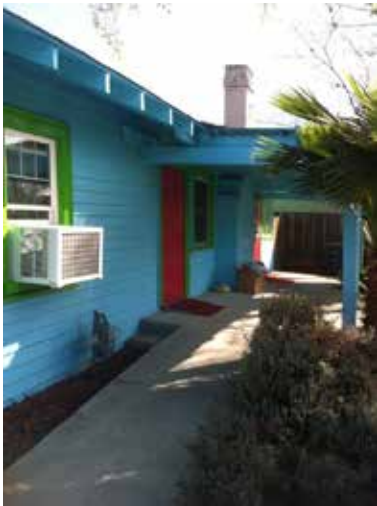
Photo 3.

In examining the masonry chimney, it appears to be a non-reinforced masonry, as it is leaning outward slightly away from the roof. In a seismic event, it could collapse in on top of the front porch cover. (see photo 3). The chimney would need to be removed.

The concrete ramp to the front entrance is of a slope greater than 1:12, and does not have handrails, curbs, or visual warning strips. The porch to house front door threshold is greater than 1/2", and has been adjusted using a metal transition strip, which does not meet current CBC standards. (see photo 3). In addition, the eastern most front door entrance is lacking the code required door hardware and side clearance (24") on the pull side. The front ramp, porch entry, door, door threshold and hardware would need to be replaced.

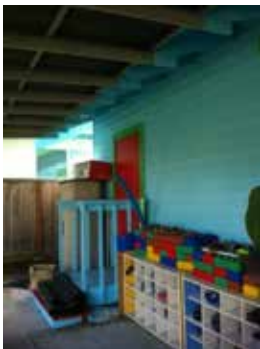
Photo 4.

In examining the rear porch cover, the framing and bolting of the cover framing are of a non-standard nature, and likely added later. There appears to be dry rot in several areas of the plywood covering the framing. Additionally, the cover framing members are bolted to the ends of the roof framing, which is structurally hazardous, as the ends of framing members are not rated to carry the added loads of this nature. In a seismic event, the porch cover could collapse thereby preventing exit from the building. (see photo 4). The rear porch cover would need to be removed.

The rear exits consist of wood stairs and handrails which do not comply with current CBC or ADA standards. The stair treads are not CBC compliant for step height or width, and landing size, and the handrails do not meet current ADA or CBC standards regarding spacing of vertical pickets, or height and construction of the rails. Both rear exit structures would need to be replaced with new ramps with compliant handrails. (see photo 4).

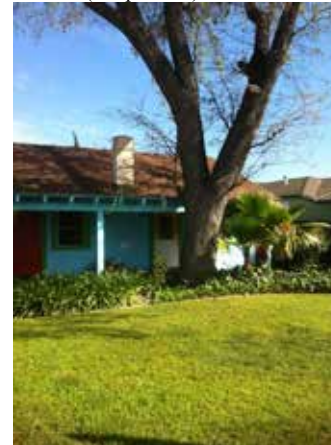
Photo 6.

A triple trunk oak tree of approx. 40" in diameter is growing directly against the edge of the southeast corner of front porch cover, with one trunk leaning towards the house. In a wind event, it is possible the large tree could fail, and thereby cause significant damage to the roof of the structure. An arborist would need to be consulted regarding the stability of the tree, and possible removal of the front porch cover to ensure the safety of the building occupants, if the tree were to remain. (see photo 6).

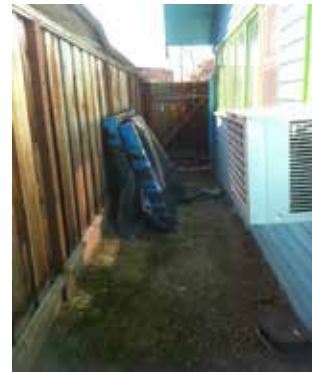
Photo 7.

The eastern roof line of the structure (wood construction) appears to be approximately 1'-6" from the east property line. The California Building Code (CBC) requires at least 5 feet from any wooden structure to the property line, to prevent the spread of fire. (see photo 7). The roof line would need to be cut back to achieve the minimum clearance.

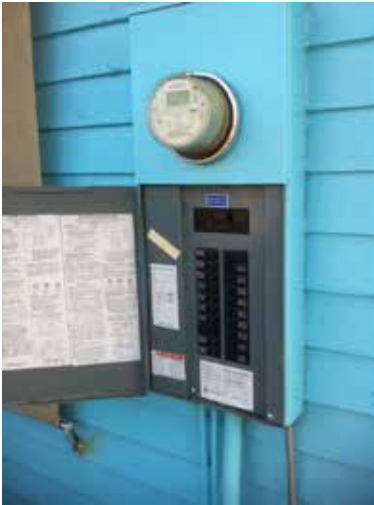
Photo 11.

The electrical subpanel appears to have been replaced several years ago, and appears serviceable for the current use. However, the electrical service main appears to be of a low Amperage, and not adequate for installation of new lights, fire alarms, restroom equipment, and other electrical service needs. The service would need to be upgraded to at least a 200 AMP service or greater, which would require new electrical equipment, as well as a new PG and E service main. (see photo 11). The actual amperage needed for a new or upgraded facility would need to be verified by an electrical engineer.

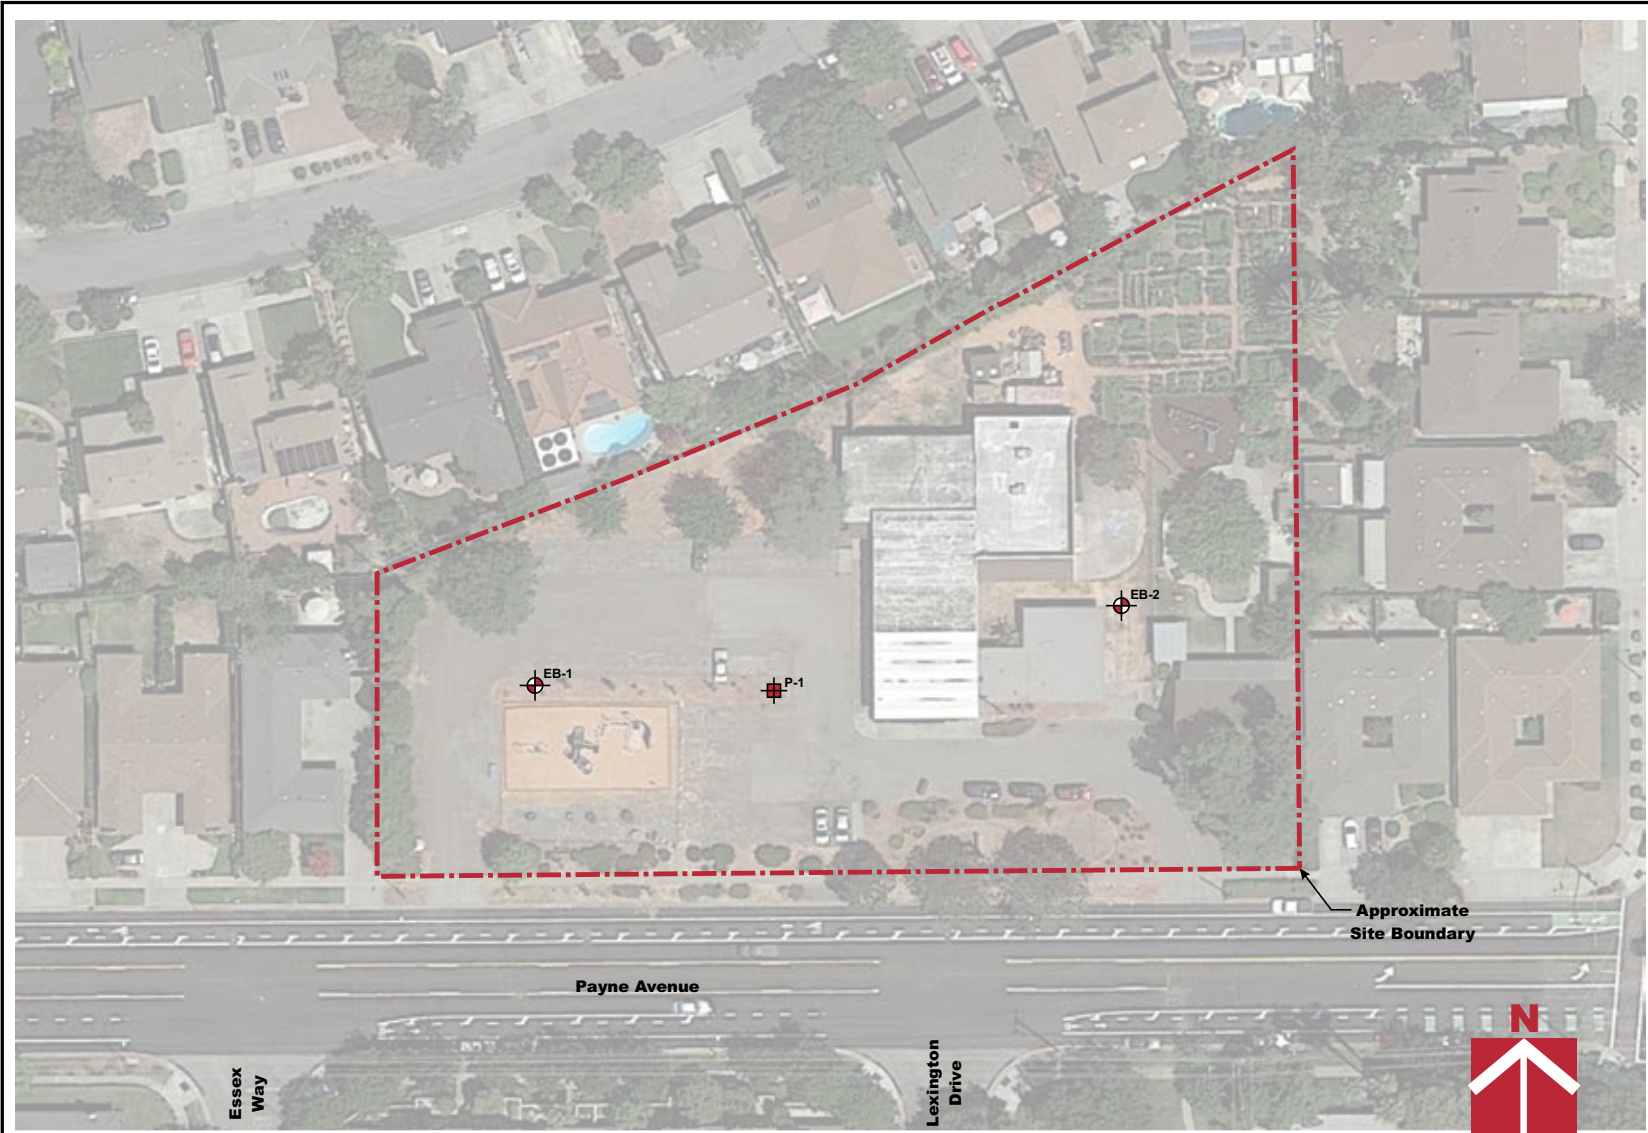
Site Plan Pueblo De Dios Park 3257 Payne Avenue San Jose, CA	Project Number 473-8-1
	Figure Number Figure 2	Date February 2019
		Drawn By RRN

Base by Google Earth, dated 8/9/2018

Our understanding of the project is based on our conversations with Mr. David Rubin of Callander Associates. The project site is located at 3257 Payne Avenue in San Jose, California. The site is currently the existing Pueblo de Dios Park and includes a church building, a child daycare facility, play equipment, natural turf and landscape areas, sidewalks and a patio area, and paved parking. We understand the new improvements currently planned for the site generally include lighting, walkways, fitness and play equipment, and new pavement. Conceptual plans were not available at the time of this letter report. A site plan showing the existing conditions is shown on our Site Plan, Figure 2.

Groundwater was not encountered within our borings or our percolation test hole. Historic high groundwater maps prepared by the California Geologic Survey (CGS) indicates a groundwater depth of 50 feet (CGS, 2002) or deeper below the ground surface across the site. The approximate locations of our exploratory borings and percolation test are shown on the Site Plan, Figure 2. Details regarding our field program are included in Appendix A.

We performed one infiltration test at a depth of 4½ feet below the existing grade using the “Deep Quick Infiltration Testing Methodology”. This testing methodology is not designated as an ASTM method; however, it is generally accepted throughout the San Francisco Bay Area for testing insitu soil to evaluate the infiltration characteristics. The results from our test are summarized below in Table 2 for the test location indicated on the Site Plan, Figure 2.

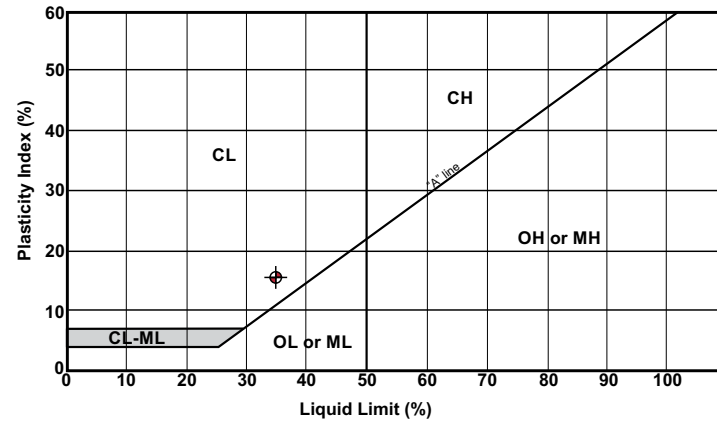
Plasticity Index Testing Summary	Project Number 473-8-1
	Pueblo De Dios Park 3257 Payne Avenue San Jose, CA	Figure Number Figure B1
	February 2019	Drawn By CLL

Plasticity Index (ASTM D4318) Testing Summary

Symbol	Boring No.	Depth (ft)	Natural Water Content (%)	Liquid Limit (%)	Plastic Limit (%)	Plasticity Index	Passing No. 200 (%)	Group Name (USCS - ASTM D2487)
⊕	EB-2	2.0	19	35	19	16	—	Lean Clay with Sand (CL)
