## **Appendix D: Geotechnical Supporting Information**

<b>Type of Services</b>	<b>Preliminary Geotechnical Investigation</b>
<b>Project Name</b>	<b>Moorpark Residential Development</b>
<b>Location</b>	<b>2323 Moorpark Avenue San Jose, California</b>
<b>Client</b>	<b>TTL Management, Inc.</b>
<b>Client Address</b>	<b>12647 Alcosta Blvd., Suite 470 San Ramon, CA</b>
<b>Project Number</b>	<b>648-20-2</b>
<b>Date</b>	<b>December 2, 2019</b>

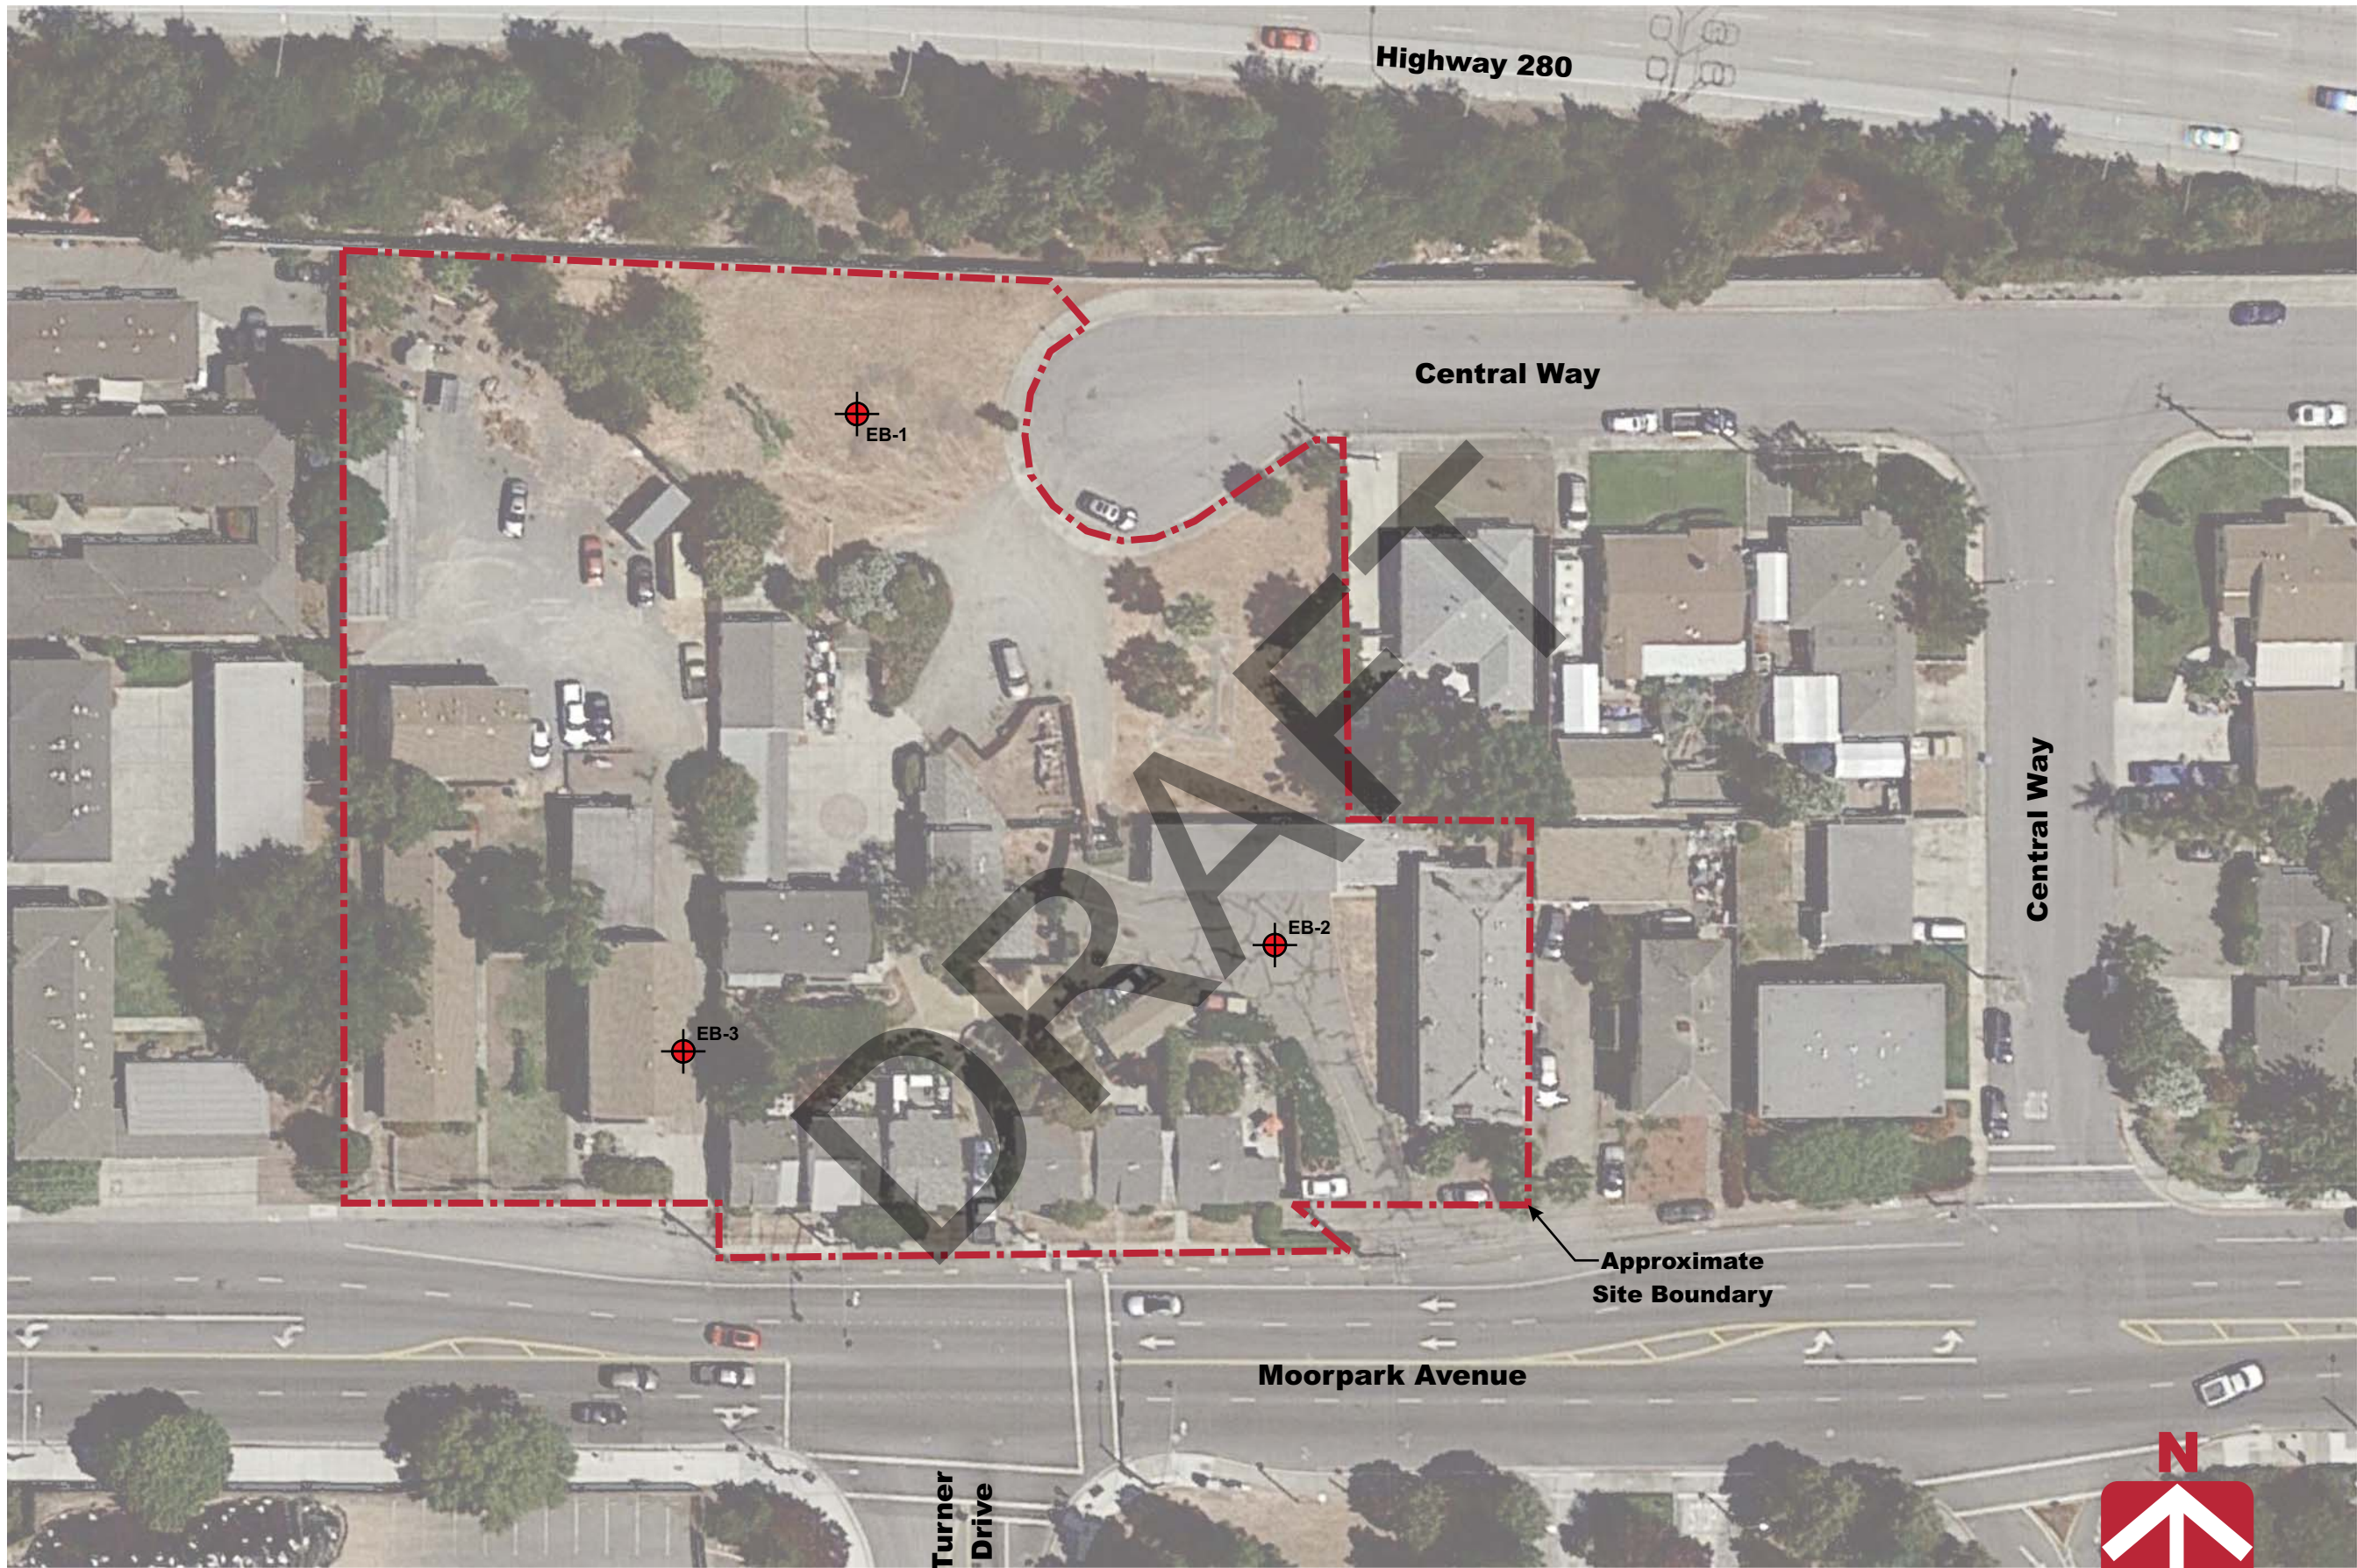
Approximate location of exploratory boring (EB)

The field investigation consisted of a surface reconnaissance and a subsurface exploration program using truck-mounted, hollow-stem, auger drilling equipment. Three 8-inch-diameter exploratory borings were drilled on October 25, 2019 to depths of approximately 20 feet. The approximate locations of exploratory borings are shown on the Site Plan, Figure 2. The soils encountered were continuously logged in the field by our representative and described in accordance with the Unified Soil Classification System (ASTM D2488). Boring logs, as well as a key to the classification of the soil, are included as part of this appendix.

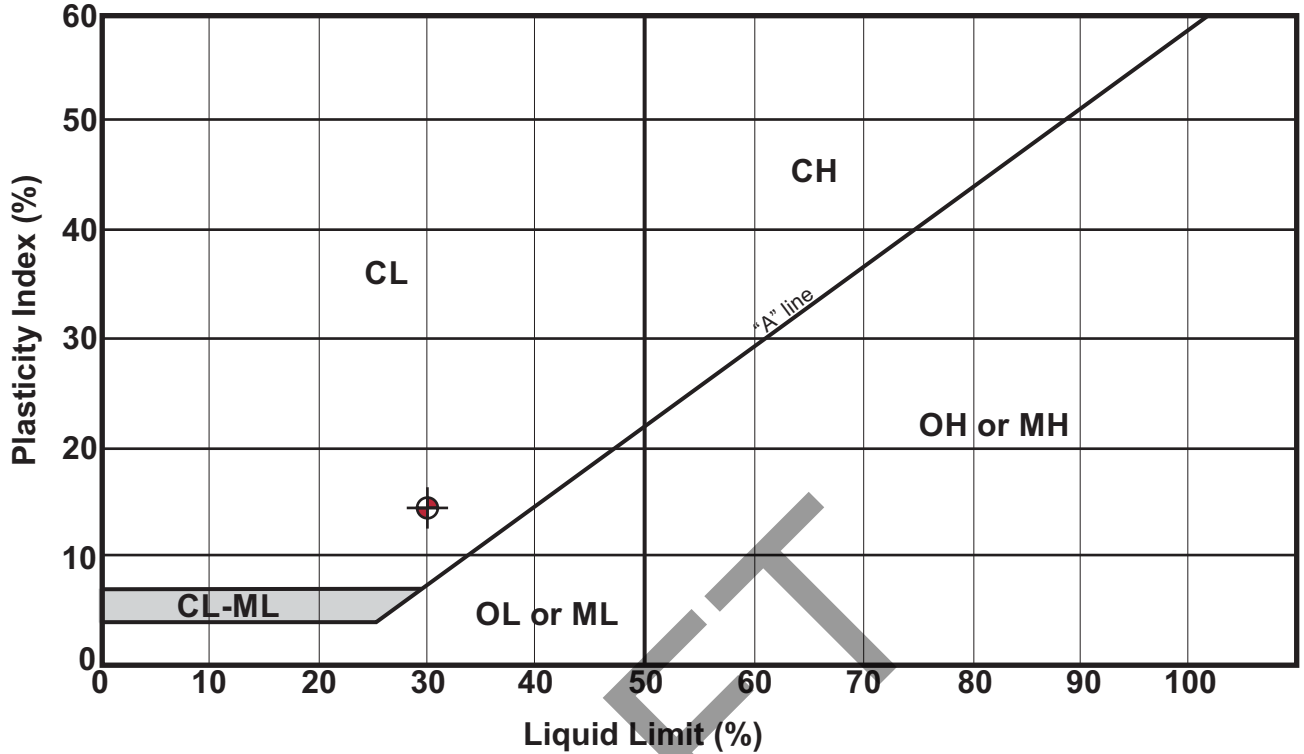
### Plasticity Index (ASTM D4318) Testing Summary

Symbol	Boring No.	Depth (ft)	Natural Water Content (%)	Liquid Limit (%)	Plastic Limit (%)	Plasticity Index	Passing No. 200 (%)	Group Name (USCS - ASTM D2487)
⊕	EB-2	2.0	14	30	16	14	—	Lean Clay with Sand (CL)
