Prepared for **SummerHill Homes**

**PRELIMINARY GEOTECHNICAL INVESTIGATION  
PROPOSED RESIDENTIAL DEVELOPMENT  
210 BAYPOINTE PARKWAY  
SAN JOSE, CALIFORNIA**

April 14, 2022  
Project No. 22-2192

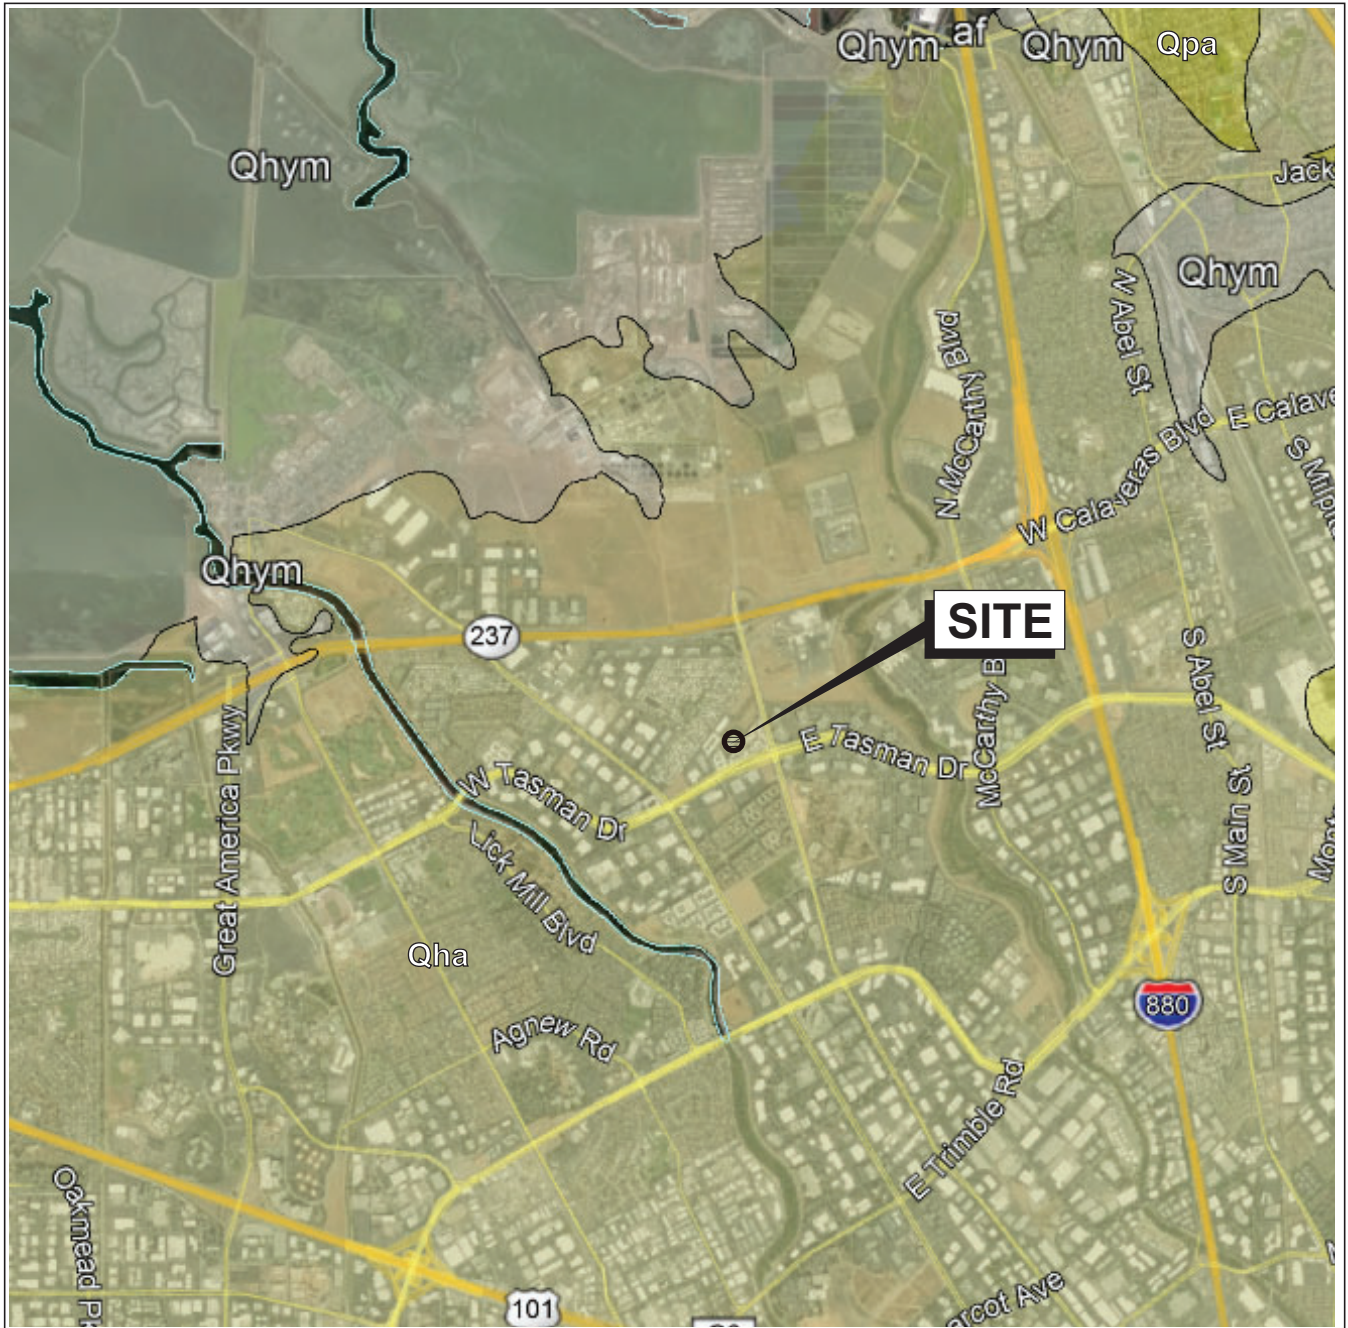
- af** Artificial Fill
  - Qhym** Mud deposits (late Holocene)
  - Qha** Alluvium (Holocene)
  - Qpa** Alluvium (Pleistocene)
- Geologic contact:  
 dashed where approximate and dotted  
 where concealed, queried where uncertain

**REGIONAL GEOLOGIC MAP**

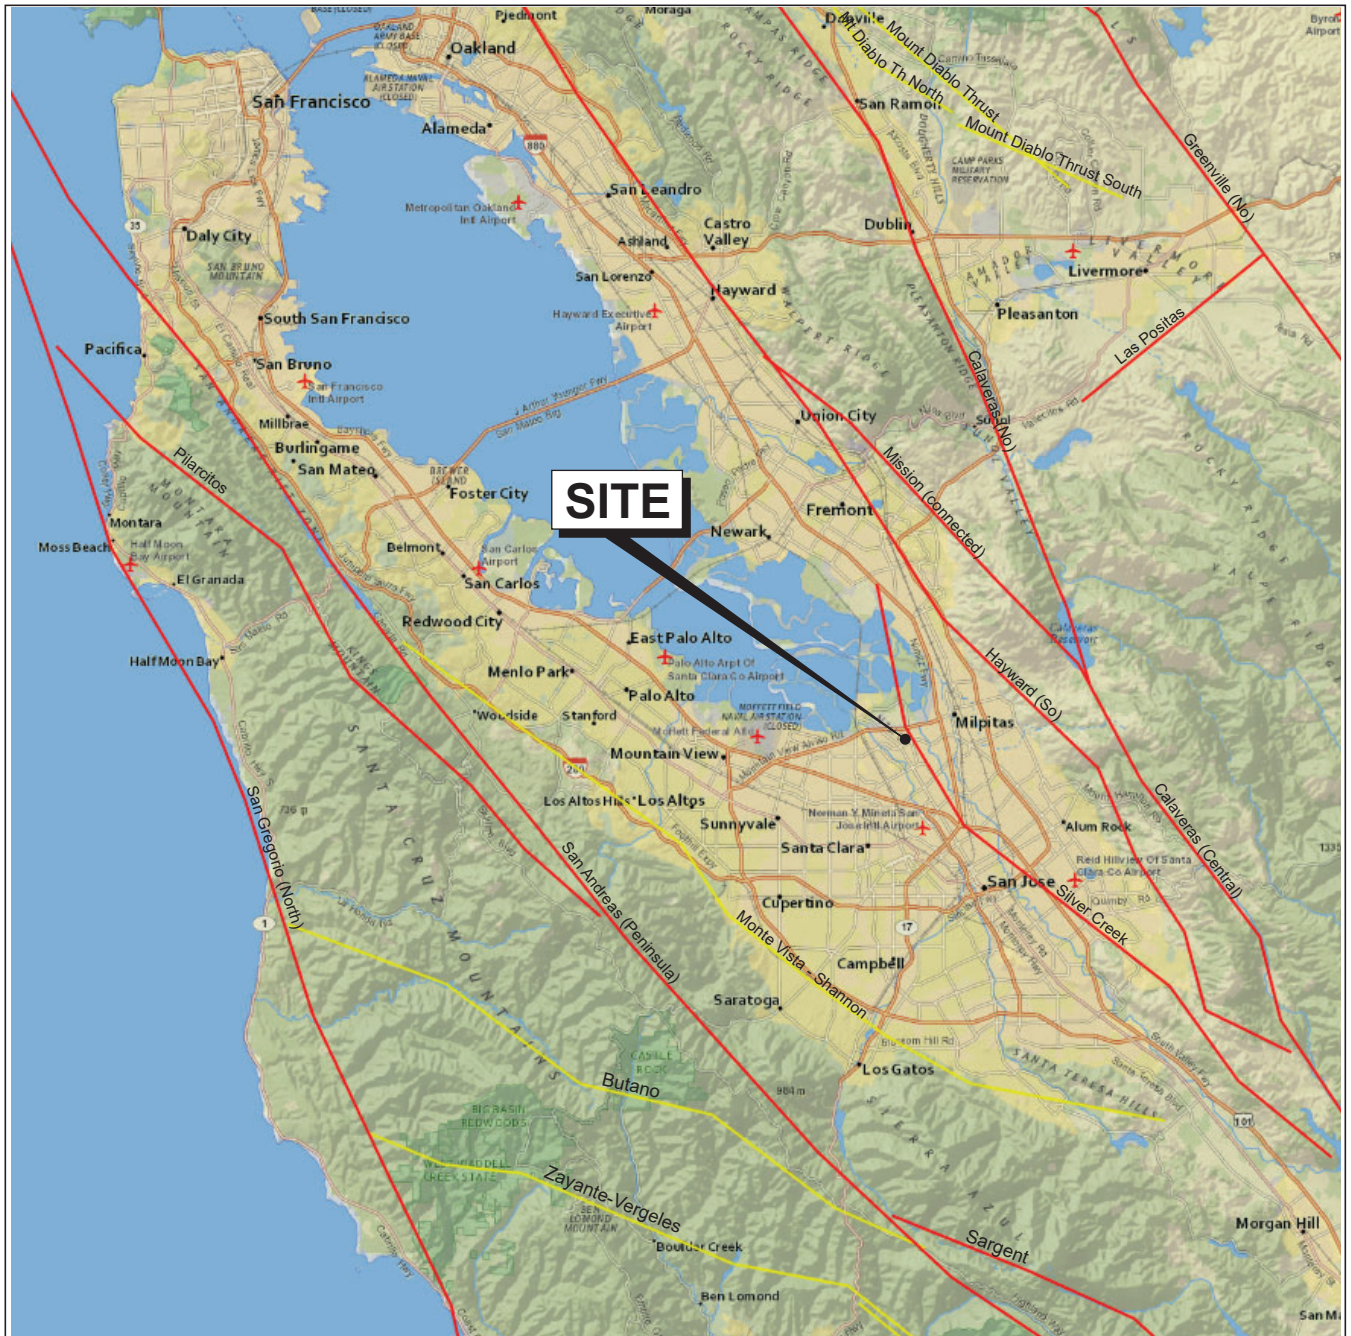
Base Map: U.S. Geological Survey (USGS), National Seismic Hazards Maps - Fault Sources, 2014.

**REGIONAL FAULT MAP**
